# Learning from Earthquakes

## The Zagreb Earthquake of 22 March 2020 A remote study by the LfE UK team for EEFIT

# THE ZAGREB EARTHQUAKE OF 22 MARCH 2020

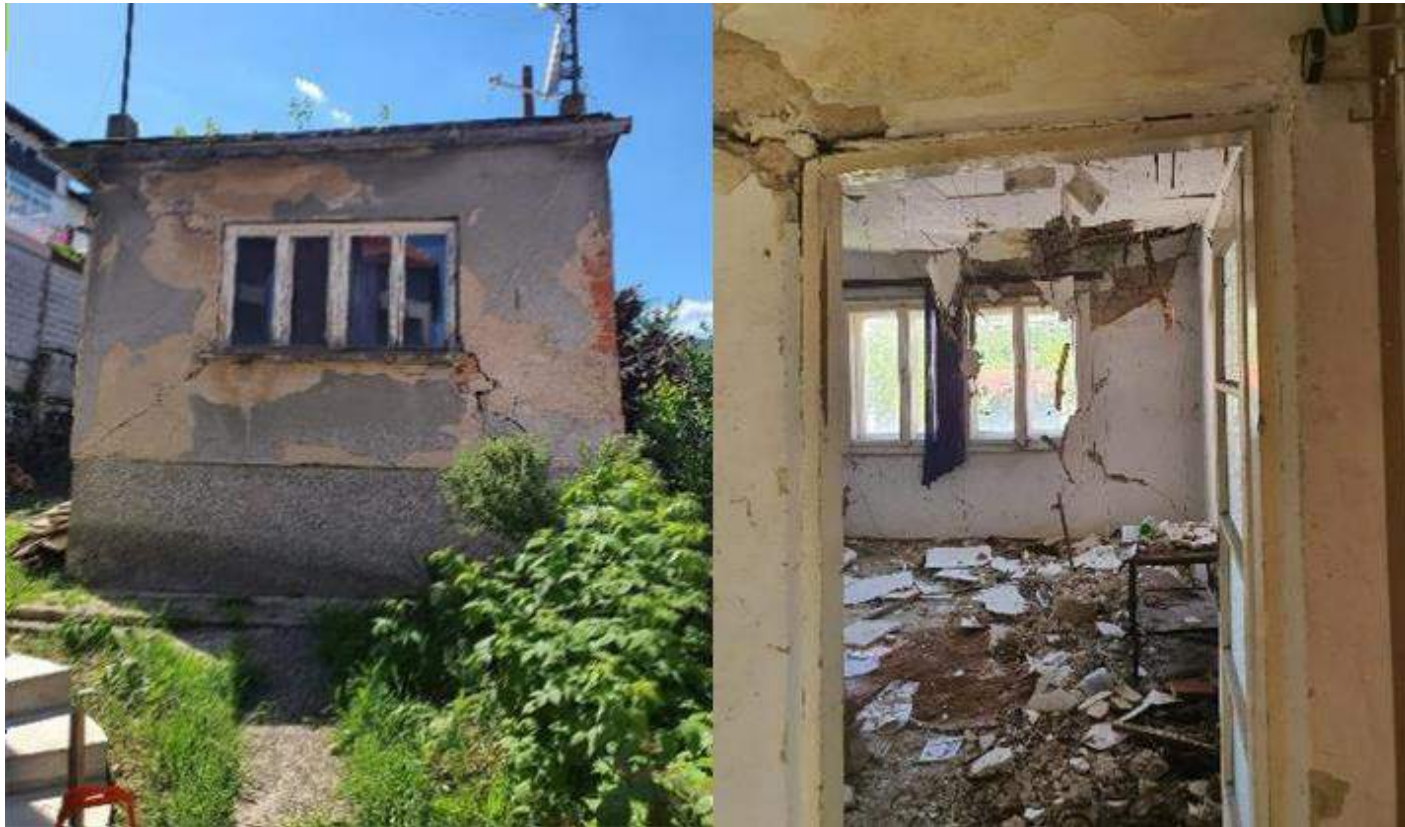
External and internal damage to a house in Orehovečki brijeg

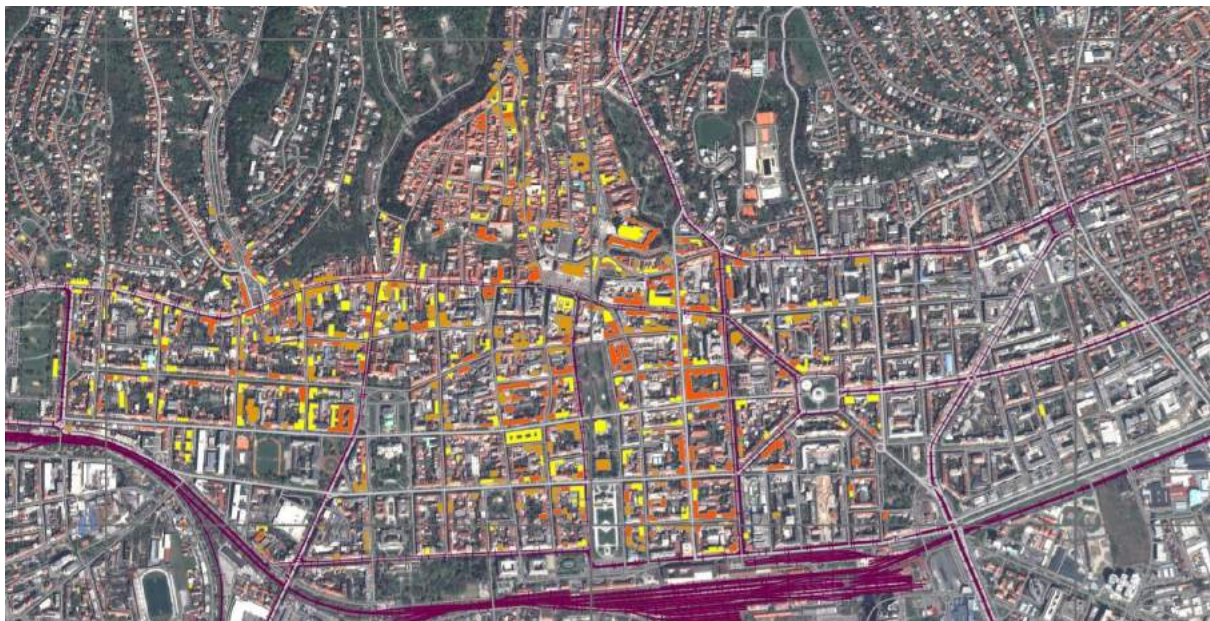
Figure 2-1 and Figure 2-2 provide, respectively, excerpts of the damage and the reconstruction monitoring maps covering the city centre of Zagreb. In the damage map, building footprints marked in red have been destroyed. In the same map, vivid orange footprints symbolise severely damaged buildings, burnt orange ones are instead moderately damaged, and lastly, the yellow footprints show buildings for which damage could be possible but could not be fully ascertained. The reconstruction maps depict progress as of 4<sup>th</sup> May 2020. Footprints are marked in green for the fully reconstructed/repared buildings, in yellow if the reconstruction is on-going and in orange if the building remained unchanged.

*Figure 2-1 – An excerpt of the damage assessment map released by CEMS on 15<sup>th</sup> May 2020.*

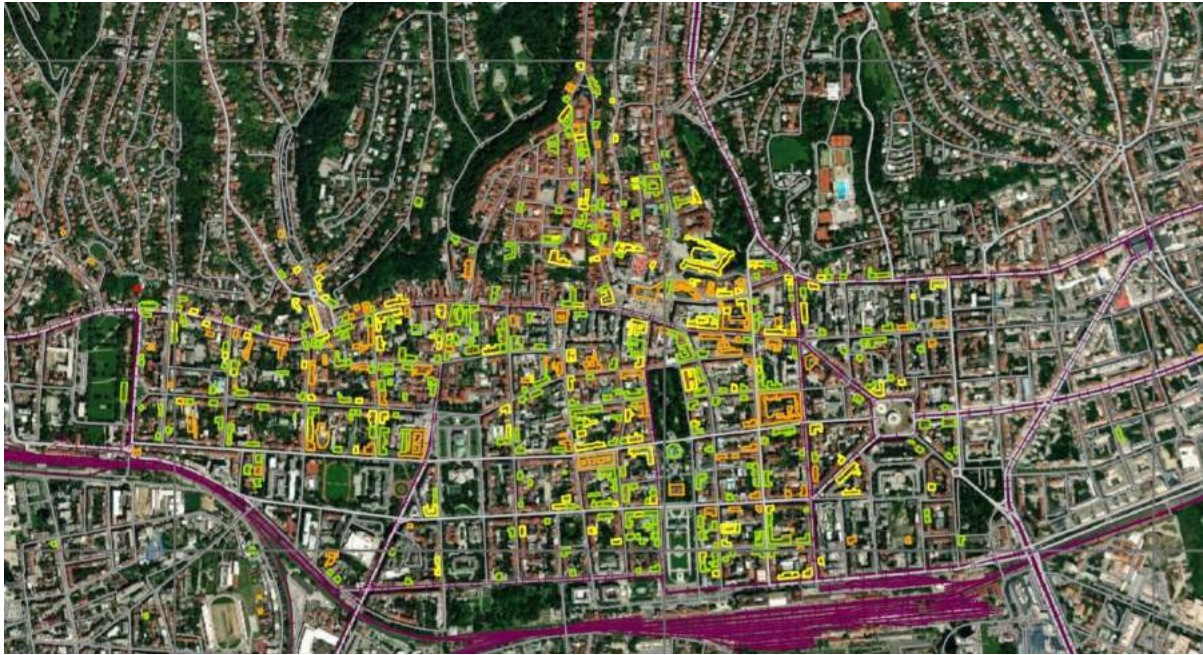
Figure 2-2 – An excerpt of the reconstruction monitoring map released by CEMS on 15<sup>th</sup> May 2020.

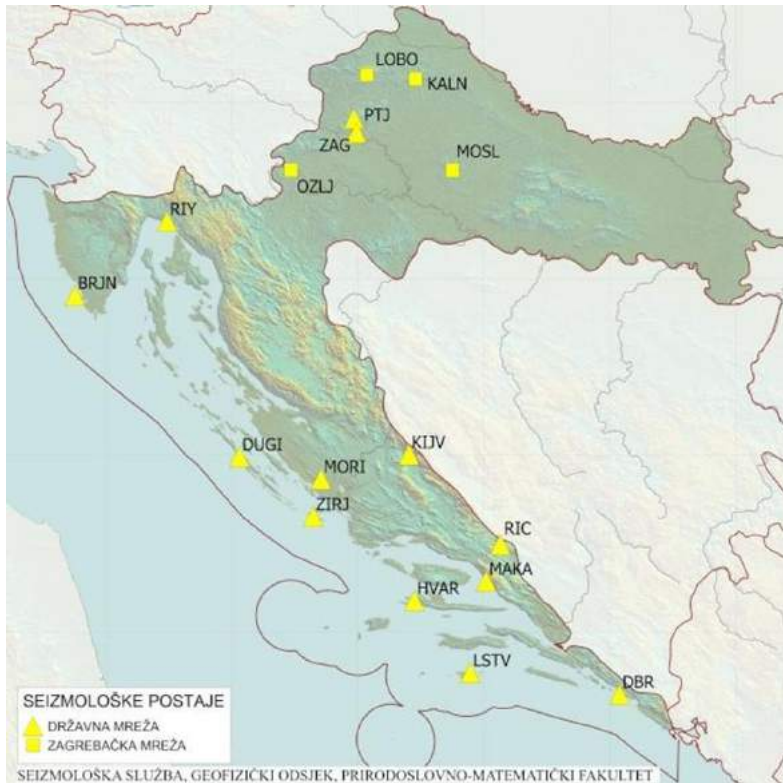
Station Name	Location
BRJN	Brijuni
DBR	Dubrovnik
DUGI	Dugi otok
HVAR	Hvar
KALN	Kalnik
KIJV	Kijevo
LOBO	Lobor
LSTV	Lastovo
MAKA	Makarska
MORI	Moriči
MOSL	Moslavačka gora
OZLJ	Ozalj
PTJ	Puntijarka
RIC	Ričice
RIY	Rijeka
ZAG	Zagreb
ZIRJ	Žirje

Figure 3-5 – Map and list of the stations of the permanent seismograph network in Croatia.

All felt events in the area have occurred below 6 km, and recent seismicity suggests the seismogenic layers extend to depths of about 16 km (Herak et al., 2009). The permanent seismograph network in Croatia now consists of the stations mapped in . Additionally, 15–20 stations are deployed in the framework of research projects or contracts with industry.

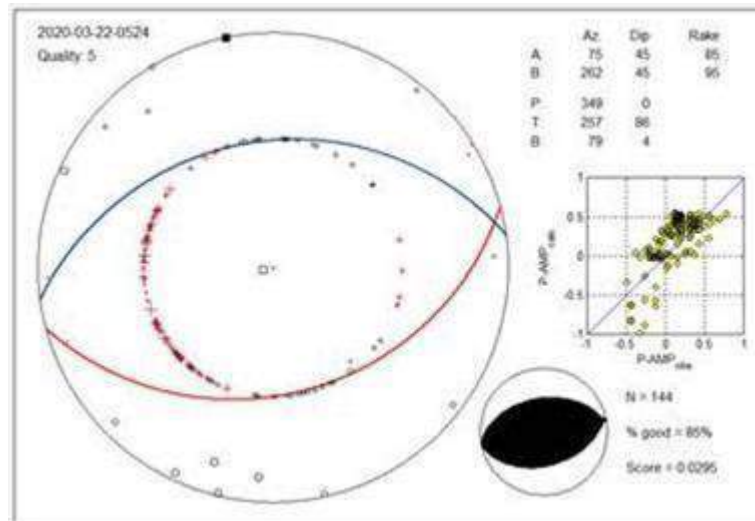
Figure 3-10 – Focal mechanism of the main shock calculated with the direction and amplitude of the first P-wave displacement taken from the 144 seismograms recorded in Croatia and across Europe.

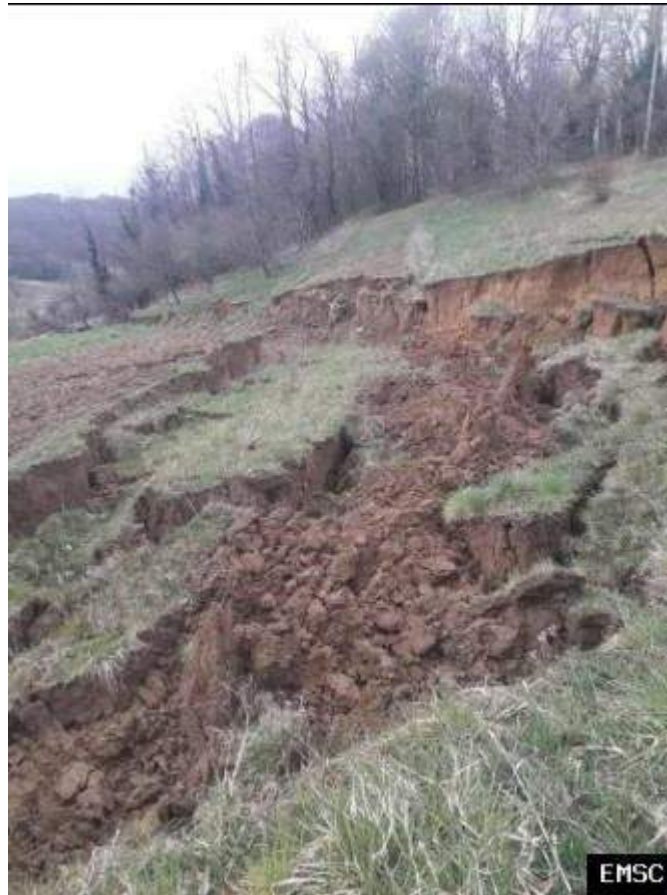
In addition to Dr. Valkaniotis' post, the photograph in Figure 3-14 was posted on EMSC (and reposted on other outlets) on numerous platforms associating the shown movement to the Markusevec fault. Still, the location of this slope failure has not been found. The photo almost certainly shows a slope that has undergone failure, but it is unclear if it is due to the ground shaking from this earthquake.

Figure 3-14 – Slope failure tagged as 6km from the epicentre on the EMSC website but not supported in any other official sources. <https://www.emsc-csem.org/Earthquake/Gallery/?id=840695>

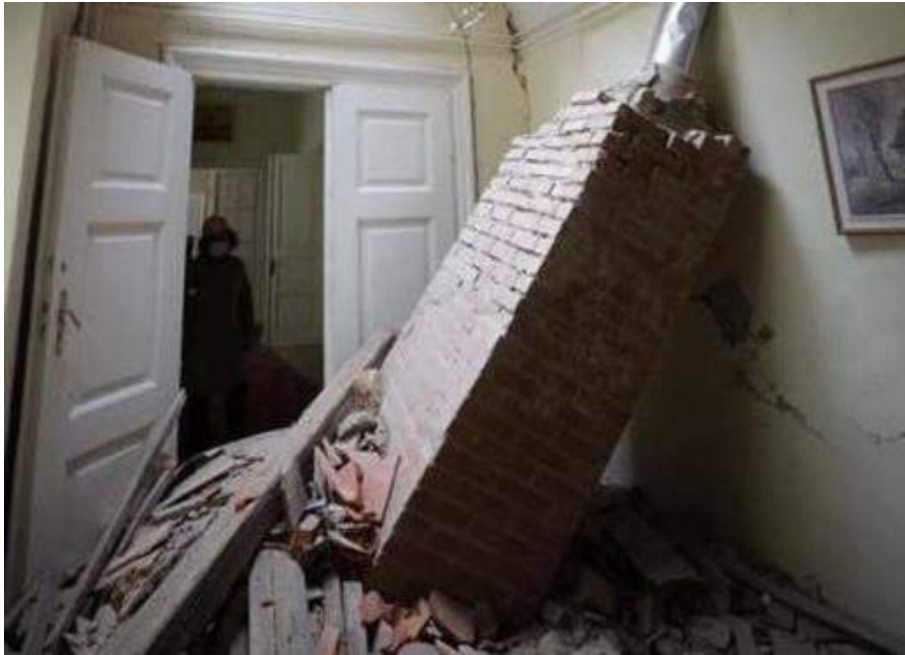
Figure 5-1 Damage of chimney falling indoor Source: City of Zagreb

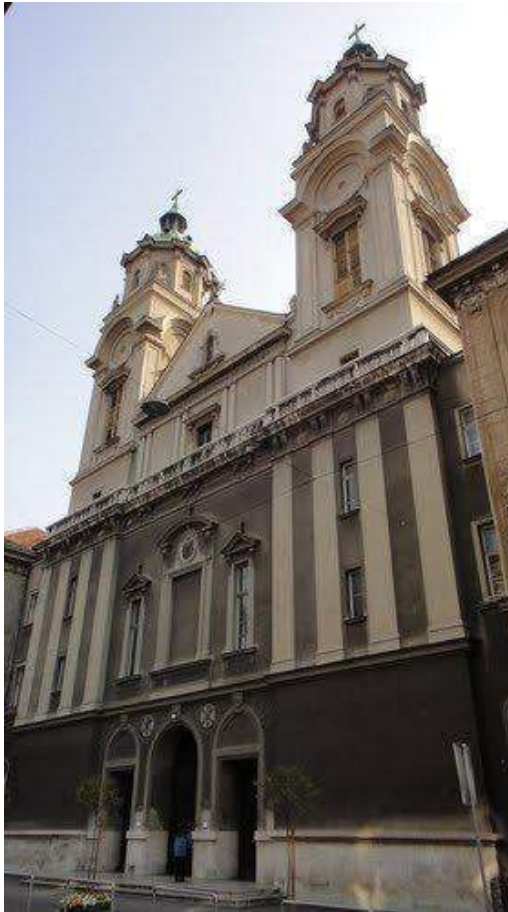
*Figure 5-3 – The outside of the Basilica*

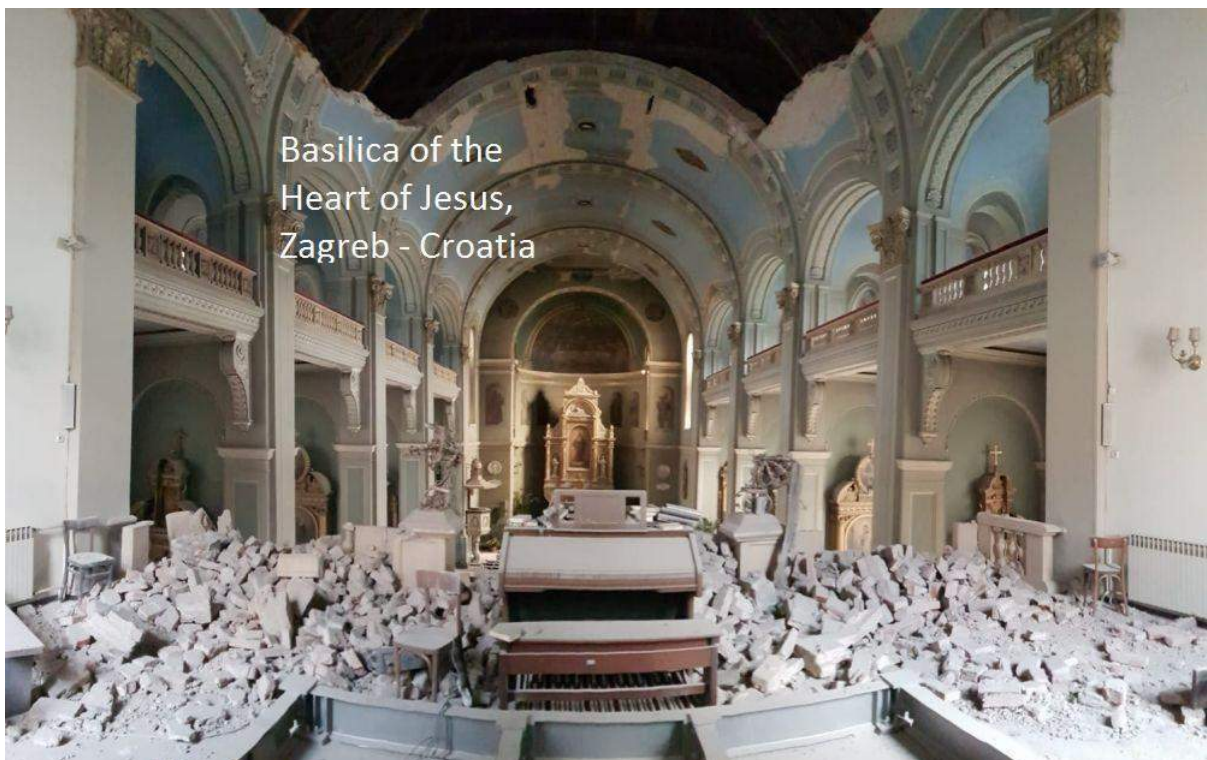
*Figure 5-4 – Indoor damage of the Basilica of the Heart of Jesus – Zagreb*

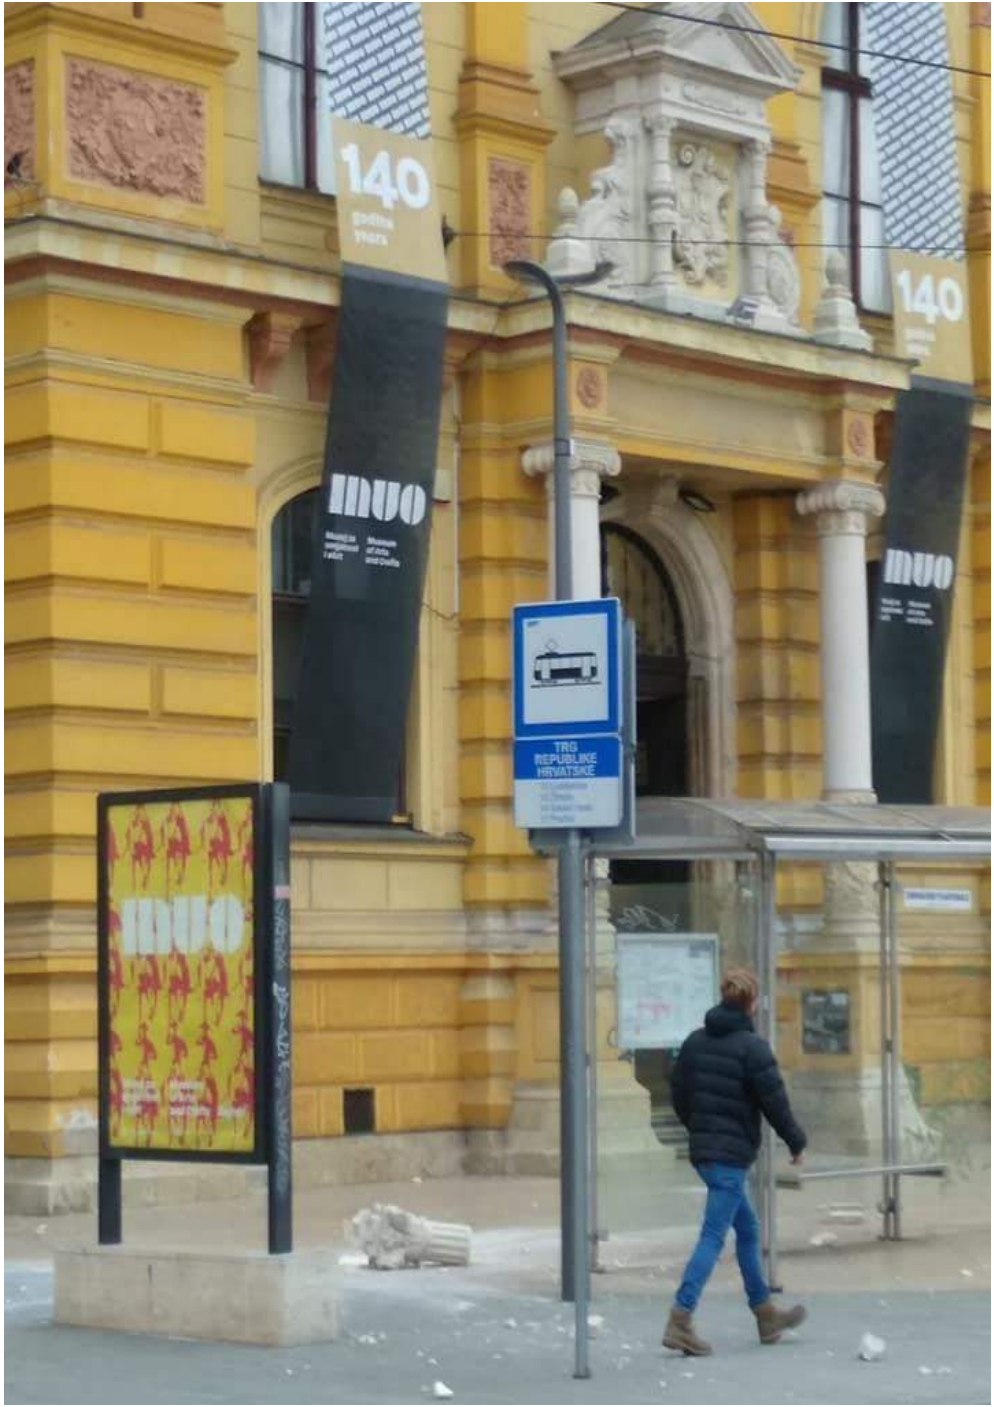
The images below of the MUO have been taken from their Facebook page, showing damage falling ornaments off the façade onto the street below and a roof collapsing inward at one part of the museum complex.

Figure 5-5 – Damage on the façade of the Museum of Arts and Crafts (MUO)

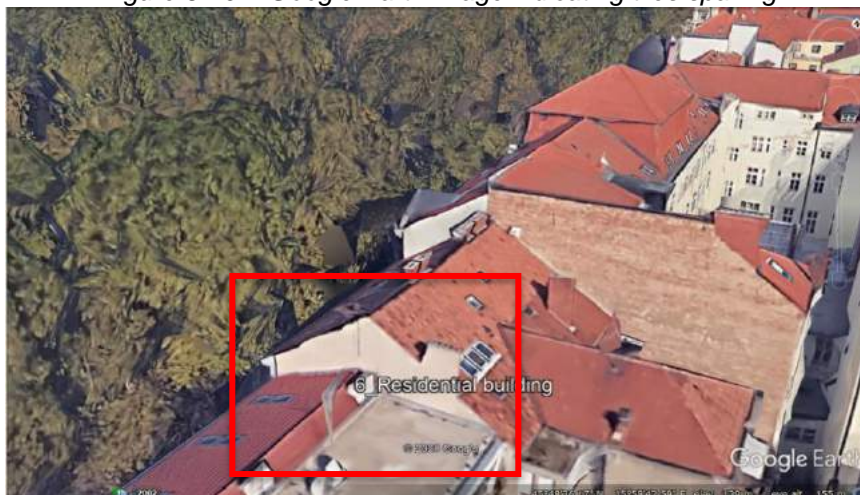
Figure 5-11 – Google Earth image indicating gable failure

Gable failure of a residential building. The damage is contained within the upper part of the façade bounded by the red box

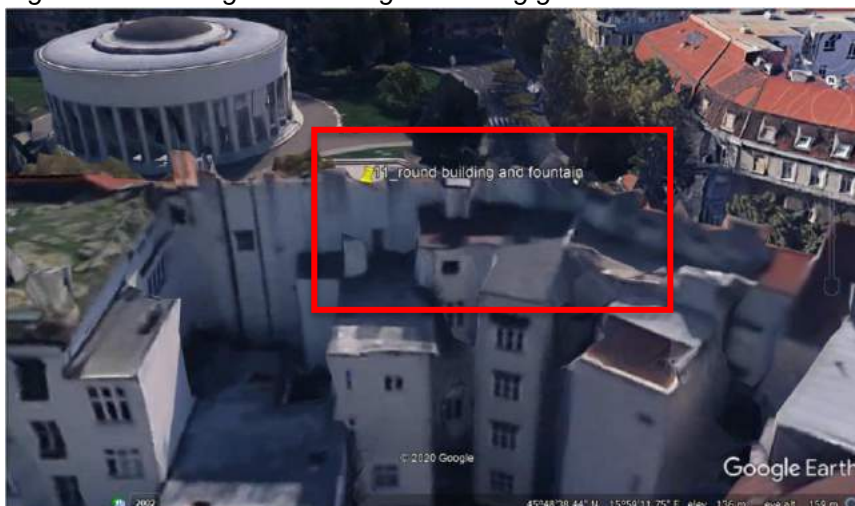
Figure 5-12 – Google Earth image indicating gable failure

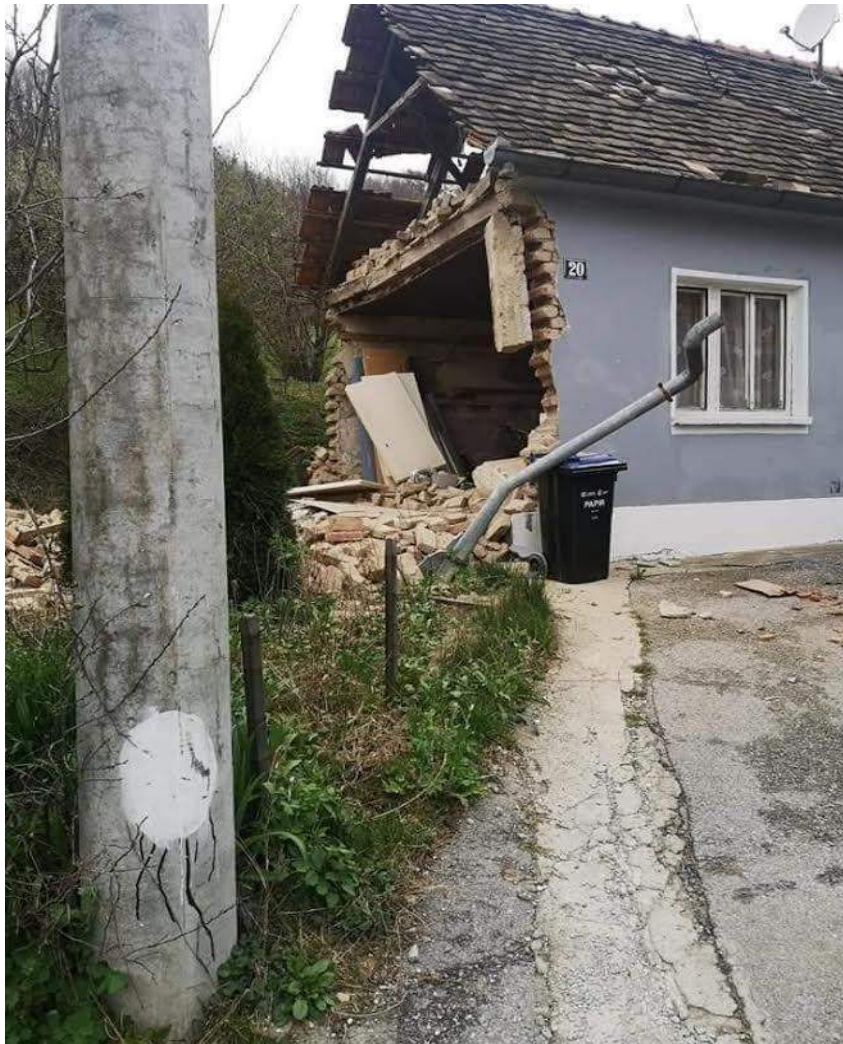
*Figure 5-13 – Collapse of the whole façade – credits to Dolores Rogic*

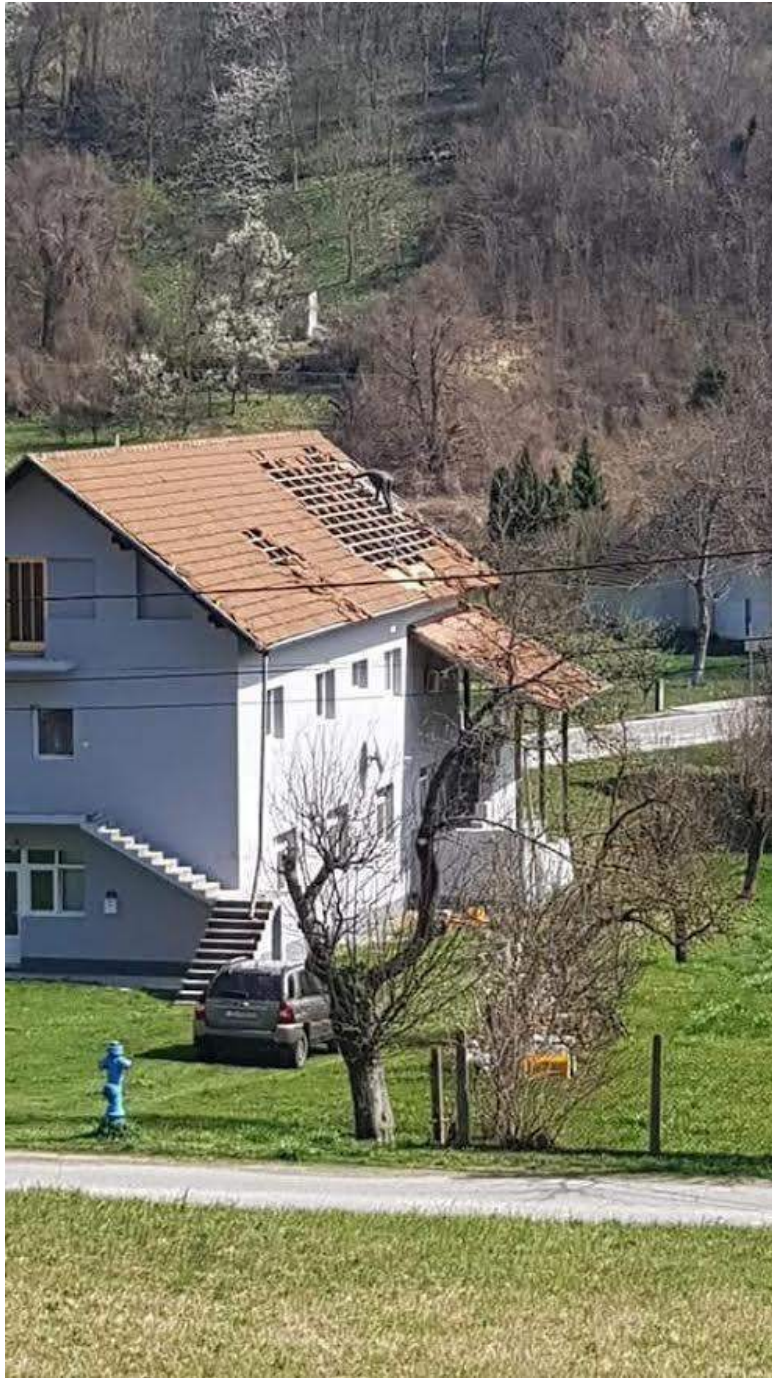
*Figure 5-14 – Roof damage, credits to Dolores Rogic*

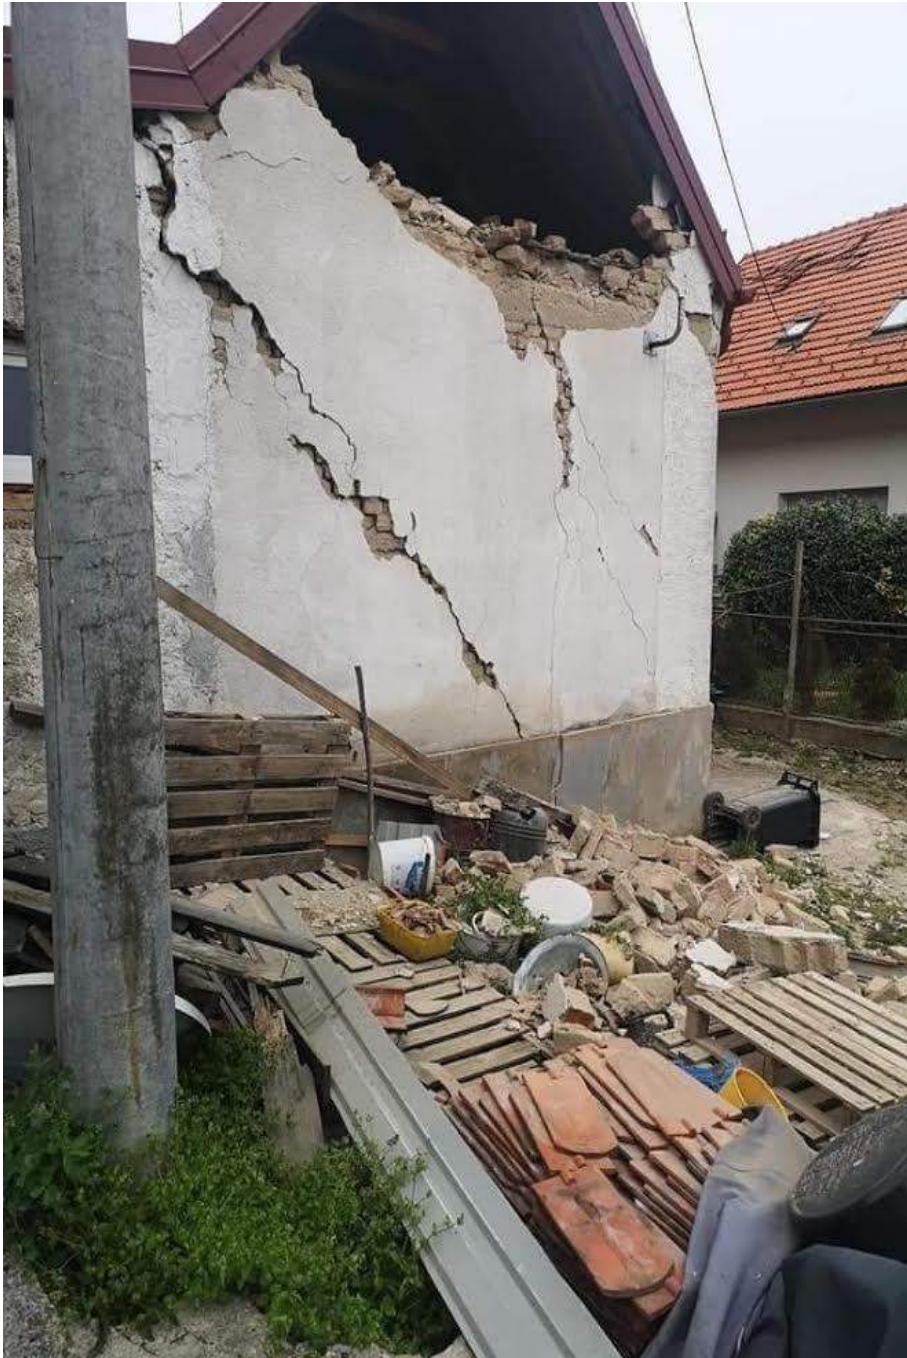
*Figure 5-15 – Gable failure, credits to Dolores Rogic*

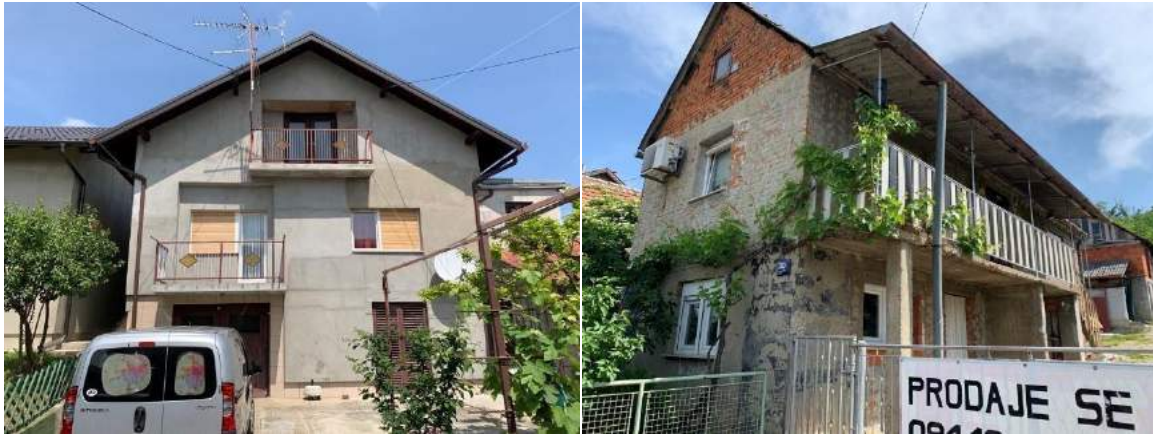
Figure 5-19 Day 1 Figure 5-20 Day 1

Figure 5-21 shows the damage assessment undertaken in the village of Kašina, on Day 1. 23 units were surveyed and 82% of them fell into the DG1 category. The secondary assessment categorised the whole sample to DG1. There is therefore a 18% discrepancy between the two assessments. Figure 5-22 Figure 5-23 are representative of the building conditions with very limited damage.

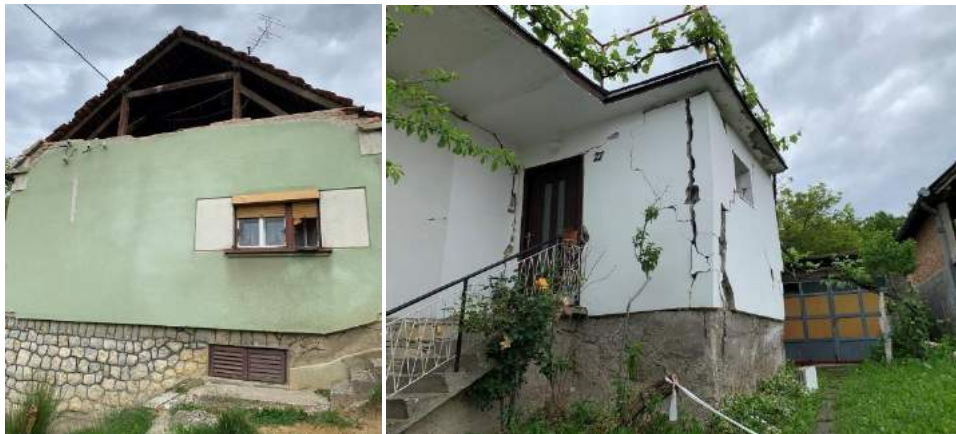
Figure 5-26 – Day 2 Figure 5-27 – Day 2

The survey carried out in the village of Markuševec showed a more varied set of damage grades which were also confirmed in the secondary assessment. While the two assessments resulted in very similar proportions of buildings being in DG1, a slight damage overestimation was noted, where the first assessment had assigned DG4 instead of DG2, in the secondary assessment exercise. Such a discrepancy might be ascribable to the partial information provided to the assessors conducting the remote survey as well as the scarce occurrences of severe damage in the village, beside the two cases as shown in Figure 5.26 and Figure 5.27.

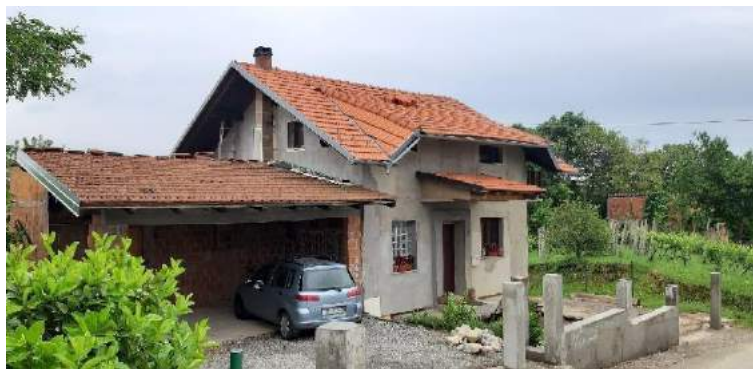
Figure 5-30: Day 3

All the surveyed buildings from the first assessment were given a DG1 grade, which signifies damage such as air crack lines or detachment of plaster or limited fall of rubbles from chimneys or balconies. In the secondary assessment, the majority were graded at DG0.

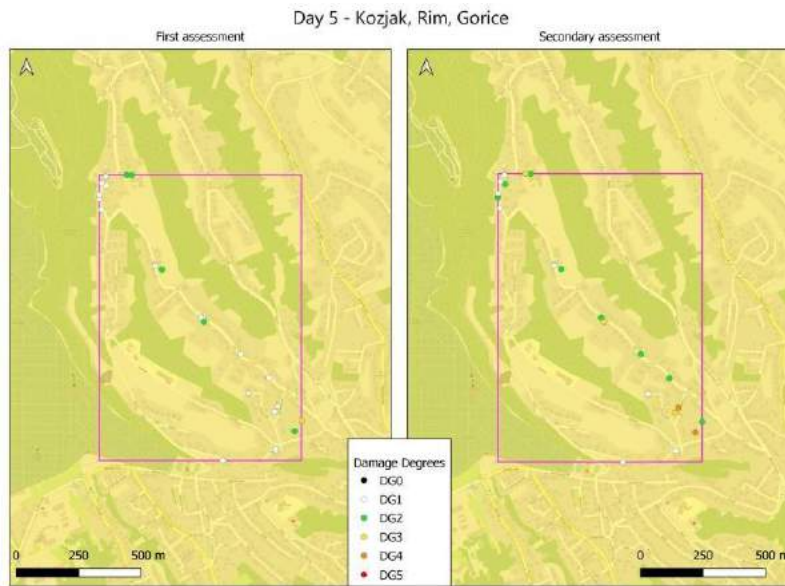
Figure 5-35: Day 5 Kozjakm, Rim, Gorice village – First and Secondary Assessment’s maps

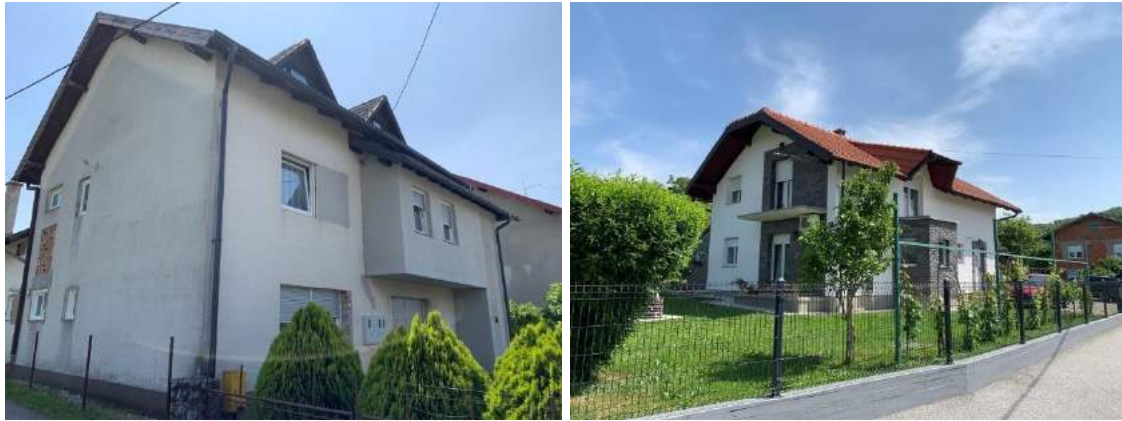
*Figure 5-42: RC buildings mistakenly reported as masonry*
