An Evaluation of the Operational Restrictions Imposed to Congonhas Airport by Civil Aviation Instruction 121-1013

Aviation Management Program – Class of 2019

A Capstone Project Submitted to Embry-Riddle Aeronautical University in Partial Fulfillment of the Requirements for the Aviation Management Certificate Program

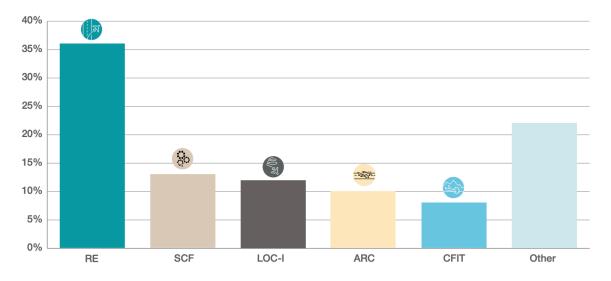
Figure 2.1 - Percentage of hull losses by accident category 1999-2018

In Figure 2.1 below, the researchers can see how significant the contribution of runway excursions to total accidents is, where more than 35% result in aircraft losses.

According to the Airbus study, Runway Excursions (RE), including both lateral and longitudinal types, are the third more important cause of fatal accidents by numbers, and the single most significant cause 15% of hull losses. (AIRBUS, 2019)

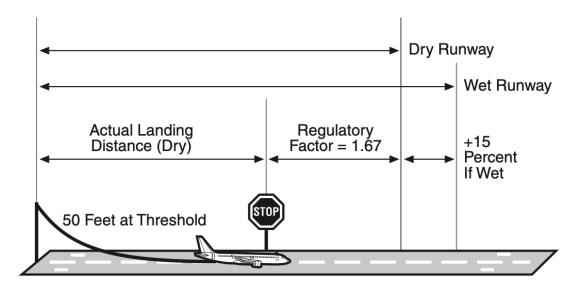
Figure. 2.2 Landing distance dispatch requirements

In figure 2.2 below, the researchers can see the requirements and factors that must be applied to the actual landing distance.

Required runway length (dry) = Actual landing distance (dry) x 1.67 Required runway length (wet) = Actual landing distance (dry) x 1.92

Besides, the RBAC 121.195 also states that when the weather forecast indicates that the destination aerodrome runway may be wet or slippery at the estimated landing time, no Dispatch will be allowed unless the runway length is at least 115% (1.92 factor) of the actual landing distance for the specific conditions (RBAC 121.195, p.42).

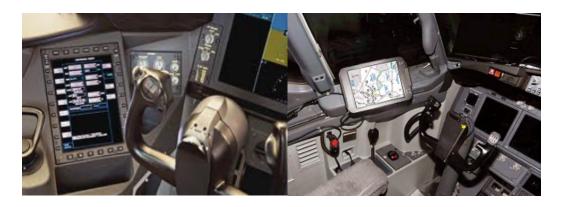
Figure 2.4 – Installed and portable EFB examples

The Electronic Flight Bag (EFB) is an electronic management device (portable or installed) that allows pilots to perform the necessary calculations more quickly and efficiently with less paper. It is a computing platform aiming to reduce, or substitute, paper-based material such as performance tables, documentation such as aircraft operating manual, navigational charts (offering moving map for air and ground operations), performance application software designed to automate tasks typically conducted by hand, such as performance take-off and landing calculations (FAA AC 120-76D, 2017). Figure 2.3 is an example of portable and installed EFBs.

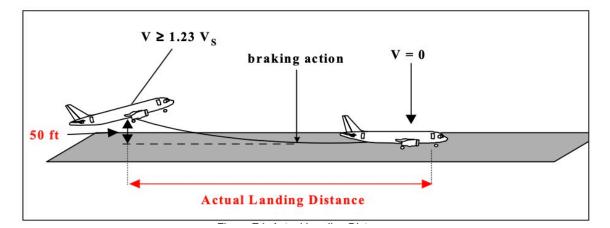
Figure 2.5 - Actual Landing Distance

- Flying an optimum flight segment from 50 feet over the runway threshold to the flare.
- Firmly touchdown (not extending the flare).
- Use maximum pedal braking

According to the Flight Safety Foundation, these published landing distances are seldom achieved in line operations (ALAR, 2000).

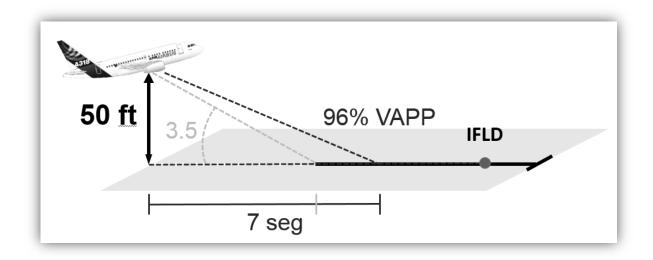
Figure 2.7 – Flare time used in EFB calculations

As shown in figure 2.6, the calculations performed by the EFB consider a 7 seconds flare in the In-Flight Landing Distance. This extended flare time adds a protection layer. As it is closer to the pilot line operation real scenario, instead of flying directly onto the ground aiming a firm touchdown.

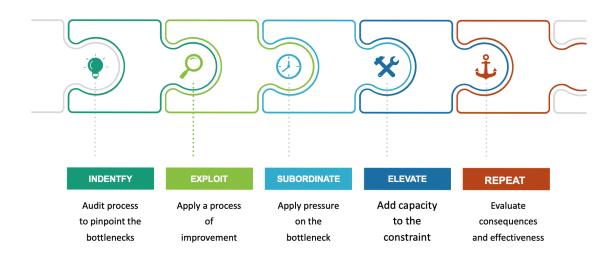
Figure 3.1 – Theory of Constrains

A theory choose to guide researchers in the Theory of Constraints (TOC). TOC is widely used to improve the efficiency of business operations. Developed by Eliyahu Goldratt (The Goal, 2004) allows researchers to perform an analysis using the five steps described below:

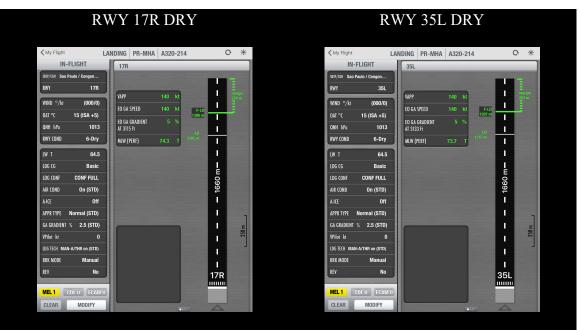
Figure 3.2 – In-flight LD with One Thrust Reverse Inoperative

One Thrust Reverse Inoperative – MEL 78-30-01A

DRY						
MEL ITEM	In-flight Landing Distance						
	LW	LD/FLD	Margin				
17R No Failure	64.5	1164/1339	321				
17R 78-30-01 One Thrust reverser	64.5	1205/1386	274				
35L No Failure	64.5	1173/1349	311				
35L 78-30-01 One Thrust reverser	64.5	1215/1397	263

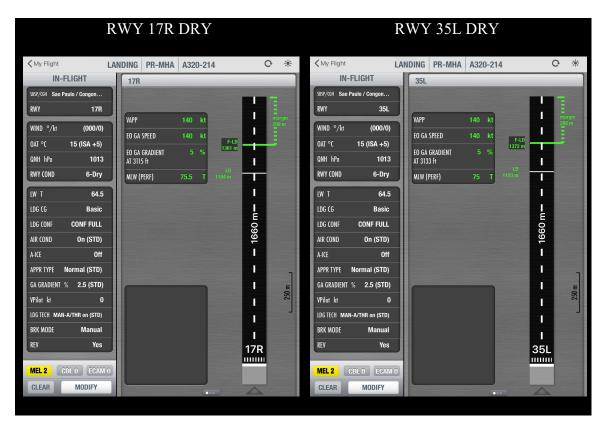
Figure 3.4 – In-flight landing distance with LGCIU 1 Inoperative

Landing Gear Control and Interface Unit (LGCIU) 1 in-flight - MEL 32-31-01

DRY						
MEL ITEM	In-flight Landing Distance						
	LW	LD/FLD	Margin				
17R No Failure	64.5	1164/1339	321				
17R 32-31-01 LCGIU 1	64.5	1184/1361	299				
35L No Failure	64.5	1173/1349	311				
35L 32-31-01 LGCIU 1	64.5	1193/1372	288

The LGCIU 1 failure shown in table 3.3, is a no-dispatch condition; this means that the aircraft will not take off when this failure is present. However, in case it occurs during the flight, the EFB can calculate the landing distances.

Taking a closer look at the landing distance numbers for LGCIU 1 failure, the researchers observe that the impacts are not significant. Once again, even though the calculation assures that the operation even with the LGCIU 1 is possible, the IAC 121-1013 doesn't allow such operation, once the LGCIU 1 failure affects the Reverser 1 (inoperative).

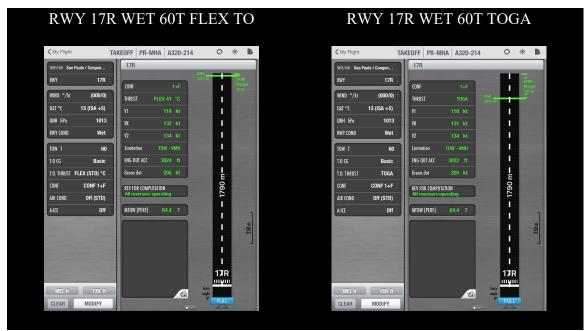
Figure 3.7 – Flex and TOGA setting with the same Takeoff weight

In Figure 3.7, the researchers can see that even on takeoffs with smaller power thrust setting, the safety margin is achieved. The limiting factor will always be the MLW and not the determination of maximum power.

The use of the maximum thrust of an engine generates high costs and reduces the engine life, so it is desirable to takeoff with reduced thrust setting whenever applicable (Airbus FCOM, 2018).

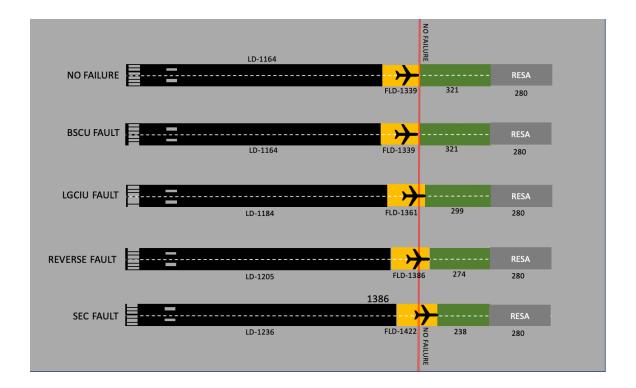
Figure 4.1 – IFLD and Margins for runway 17R (DRY)

In figure 4.1, the researchers can observe that the failures have minimal impact on safety margins. In the worst-case scenario (SEC FAULT), the margin is 238 meters, already included 15% for a factored landing distance. Including RESA, created by the virtual reduction of the track, we have 518 meters, equivalent to 1700ft.

After performing the landing analysis of the main failures that affect landing performance and comparing the respectively achieved margins, the researchers can conclude that the impact of the failures for the presented configuration and runway condition is minimal and does not justify being in place.

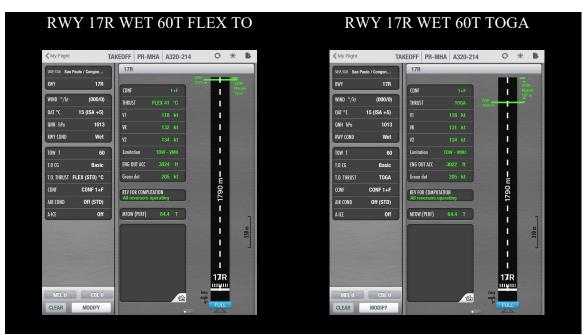
Figure 4.3 – Flex and TOGA setting with the same Takeoff weight

In Figure 4.3, the researchers can observe that in aircraft with the same take-off weight (60T), there is an increase in Accelerating and Stopping Distance (ASD) that results in a reduction in the final margin.

The researchers believe that the runway reduced power setting prohibition should be applied only in cases of a contaminated runway or the presence of heavy rain. In other cases, pilots and flight dispatchers should use EFB power settings.
