Title: Environmental Transformation and the Current State of Hydrogeological Condition in the Wojkowice Area-Southern Poland

Environmental Transformation and the Current State of Hydrogeological Condition in the Wojkowice Area—Southern Poland

Abstract: Based on the analysis and interpretation of maps, remote sensing data published in the literature, and environmental reconnaissance, this article discusses environmental transformations in the Wojkowice area in southern Poland (up to the year 2020). A comprehensive analysis was carried out concerning spatial development, mining activity, hydrogeological conditions and the biotic environment. The current state of the hydrogeological conditions was also characterized. Mining activity in the vicinity of the studied town caused significant changes in its relief, which contributed to its area dropping by about 5 m. In fact, these terrain forms are overgrown by various forms of vegetation that colonized these areas both naturally and as a result of forest reclamation. The contemporary vegetation of Wojkowice differs from the potential natural vegetation, which is an indicator of the complete anthropogenization of the natural environment.

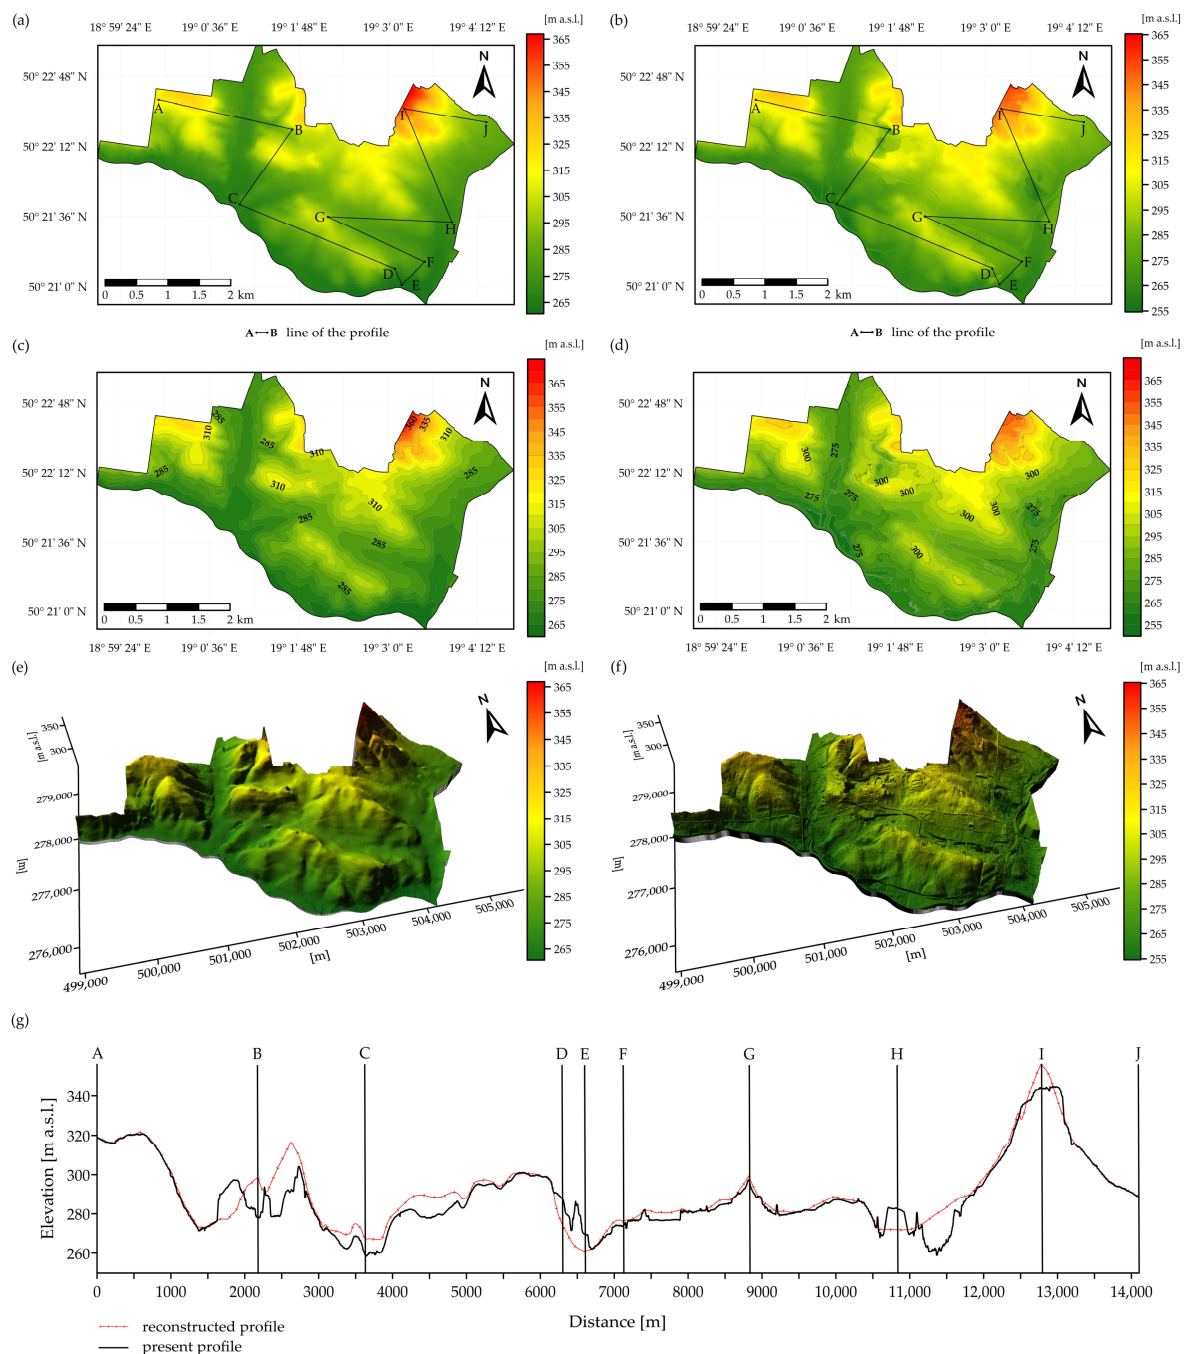
Figure 2. Changes in the relief of Wojkowice. Relief before the beginning of human impact: (a)—color relief map with topographic profile, (c)—hypsometric map, (e)—digital elevation model (DEM). Contemporary relief: (b)—color relief map with topographic profile, (d)—hypsometric map, (f)—digital elevation model (DEM); (g) topographic profile including reconstructed relief and present relief.

In order to better display the largest transformations of the landscape in Wojkowice, a 14,000 m long line of topographic profile A–I (Figure 2a,b,g) was marked across these objects (Figure 2g). In profile A–B, at a distance of 1900 to 2600 m, there is a depression which originated due to extraction activity of the “Saturn” Cement Plant. As a result of mining, this area has dropped by almost 36 m (from 315 to 279 m a.s.l.) (Figure 3).

In section B–C–D, at a distance of 3000 to 5100 m, mining subsidence is observed. This area now belongs to the Collective Farm “Przyjaźń”. The land has dropped by 10 m. The subsidence was caused by coal extraction in the “Jowisz” Coal Mine. Profile D–E (6200–6600 m) shows an overburden of extracted material—the height of the waste tip reaches 24 m. The ground rose from 259 to 183 m.a.s.l., mainly in the south-eastern part where two waste tips (No. 1 and No. 2) of the “Jowisz” Coal Mine were located. The next section of profile F–G runs across the industrial area of the former “Jowisz” Coal Mine and “Saturn” Cement Plant (7500–8600 m). Ground levelling necessary for the construction of both plants caused the surface to drop by 7 m (from 278 to 271 m.a.s.l.). Section G–H runs along the part of the town where no industrial activity was carried out. Only its terminating part, at a distance of 10,600 to 11,000 m, runs across the reclaimed sub-surface waste tip of “Grodziec” Coal Mine. Originally, this area was located at 265 m.a.s.l. As a result of extracting activity, the coal gangue from several coal mines, including “Jowisz” Coal Mine, was dumped there. The tip is 14 m high and reaches an altitude of 279 m.a.s.l. Profile H–I runs towards the north-west, where the “Uciekaj” Mine (11,200–11,700 m) used to operate with bootleg mining. Uncontrolled coal extraction by local people resulted in the development of a 25 m deep excavation, and the ground surface dropped from 282 to 260 m.a.s.l. Due to processes of plant succession, the excavation regenerated and is now overgrown by forest. The terminating part of section H–I and beginning of section I–J (12,500–13,100 m) includes part of the reclaimed Limestone Quarry of “Grodziec” Cement Plant. Limestone excavation caused the ground to drop by about 15 m (from 360 to 345 m.a.s.l.).
