# Assessment of the effects of vegetational cover on the long-term stability of a waste rock dump

Waste rock dump reclamation includes re-grading the banks to flatten the overall slope followed by re-vegetation. These measures are required to reduce surface erosion, provide physical stability, and meet future use goals. In some cases, the presence of trees can cause localized shear zones in a waste rock dump by the load of the tree mass and the action of wind, the presence of roots in the soil and the death of some species. In geotechnical assessment, however, the influence of trees on slope stability of waste rock dumps is only qualitative. This article assesses the effects of trees on slope stability of a reclaimed waste rock dump of an iron ore mine. Historic data of construction, laboratory tests, and stability analysis were evaluated. Slope stability assessments were performed after an extensive geotechnical and forest campaign, considering two scenarios - the final waste rock dump without the vegetational cover and the final waste rock with vegetational cover. Tree vegetation in slopes produces both positive and negative effects on slope stability. For scenario 1, the lowest

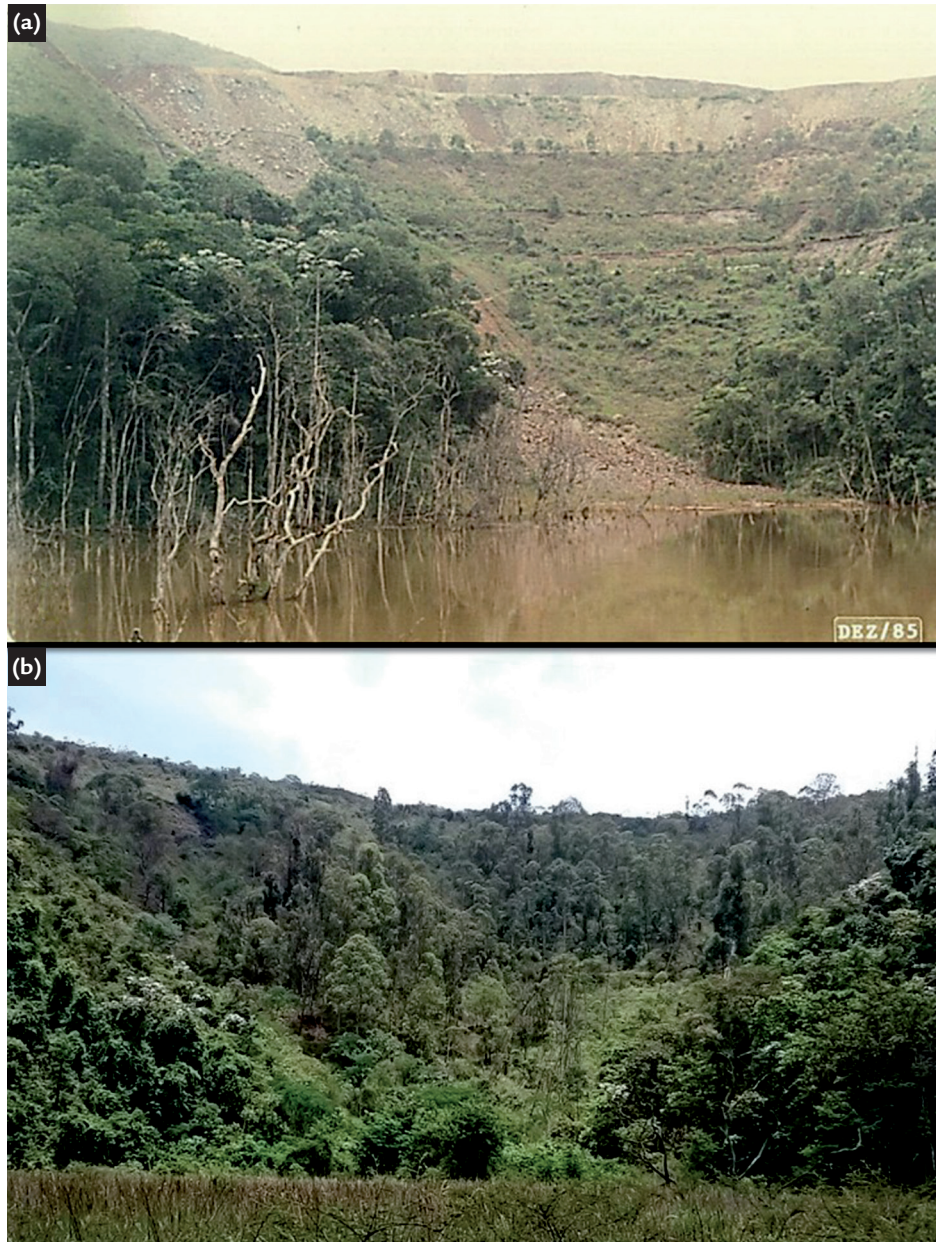
Figure 1  
The waste rock dump during the construction phase (a) and current (b).

However, the stability assessment considering the final vegetation cover is, usually, not performed. This article presents the geotechnical stability assessment, conducted on a 20-year old reclaimed waste rock dump (Figure 1). The dump is 190 m in height, contains about 50 Mm<sup>3</sup> of waste rock and occupies an area large than 270 ha. Historic data of construction, laboratory tests, and stability analysis were evaluated, as well as a more detailed characterization of the vegetation.

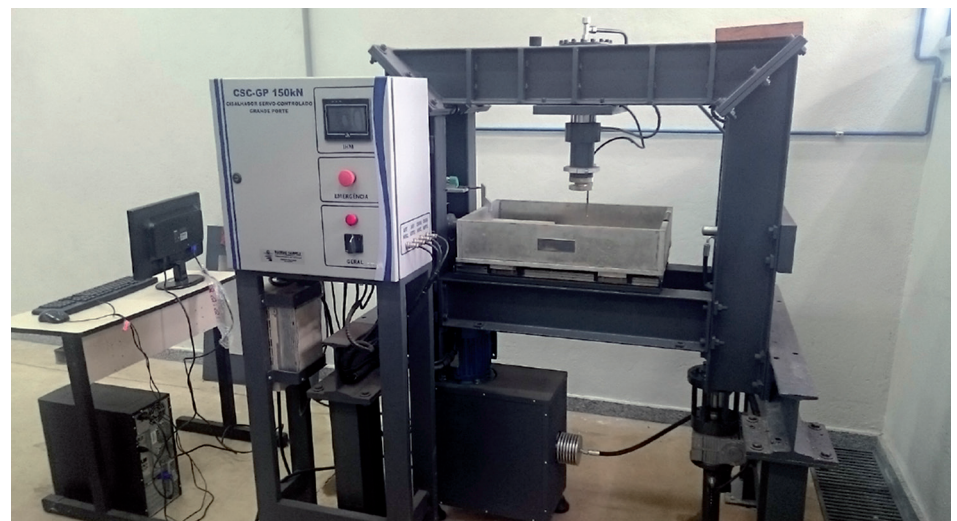
Figure 3  
Large direct shear test equipment - UFOP Geotechnical Laboratory.

geotechnical characterization. In order to obtain the geotechnical parameters of the surface layer, large-scale shear tests were conducted (Figure 3), as indicated

by Paria *et al.* (2017) for granular waste rock. This experiment differs from conventional by the box of 20 cm wide and 5 cm high.

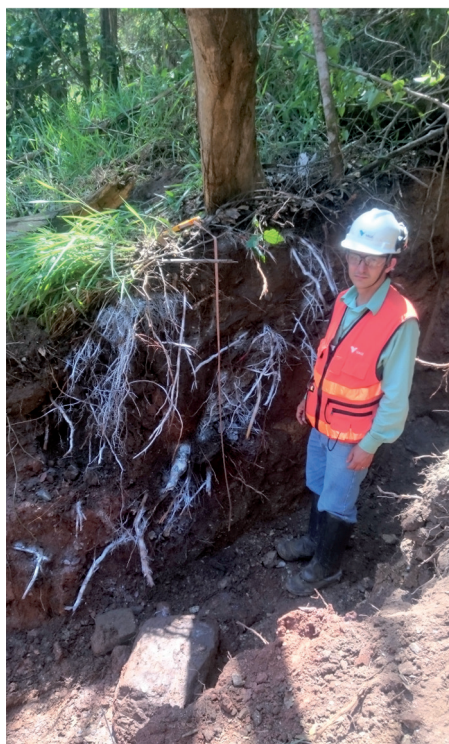
Figure 4  
The trench for assessing substrate layers and the roots system.

To understand the root system, trenches 2 m in depth and 1 m in width, staged in a window, were opened on the face of the slope (Figure 4). The trenches were opened just in front of the tree's trunk, with the purpose of assessing the substrate layers, the behavior of the root system and the development of the roots in different layers.
