Pelletizing furnace refractory lining life cycle extension by applying thermography analysis and direct refractory injection

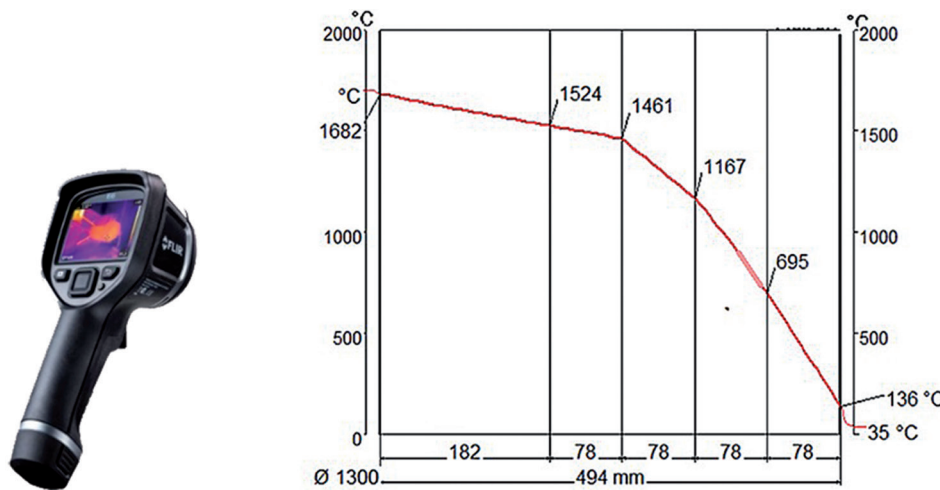
In this study, a thermographic camera FLIR series E30 was used to obtain detailed information about the furnace's inner surface temperature. Figure 1 shows the thermographic camera used.

Figure 1
Thermographic camera series E30 of FLIR and Typical thermal profile possible to find in across the burner chamber refractory of a pelletizing furnace.

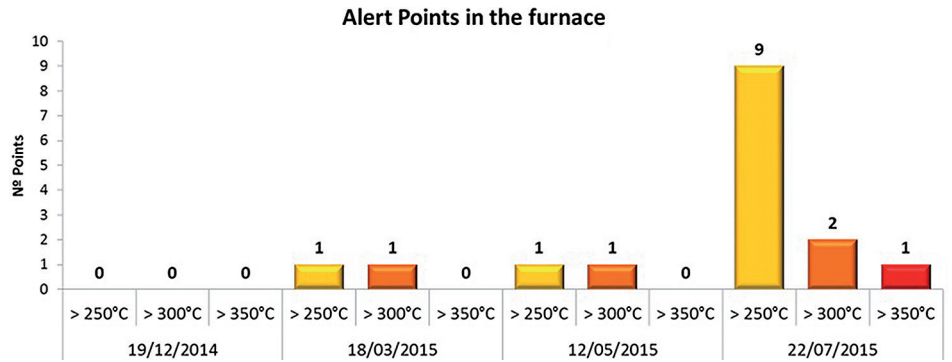
According to the procedure, Figure 3 presents the results of the last 4 mea-

Therefore, the thermography

results indicate degradation of the refractory lining condition.

Summary results of the recent inspections.

By examining the results, it is possible to verify that the hot spots were located mainly in the corners of the structure, indicating that most

failures in the refractory lining start at its borders.

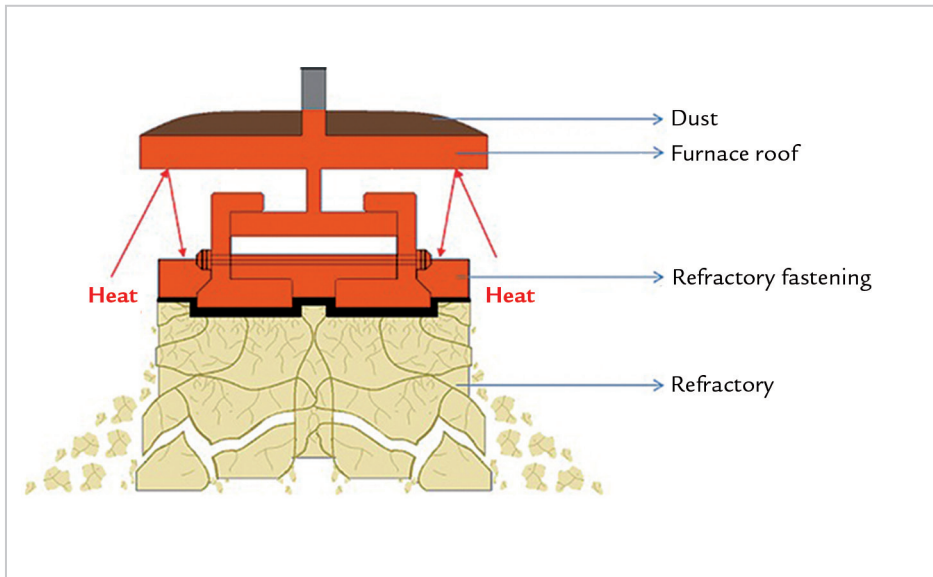
In an attempt to understand the reasons why hot spots are happening, besides cracks in the refractory borders, it was possible to conclude that the dust

accumulated on the inner furnace surface prevents the heat exchange with the atmosphere, reflecting the head back to the refractory fastening and lining.

Figure 7 shows the scheme of the cracks' evolution due to the prevention of heat transfer between the structure surface and atmosphere air.

Figure 7
Cracks evolution due to dust accumulation on the structure surface.

Therefore, the cleaning of the surface structure is a factor as important as the refractory wear out. Therefore, a periodic cleaning must be done to avoid crack formation/evolution in the refractory lining.

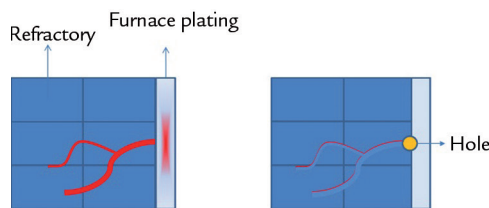
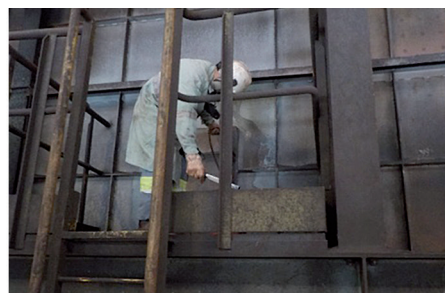
Figure 8
Mass Injection.

To inject the refractory mass, a very simple manual device was used. The injectable mass was selected with the same chemical quality of the refractory lining.

For the mass injection, a hole is

bored through the furnace structure in the area where hot spots were detected, using an industrial drilling machine and a 12mm drill bit. The refractory mass is then injected through the bore by pressure.

To repair the refractory lining issues, a mass injection was made in the hot spot areas to block the evolution of cracks and to reduce the temperature in these regions identified in the thermography.

The main idea of the mass injection is to fill the cracks with refractory mass, taking advantage of the process temperature to make quick solidification, thus blocking the crack evolution as per the scheme in the Figure 8.

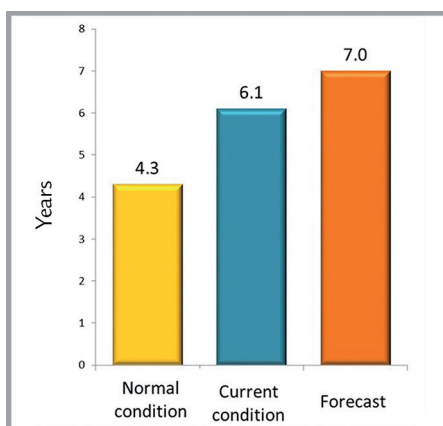
The application of this method yields the results shown in the Figure 10:

Figure 10 Furnace life cycle forecast.

From historic data, normally the furnace campaign is around 4.3 years. Using the preventive methods in this

document, it is probably possible to reach more than 7 years of life. This result has a very high impact in the total
