**THE MODERN ARCH:
AN ANALYSIS OF THE PRESERVATION OF
EARLY REINFORCED CONCRETE ARCH BRIDGES IN THE U.S.**

**Submitted in partial fulfillment of the requirements for the degree
Master of Science in Historic Preservation**

**Columbia University
April 2021**

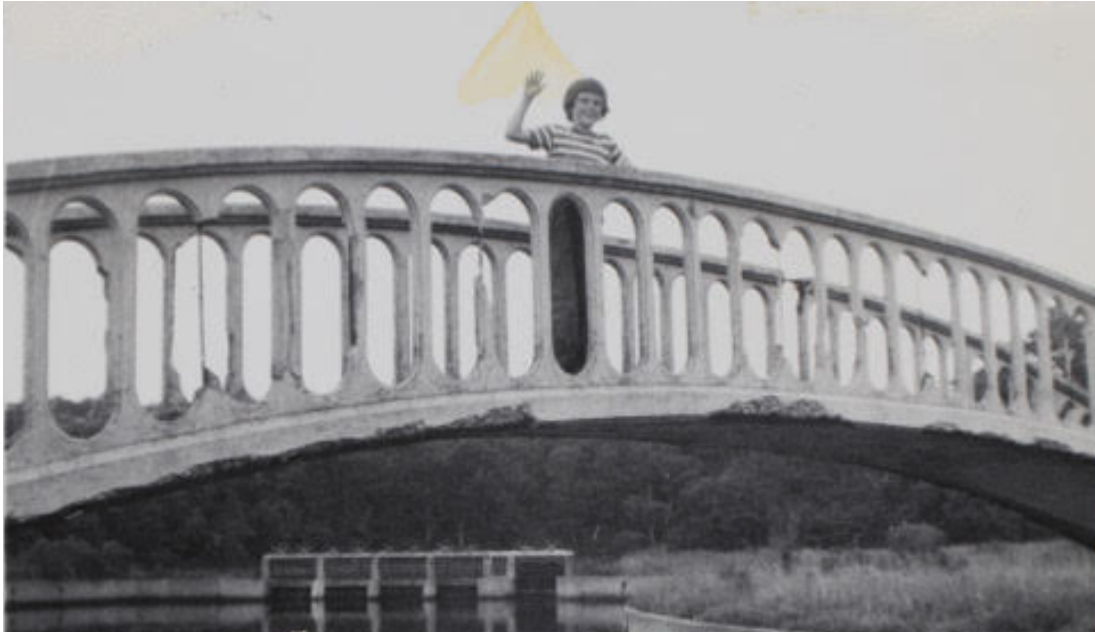
Figure 5: Barbara Bayley on the bridge, 1951. Source: Bob Bayley.

century photograph shows multiple destroyed balusters on the 40-year-old structure (Figure 5). In 1993, a contractor surveyed the bridge and noted the extensive deterioration. There were no available records for the bridge prior to the subdivision of the Smith Estate.¹²

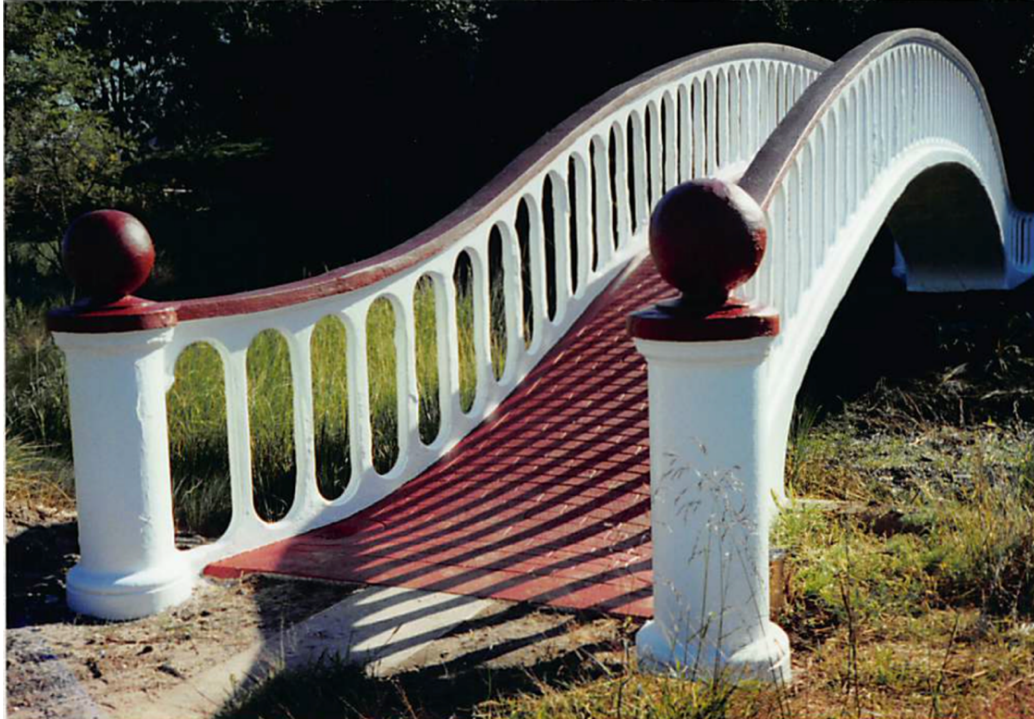
Figure 6: The bridge circa 1997. Source: South Ferry Hills Association, Joel Snodgrass.

East Area General Contractors, Inc., completed a restoration of the bridge in 1997. The job involved patching of concrete and the use of zinc epoxy coating, and the total cost was quoted as \$34,950.¹³ The result of this restoration is visible in Figure 6. The bridge was not originally painted with these colors, and they arguably detract from its historic character. The repairs themselves were unrefined, and did not replicate original details such as the cove moldings in the balusters. Some of the repaired balusters are visible in Figure 7, and the rough workmanship can be compared with that of the (deteriorated) finer original detailing shown in Figure 8. It has now been almost 24 years since the repairs were completed, and as evidenced by the exposed Ransome Bar in Figure 8, more repairs are necessary.

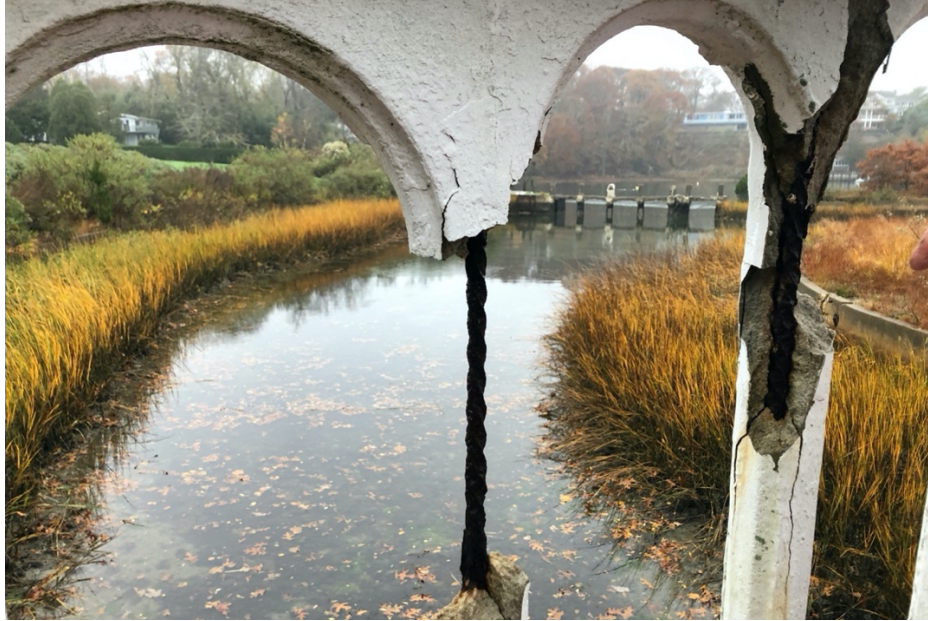
Figure 8: Damaged balusters showing exposed twisted rebar, November 2020.

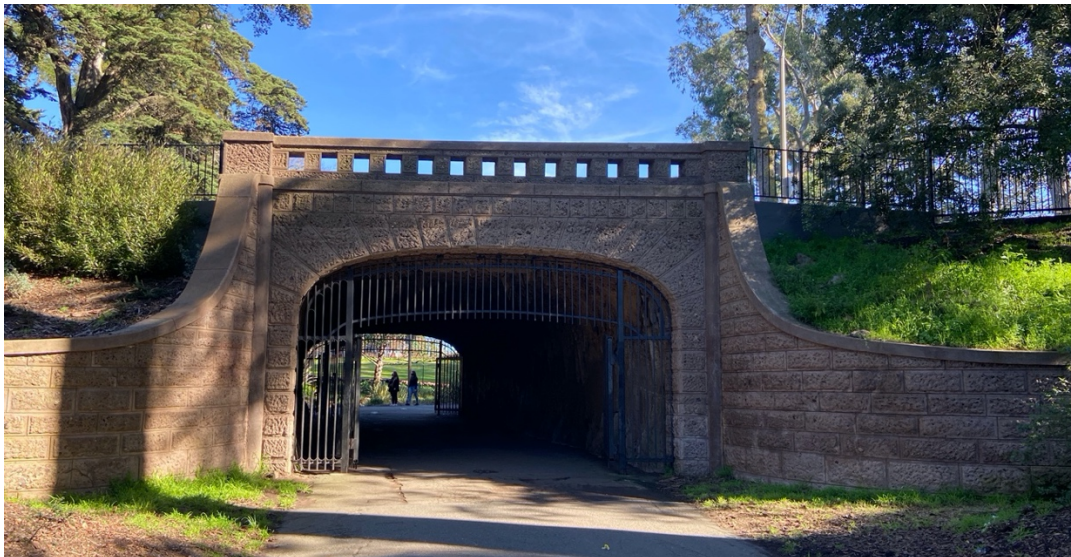
Figure 1.4: The Alvord Lake Bridge, January 2021. Source: Emily Fitts.

Ernest Ransome built the first reinforced concrete arch bridge in the U.S., the Alvord Lake Bridge in Golden Gate Park in San Francisco (Figure 1.4).⁶⁷ The bridge is listed as a Historic Civil Engineering Landmark by the American Society of Civil Engineers, and is often considered to be “the defining aspect of [Ransome’s] life history.”⁶⁸ The closed spandrel arch carries a road over a pedestrian walkway, with a span of 20 feet and a rise of four feet and three inches, and a width of more than 60 feet, reinforced with Ransome’s signature twisted rebar.⁶⁹

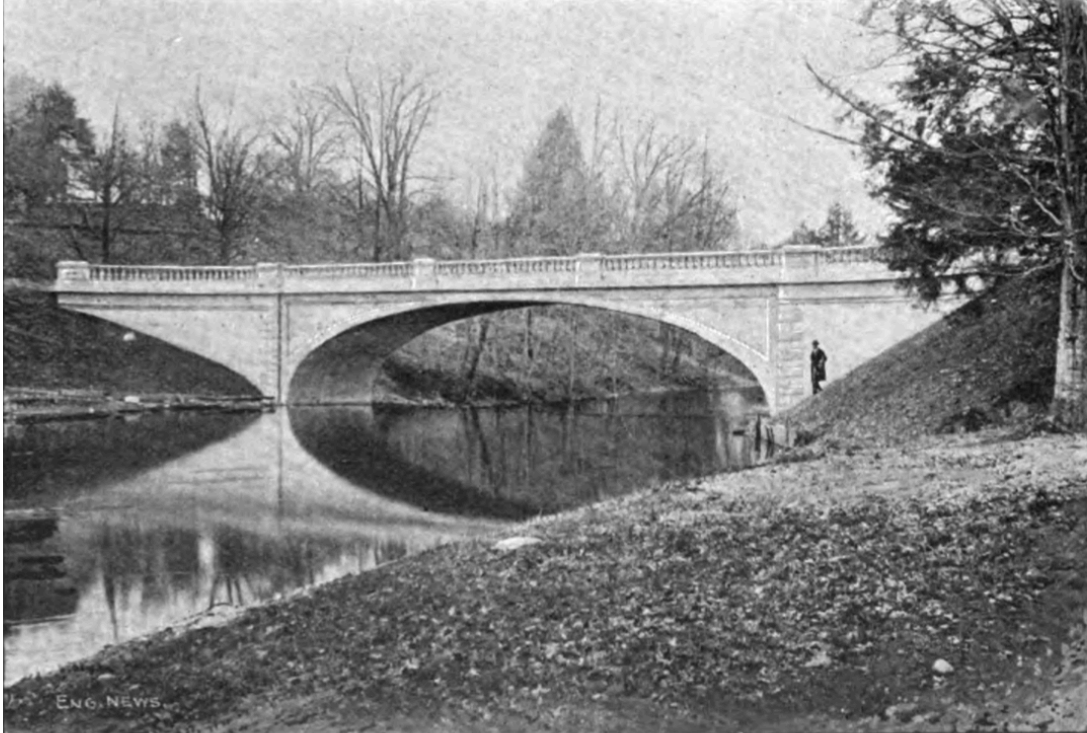
Figure 4.1: The White Bridge, Hyde Park, N.Y. (1897). Source: *Engineering News*, November 10, 1898, 290.

W.T. Hiscox designed for the property¹⁷¹ is directly under the White Bridge; the dams created ponds which “complement the architecture of the bridge.”¹⁷² The White Bridge features an urn-type balustrade (Figure 4.4), classical acanthus leaf ornamentation in concrete pots (Figure 4.8), and quoins framing the arch spandrel (Figure 4.11). The Coach House Bridge is off to the south side of the estate, and is in a more wooded and secluded location. It uses fieldstone for its spandrel walls and cut stones on the arch rings. The pier of the bridge is constructed with a larger and rougher pointed stone than the spandrel walls (Figure 4.10). The Coach House Bridge is asymmetrical, with one span of 53 feet and one of 26 feet. Both have a rise of 7.5 feet, yet one springs from an abutment to the pier, the other from an outcrop to the pier, as illustrated in Figure 4.6. The *Engineering News* writes,

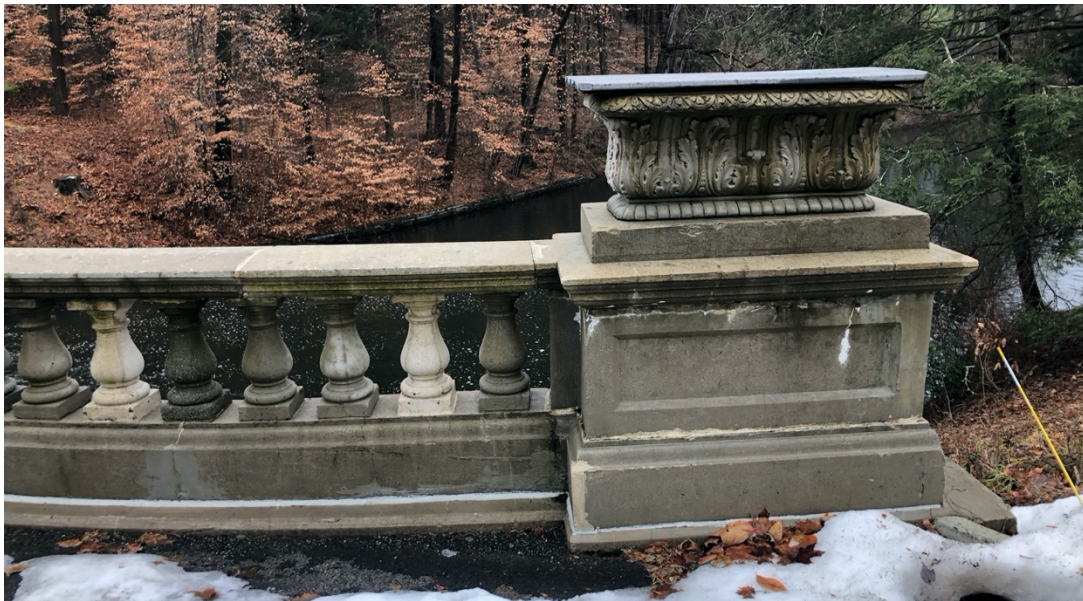
Figure 4.8: White Bridge Balustrade, January 2021.

The 1992 Cultural Landscape Report continues to detail later 20th century work on the White Bridge. In 1973, the NPS cast twelve new planters for the balustrade from a mold of one of the original ones.¹⁷⁵ Figure 4.8 shows a planter and the balustrade with visible replaced elements. The road surface again became a point of failure for the bridge:

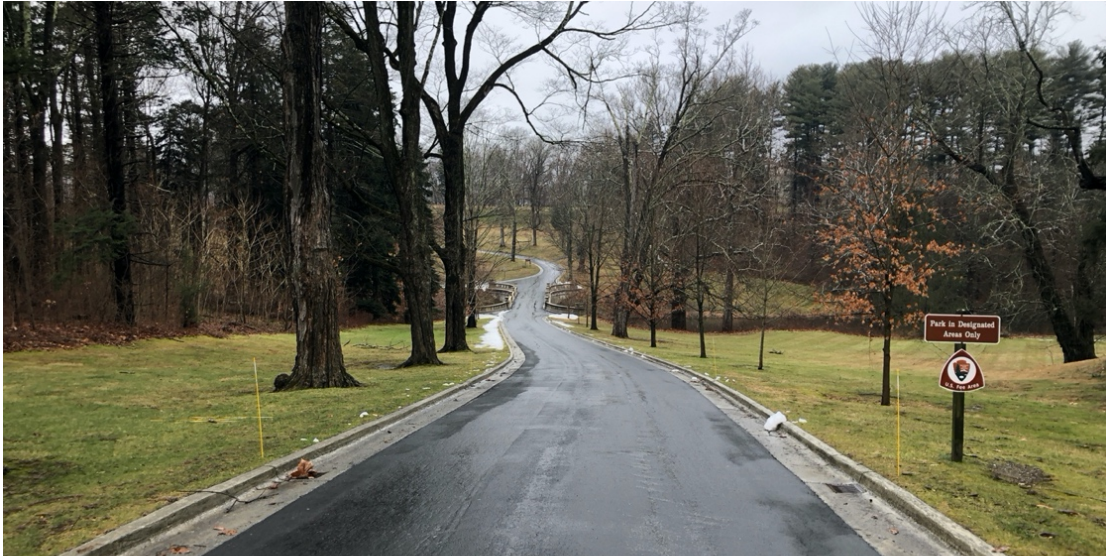
Figure 4.9: Main Entrance Drive, January 2021.

This problem is likely one faced by other historic concrete bridges, in which layers and layers of asphalt have compromised original drainage schemes. Figure 4.9 shows the White Bridge and the asphalt drive from the Main Entrance. In this case, the importance of the bridge was recognized when determining a course of action. The report notes that the bridge will require a major upgrade, and recommends the following:

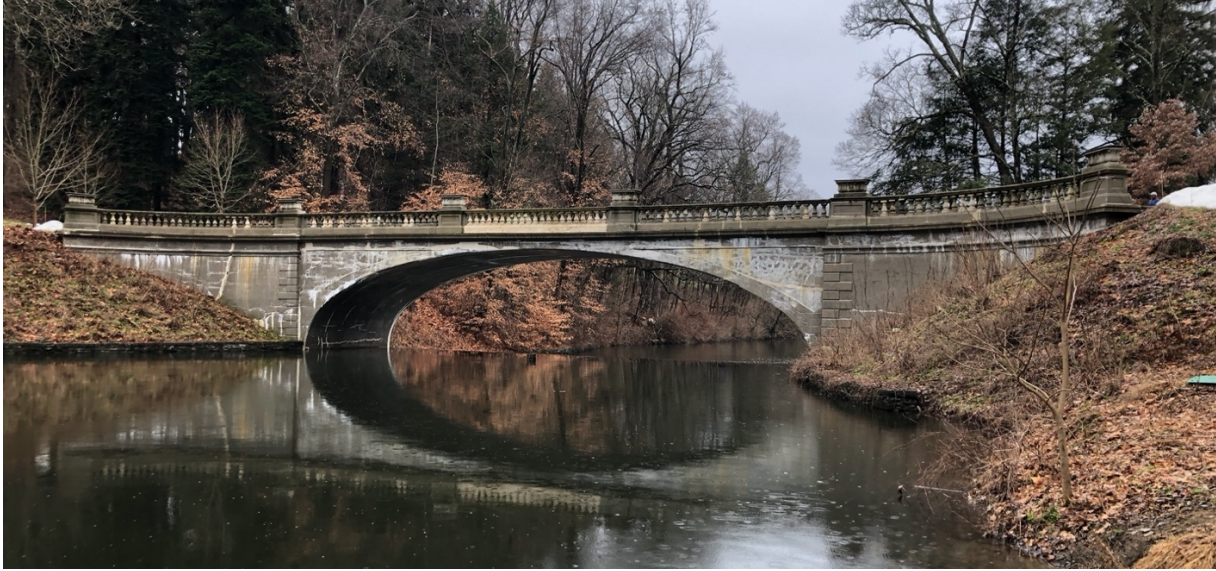
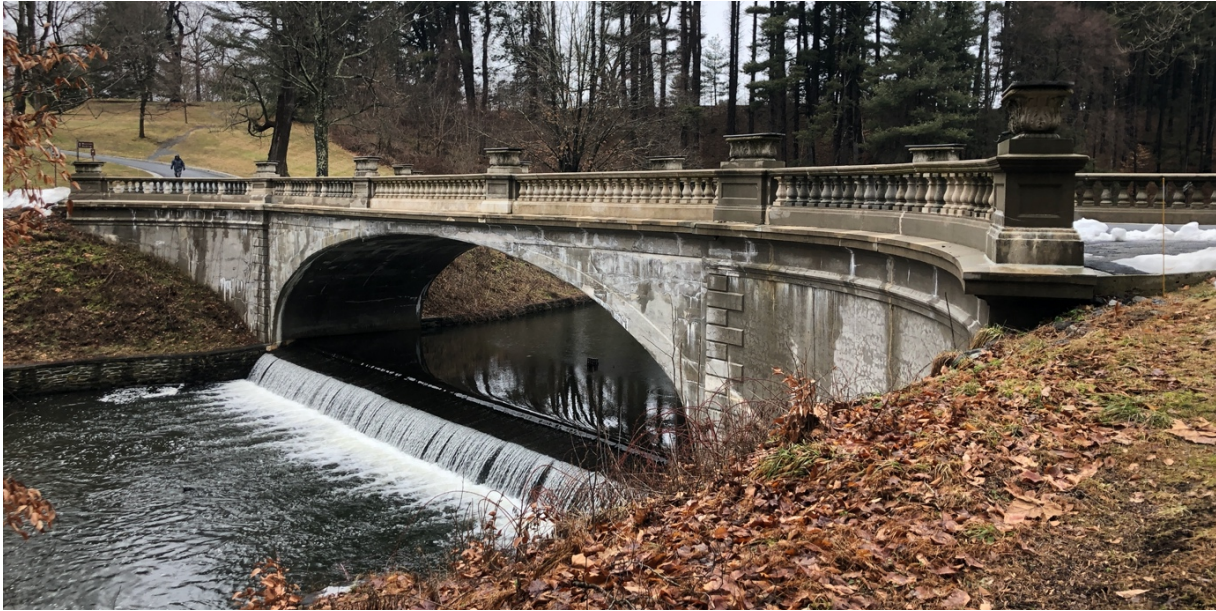
Both bridges have been rehabilitated in the recent past. There is significant cracking and evidence of moisture penetration visible on the spandrel walls of the White Bridge. There is also evidence of color mismatching on replaced parts of the balustrade (Figures 4.12, 4.13). These conditions indicate that the bridge may require further work to prevent moisture intrusion into the arch. The Coach House Bridge intrados is painted white, and it is unclear whether this is an original feature as the intrados is in shadow in Figure 4.2. Some runoff of the white color is visible in Figure 4.14.

Figure 4.12: The White Bridge, January 2021.

Figure 4.13: The White Bridge, January 2021.

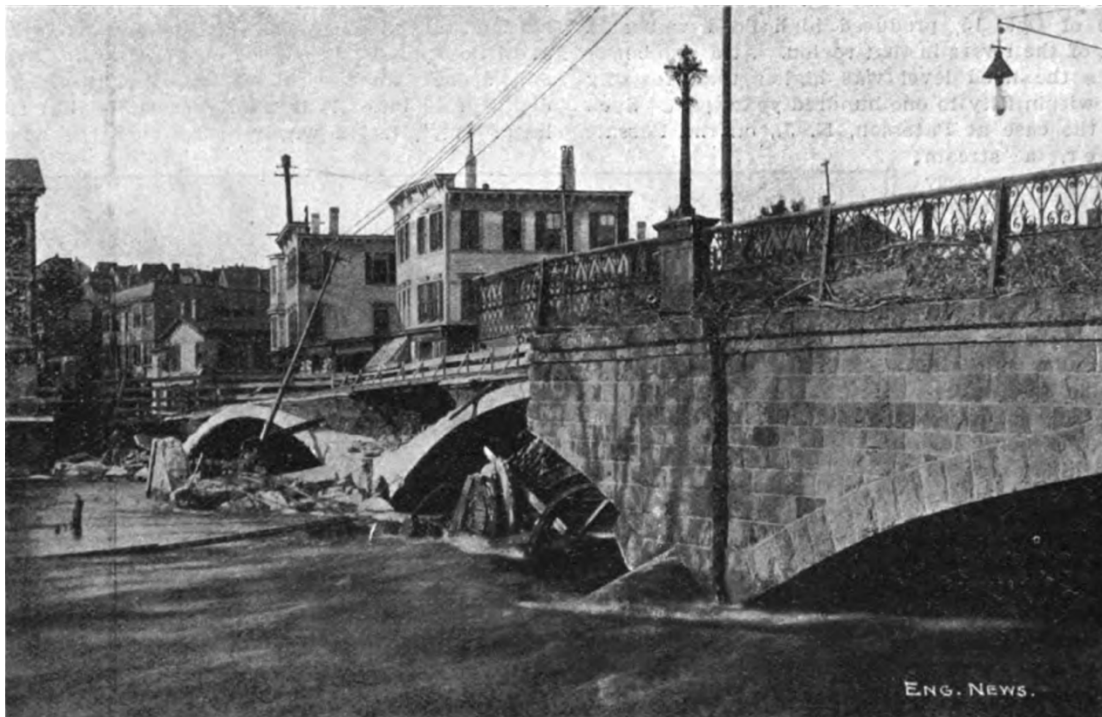
Figure 5.6: Damage from the 1903 Flood. Source: *Engineering News*, October 29, 1903, 378.

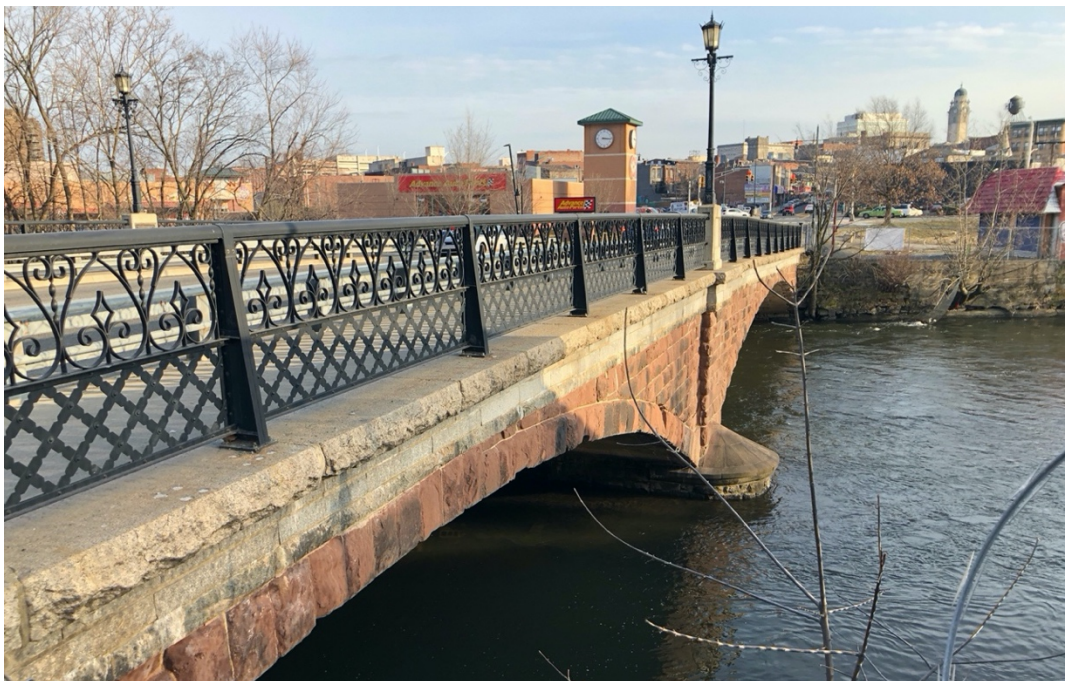
Figure 5.7: West Broadway Bridge, central and southern spans, January 2021.

wall, creating a “discreet” feature that “expresses where new fabric has been placed.”²⁰⁵ This new course of granite is visible underneath the capstones in Figure 5.7.

Another important feature of this bridge is the new railing (Figure 5.7). The railing design is based on photos of the original railing, which was lost in 1937 or earlier. The reconstruction features rivets and square bolts to simulate the turn of the century construction methods, while the end posts of the new railing are cast from the surviving originals.²⁰⁶ The report credits Passaic County for its commitment to the rehabilitation, including the reconstruction of the original ornamental pedestrian railings.²⁰⁷ This serves as an important example because, as discussed earlier, reconstructions are uncommon with historic bridges.

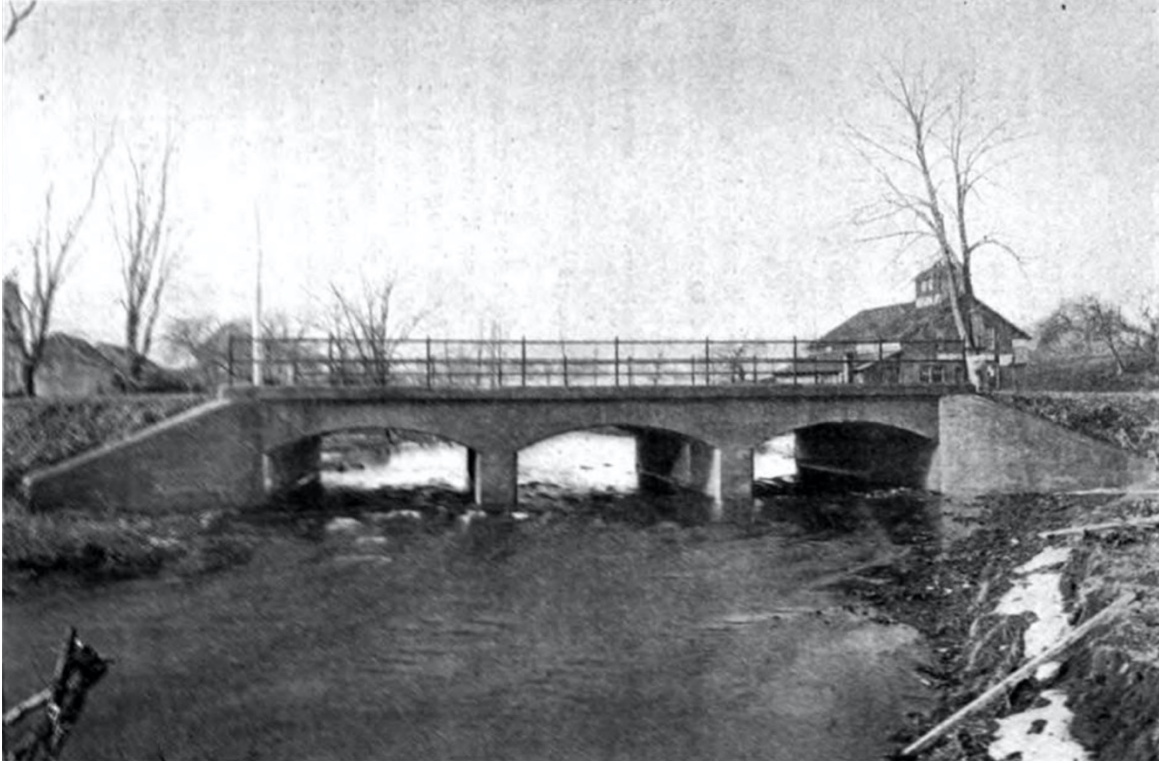
Figure 6.2: The North Main Street Bridge in 1901. Source: Town of West Hartford, we-ha.com

Historic photos and documentation show that the bridge has been altered since its construction in 1901 (Figures 6.1, 6.2). The West Hartford town engineer believes the concrete parapet railings date to circa 1930–40 when the street was widened.²¹⁸ According to the recent State Level Documentation Report, there is “no physical evidence” that the bridge itself was widened.²¹⁹ The added reinforced concrete railings are a red or brown color and appear to be monolithic with the façade. It is clear that the entire side of the bridge was modified because Figure 6.2 shows a deep lip at the road deck and wing walls, which do not appear in the later photos of either the east or west sides of the bridge. The removal of the wing walls indicates that the bridge was probably widened when the new spandrel walls and railings were added. There is evidence of rebar within the piers, abutments, and railings in the widened part of the bridge

Preservation Plan categorizes this bridge as a “Simple Highway Concrete Arch” as opposed to a “Decorative Concrete Arch.”²²⁷ Returning to an original design is not unprecedented, the reconstructed railings of the West Broadway Bridge show. Close examination of Figure 6.2 shows the 1901 appearance would highlight the arch dimensions, with a thinner deck and railings which were not solid. The railing would require modifications for safety. While it is too late to incorporate these ideas in the current rehabilitation of the North Main Street Bridge, they are applicable to other bridges of the type.

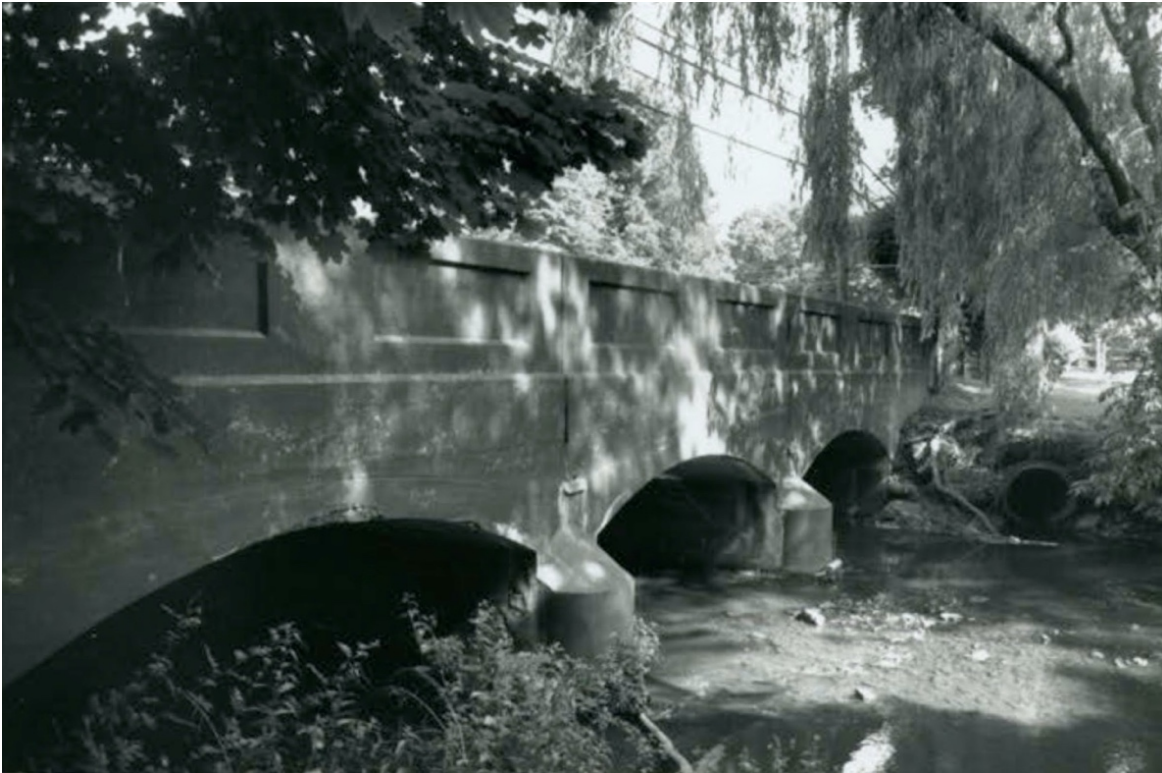
Figure 6.6: The western spandrel wall, photographed in 1990. Source: 1990 CT DOT Historic Bridge Inventory Report, Bridge 3651.

On the west side, the bridge features “debris fins,” also known as cutwaters, on the two piers.²²⁰ Figures 6.6–6.8 show this portion of the bridge over a period of more than twenty years, including significant deterioration of the spandrel wall between 1990 and 2018, and the completed replacement in 2021. In Figure 6.7, sets of steel reinforcement bars running from the pier around the arch are exposed.

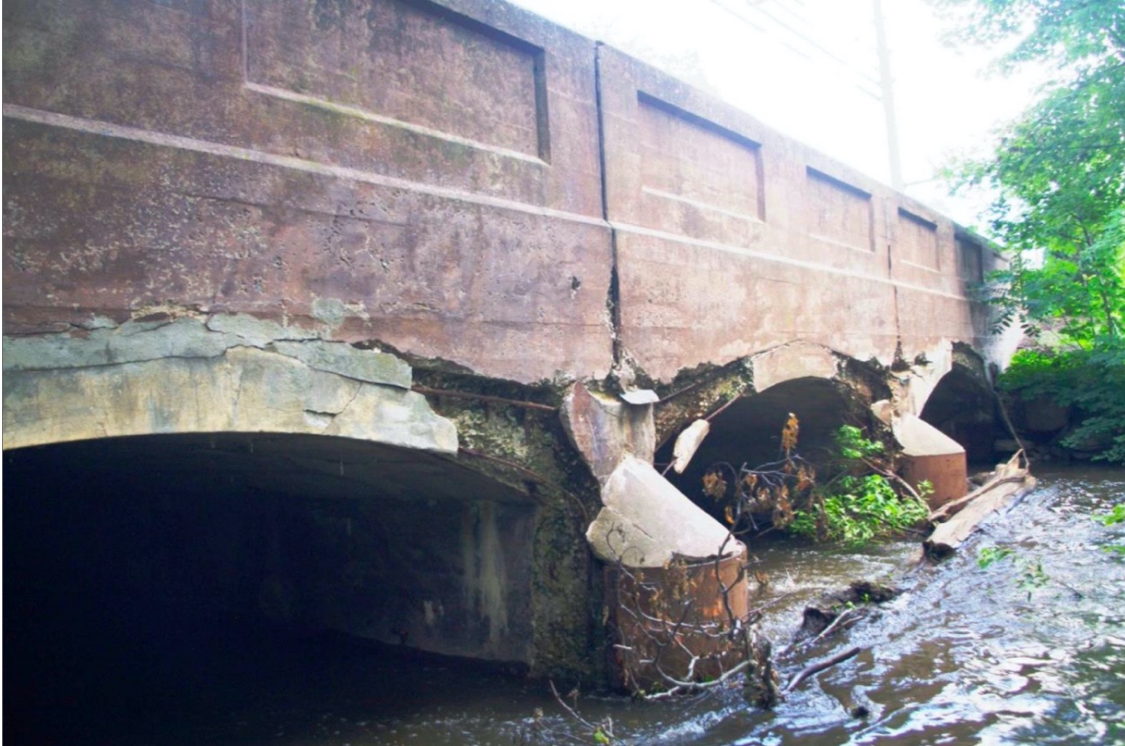
Figure 6.7: Damage to the western spandrel wall, 2018. Source: CT DOT Update of 1991 Connecticut History Bridge Inventory, Bridge 3651.

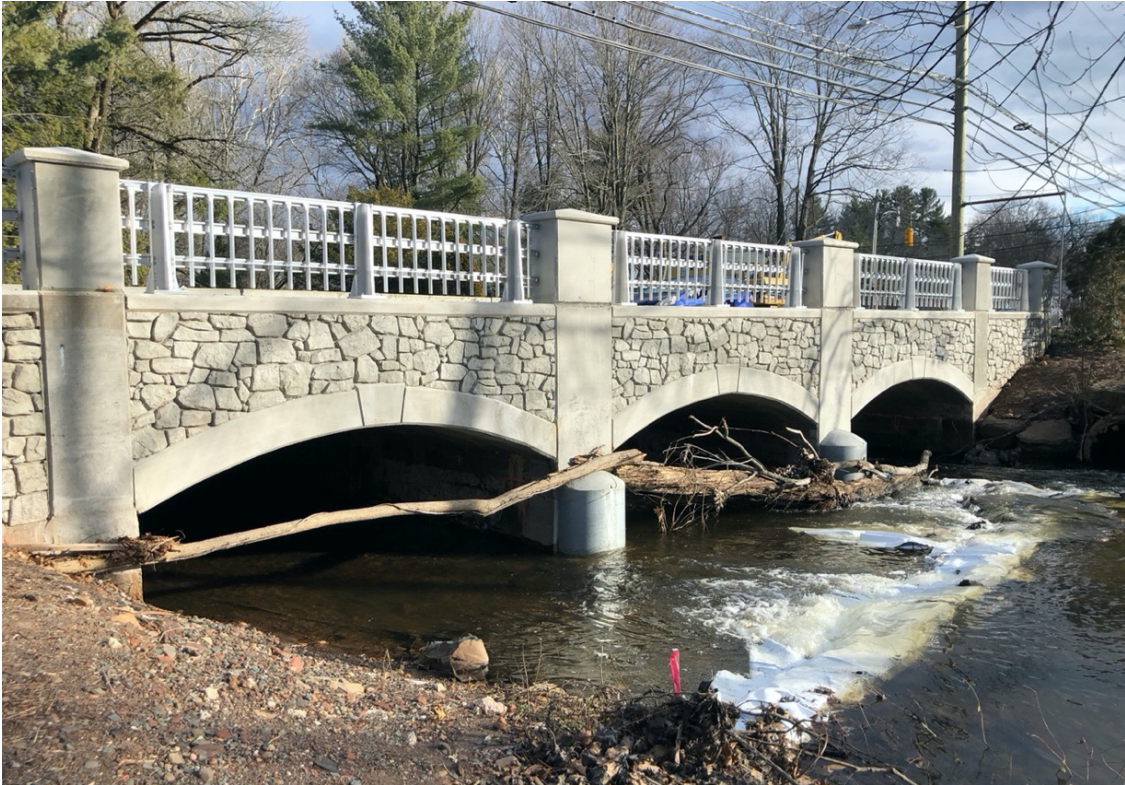
Figure 6.8: The west spandrel wall after reconstruction, January 2021.

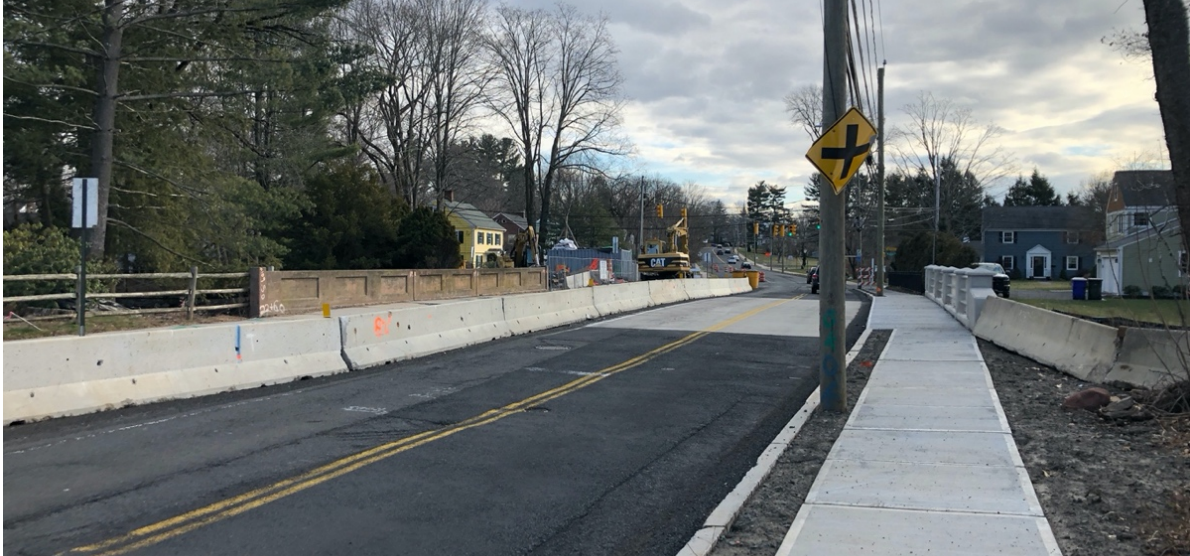
Figure 6.9: The roadway looking south with temporary Jersey barriers, January 2021.

The rehabilitation of the bridge is ongoing (Figure 6.9), with plans prepared by an engineer from Tectonic Engineering.²²³ In March 2018, the bridge was inspected and determined to be in poor condition, with a sufficiency rating of 48.2, just less than the rating of 50 required for federal rehabilitation funding.²²⁴ The west spandrel wall has already been replaced as of January 2021 (Figure 6.10), and the contractor is beginning work on the east façade in Spring 2021.²²⁵ The replacement material is concrete, designed to simulate rubble stone. While this is historically inaccurate, the spandrel does allude to the concrete nature of the arches, as there is a band of concrete that approximates each arch, although it incorrectly simulates a keystone. (Figures 6.7, 6.9). The simulated rubble stone filling and keystone, spurious in themselves, have no relation to the earliest or later historical materials and appearance of the bridge; neither does the concrete and shiny steel railing.

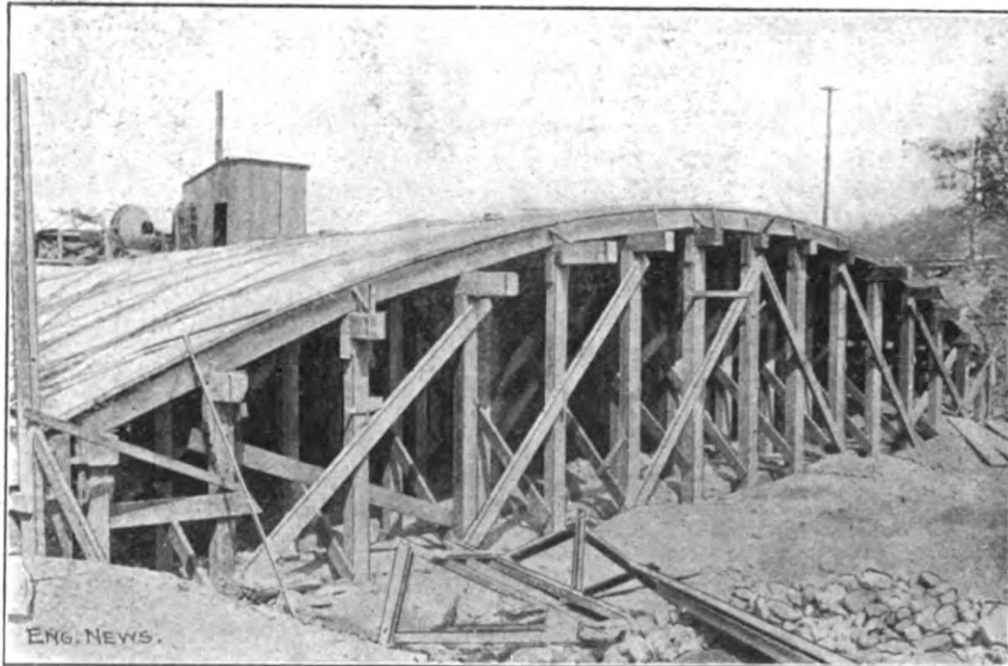
Figure 7.5: Wooden forms used for construction. Source: *Engineering News*, December 31, 1903, 588.

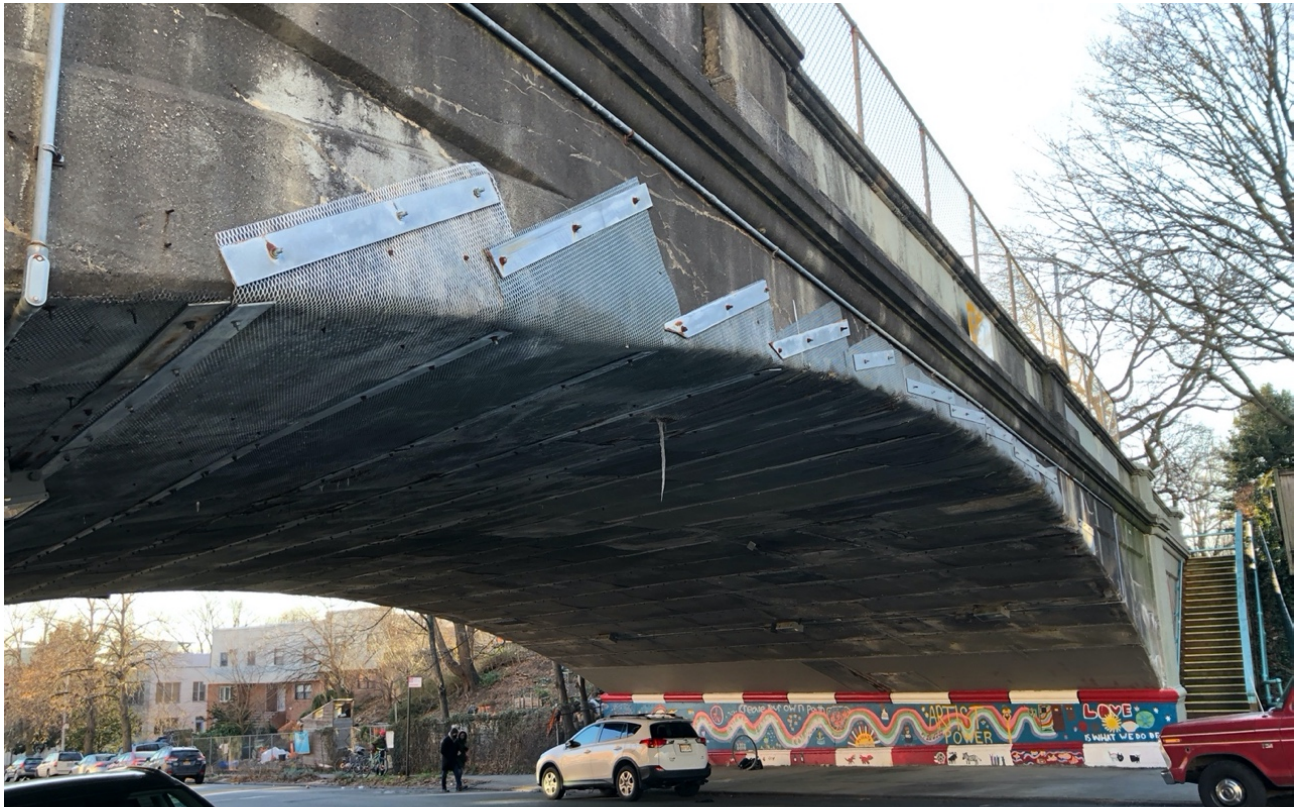
Figure 7.10: Steel netting covering the intrados, facing southwest, January 2021.

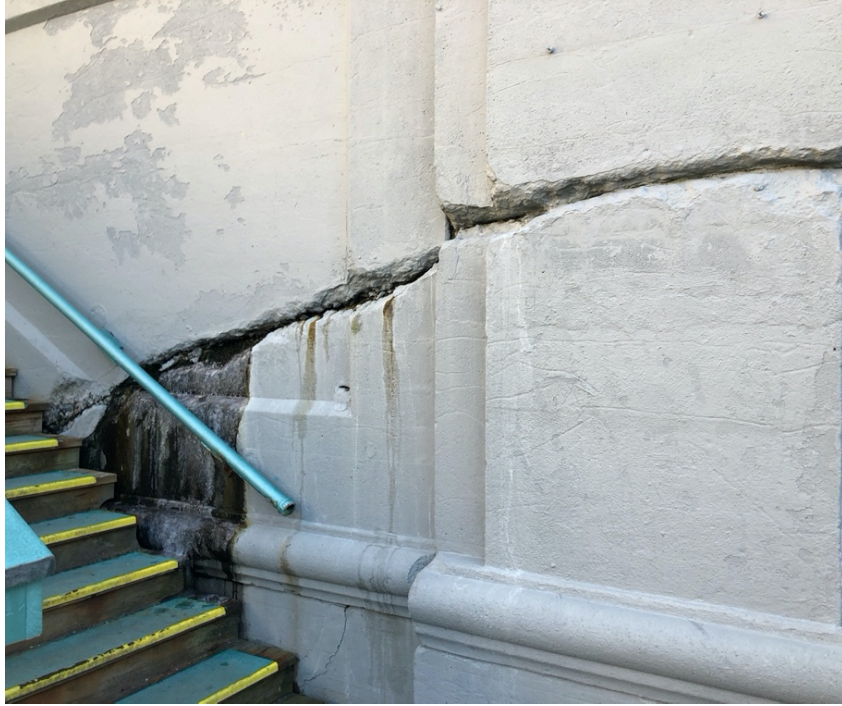
Figure 7.11: Cracks in the northern side wall of the east abutment, January 2021.

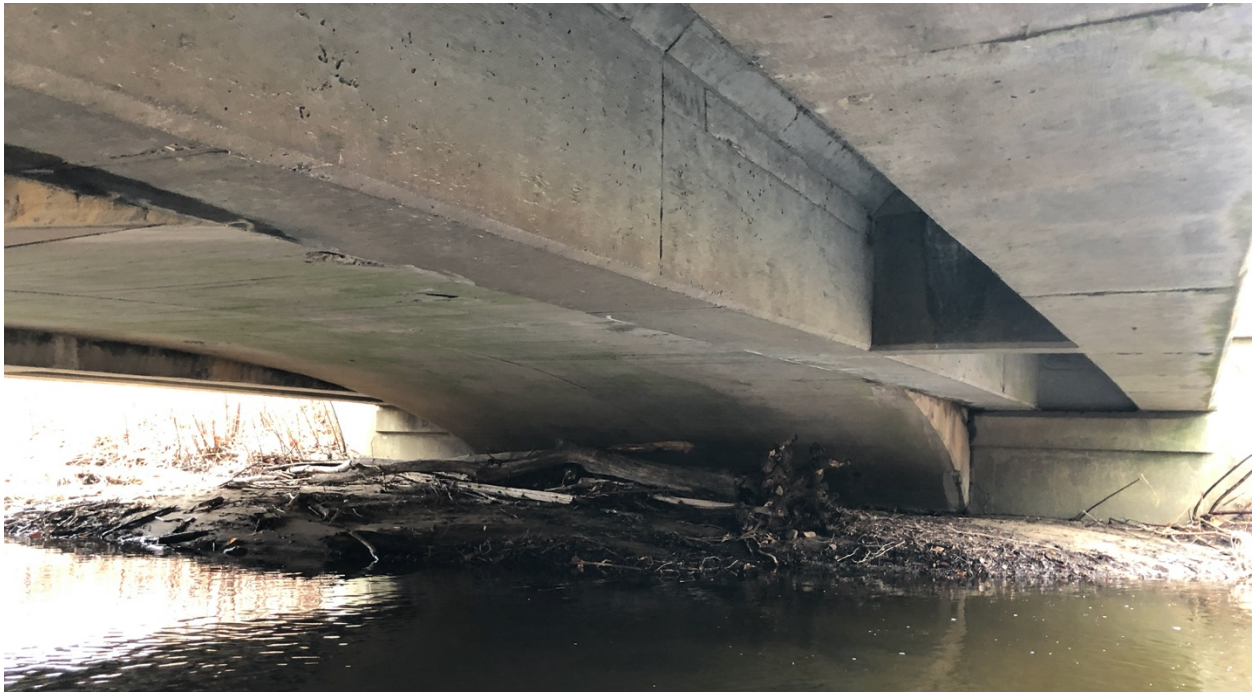
Figure 8.7: The underside of the bridge, facing west. January 2021.

no signs of spalling, although there is some exposed rebar on the balustrade (Figures 8.7, 8.8).²⁶³ The arch springs from far lower than the abutments for the T-beams (Figure 8.7). The arch is board-formed, with indentations visible on the intrados, while the arch ring appears to have been smoothed (Figure 8.8). The spandrel walls may have been smoothed, and indented a few inches in from the arch ring (Figures 8.9, 8.10) There is riprapping, consisting of a row of stones, to prevent scour on the eastern edge of the arch (Figure 8.8).
