Full Length Research Paper

The earthquake/seismic risk, vulnerability and capacity profile for Karonga town

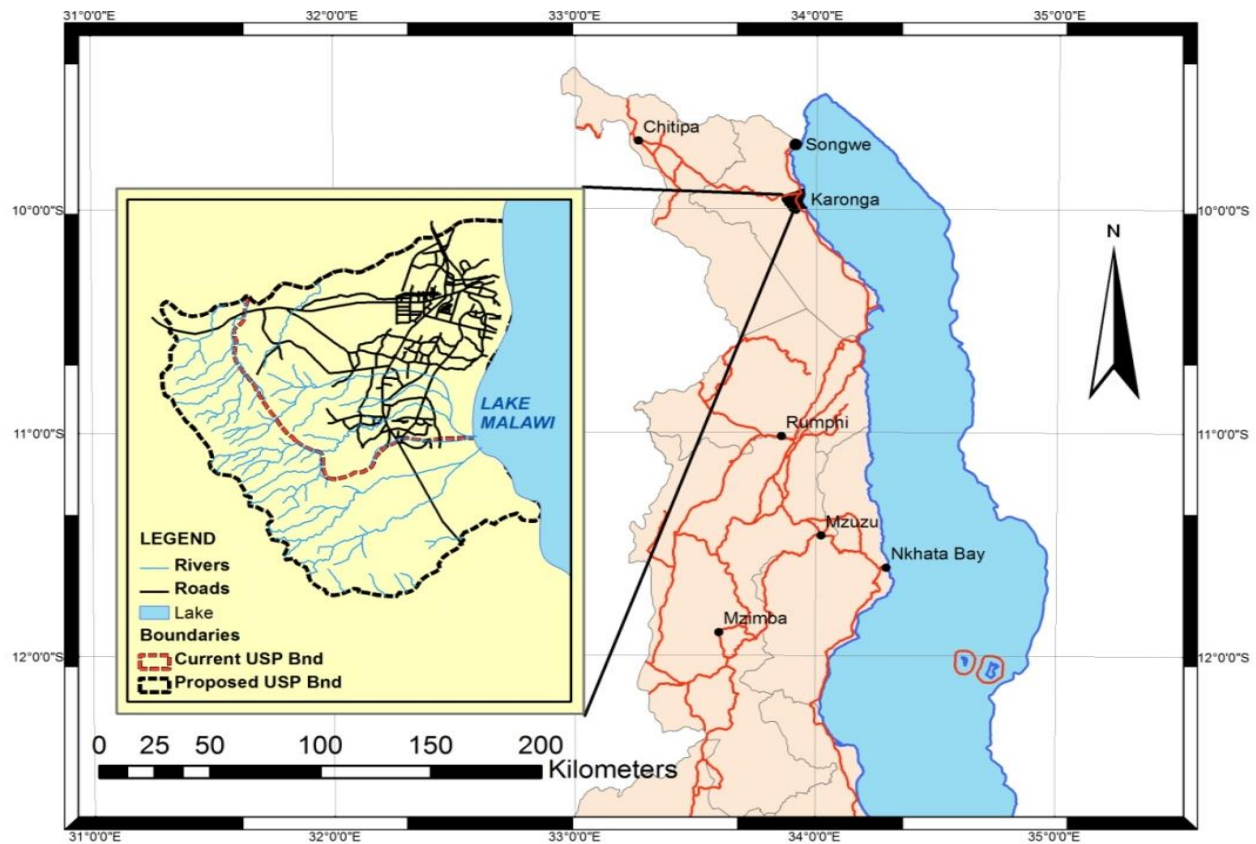
Figure 1. Map of Northern part of Malawi with an inset of Karonga Town (source Malawi Geological Survey Mzuzu Office).
