## SPATIO-TEMPORAL CHANGES OF LAND USE LAND COVER DYNAMICS AND ITS IMPLICATION ON URBAN FLOOD VULNERABILITY IN MAKURDI, NIGERIA

\*Acha S. and Aishetu A.

Department of Geography, Federal University of Technology, PMB 65, Minna, Nigeria.

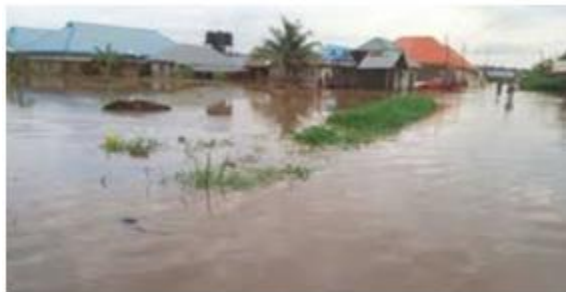
Plate 1: Radio Benue area of Makurdi

Furthermore, from the analysis of the steady state infiltration conducted in the study area, it has been identified that most of the soil in the study area exhibit low infiltration as evidence in 2017 flooding in the area. Plate 1-3 affirms that more built-up areas has been on the increase on flood ways making more community vulnerable.
