TRACKING LOCAL BRITTLE ZONE IN THE HEAT AFFECTED ZONE OF GIRTH-WELDED API 5L X46 PIPE

M. O. H. Amuda¹, L. O. Osoba^{2,*}, N. N. Etuk³, T. F. Lawal⁴ and A. O. Adetayo⁵

^{1, 2, 3, 4}, MATERIALS DEVELOPMENT AND PROCESSING RESEARCH GROUP (MADEPREG), DEPARTMENT OF METALLURGICAL AND MATERIALS ENGINEERING, UNIVERSITY OF LAGOS, AKOKA, LAGOS STATE, NIGERIA

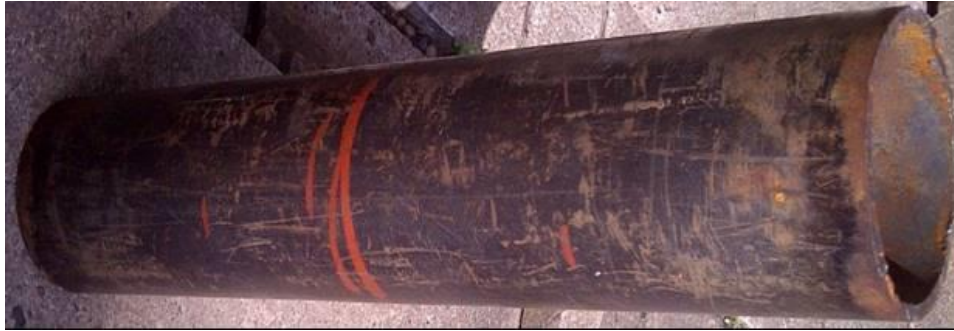
Figure 1: Image of the as-received API 5L X46 pipeline material

The normalized seamless API 5L X46 pipeline steel grade supplied by Compact Manifold Energy Services (CMES), Marina, Lagos was used in this present investigation. The length of the material pipe was 1500 mm with an inner diameter of 152 mm and 10 mm wall thickness. It can be classified as schedule XS or schedule 80 line pipes according to American Iron and Steel Institute (AISI) schedules for line pipes. Figure 1 shows the image of the seamless as-received API 5L X46 pipeline materials while the chemical composition is presented in Table 1. The carbon equivalent (CE) value was calculated from the relationship proposed by Dearden and O'Neill [9] and adopted by the International Institute for Welding. Additionally, a failed welded API 5L X46 pipe recovered from pipeline network in the Niger-Delta creek of Nigeria was used for validation.

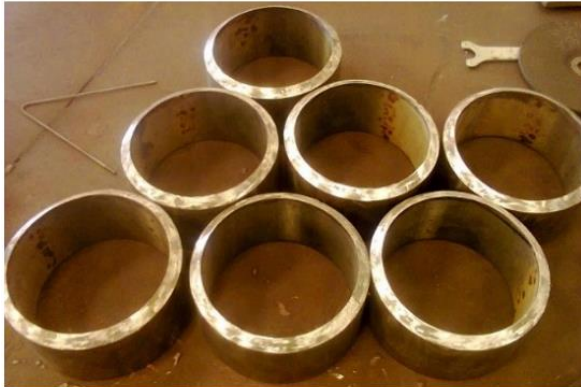
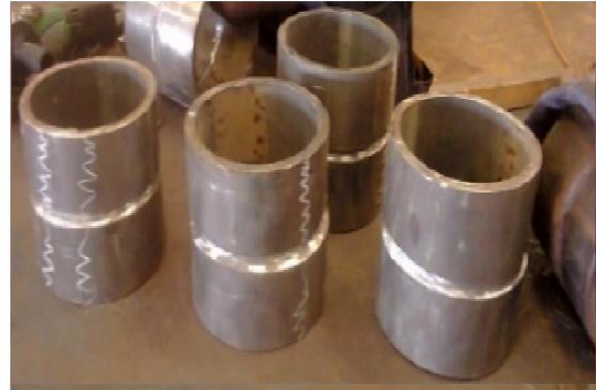
Figure 2: Bevelled and fitted samples (a) bevelled Surfaces (b) fitted samples

The as-received API 5L X46 line pipe steel grade of 1500 mm length was sectioned into 18 pieces with each piece having a length of 80 mm using power saw in a cooling medium under a flowing fluid. The surfaces of the sectioned pieces were prepared (bevelled) to create a root, fitted by tag-welding followed by mechanically clamping for girth welding. Figure 2 shows the bevelled and fitted samples.

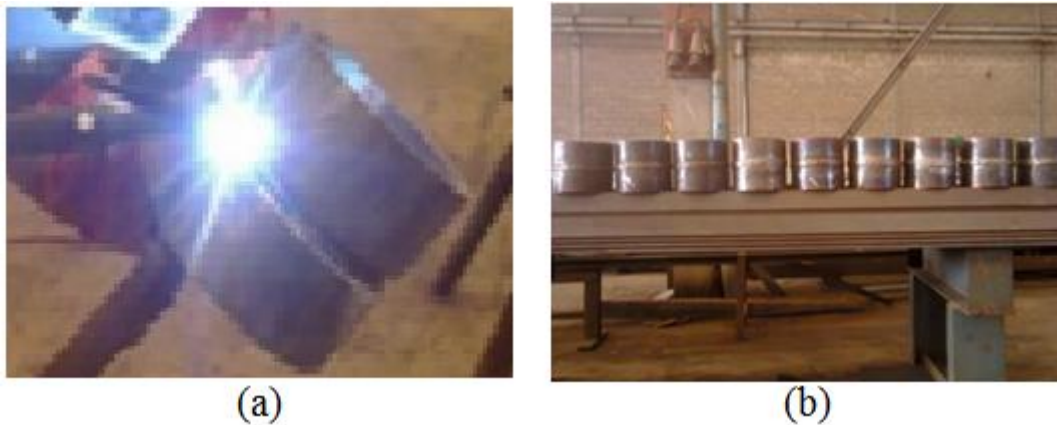
Figure 3: Gas tungsten arc welding process: (a) welding of specimens at 6G position and (b) weld specimens

GTAW was adopted for both the preliminary passes and the filler and weld cap passes at heat input ranging from 695J/mm to 2567J/mm, corresponding to the ranges of welding current between 80A-140A; and travel speed between 72 mm/min and 152 mm/min. Direct current electrode negative polarity (DCEN) with argon as shielding gas was used for the GTAW. Figure 3 shows the welding process at 6G position and the resulting weld specimens at different welding conditions.

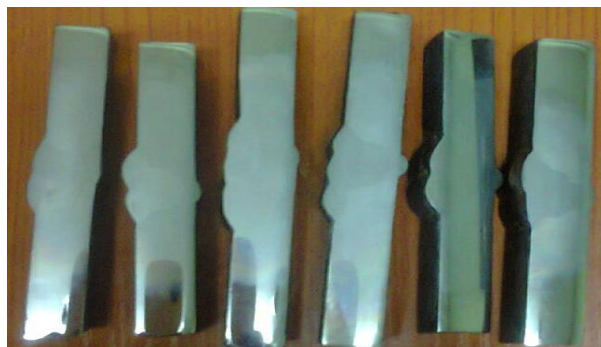
Figure 4: Image acquisition of specimens extracted from the weldments for microhardness profiling

In this investigation, Vickers microhardness survey was conducted under the applied load of 5 kgf for 10 seconds using automated microhardness tester (Innova test Falcon 500), in accordance to ASTM E384 standard test method. The Microhardness survey was conducted at 0.5 mm across and 2 mm along the transverse and longitudinal sections on all samples extracted from each of the API 5L X46 welds. The test was repeated thrice and the average taken as the representative value. Given that LBZs are produced at particular orientation to the weld line, the microhardness survey was aimed at profiling LBZs at transverse, longitudinal and 45° locations within the fusion zone and HAZ of the API 5L X46 welds. Figure 4 presents the image acquisition of specimens for microhardness survey extracted from the parent weld.

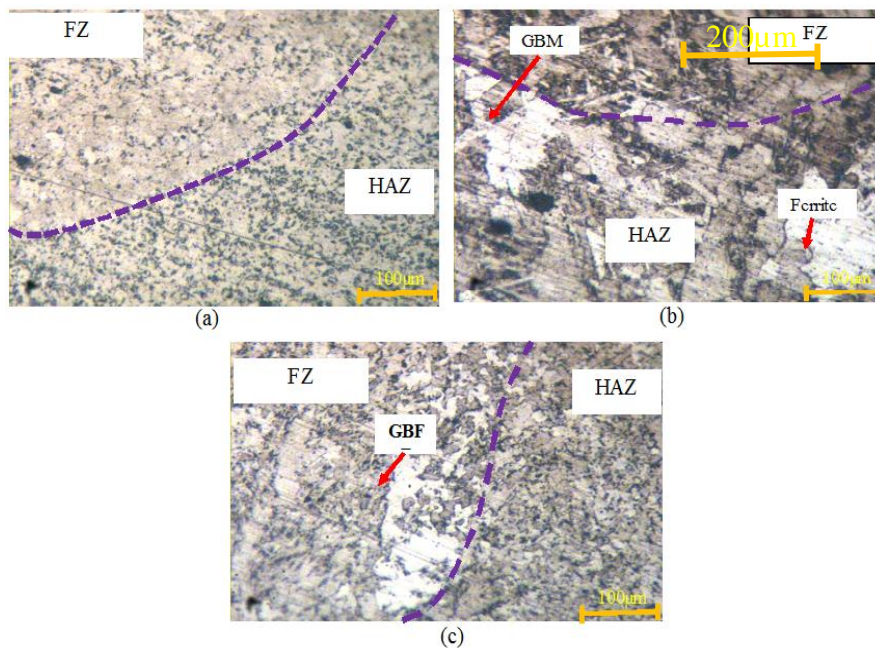
Figure 11: Micrographs of weld coupons at ranges of low heat input less than 1000 J/mm: (a) 695 J/mm, (b) 943 J/mm and (c) 955 J/mm

Microstructural analyses of the weld coupons produced at different heat inputs could be used to evaluate the influence of heat input on microstructural inhomogeneity in the welds which facilitates the development of LBZs in the HAZ. The micrographs of the welds at various heat inputs shown in Figure 11-13 clearly reveal the change in grain morphology in relation to the heat input. Also, some phase transformation products were also observed. For weld coupons at low heat input (less than 1000 J/mm, see Figure 11), the microstructure in this condition indicates the formation of equiaxed ferrite matrix in the FZ and carbides at the HAZ. The typical elongated columnar structure often obtained in fusion welds was absent under this condition. This suggests that the development of columnar structure in fusion welds may after all be a function of the level of the heat input. Other microstructural features equally observed under this condition of heat input include grain boundary ferrite (GBF) and grain boundary martensite (GBM) (see Figure 11 b and c).

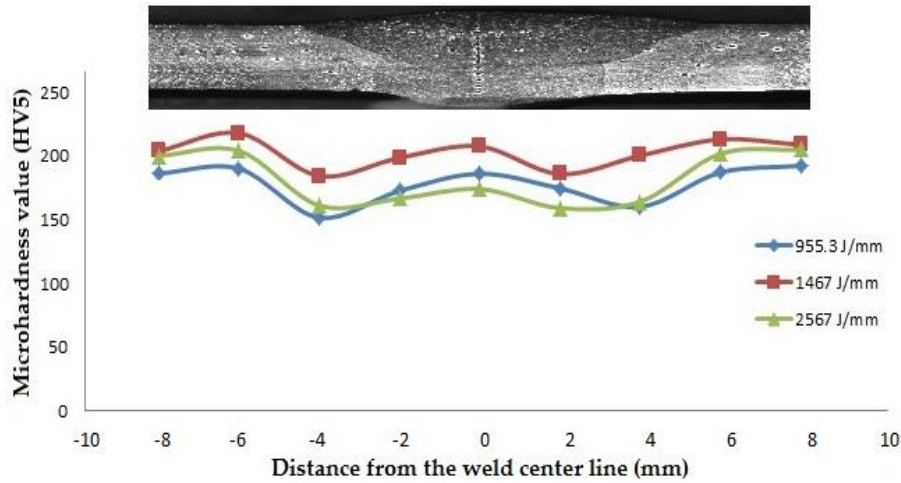
Figure 14: Longitudinal microhardness profiles of the grit welds produced at varying heat input

The microhardness profiles of resolidified welds in longitudinal direction are presented in Figure 14. The figure revealed that the microhardness values in the resolidified weld follows a sinusoidal behaviour in the longitudinal directions across all heat inputs revealing the significance of welding heat input on the parameter. It is higher at the weld centre line in the FZ and decreases onwards to the HAZ with a further increase from the HAZ to the base metal generating a periodical behaviour. Peak values in microhardness are displayed at the weld center as well as at a distance 6 mm to both left and right of weld center line. This trend suggests the generation of cyclic thermal strains in the weld initiating from the FZ to the HAZ and then to the base metal. The thermal strains must have resulted from thermal stresses induced during welding and their magnitude is dependent on allowable heat input.

The specific microhardness profiles observed in the longitudinal direction is further accentuated by the heat input. For instance, coupons welded with intermediate heat input of 1467 J/mm exhibits the highest microhardness value of 219HV across the indentation points unlike those welded at low heat input of 955.3 J/mm and the high heat input of 2567 J/mm.

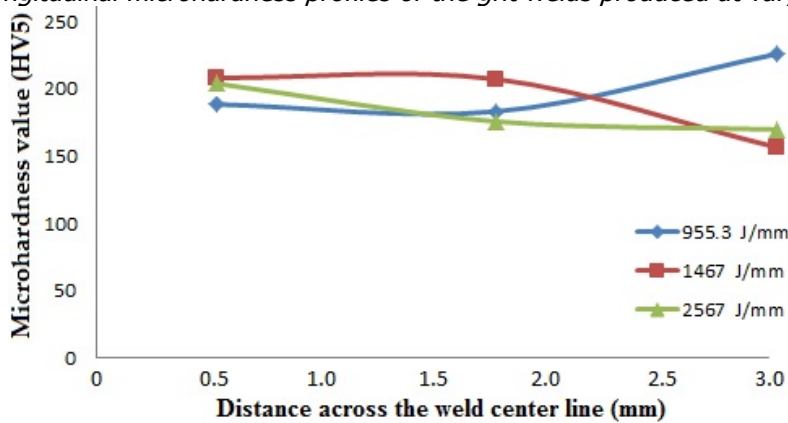
Figure 15: Transverse microhardness profile of the grit welds produced at varying heat input.

Figure 15 presents the microhardness profiles of the resolidified welds in the transverse direction. Whilst the trend is different from that in the longitudinal direction, it is equally dictated by the welding heat input. For welds produced at low heat input, the

microhardness value remain almost constant until at a depth of 1.5 mm beyond which it increased with depth of penetration. In welds produced at intermediate heat input, marginal increase in microhardness value was obtained until at a depth of about 1.8 mm where a progressive decrease in microhardness was obtained. Whereas in the welds produced with high heat input, progressive decrease in the microhardness value was obtained across the depth of the welds. A maximum microhardness value of 230 HV was obtained in welds produced with low heat input at a depth of 3.0 mm which is higher than the maximum microhardness value obtainable from either intermediate or high input condition. The peak value in intermediate heat input welds is about 220 HV at a depth of 0.5 mm and in high input welds,

the value is about 207 HV at a depth of 0.5 mm. This trend of microhardness in the transverse direction is attributable to differential cooling rate in the thickness direction due to the varying heat input. Microhardness behaviour at 45° left and right to the weld centreline is shown in Figure 16. The figure shows that the trend is similar to that in the transverse direction at low heat input condition (955.3 J/mm). Since the 45° orientation is within the HAZ, the trend in the microhardness characteristics in the welded coupons confirms that spots of high hardness value are restricted within the HAZ. This is suggestive that LBZs are essentially HAZ phenomenon. These spots are about 2 mm from the weld centre line both from the left and right (See Figure 16a and b) irrespective of the heat input.
