Linking channel instability to urbanization in the upper Beaver Creek Watershed, Knox County, Tennessee

LINKING CHANNEL INSTABILITY TO URBANIZATION
IN THE UPPER BEAVER CREEK WATERSHED,
KNOX COUNTY, TENNESSEE.

A Thesis
Presented for the
Master of Science
Degree
The University of Tennessee, Knoxville

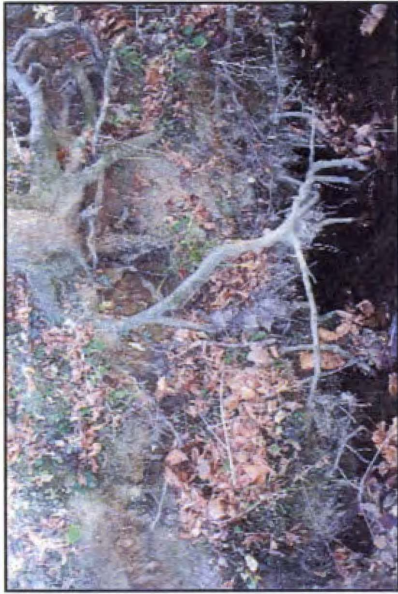
A. An undercut bank with exposed tree roots at KB01.

Figure 3-2. Examples of Bank Erosion

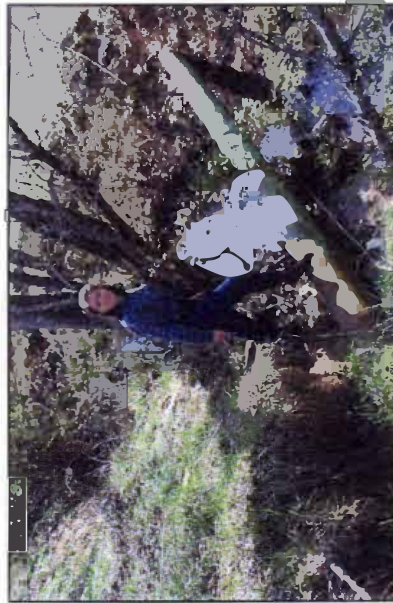
B. An exposed sewer line at TS01.

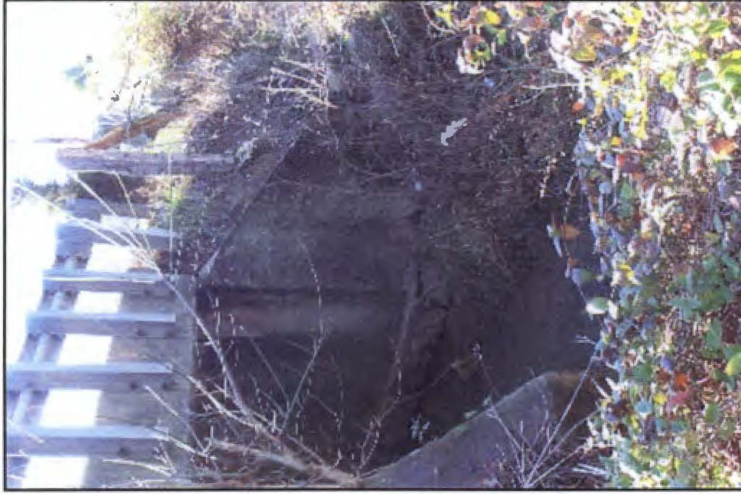
C. An exposed bridge footing at TS01.
