# Removal of a broken dental needle in the pterygomandibular space using an image intensifier: two case reports

**DESCRIPTORS** | Needle; Fracture; Local anesthesia; Image.

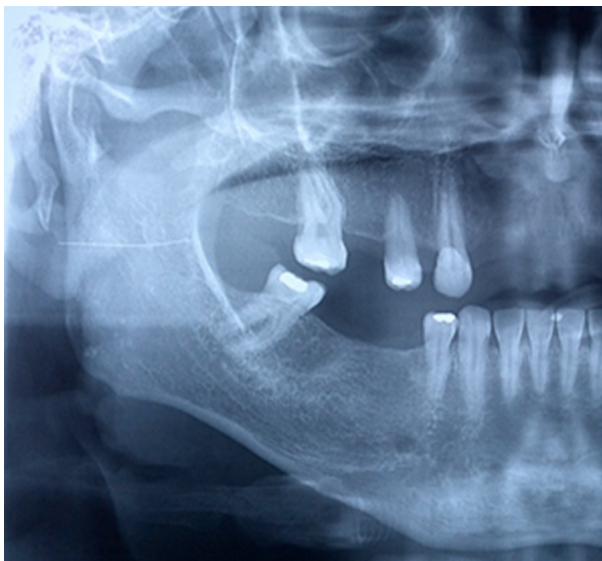
**FIGURE 1** | Preoperative panoramic radiograph showing the broken needle.

The clinical examination revealed a slight growth volume in the region, with associated painful symptoms. The patient also had trismus, but there was no infection sign. Imaging exams were requested: face tomography with 3D reconstruction and panoramic radiography (Figure 1), enabling the observation of an object of approximately 20 mm, compatible with the size of a needle.

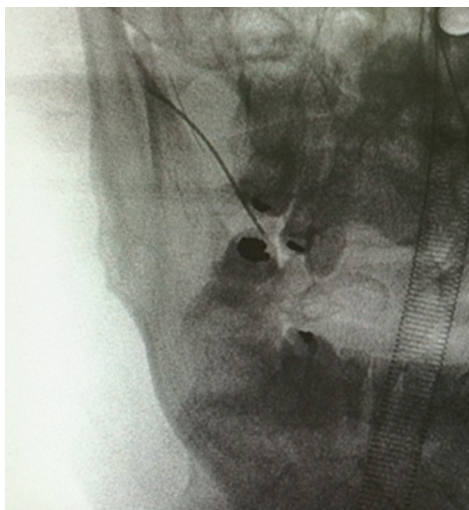
**FIGURE 2** | Trans-operative image of the needle (image intensifier).

An incision was made along the external oblique line from the third molar lateral region to the first molar right side with delicate detachment of all tissue, perpendicular to the needle plane, especially in the lingual region. After the detachment, the needle was not found. With the image intensifier, model Veradius Philips Medical Systems Nederland B.V, surgical images in region were obtained in the operation, and the precise location of the needle

was determined (Figure 2). With the support of a curved Halstead forceps, the needle was located and clamped, being removed, without major complications. Soon after the procedure, a radiographic control was made (Figure 3), in which the presence of the radiopaque object was no longer observed. Complications, such as hemorrhage, infection, or paraesthesia were not observed. Currently, the patient is under post-operative follow-up for 90 days, with no functional complaints.

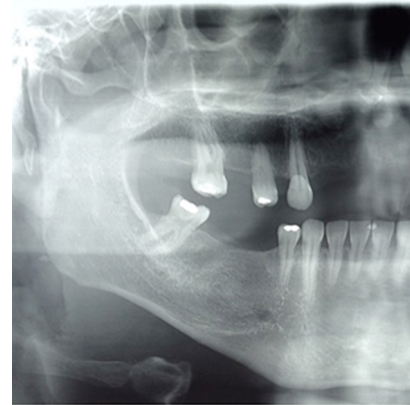
**FIGURE 3** | Postoperative panoramic radiography showing the removal of the broken needle.

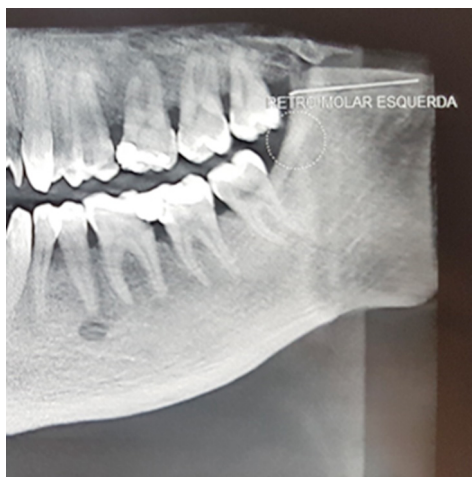
**FIGURE 4** | Tomography showing the presence of a broken needle on the left side.

On clinical examination, the patient reported pain and discomfort in the region. Cone beam computed tomography was requested to locate the needle, and the sections showed a hyperdense fragment of approximately 20 mm, located in the left pterygomandibular space (Figure 4).

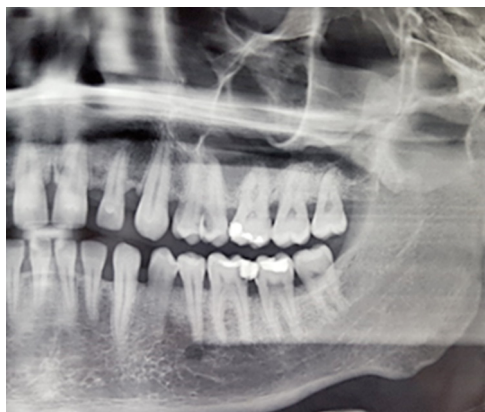
**FIGURE 5** | Postoperative panoramic radiograph showing the absence of the broken needle.

After the procedure, a control radiograph (Figure 5) was taken, in which the presence of the radiopaque object was no longer observed. The patient is currently under post-operative follow-up for 90 days, with no functional complaints.
