## Fiber reinforced polymer bar investigation: Long-term in-situ durability and bond strength assessment in conventional and sustainable concrete

FIBER REINFORCED POLYMER BAR INVESTIGATION: LONG-TERM IN-SITU  
DURABILITY AND BOND STRENGTH ASSESSMENT IN CONVENTIONAL AND  
SUSTAINABLE CONCRETE

A DISSERTATION

CIVIL ENGINEERING

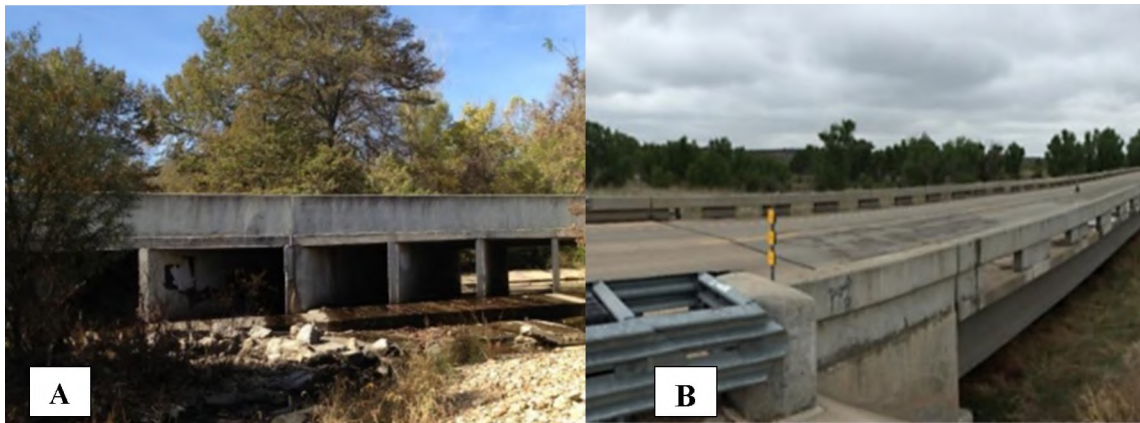
Southview Bridge is located on Carter Creek in Rolla, Missouri, shown in Figure 1.A. The original bridge was one-lane and consisted of four box culverts and topped with steel reinforced concrete deck of a 254 mm (10 in.) thickness. An expansion occurred in 2004 by replacing the existing sidewalk with a new one and adding another lane that consisted of four-box culverts and topped with glass fiber reinforced concrete deck. The expansion phase involved removing the curb from the existing deck to allow extending the bridge total width from 3.9 m (12.8 ft) to 11.9 m (39 ft). The new resulting width of the bridge is 9.1 m (30 ft) 13. GFRP reinforcement with 19 mm (3/4 in.) diameter was used as a main reinforcement and 13 mm (1/2 in.) diameter was implemented for shrinkage and temperature reinforcement in the deck <sup>2</sup>. Also, 10-mm (3/8 in.) diameter GFRP bars were used as prestressing tendons. Figure 2 shows the cores locations. The bridge is exposed to a range of temperature between -5° to 35° C (22° to 95° F) during the year. Also, it experiences regular wetting, drying, freezing, and thawing cycles. In addition, deicing salt is sprayed in winter months.

The temperature range and precipitation (from 1981 to 2015) are shown in Figure. 3. The second investigated bridge was Sierrita de la Cruz Creek Bridge and is located north-west of Amarillo, Texas. Figure.1. B. shows the Sierrita de la Cruz Bridge. The bridge was severely corroded, so it was considered structurally deficient, therefore a bridge replacement was necessary.

Figure 1. (A) Southview Bridge, Rolla, MO. (B) Sierrita de la Cruz Creek Bridge, Amarillo, TX

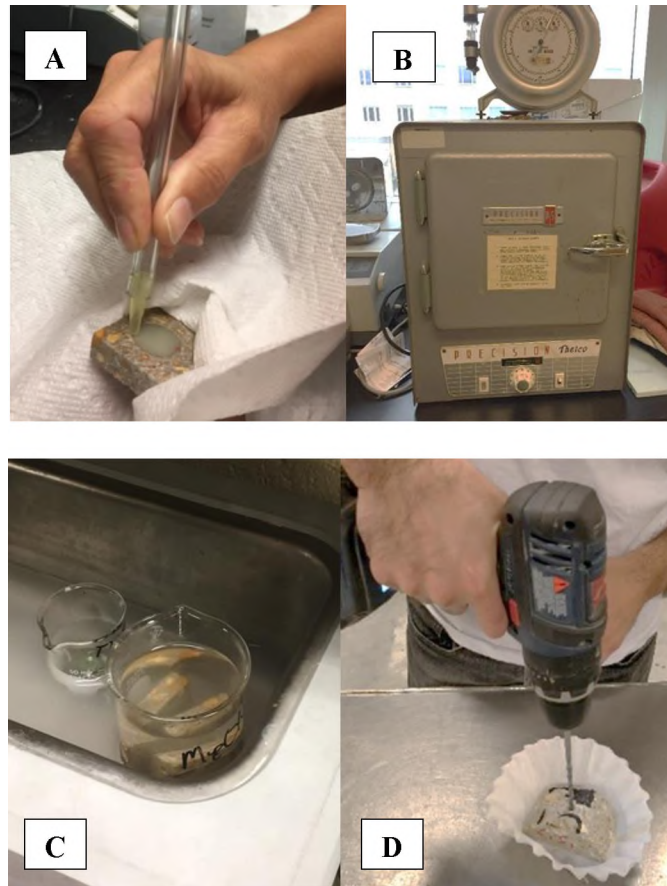
Figure 7. Preparations of Specimens: (A) air drying, (B) oven drying, (C) sonic bath, (D) drilling to get concrete powder

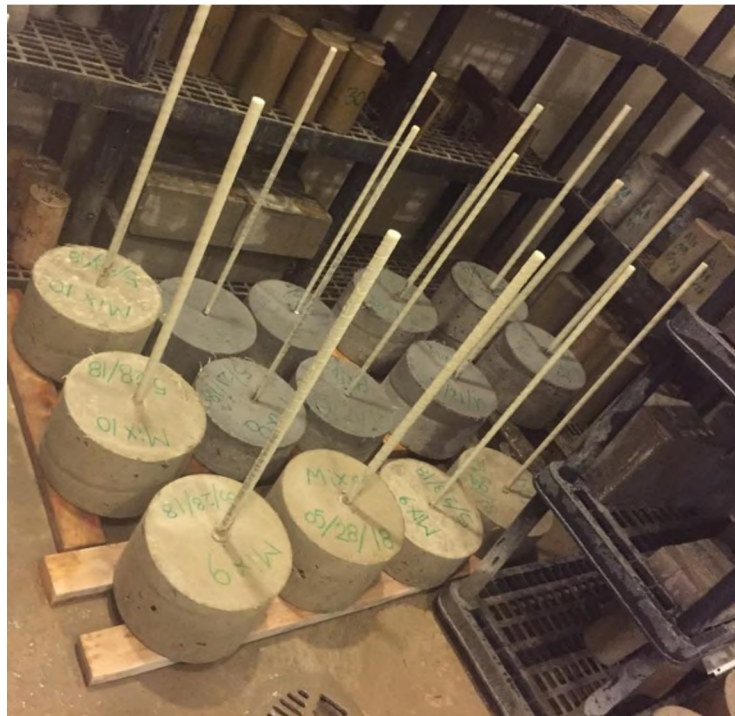
secure environment. Table 4 shows fresh and hardened concrete properties. Figure 2 shows the specimens. Specimens and cylinders demolding were conducted after 24 hours from casting. After that, all the specimens were labeled and moved inside the curing room. Figure 3 shows specimens inside the curing room.

Figure 3. Specimens in curing room

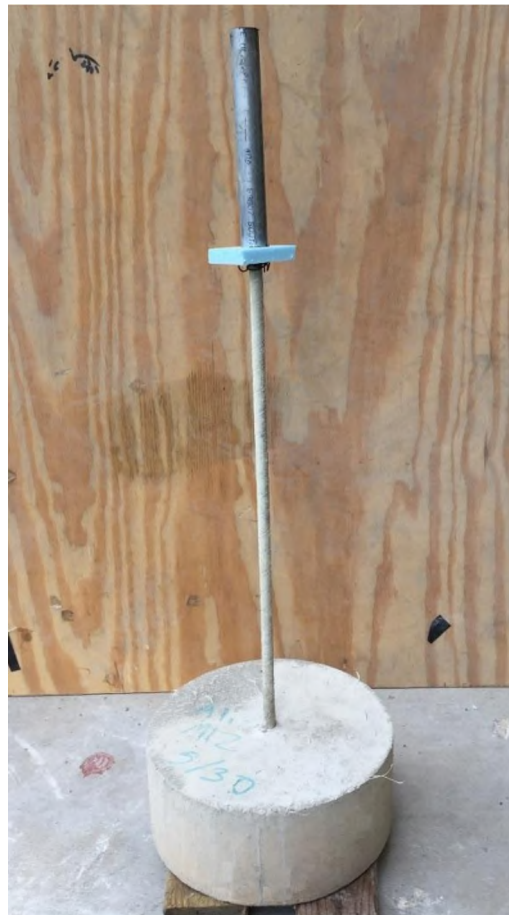
Figure 4. GFRP's specimen steel grip

a 19 mm (3/4 in.) tube was used with a thickness of 2.87 mm (0.113 in.) and, for 19 mm (3/4 in.) GFRP rebar, a 25.4 mm (1.0 in.) tube was used with the same thickness as the one used for the 13 mm GFRP bar. Skia-Dur 30 epoxy was used to attach steel tube to the GFRP rebar to prevent crushing of the GFRP rebar during pullout testing.

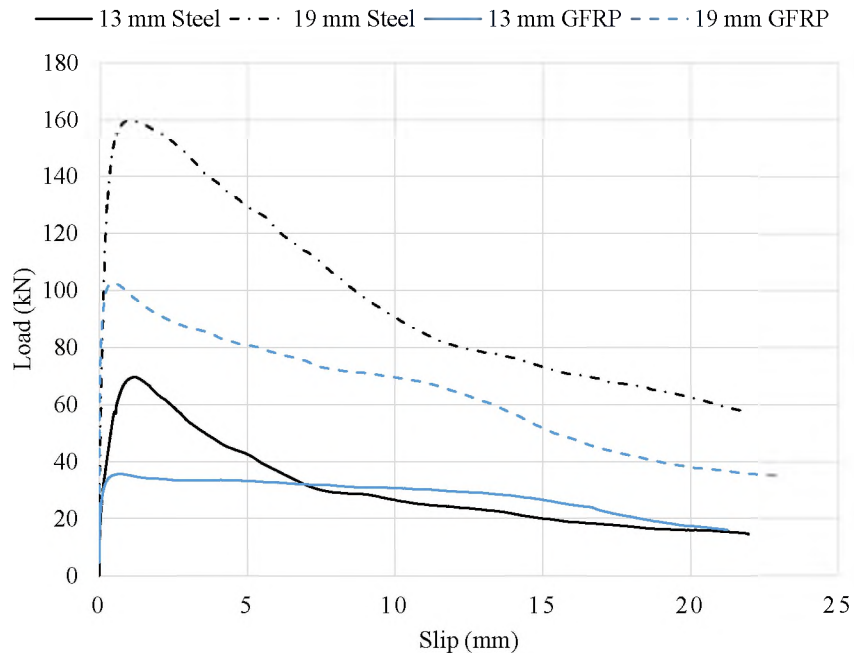
Figure 9. Pullout results of steel and GFRP rebars in 50% high volume fly ash

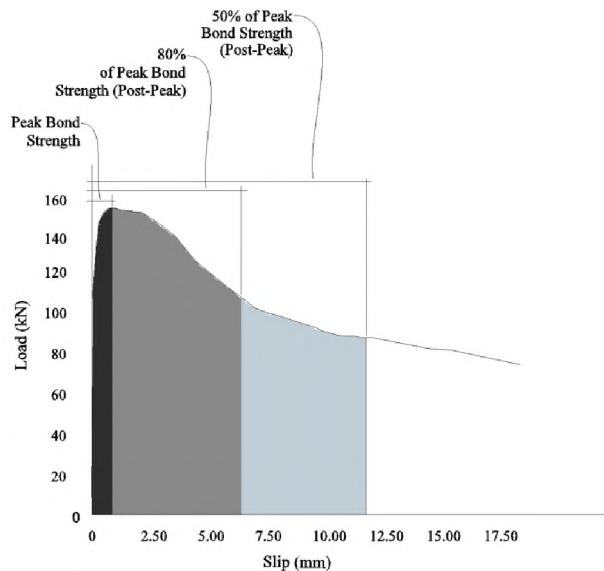
Figure 14. Measured toughness levels

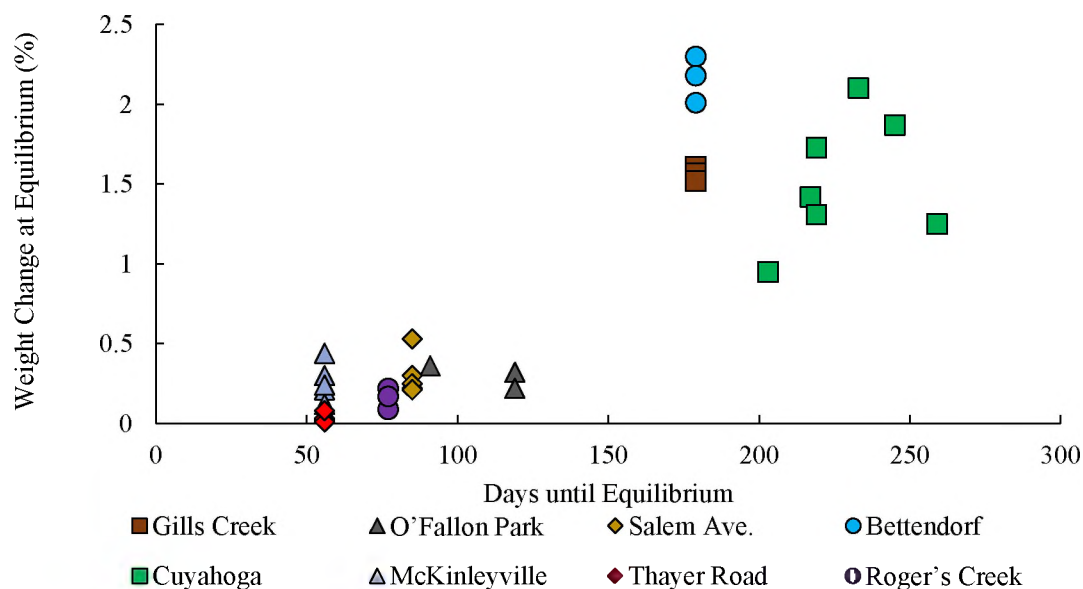
Figure 3. Equilibrium weight change and time to reach equilibrium for bars immersed in 50°C water

Table 2 shows the average weight change measured at 24 hours and at equilibrium as well as the average time required to reach equilibrium for each bridge. It is emphasized that the water uptake measurements are relative to the existing water content of the bars following the superficial 48 hr., 40°C (104°F) preconditioning regimen. In the cases of O'Fallon and Cuyahoga bars, the water content at the beginning of the uptake test (i.e., after preconditioning) was found to be approximately 0.36%, according to dry-out tests performed at 80°C using ASTM D5229 (ASTM, 2014). Thus, actual moisture contents in the bars at equilibrium can be expected to be approximately 0.36% more than the values listed in Table 2. While some of the extracted bars clearly have the capacity to exceed the 1% absorption limit of ASTM D7957, it should be noted that the bars evaluated in this investigation were manufactured before the existence of contemporary standards. Also, as shown in the following section, the water content of the bars after 15–20 years of service was well below 1%.

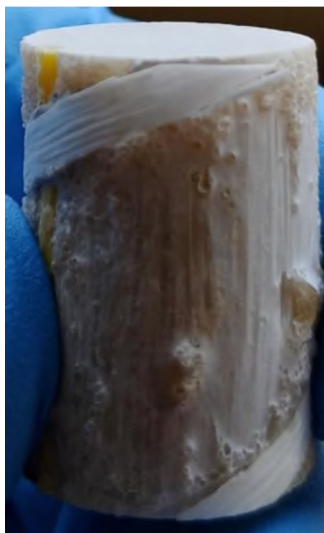
Figure 4. Part of the helical wrap fell off of a bar from the Cuyahoga Bridge during 50° C (122° F) water absorption testing

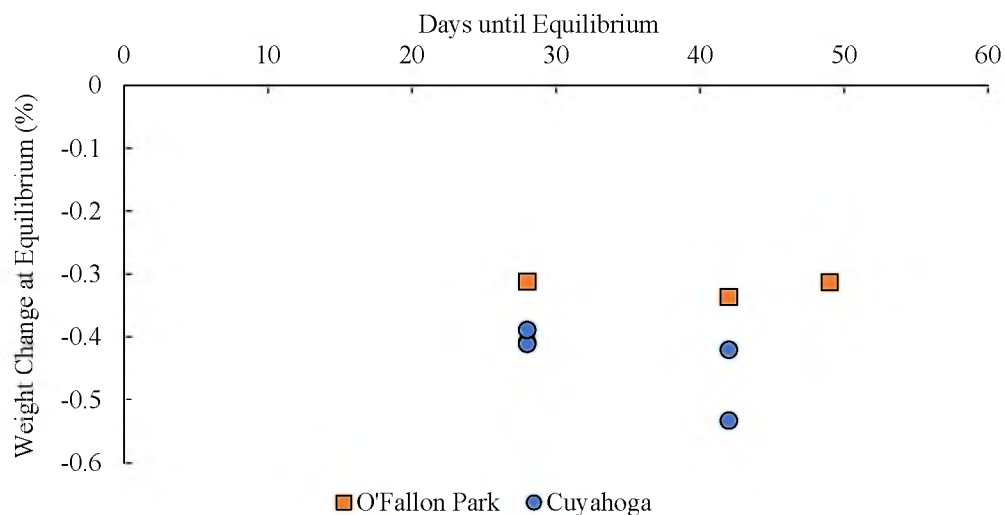
Figure 5. As-received moisture content of bars as determined by drying at 80° C (176° F), along with time required to reach equilibrium

Weight loss was observed to be non-monotonic, possibly due to the variations in the humidity level in the laboratory. The O'Fallon Bridge bars had less as-received moisture (0.32% on average) than the Cuyahoga Bridge bars (0.44% on average).

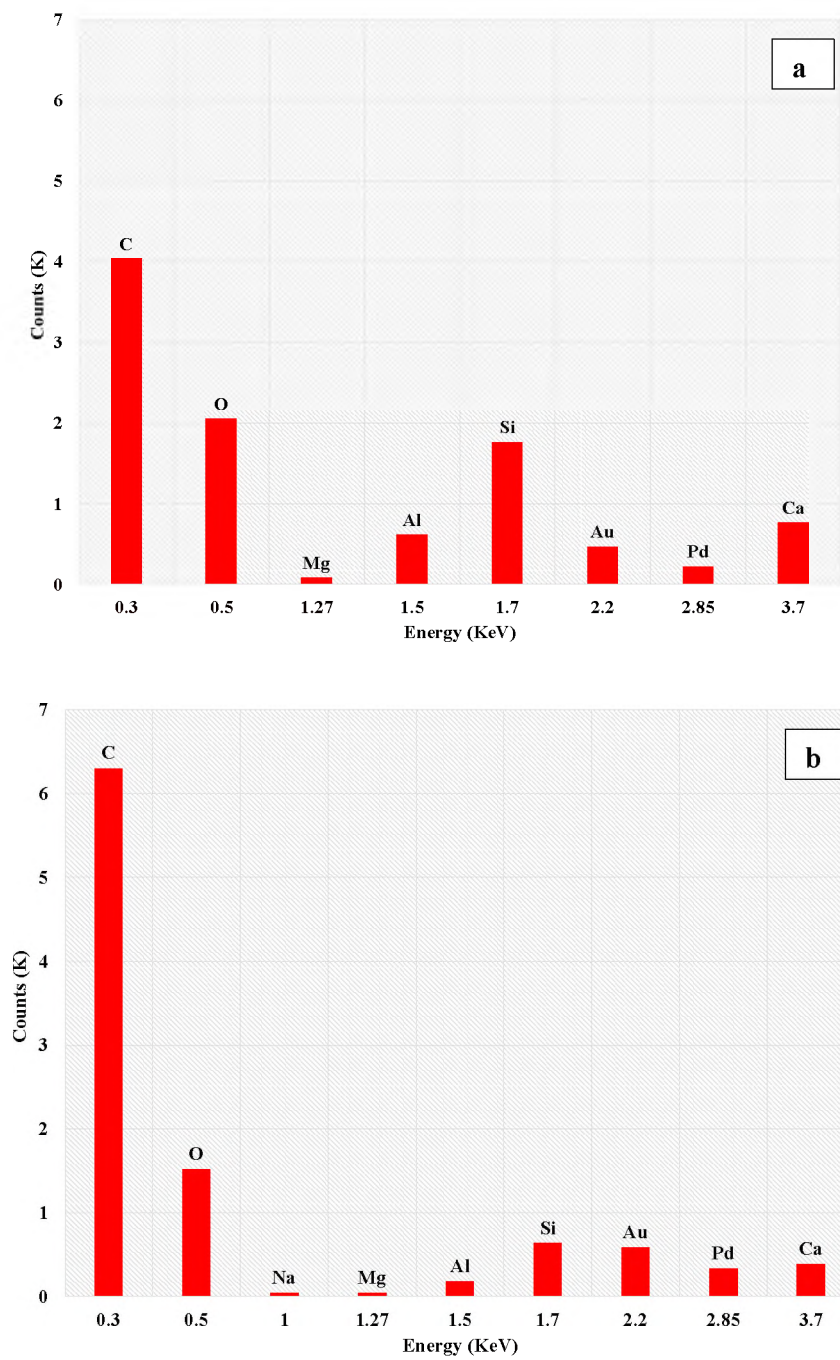
Figure 11. EDS test results for a bar from the Southview Bridge: (a) fiber and (b) resin

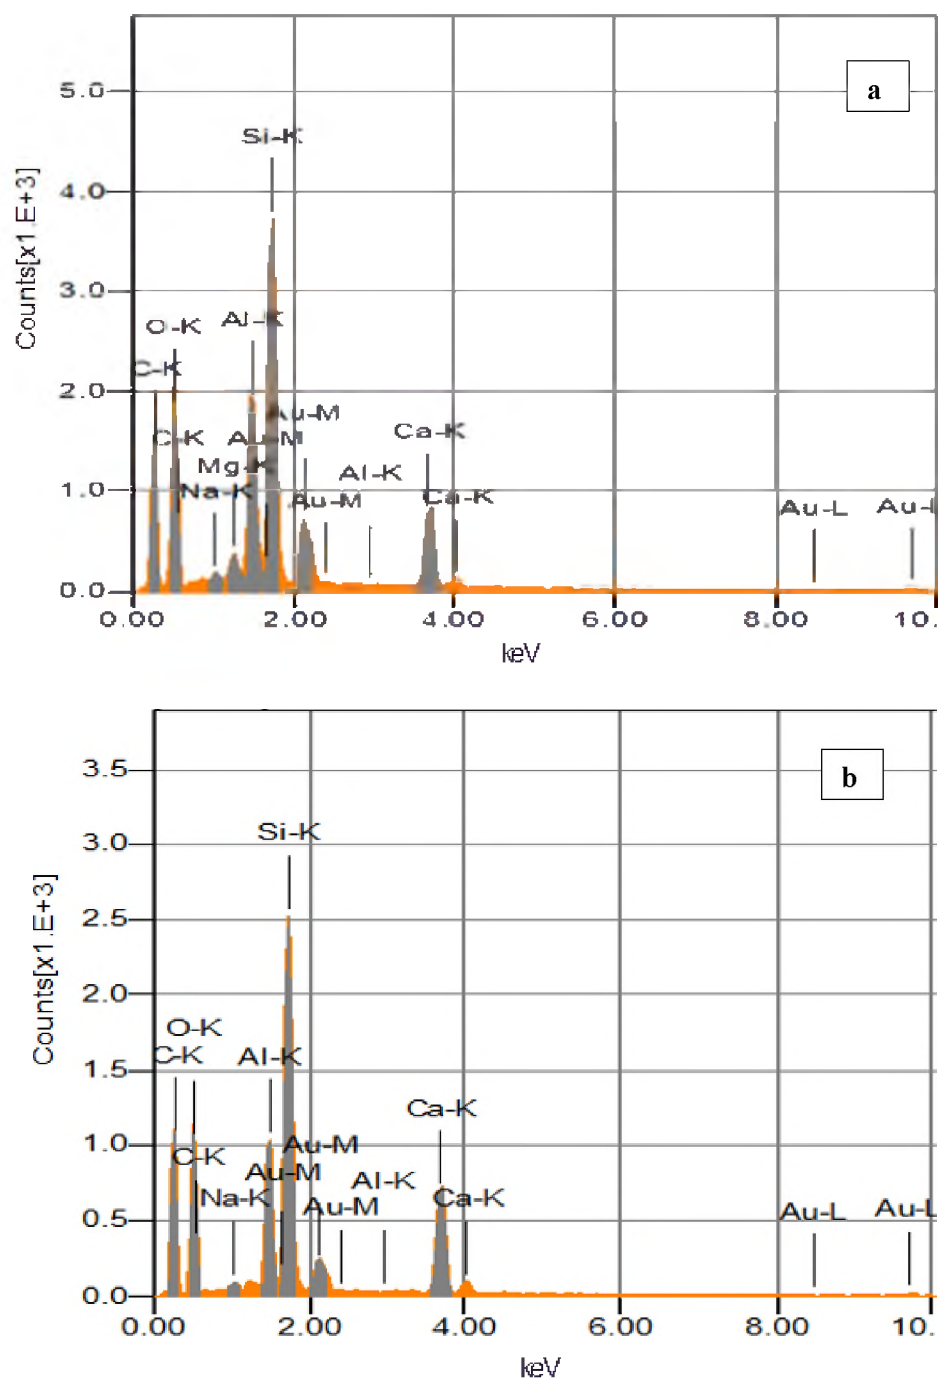
Figure 12. EDS test results for bars from the Sierrita de la Cruz Creek Bridge: (a) extracted bars; (b) pristine new-generation bars

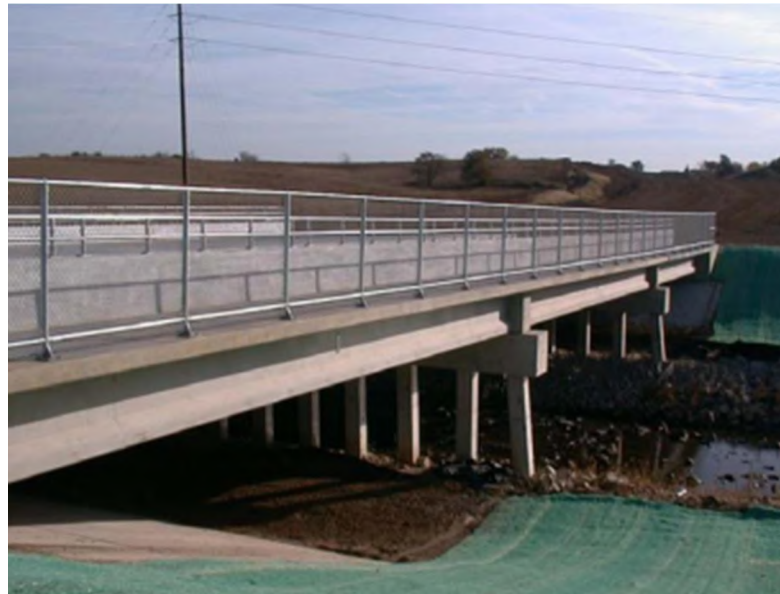
Bettendorf Bridge was completed in May 2003. It was built using funds provided through the Federal Highway Administration's (FHWA) Innovative Bridge Research and Construction (IBRC) program. The bridge extends 53<sup>rd</sup> Avenue over Crow Creek in Bettendorf, Iowa and is exposed to approximately 90 freeze-thaw cycles per year (Haley 2011). It is a 52.9-m (173.6 ft) three-span bridge as shown in Figure 1 (Wipf 2006).

Figure 1. Bettendorf Bridge

The bridge was the widest FRP reinforced concrete deck at the time of construction, measuring 30 m (98.7 ft) wide. It was also the first FRP bridge deck in the US to use composite action with prestressed concrete girders (Lee 2009).

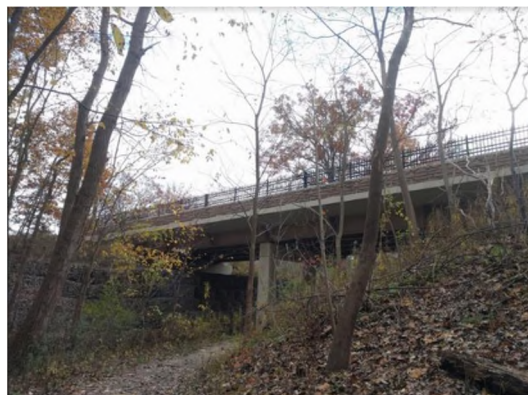
Cuyahoga County Bridge is located in the Southeastern Lake Erie snow belt in Ohio and is exposed to approximately 90 freeze-thaw cycles per year and heavy application of deicing salts. The bridge consists of two spans of 13.7 m (45 ft) long and an 11.6-m-wide (38-ft) deck. The original bridge was built in 1956 and consisted of five steel girders with a 229-mm-thick (9-in.) steel reinforced concrete deck with a 76-mm (3-in.) asphalt overlay. This bridge has the first deck on a multi-span vehicular bridge to be entirely reinforced with GFRP bars. The GFRP bars used in this bridge were made of E-glass fibers and vinyl-ester resin (Eitel 2005).

The Cuyahoga County Bridge is shown in Figure 3. The plan and section view are shown in Figure 4. Eight concrete cores were extracted from the Cuyahoga County Bridge deck, as shown in Figure 5.

Figure 3. Cuyahoga County Bridge

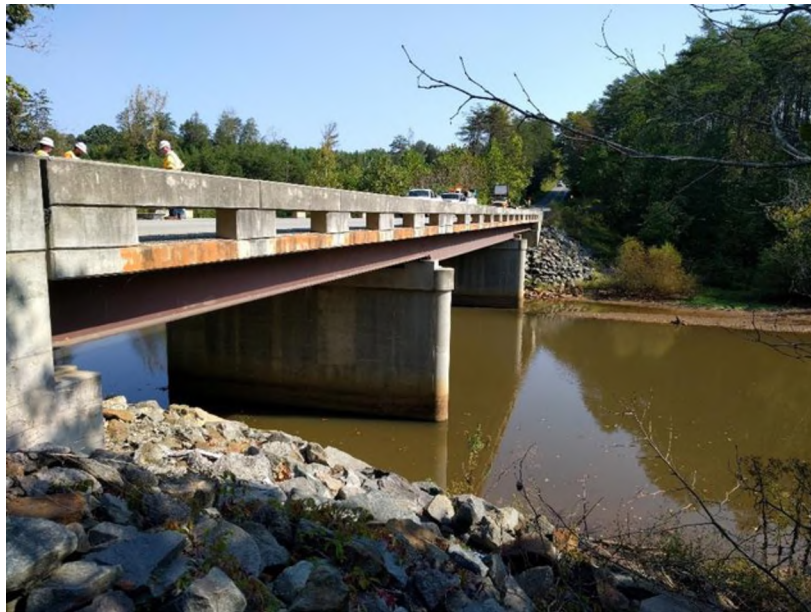
The bridge is located in Franklin County, Virginia and is exposed to approximately 75 freeze-thaw cycles per year (Haley 2011). It is a 52-m (170-ft) three-span steel girder bridge that cross over Gills Creek, as shown in Figure 6. The bridge has a width of 9.2 m (30.3 ft) and its spans A, B, and C measure 13.7 m (45 ft), 24.4 m (80 ft), and 13.7 m (45 ft), respectively.

Figure 6. Gills Creek Bridge

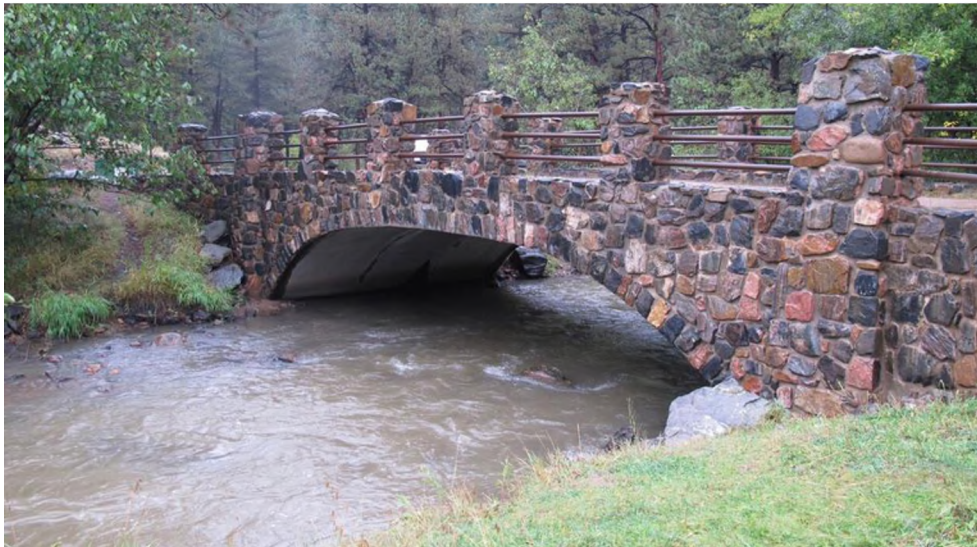
O'Fallon Park Bridge, shown in Figure 11, was completed in 2003. This bridge was part of a project to investigate the feasibility of the use of FRP in highway bridge decks. The construction was developed through a collaboration between the City and County of Denver, the Colorado Department of Transportation (CDOT), and FHWA, and it was funded by the FHWA IBRC program (Camata and Shing 2005). This bridge is located west of the city of Denver and is exposed to approximately 200 freeze-thaw cycles per year (Haley 2011).

Figure 11. O'Fallon Park Bridge

O'Fallon Park Bridge has a total length of 13.34 m (43.75 ft) and a width of 4.95 m (16.25 ft). The bridge deck is a GFRP deck supported by five reinforced concrete risers built over an arch. The arch is made of concrete reinforced with GFRP bars, with M19

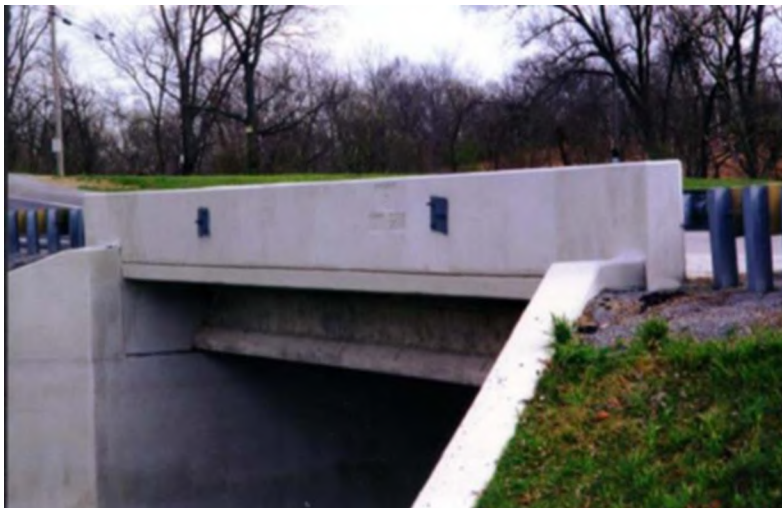
Roger's Creek Bridge was built in 1997. This bridge is the US-460 Bridge over Roger's Creek in Bourbon County, Kentucky and is exposed to approximately 80 freeze-thaw cycles per year. Its superstructure consists of a deck over simply supported prestressed concrete girders for a length of 11.1 m (36.5 ft) and a width of 11 m (36 ft), as shown in Figure 13. The bridge deck is partially reinforced with GFRP and steel bars. The GFRP reinforcing bars are placed as the top mat over an area that measures 2.7 m  $\times$  4.7 m (9 ft  $\times$  15.5 ft) and runs over three supporting girders (Harik et al. 2004). Six concrete cores were extracted from the Roger's Creek Bridge deck, as shown in Figure 14.

Figure 13. Roger's Creek Bridge

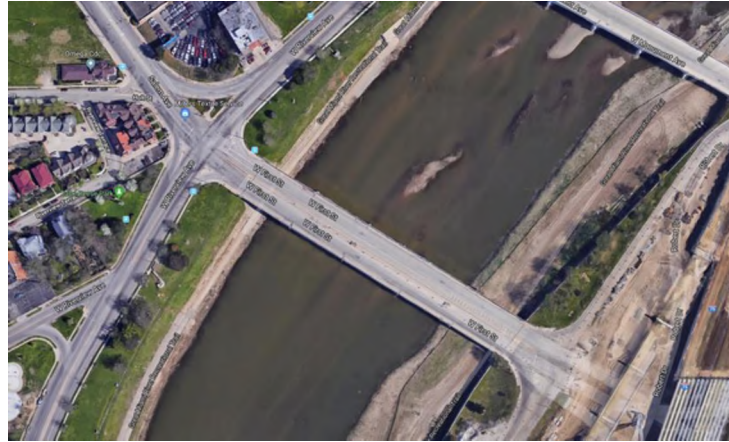
Salem Ave. Bridge was a retrofit project completed in 1999. This project was part of a study to understand the effectiveness of replacing concrete decks with FRP deck panels through the IBRC program (project OH-98-05) and the Ohio Department of Transportation (Mertz 2003). Salem Ave. Bridge consists of a pair of parallel bridges located on State Route 49 in Dayton, Ohio and exposed to approximately 90 freeze-thaw cycles per year (Haley 2011). The bridges are 207.3 m (680 ft) long and cross the Great Miami River, as shown in Figure 15. The bridges consist of built-up steel stringers with five spans of 39.6 m (130 ft), 41.8 m (137 ft), 44.2 m (145 ft), 41.8 m (137 ft), and 39.6 m (130 ft.). The deck of the original bridge, built in 1952, was retrofitted with four different FRP deck systems for one of the twin bridges, while the second bridge was retrofitted with only one deck system (FRP-4). (Reising et al. 2001).

Figure 15. Salem Ave. Bridge aerial view

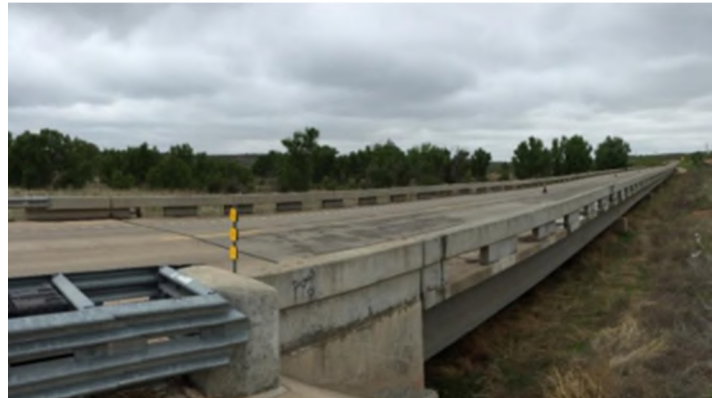
Sierrita de la Cruz Creek Bridge was a replacement project completed in 2000. The bridge, shown in Figure 17, is located on State Highway 1061, approximately 50 km (30 mi) northwest of Amarillo, Texas (Gooranorimi & Nanni 2017) and is exposed to approximately 110 freeze-thaw cycles per year (Haley 2011). The replacement was performed due to the bridge being structurally deteriorated and obsolete. The new design consists of seven spans, 24.1 m (79 ft) long and 14.3 m (45-ft) wide, supported by six prestressed concrete Texas type “C” I-beams (Phelan et al. 2003). The replacement project included M16 (#5) and M19 (#6) GFRP reinforcing bars made of E-glass fibers and vinyl-ester resin. The GFRP bars were placed in the top mat of the deck of the two southern-most spans (Spans 6 and 7). The other five spans used epoxy-coated steel bars, including Spans 1 and 2, which are symmetric with Spans 6 and 7, as shown in Figure 18. Witness bars were also embedded in the bridge overhang during construction, these were M16 (#5) GFRP bars with 15.9 mm of cover (0.63 in.) (Gooranorimi et al. 2016). Five concrete cores and three witness bars were extracted from the overhang of Sierrita de la Cruz Creek Bridge deck. The cores were extracted from locations near the bridge guardrail, as shown in Figure 19. Figure 20 shows the location of the extracted witness bars.

Figure 17. Sierrita de la Cruz Creek Bridge

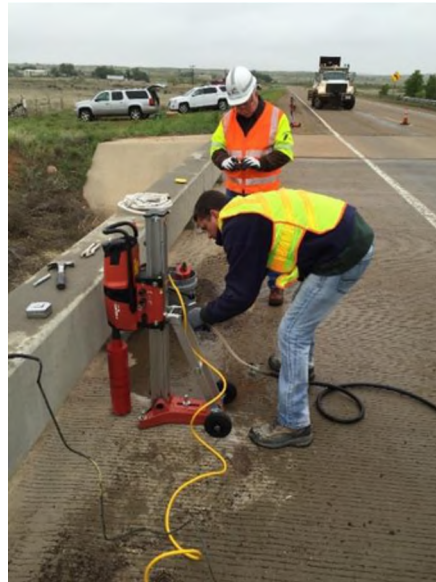
Figure 19. Sierrita de la Cruz Creek Bridge extracted core approximate location

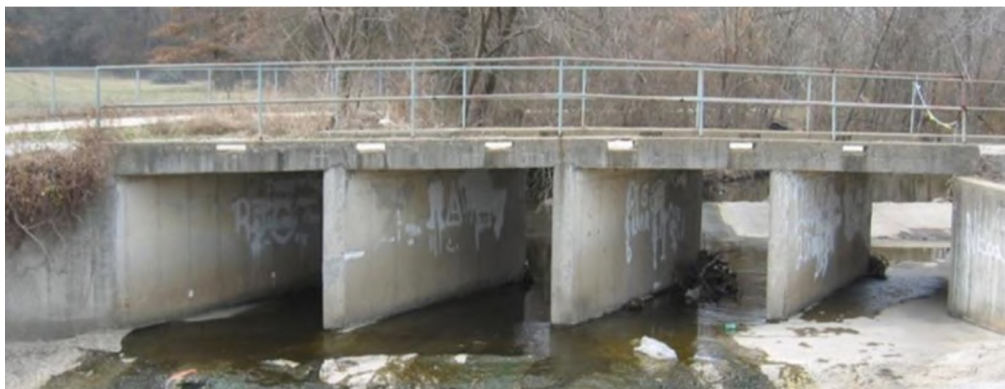
Southview Bridge was an expansion project completed in 2004. The bridge is located in Rolla, Missouri over Carter Creek and is exposed to approximately 90 freeze-thaw cycles per year. The bridge has an overall length of 12 m (40 ft), as shown in Figure 21. It was originally a one-lane bridge using conventional four-cell steel RC box culverts. It went through a widening in 2004 which included the construction of an additional lane and a sidewalk (Holdener et al. 2008). As a demonstration project to apply the use of FRP bars and tendons, the new deck was made of FRP prestressed/reinforced concrete, including M19 (#6) GFRP bars at the top and bottom mat, M13 (#4) GFRP bars for temperature and shrinkage, and M10 (#3) CFRP bars as the prestressing tendons, as shown in Figure 22. The 254-mm-thick (10-in.) concrete deck is continuous on three conventional RC walls as for the existing structure (Fico et al. 2006). The extension of the deck plus a 2-m-wide (6.6-ft) conventional RC sidewalk on the opposite side extended the overall width of the bridge from 3.9 m (12.8 ft) to 11.9 m (39.0 ft). Ten concrete cores were extracted from the Southview Bridge deck but only two cores were available for this specific study. Figure 23 shows the location of the extracted cores.

Figure 21. Southview Bridge before extension

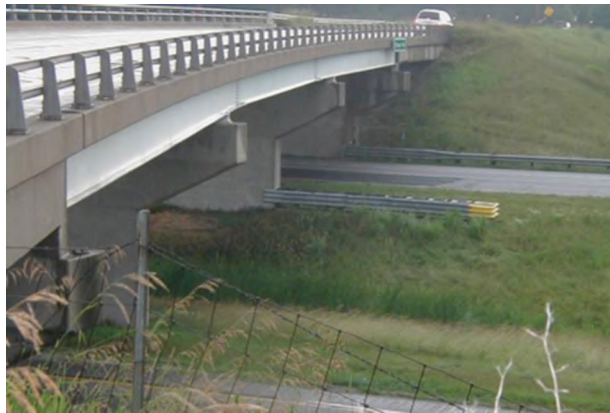
The Thayer Road Bridge replacement project was completed in 2004. The bridge is located on Thayer Road crossing I-65 Newton County, Indiana and is exposed to approximately 95 freeze-thaw cycles per year (Haley 2011). The bridge, shown in Figure 24, was designed for 60-km/h (40-mph) traffic of cars and trucks and consists of five spans of 12.1 m (39.8 ft), 19.4 m (63.5 ft), 23.7 m (77.8 ft), 19.4 m (63.5 ft), and 12.2 m (40 ft), respectively, summing up to a total length of 86.6 m (284 ft) with a 10.5-m-wide (34.5-ft) deck. The project was a collaboration of the Indiana Department of Transportation and Purdue University and involved the replacement of a concrete deck. The deck is supported by seven wide-flange steel girders and is reinforced with GFRP bars on the top mat and epoxy-coated steel on the bottom mat, as shown in Figure 25

Figure 24 Thayer Road Bridge

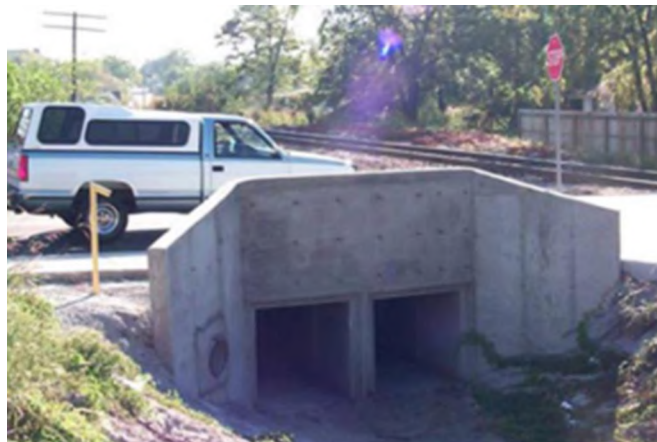
The Walker Box Culvert Bridge replacement project was completed in 1999. The bridge is located on Walker Avenue in Rolla, Missouri (Gooranorimi et al. 2017) and is exposed to approximately 90 freeze-thaw cycles per year (Haley 2011). The original bridge became unsafe to operate due to excessive corrosion of the steel pipes (Nanni 2001). To replace the original bridge, GFRP bars made of E-glass fibers and polyester resin were used to reinforce the concrete box culvert. The new bridge, shown in Figure 27, is 11 m (36 ft) wide, consisting of 18 box culverts that are  $1.50 \times 1.50$  m ( $4.92 \times 4.92$  ft) with a thickness of 150 mm (5.9 in.) (Wang et al. 2018). The RC boxes were entirely reinforced with M6 (#2) GFRP bars pre-bent and cut to size by the manufacturer (Alkhrdaji and Nanni 2001). Six concrete cores were extracted from Walker Box Culvert Bridge. The extracted cores were taken from the bottom of the two culverts, as shown in Figure 28.

Figure 28. Walker Box Culvert Bridge

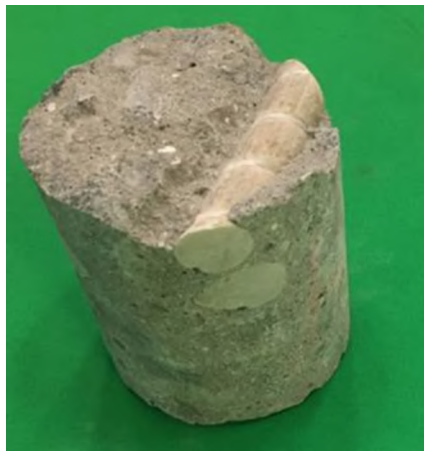
To extract the concrete cores from the bridges, a barrel of 102 mm (4 in.) in diameter was used. The targeted locations for core extraction were, when possible, areas with cracks or signs of environmental deterioration. No non-destructive method for identifying bar location is yet available. As a result, some concrete cores had no GFRP bars and others had GFRP bars shorter than 51 mm (2 in.). An extracted core with a short bar is shown in Figure 29.

Figure 29. A core sample

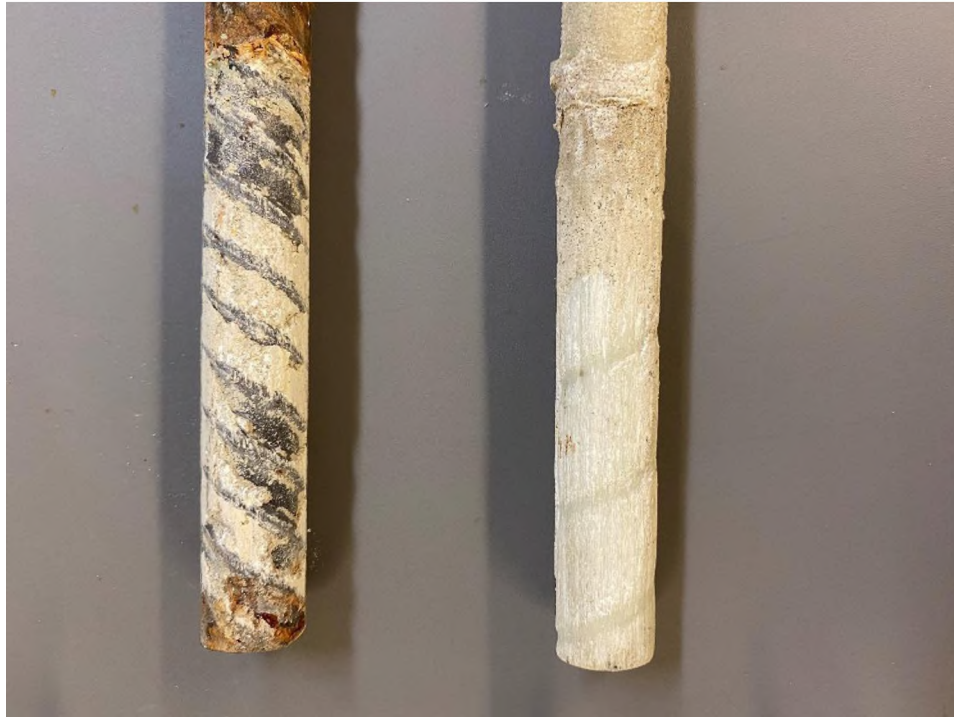
Figure 3. GFRP bar after pullout test
