Liu, A., Marshall, M., Rahimov, E. et al. (1 more author) (Accepted: 2021) Investigation of wear mechanics and behaviour of NiCr metallic foam abrasives. Proceedings of the Institution of Mechanical Engineers, Part C: Journal of Mechanical Engineering Science. ISSN 0954-4062 (In Press)

# Investigation of Wear Mechanics and Behaviour of NiCr Metallic Foam Abradables

**Keywords:** *Abradables, Metal Foams, Rub, Wear Mechanism, Incursion.*

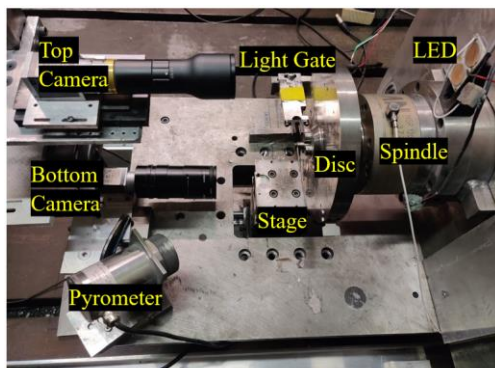
Figure 1. Representative high speed test rig used for experimentation

Testing in this work is performed on a scaled test rig at the University of Sheffield which has been previously described extensively [17] and shown in Fig. 1. This test rig is comprised of a

rotating disc with two blades coupled to it, one a dummy blade and another the wearing blade. The disc is coupled to a spindle which is controlled through use of an inverter controller which enables setting of a constant rotational speed. The abrasable sample is placed upon a z axis microscope stage which is positioned below the blade, prior to testing the stage position is adjusted to allow the abrasable surface and blade tip to touch where the blade position is perpendicular to the rub surface. When starting the test, the stage and sample are offset  $500 \mu\text{m}$  from the original location. The spindle is rotated at the desired speed, the microscope stage is then used to drive the abrasable sample into the rotating blade at a uniformly set incursion rate. This operation generates an intermittent high speed contact between the sample and the blade, all tests are carried out in ambient temperature conditions.

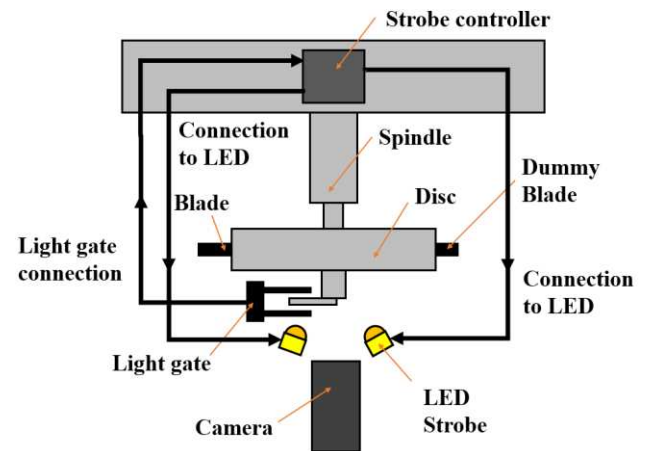
Figure 2. Schematic to show camera set up for DIC technique

Additionally to this setup, a lower camera (Basler Ace acA1600-60gm Monochrome GigE) is used to capture images of the abrasable sample side profile throughout the test. LEDs are positioned appropriately in front of the sample to allow sufficient lighting of the sample, and are controlled through a signal delay board to ensure coherence with the blade rotation. This setup allows for further digital image correlation (DIC) processing, calculating strain in the foam as the blade interacts with it, schematic is shown in Fig 2.

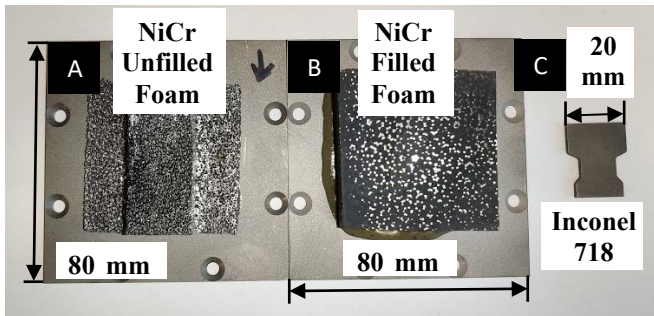
Figure 3. Samples including dimensions and size

This study makes use of a NiCr foam, the basic characteristics are outlined in Table 1. Some of the NiCr foams were injected with polyester filler material, the filler has additional amounts of silicon for high temperature applications. Fig 3 shows examples and the relative dimensions for testing, (A) example of an abraded unfilled sample, (B) example of a filled foam sample before testing, (C) Inconel 718 Blade.

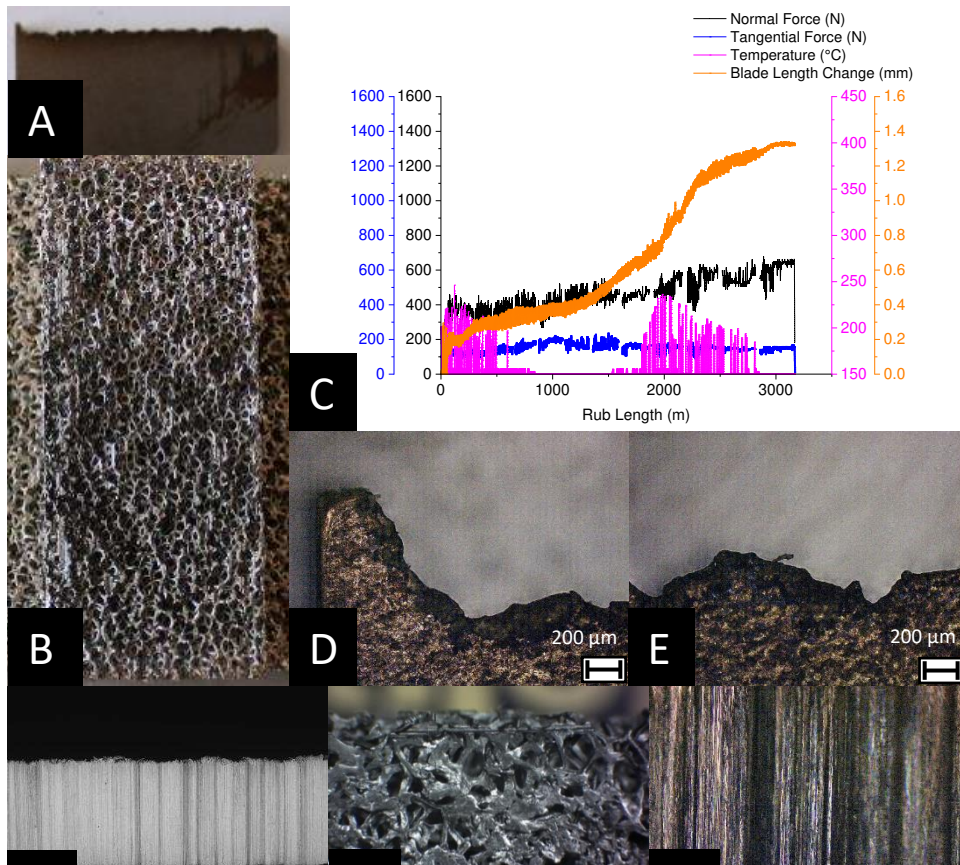
Figure 4. A-H showing examples of blade (A) and abradable (B) samples, force, temperature and blade length change (C), optical post-test blade wear (D,E), SEM blade tip surface (F), stereoscopic image of abradable post-test (G) and optical image of blade tip surf (H)

Fig 4 shows results from the test for small cell size (1200) NiCr foam at and incursion rate of  $0.02 \mu\text{m}/\text{pass}$ , it shows characterisation of the blade and abrasible as well as forces experienced during the test. Conversely Fig 5 shows results for larger cell size (3000) NiCr foam under the same testing conditions. From Fig 4D,E and 5D,E indicate that for open cellular structures a significant amount of blade wear is observed, this is seen for both foams in the optical images to identify the severity. The depth of blade wear can be approximated to be  $900 \mu\text{m}$  for NiCr 1200 and  $400 \mu\text{m}$  for NiCr 3000, larger pore size is seen to be less however the test duration till fracture is significantly shorter. Further, this sample fractured and broke after the first 1000 m of rub length due to rapid release of energy from the system through breakage and loss of metallic ligaments due to the fact the foam is unfilled. If the test is repeated the same result would be expected as there is no load transfer present and the energy will release in the same way, leading to sample rupture and delamination. Hence a repeat was not performed as the outcome was a function of the material. For larger nominal pore size there is more severity to the amount of blade wear that occurs which is a major concern which needs to be addressed and will be fully detailed in the discussion.

For both abrasible samples due to the structure of the foam having open cell formation, the areas where metallic ligaments exist cause ridges to form within the blade when worn. SEM and optical images show these ridges. Due to larger struts and nominal pore size in NiCr 3000 the ridges formed are larger in width compared to that of NiCr 1200 as shown in Fig 4H and 5G,H. Fig 4G shows the compaction and compression that the metal foam experiences during the test, many of the open cellular region have fractured and are compacted together.

The rubbing forces for small and large nominal pore size are shown in Fig 4C and 5C, the tangential force experienced can be seen to be greater for a larger nominal pore size. The metallic struts are larger as seen in Fig 4B and 5B and thus require more energy to remove it, for smaller pore size the relative metallic struts are smaller and therefore less energy is needed to break and fracture these from the rub surface. The normal force for NiCr 3000 is greater in comparison to NiCr 1200, this would imply less compression and more violent wear of the two components. A smaller normal force for NiCr 1200 indicates that it is easier for the ligaments to plastically deform out of the way and compaction of the abrasible material occurs, this is due to the energy being absorbed upon impact by the metallic struts within the top rub surface or breaking earlier.

Observing the rub area seen in Fig 4B there are large cavities in the abrasible material surface, this is where dislocation and fracture has caused areas to delaminate and break off. From the imaging as well as characterisation it can be clearly identified that a large amount of material is removed as well as a substantial amount of blade wear. Stress accumulation from the force applied by the blade which localises in the metallic struts is a point of interest which is detailed fully in the discussion.

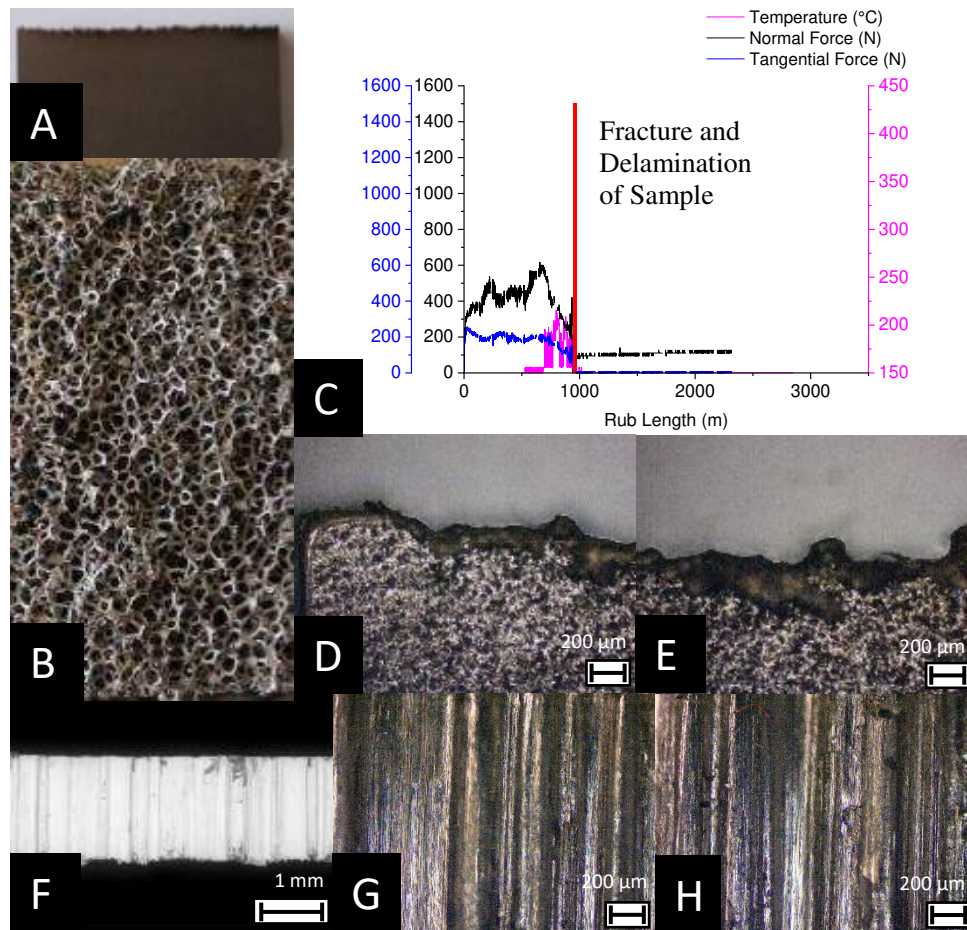
Figure 5. A-H showing examples of blade (A) and abrasible (B) samples, force, temperature and blade length change (C), optical post-test blade wear (D,E), SEM blade tip surface (F), optical image of blade tip surface (G,H)

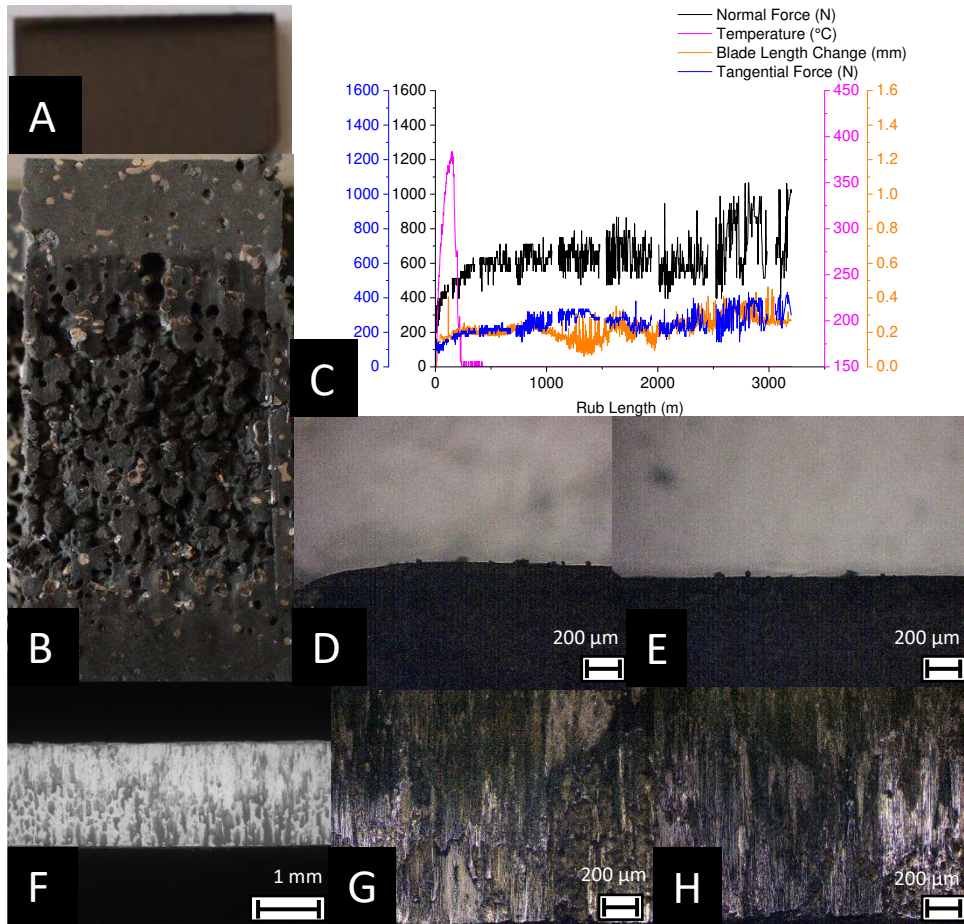
Figure 6. A-H showing examples of blade (A) and abrasible (B) samples, force, temperature and blade length change (C), optical post-test blade wear (D,E), SEM blade tip surface (F), optical image of blade tip surface (G,H)

Fig 6 shows the results for a filled foam, it shows characterisation of the blade and abrasible as well as forces experienced during the test. The contact surface for in Fig 6B shows a large amount of empty pores, the metallic phase is seen to be removed and pulled out during the test. The abrasible material shows good compaction upon contact which is a desired property, displacement means that the abrasible material becomes concentric to the blade path.

From Fig 6C the shear and normal forces recorded are identified to be larger for when filler material is present within the NiCr foam structure, when considering the shear force the contact surface area is greater and therefore more cutting resistance force exists, the

Fig 6A shows that with filler material there is little to no blade wear however more material pickup. The optical images 6D,E show that material pickup exists as a thin layer covering the blade tip, small areas exist where the debris formation is seen as small fragments of filler attached. The SEM image shown in Fig 6F indicates the location of the debris pickup and adhesion to the blade. The upper part of the blade is the leading edge, most of the pickup can be seen to occur along the trailing edge of the blade as it passes across the sample.

Little blade wear is seen through optical imaging of the blade tip face indicated from Fig 6G,H. a few minor chips and breakdown is from the recast layer which is a result of the manufacturing process. The darker areas illustrate where the filler has adhered onto the blade tip surface.

At faster incursion rates more damage is seen to the recast layer along the blade tip as shown in Fig 9G,H in comparison to Fig 6G,H, at faster incursion rates there is more energy entering the system

upon contact between blade and abrasible sample. From the post-test characterisation seen in Fig 6B, 7B and 9B faster incursion rates create a smoother wear surface as well as less material pull out as clear fracture of the ligament with removal of the filler is more likely.

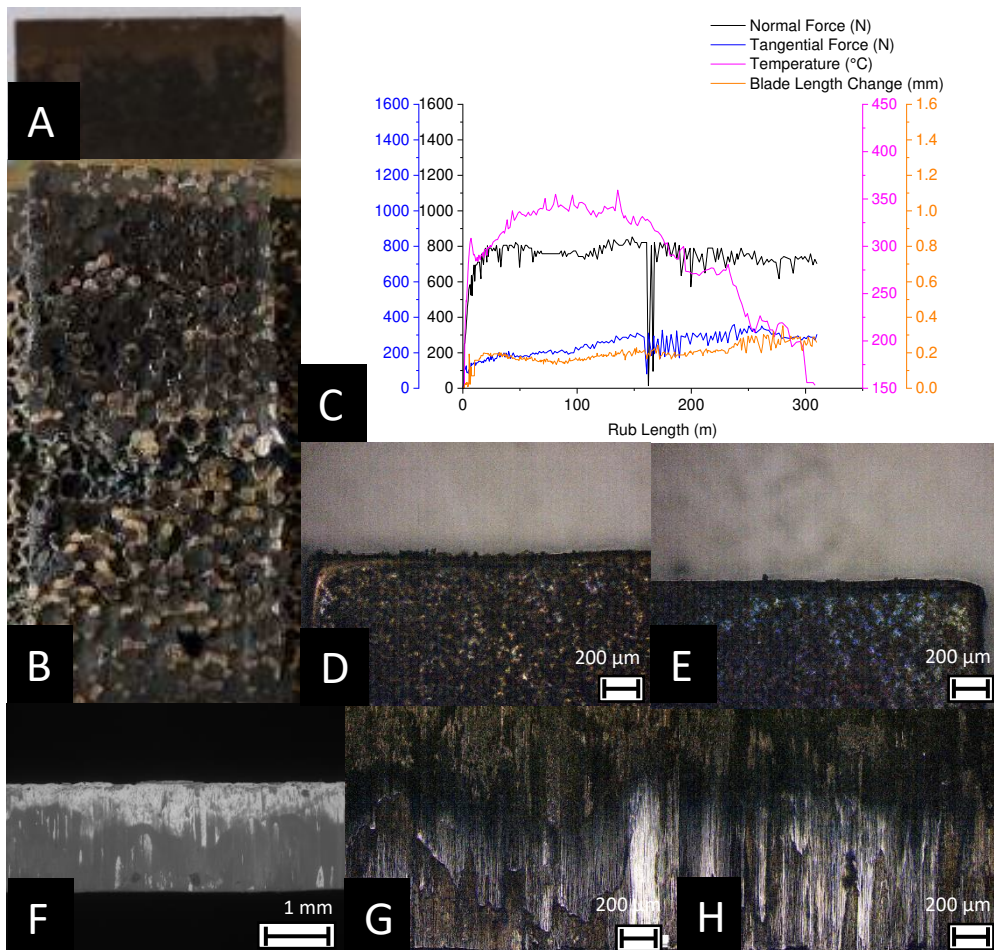
Figure 7. A-H showing examples of blade (A) and abrasible (B) samples, force, temperature and blade length change (C), optical post-test blade wear (D,E), SEM blade tip surface (F), optical image of blade tip surface (G,H)

Fig 7 shows the results for NiCr foam at 2  $\mu\text{m}/\text{pass}$ , pickup is very low however if the incursion rate is decreased by a factor of 10 and 100 to 0.2 and 0.02  $\mu\text{m}/\text{pass}$  pickup starts to increase as shown from the images shown in Fig 6 and 7, this is seen on the blade tip surface. At higher incursion rates the rub surface has a smoother morphology with less material pull out. The average and maximum forces acting on the abrasible sample are very similar between the tests in the shear and normal direction, however the wear mechanics and final morphology is significantly different. A main point of discussion is why the variation in morphology is achieved with different incursion rate.

The particle adhesion is more evenly distributed for smaller incursion rates such as 0.2 and 0.02  $\mu\text{m}/\text{pass}$ , where the optical images in Fig 6D and 7D show that the debris pick up is a more uniform layer spread along the blade surface and the particle size is relatively consistent. However as incursion rate is increased to 2  $\mu\text{m}/\text{pass}$ , from Fig 9D,E it is identified that little material adhesion occurs with uncontrollable location and size of debris formation.

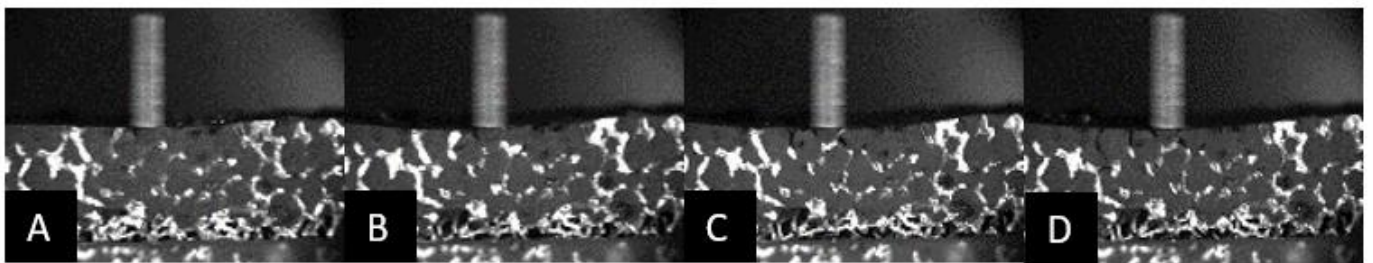
Figure 8. Evolution of material pull out phenomenon captured by bottom camera for recemat 0.02  $\mu\text{m}/\text{pass}$  incursion rate

For an incursion rate of 0.02  $\mu\text{m}/\text{pass}$  a lot of material pull out is experienced. Due to this loss of metallic phase the remaining material revealed at the surface is polyester filler, polyester filler has a low emissivity and isn't picked up by the pyrometer as having any temperature. This in turn causes the sudden drop in temperature seen

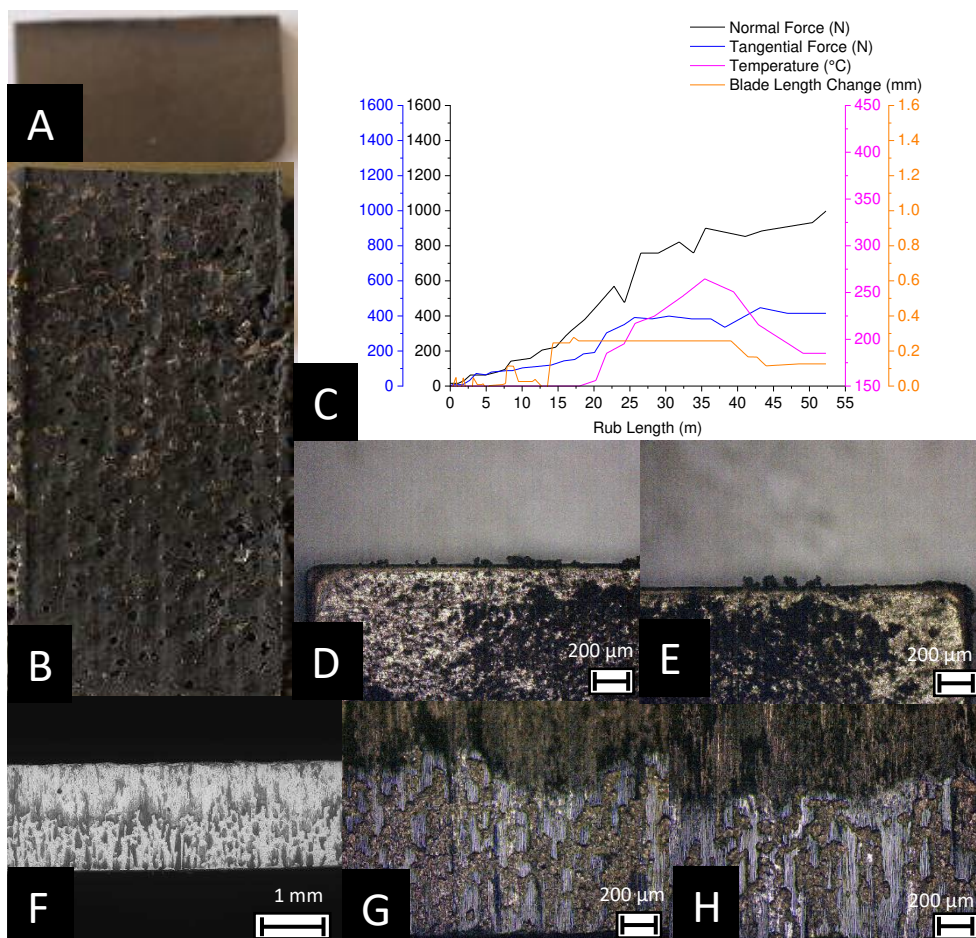
Figure 9. A-H showing examples of blade (A) and abrasible (B) samples, force, temperature and blade length change (C), optical post-test blade wear (D,E), SEM blade tip surface (F), optical image of blade tip surface (G,H)

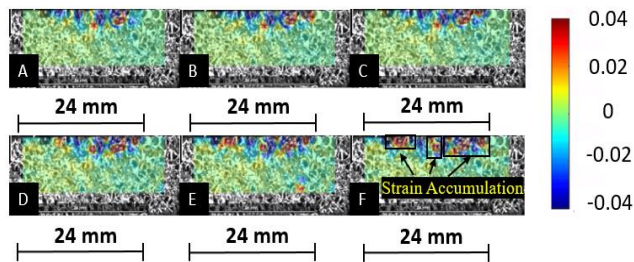
Figure 10. Evolution of strain localisation within the top rub surface for NiCr Foam 1200 0.02  $\mu\text{m}/\text{pass}$

For the larger foams significant fracture occurs at the surface with a compactive built up layer starting to occur before material ultimately breaks away, bulk densification of the material is small and more fracture occurs. Given all occurs within the locality of the surface, surface high forces and blade wear are observed. Comparing now the DIC for the finer foams it is seen that less compaction occurs and more fracture occurs on a strike by strike basis, meaning that lower forces occur and the material doesn't wear the blade as much, however this is still enough for some wear. For unfilled foams, the stress and strain localisation in the top rub surface implies a lack of energy absorption and transfer. Fig 10 shows a series of images with the DIC processing overlaid showing the localisation of strain accumulation within the top contact surface.

It is also interesting to note that the strain accumulation can be seen to vary dependant on position within the arc of contact. For example in Fig 10 the strain accumulation can be seen to amass in two main locations. Towards the left side where the blade first enters contact, strain accumulation can be seen, similarly at the exit of contact. This may well be due to the shock loading of entry and exit when the blade interacts with the sample much in the way seen for a machining insert or tool flute in milling [26].

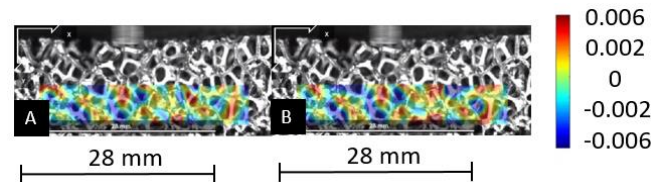
Figure 11. Evolution of strain accumulation in the bottom section of the abrasible for NiCr Foam 3000

The locations where stress and strain build up is clearly pinpointed within a larger pore size structure since the metallic struts can be identified more easily as shown in Fig 11. Open cellular foam structures always have two outcomes, significant wear of the blade or significant wear of the abrasible. For large pore size the number of interconnecting struts within the base is significantly less in comparison to a smaller pore size foam, if any of the major ligament

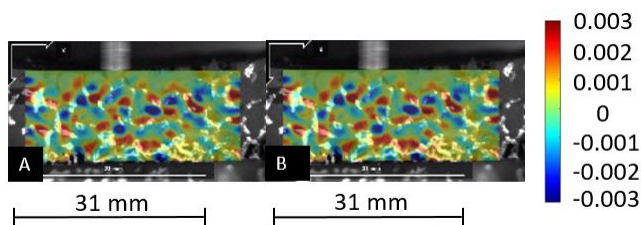
Figure 12. Evolution of strain distribution in the abrasible sample for NiCr – Filled Foam  $0.02 \mu\text{m/pass}$

Filler material is therefore useful to help absorb and dissipate energy from the blade impact, and the main role of DIC processing is to identify failure regions of high stress and understand how the filler impacts the behaviour and response of the metallic foam structure. This highlights how fillers are important due to their capability to promote load transfer. A good example of this load transfer is shown in Fig 12 for an incursion rate of  $0.02 \mu\text{m/pass}$  where it can clearly be seen that the filler absorbs the energy and transfers the load through the sample, and repetition helps reduce the breaking of the metallic phase by absorbing the energy upon impact of the blade.

Areas of large strain and buckling occur where small regions of filler are surrounded by neighbouring metallic struts/ligaments, and a large impact force from the blade contact can cause the metallic phase to loosen within the entire structure. Without the presence of filler material the strain accumulates in such areas. The filler helps to reduce the severity of this phenomenon, however, long term

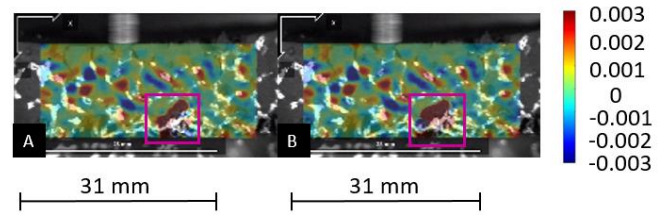
Figure 13. Evolution of strain build up when lack of filler for NiCr – Filled Foam  $0.02 \mu\text{m/pass}$

solutions will need to be implemented to avoid or control the filler distribution. Fig 13 shows a good example of where the effects of open pores and uneven distribution or lack of filler is present, leading to large strain accumulation followed by breaking away and formation of large cavities. This highlights the importance of filler evenly distributed within the metallic foam structure.

As such a good load transfer mechanism requires an evenly, well distributed amount of filler in the NiCr metallic foam structure. Fig 13 shows an example of where the strain accumulation builds and will ultimately end in fracture and damage to the abrasible. The evolution of strain accumulation can be captured in these two frames, in these circumstances this can cause delamination of the abrasible sample. This clearly highlights the importance of the filler to better promote the load transfer mechanism to prevent blade wear and significant damage to the foam.
