## Post-Fire Assessment of Concrete Tunnel Structures

**POST-FIRE ASSESSMENT OF CONCRETE TUNNEL STRUCTURES**

MASTER OF SCIENCE IN CIVIL ENGINEERING

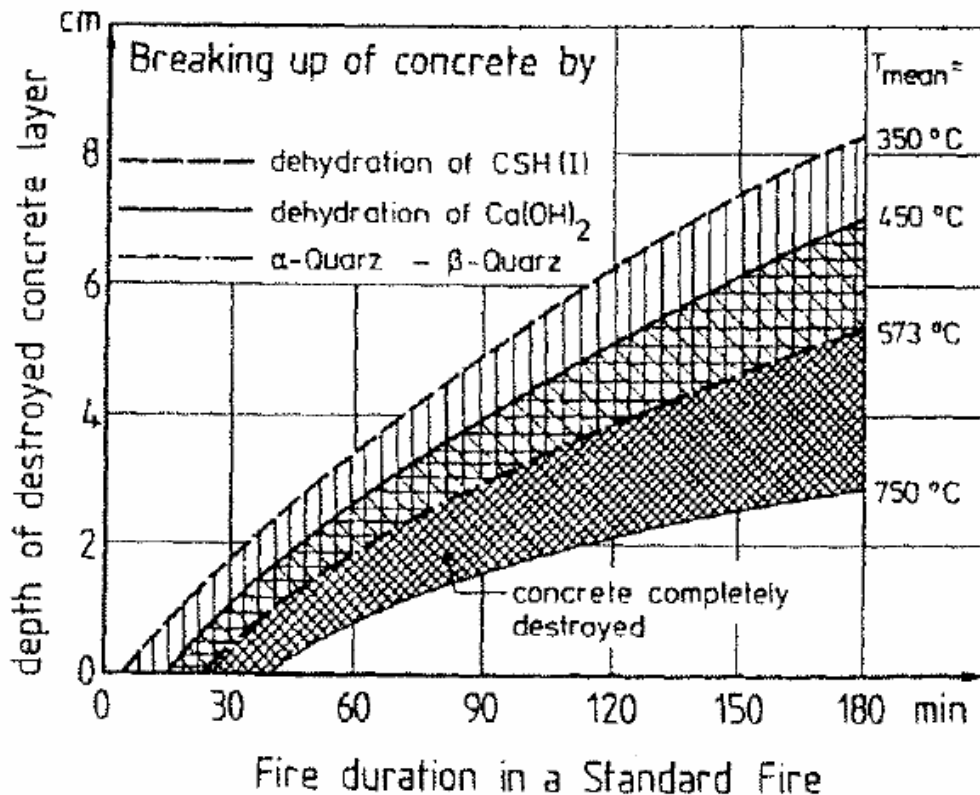
Figure 2.18: Damage and temperature depth in concrete exposed to the ISO 834 fire (Reproduced from fib Bulletin 46, page 99 - "Depth of transformation at increasing duration of the ISO fire," by Schneider (1990) with permission from the International Federation for Structural Concrete (fib) [8])

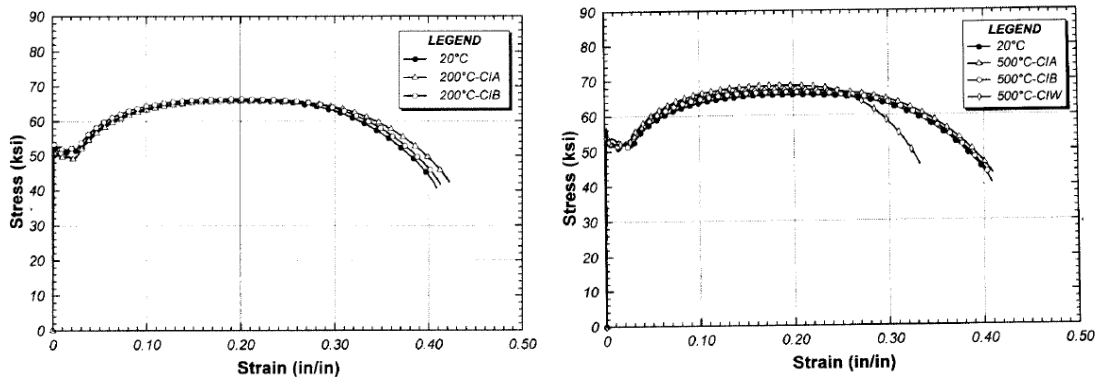
**Figure 2.22: Residual stress-strain curves for A992 steel after heating to: 200°C (left), 500°C (right) and cooling by each method (reprinted from [35])**

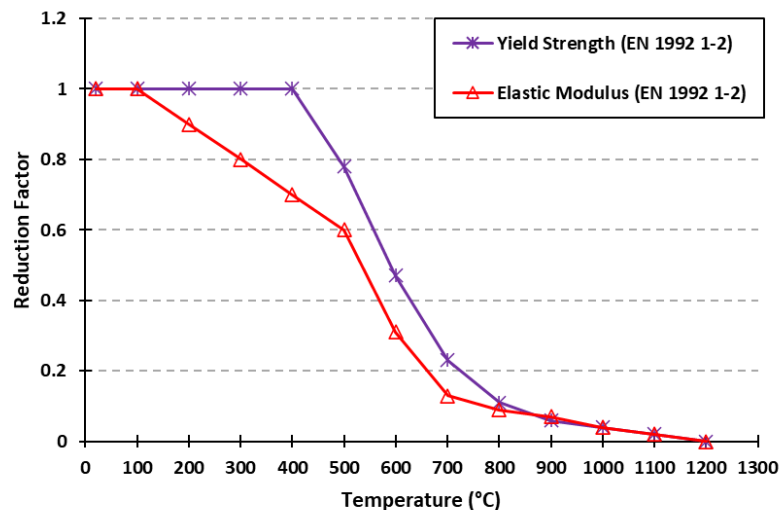
**Figure 2.26: Reduction factors for the yield stress and elastic modulus of Class N hot rolled reinforcing steel at elevated temperatures per *EN 1992 1-2***

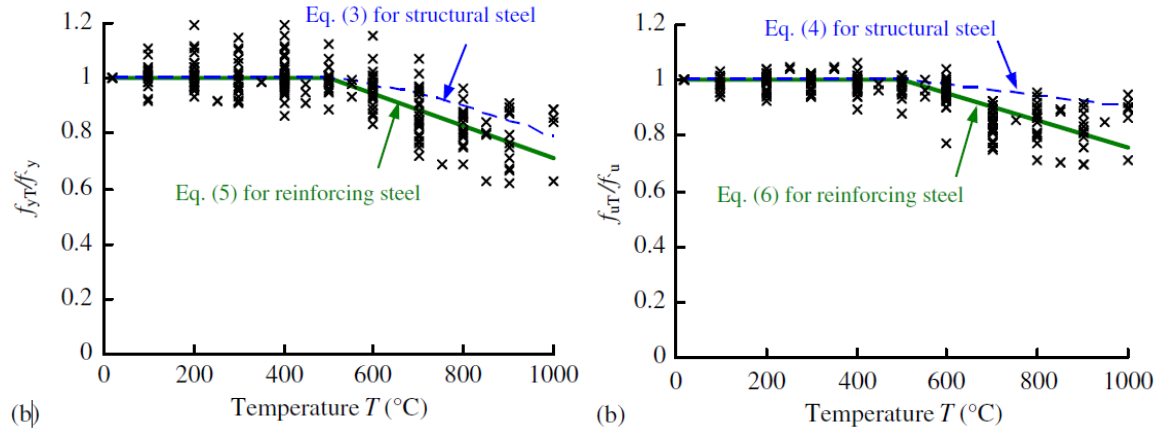
**Figure 2.28: Relative residual yield strength of hot rolled reinforcing steel (left), relative residual ultimate strength of hot rolled reinforcing steel (right) [used with permission from ASCE, this material may be downloaded for personal use only. Any other uses requires prior permission of the American Society of Civil Engineers] [7]**

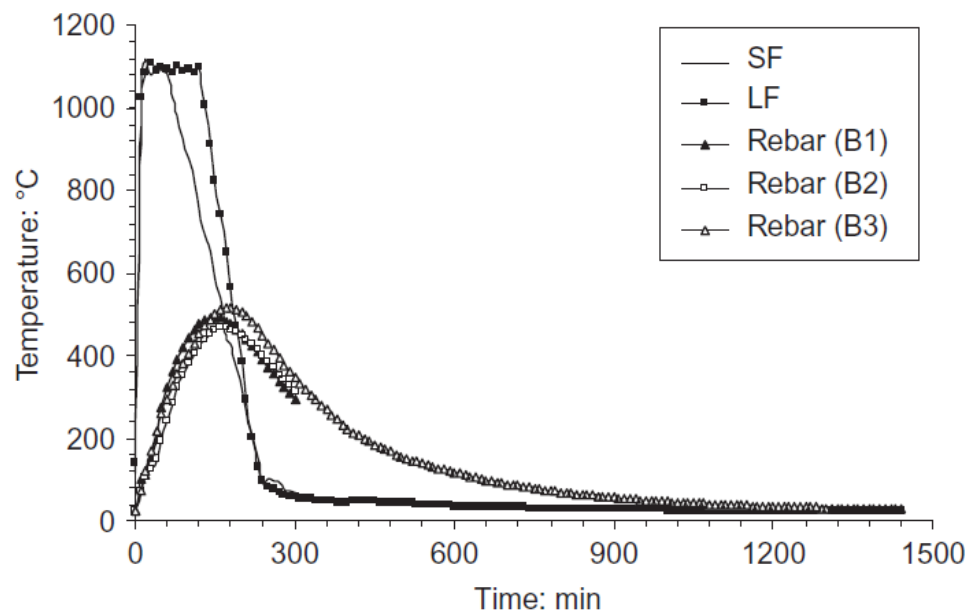
**Figure 3.5 Bottom rebar temperatures during heating (Republished with permission of Institution of Civil Engineers, from An approach for evaluating the residual strength of fire-exposed RC beams, V. Kodur, M.B. Dwaikat, R.S. Fike, Vol. 62, No. 7, 2010; permission conveyed through Copyright Clearance Center, Inc. [50])**

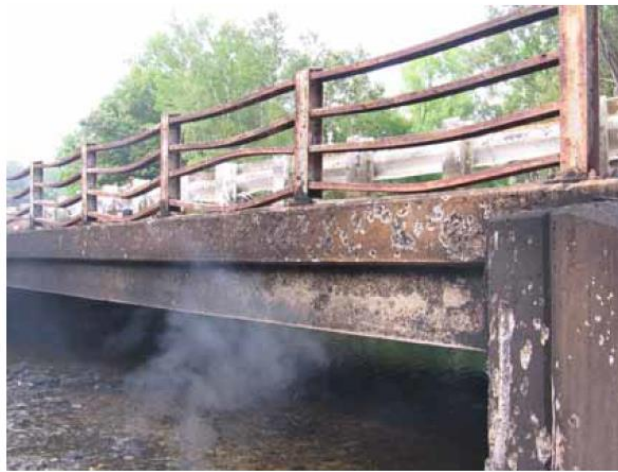
**Figure 3.6: Fascia of the bridge after the fire (reprinted from [48])**

Unlike the other studies presented in this section, in which the specimens were heated in laboratories and testing facilities under controlled conditions, a 2007 study by the FHWA analyzed the residual flexural strength of concrete box beams from a bridge that had been exposed to a fire in service [48]. On July 12, 2005, a gasoline tanker truck on a bridge near Ridgefield, CT overturned and caught fire. Burning fuel covered portions of the deck and spilled into the Norwalk River beneath the bridge. Figure 3.6 shows the condition of the exterior of the bridge after the fire.

After the fire, the Connecticut Department of Transportation (ConnDOT) elected to replace all the beams in the bridge, since it could not be determined if the fire had damaged the prestressing strands in the beams. It was then decided that four of the interior beams which were removed would be inspected and tested to see if they had actually lost significant flexural capacity.

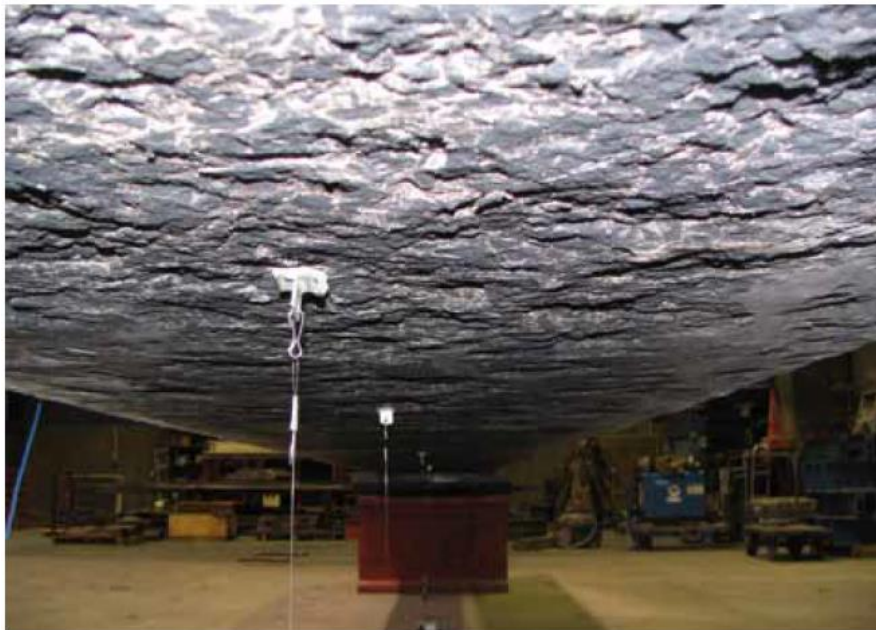
**Figure 3.8: Visual condition of the bottom of beam 4 (reprinted from [48])**

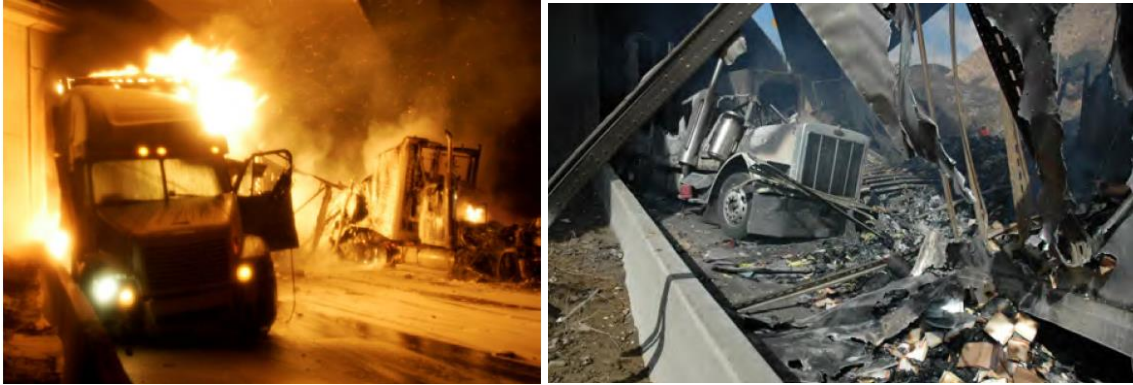
**Figure 4.1: Picture taken during the fire event (left), after the fire event (right) (reprinted from [67])**

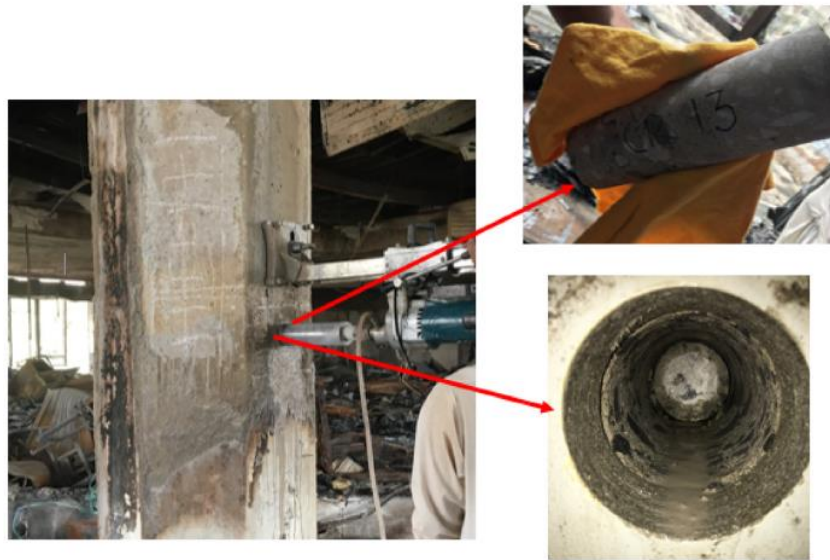
**Figure 4.10: Extraction of concrete cores for compressive strength tests (Reprinted from Case Studies in Construction Materials, Vol. 11, Structural health assessment of fire damaged building using non-destructive testing and micro-graphical forensic analysis: A case study, 2019, with permission from Elsevier [75])**

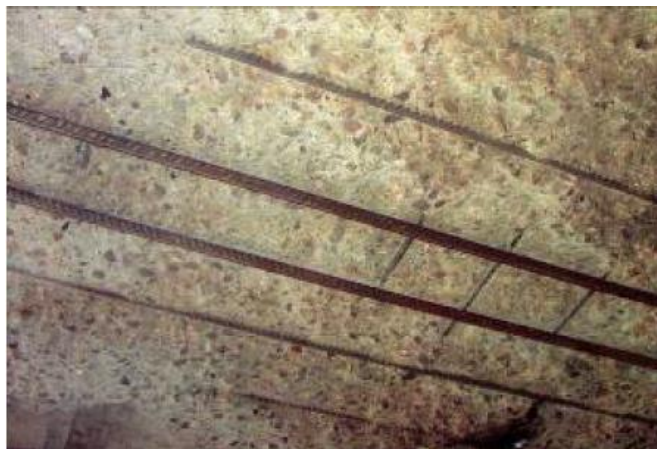
**Figure 5.1: Buckled reinforcing bars in the underside of a slab [used with permission from The Concrete Society] [65]**

For reinforced concrete, the main steps in the repair process are to remove damaged concrete, to replace the concrete to restore the member to its original size, and to replace or supplement weakened reinforcement. It is generally recommended that all concrete which experienced temperatures above 300°C be removed. The 300°C isotherm in the concrete can sometimes be determined by observing the depth of pink discoloration in some concretes or can be determined by laboratory analysis on core samples collected from the structure [8], [65]. In some cases, such as when buckling of reinforcement has occurred (Figure 5.1), additional concrete may need to be removed from behind the reinforcement to ensure that the concrete replacement material can fully surround the reinforcement. Damaged concrete can be removed by hammer and chisel, by powered breaking tools, or by high-pressure water jets. Removal of concrete with a hammer and chisel is only practical when the damage area is small. If extensive areas of concrete have been damaged, powered breaking tools or high-pressure water jets are more suitable [65].

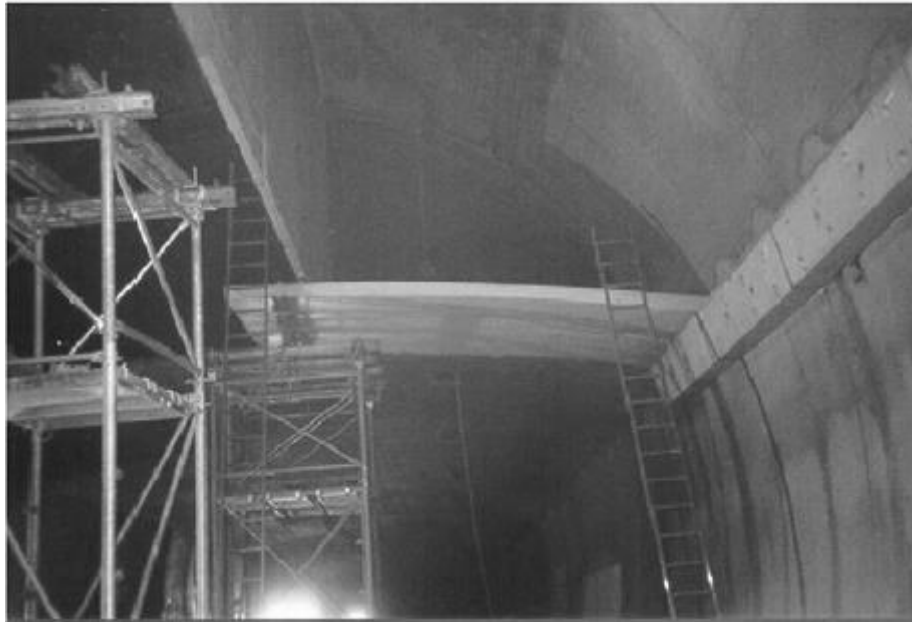
**Figure 5.8: Installation of precast ceiling panels (Reprinted from Tunnelling and Underground Space Technology, Vol. 16, No. 3, The fire catastrophe in the Tauern Tunnel: experience and conclusions for the Austrian guidelines, 2001, with permission from Elsevier [90])**

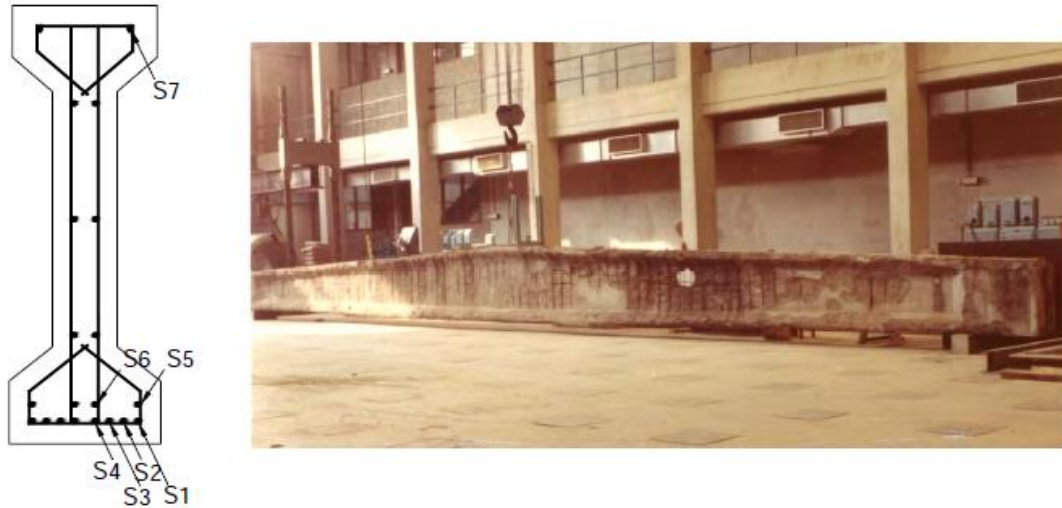
**Figure 5.10: Cross-section of pretensioned roof girder (left), pretensioned roof girder after the fire test (right) (Reproduced from fib Bulletin 46, page 129 - “Pretensioned roof girder – cross section and view after fire test,” with permission from the International Federation for Structural Concrete (fib) [8])**

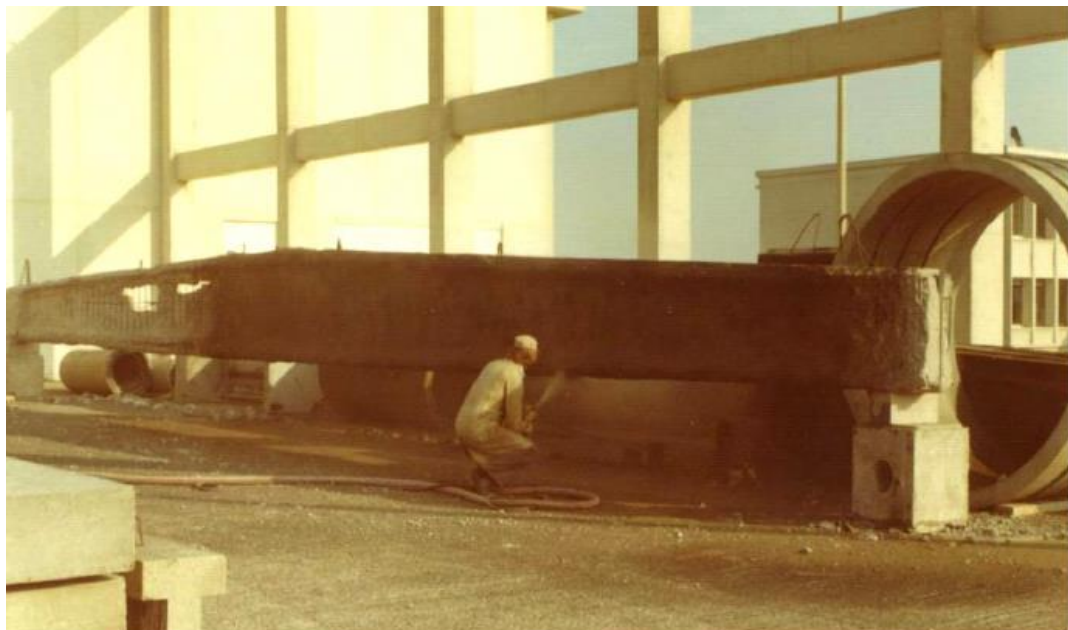
**Figure 5.11: Application of shotcrete to damaged girder (Reproduced from fib Bulletin 46, page 130 - “shotcreting of the damaged girder” by Taerwe et al. 2006, with permission from the International Federation for Structural Concrete (fib) [8])**

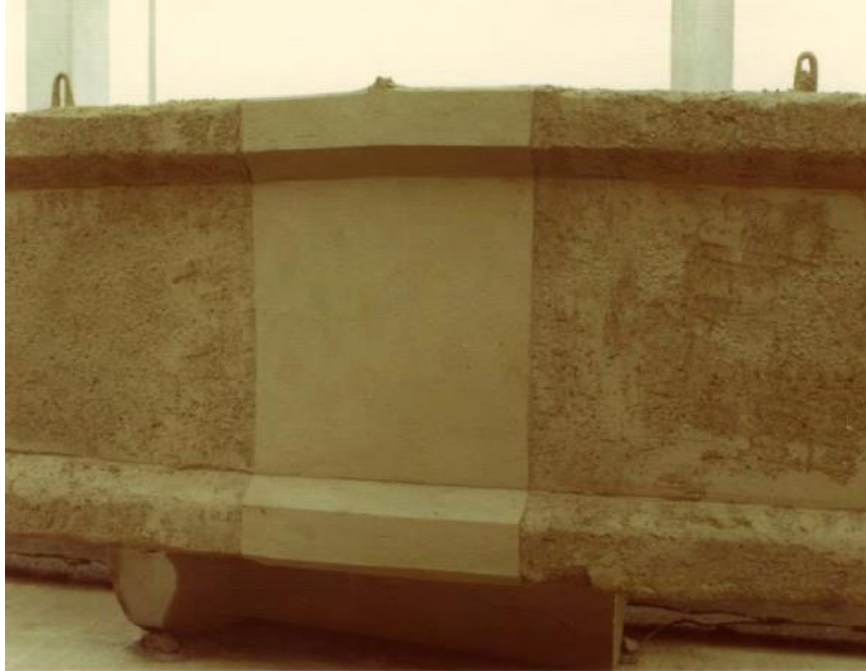
**Figure 5.12: Midspan of the girder after repair (Reproduced from fib Bulletin 46, page 130 - “central part of the girder after shotcreting” by Taerwe et al. 2006, with permission from the International Federation for Structural Concrete (fib) [8])**

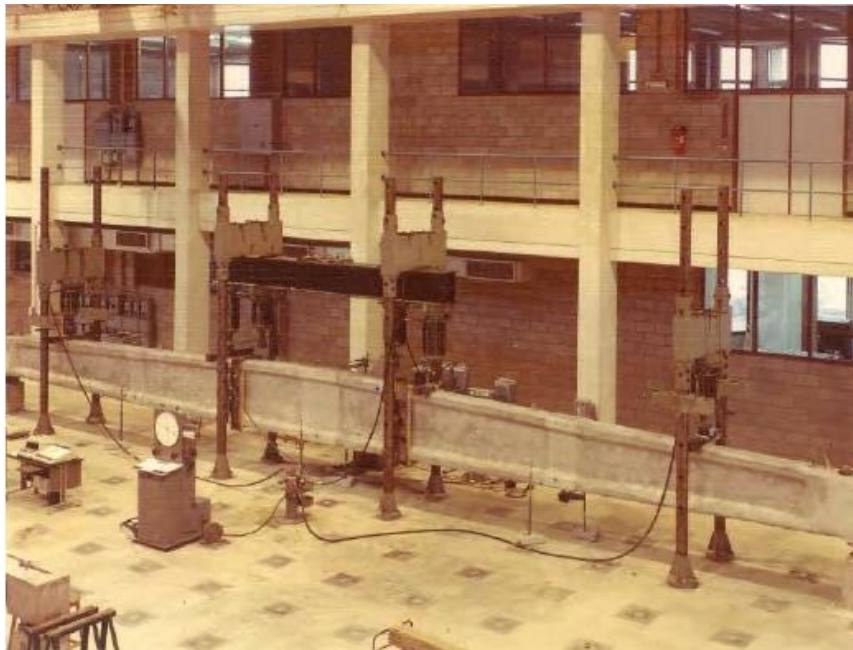
**Figure 5.13: Load testing setup for the girder (Reproduced from fib Bulletin 46, page 131 - “Test setup” by Taerwe et al. 2006, with permission from the International Federation for Structural Concrete (fib) [8])**

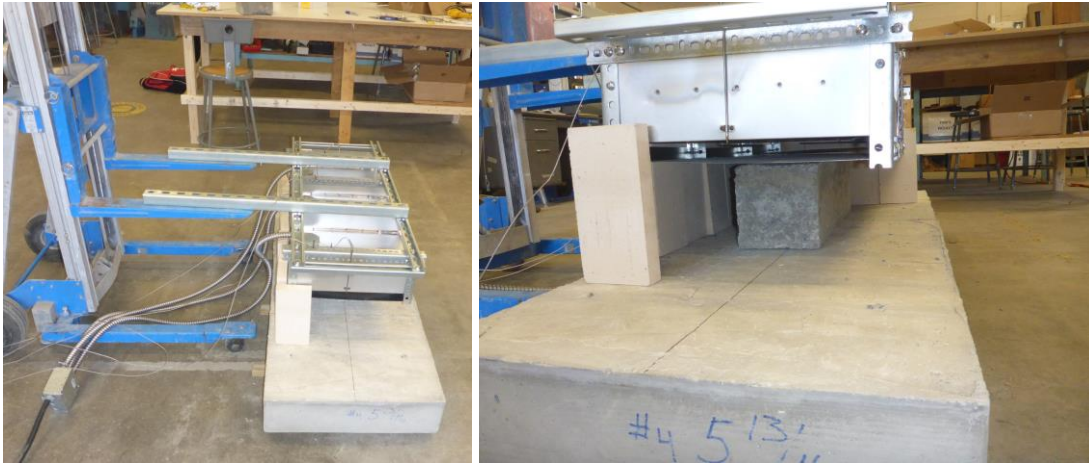
**Figure 7.4: Heaters on wheel dolly assembly**

The heaters were mounted on a custom fabricated frame that could be easily attached to a portable wheel dolly for ease of heating of specimens (Figure 7.4). This allowed for the heating of several different types of specimens (e.g., aluminum, concrete

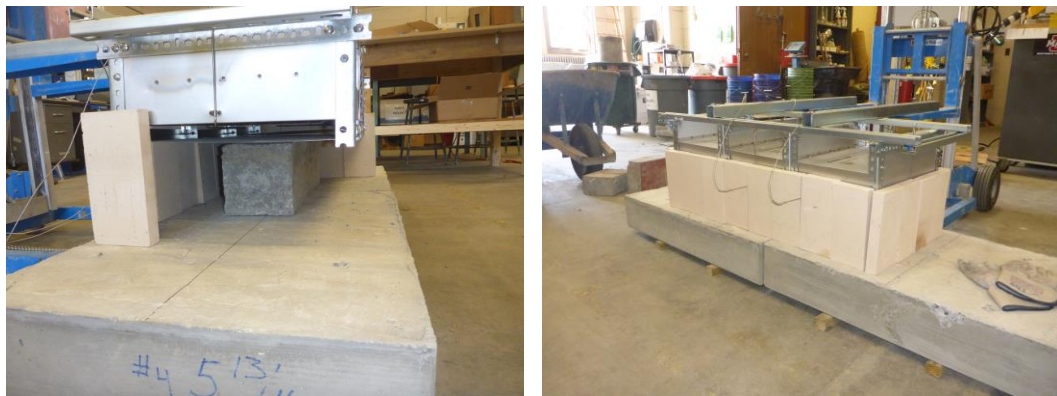
**Figure 7.5: Heating chamber test setup**

blocks, beams, etc.) using different configurations, such as those shown in Figure 7.5-  
Figure 7.7.

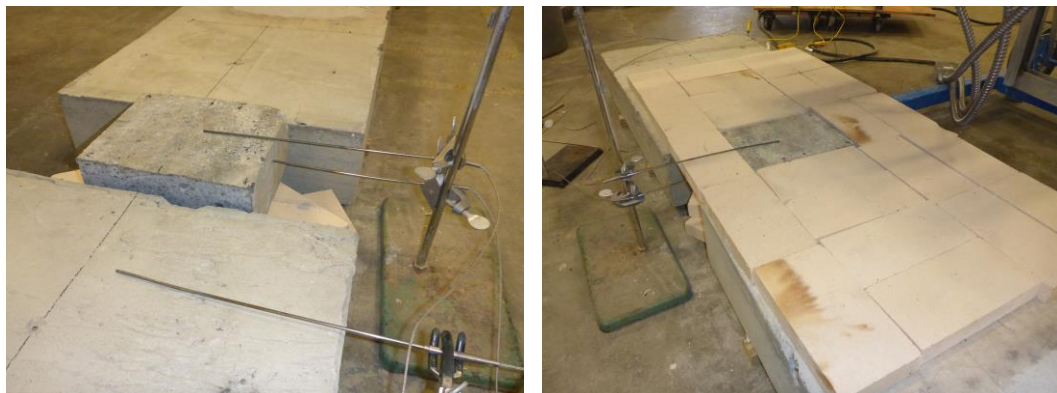
**Figure 7.6: Heating of smaller specimen between two throwaway slabs**

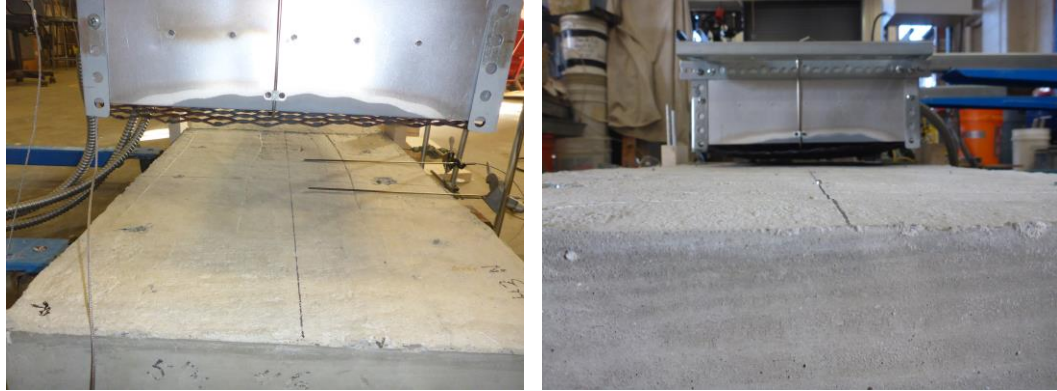
**Figure 7.7: Direct heating of specimens**

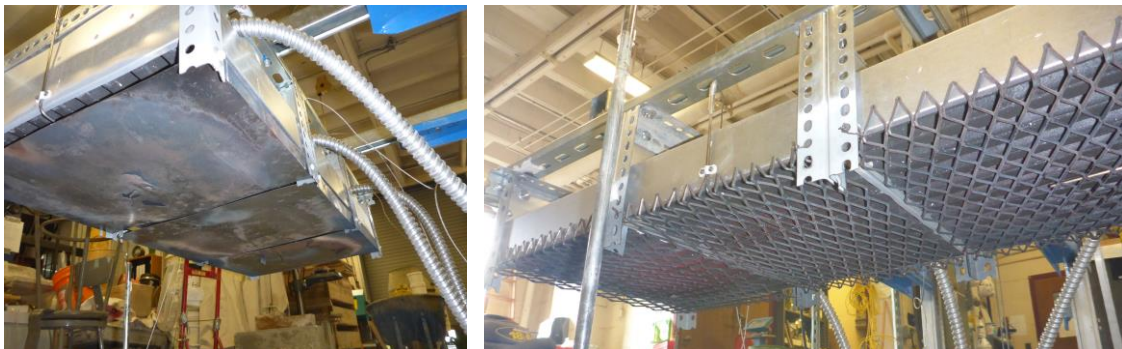
**Figure 7.8: Sheet metal shield (left), flat expanded metal shield (right)**

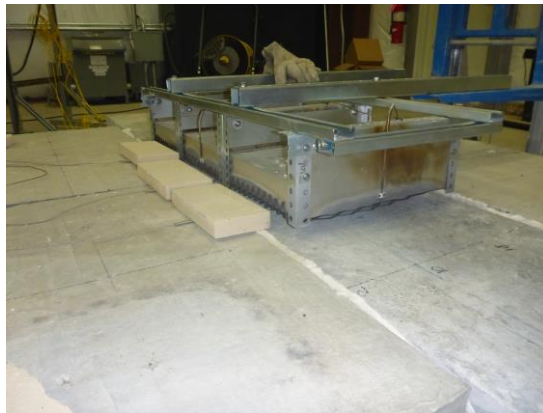
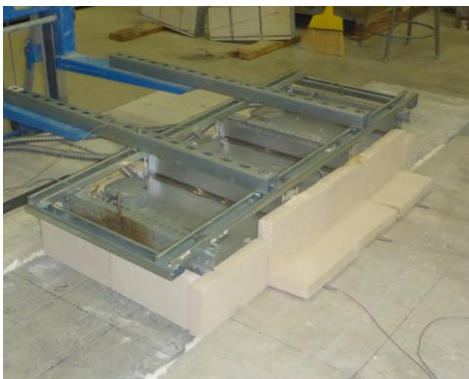
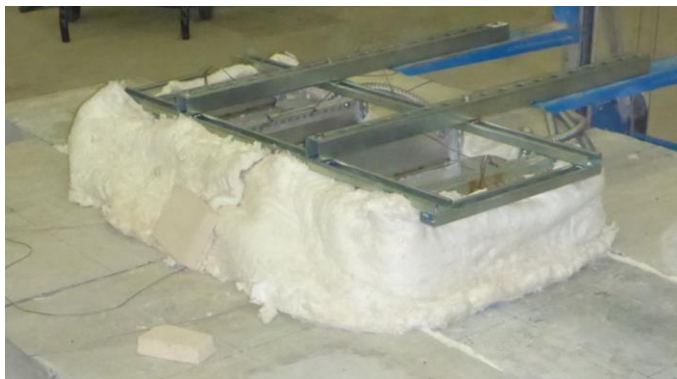
**Figure 7.11: Typical Insulation setup. Heating setup before adding any insulation (top), firebrick around heaters (bottom left), insulation around firebrick (bottom right)**

consistently be obtained by minimizing the volume of air being heated and the loss of heat due to drafts. The optimal setup for maximum temperatures was as follows: specimens placed on or between concrete slabs with minimum distance between the heaters and the specimens, a layer of firebrick around the perimeter of the heaters, a 2” insulation blanket surrounding the firebrick and heaters, and the remaining gaps filled in with pieces of 1” insulation blanket. In order to position thermocouples, stands were provided on the outside of the insulation. This setup requires some openings in the insulation for the thermocouple body and/or wiring to enter the heated zone. The setup was varied for each test, depending on specimen size and temperature monitoring requirements. A typical setup is shown in Figure 7.11.

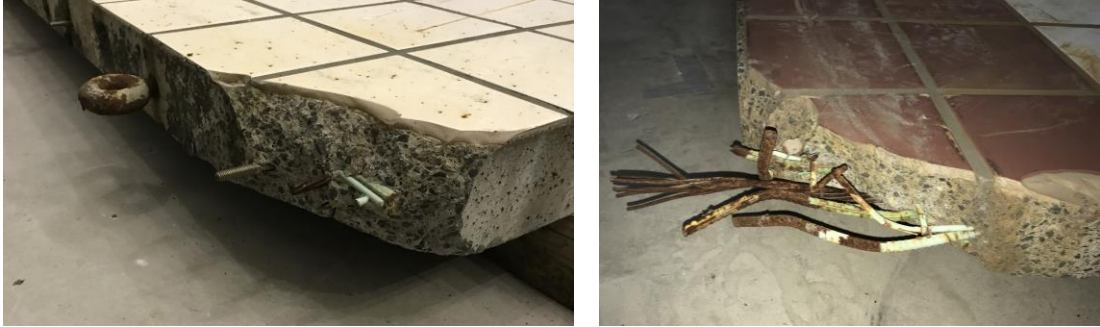
**Figure 7.14: Panel as delivered**

A single wall panel was provided to the laboratories at UMass Amherst for testing (Figure 7.14). The panel was removed from a Massachusetts tunnel during maintenance and had been stored. Additional information was not available. This panel was compared to construction document drawing sets for ceiling panels, and it was found that similar details and overall dimensions were used, with the wall panels not including details such as recesses for lighting and openings for anchorage. The inside face of the panel had a tile covering, with the remaining sides plain concrete. Staining was prevalent on the back (non-tile) face of the specimens of reddish or whitish hues. The panel thickness is 4 in. with tiled surface of grouted 8 in. square 0.25 in. thick clay tiles.

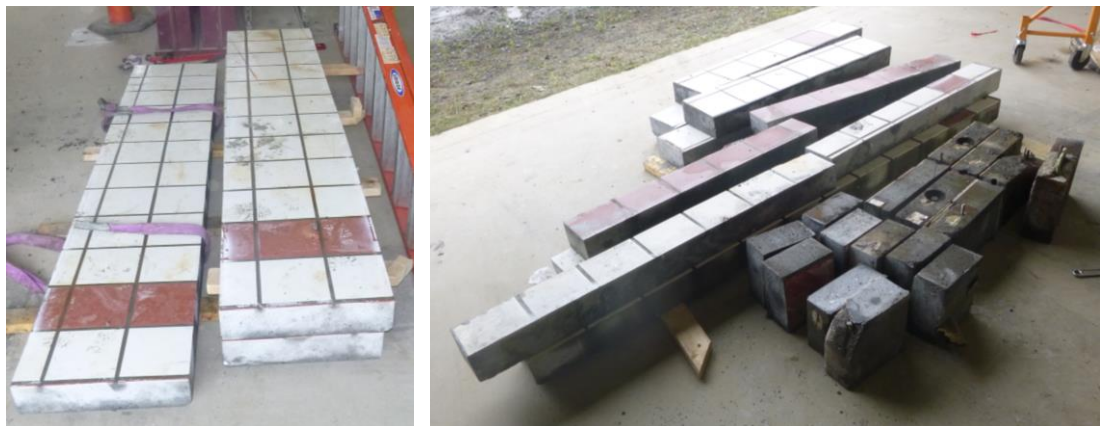
**Figure 7.16: Specimens obtained from panel: Three primary beams (left), blocks, smaller beams, and miscellaneous (right)**

confirmed reinforcing bar and prestressing strand locations. The top and bottom strips were cut into small specimens one or two tiles wide. Longitudinal cuts of 19 in. wide sections were made, centered on the three interior prestressing strands. Additionally, two strips of 9.75 in. were made to include only welded wire mesh reinforcement, further cut in half to make four identical specimens with minimal reinforcement. The remainders from the panel were retained to use for preliminary testing. This resulted in the following specimens (shown in Figure 7.16).

- Three primary beam specimens 19 in. by 96 in. with one prestressing strand and five longitudinal wires from the wire mesh reinforcement
- Three beam specimens 9.75 in. by 48.25 in. with wire mesh reinforcement only
- Ten single tile dimension specimens (8 in. by 8 in.) (some damaged)
- Six two tile dimension specimens (16 in. by 8 in.) (some damaged)
- Nine miscellaneous remainders, often one of a kind or pairs with one having significant spalling or inserts, some end sections with reinforcing steel and two prestressing strands, though these had pre-existing edge damage when delivered and therefore had no companion specimens of similar properties

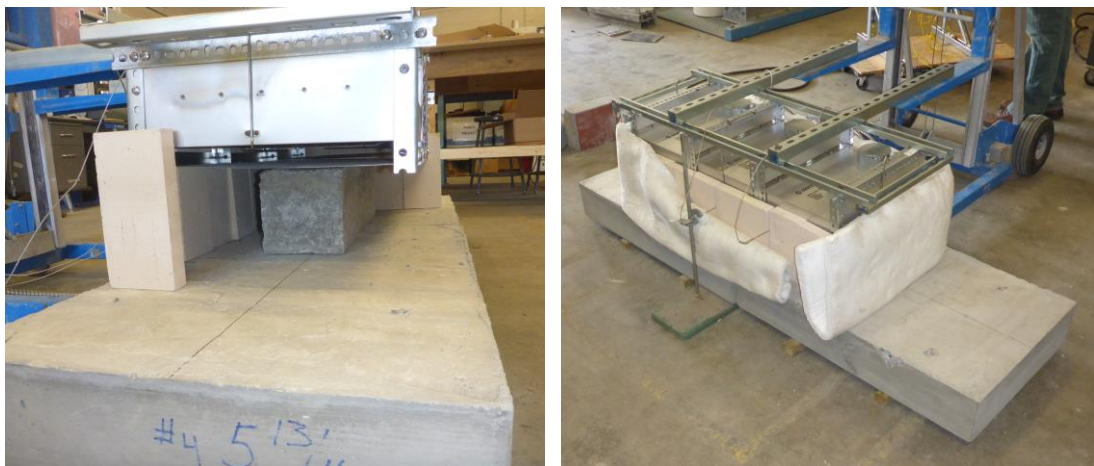
**Figure 7.17: Sample test setup for heating plain concrete specimens**

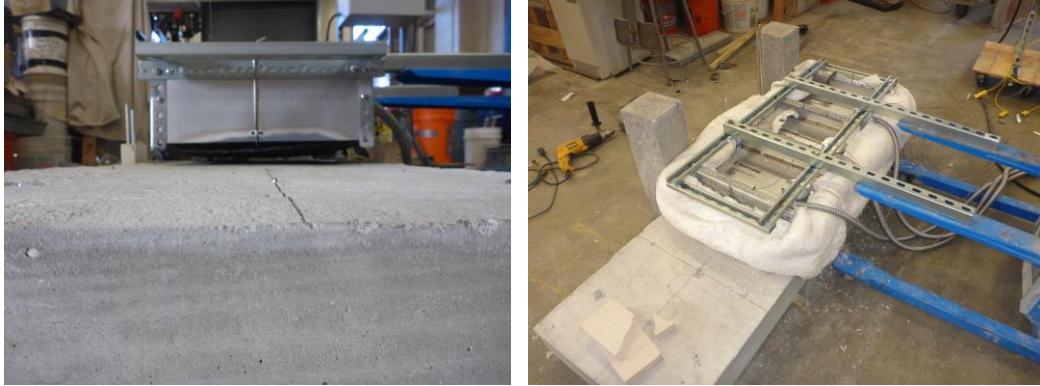
**Figure 7.19: Concrete slab heating setup**

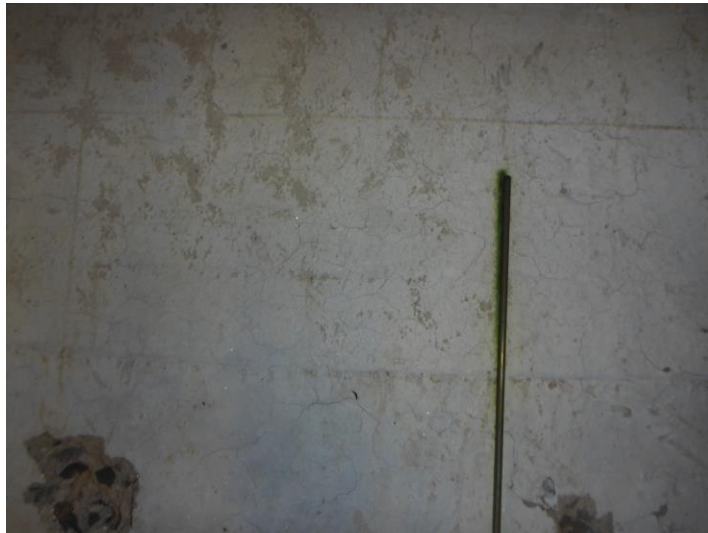
**Figure 7.20: Typical map cracking pattern for slabs after heating up to 930°C**

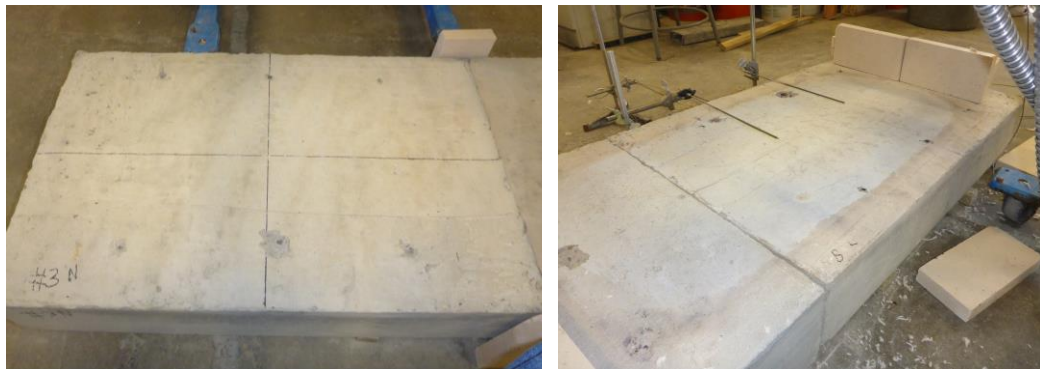
**Figure 7.21: Slab before heating (left), whitening after heating to surface temperatures up to 930°C (right)**

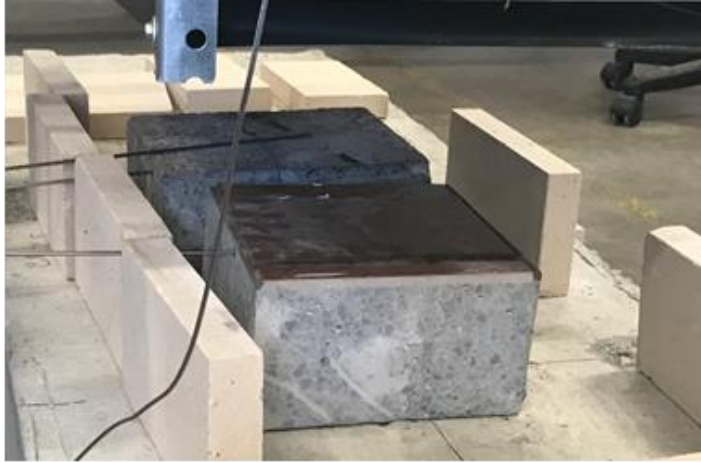
**Figure 7.22: Specimens with tile side up (near) and tile side down (far)**

Figure 7.22 shows a test where two specimens were heated simultaneously, one with the tile facing upward and the other with the tile on the bottom against the concrete slab. As the specimens reached approximately 470°C, the testing was halted due to a noxious chemical odor from the specimens that spread through the laboratory and adjacent hallway. After cooling, inspection of the specimen with the tiles facing upward toward the heater showed a significant section of the grout between tiles and exposed on the edge had charred. This area of grout was easily sluffed off with a screwdriver (Figure 7.23). Subsequently, the researchers used a chipping hammer and hammer with chisel to break off the tile. When struck, the tiles in the vicinity of the charred grout broke off in small sections that separated near the grout line (Figure 7.24, bottom). In unheated specimens, the tiles and grout could not be separated from the concrete, instead breaking off in small sections that indicated no weak planes in the tile or grout (Figure 7.24, top).

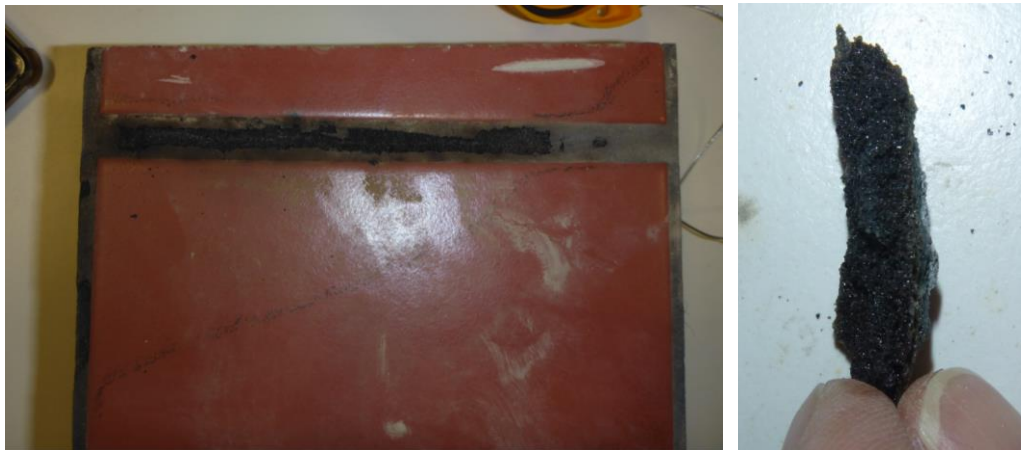
**Figure 7.23: Charring of grout material**

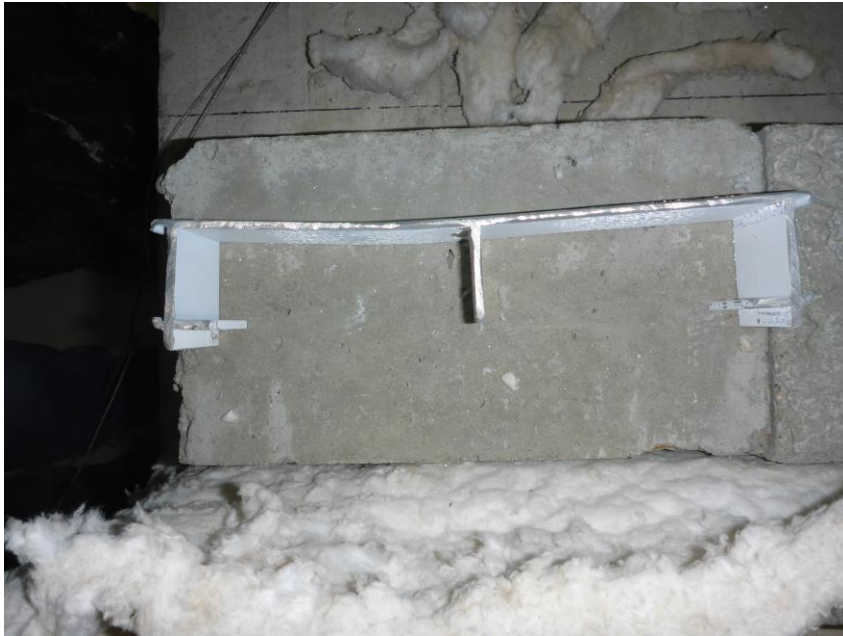
**Figure 7.26: Sagging of aluminum wireway after heating**

whitish/gray color. At 750°C, the wireway had noticeably sagged, as shown in Figure 7.26, and the grout remained the same whitish/gray color as at 550°C. After the heaters were removed, a single hairline crack in the tile was observed, and additional smaller cracks could be seen forming during the first 5 minutes of cooling. The tile cracking pattern and aluminum wireway after heating and cooling are shown in Figure 7.27. After cooling, it was found that the grout had turned into a powder which could easily be scraped off with a screwdriver, as shown in Figure 7.28. Though attempts to pry the tile off the concrete were unsuccessful, it is postulated that the tiles can detach from the concrete during a fire due to the formation of cracks and the deterioration of the grout. Furthermore, it was noted that when water was poured on the hot tiles, the existing cracks grew and new cracks formed, indicating that water from fire suppression efforts could also contribute to the detachment of tiles from concrete after a fire event.

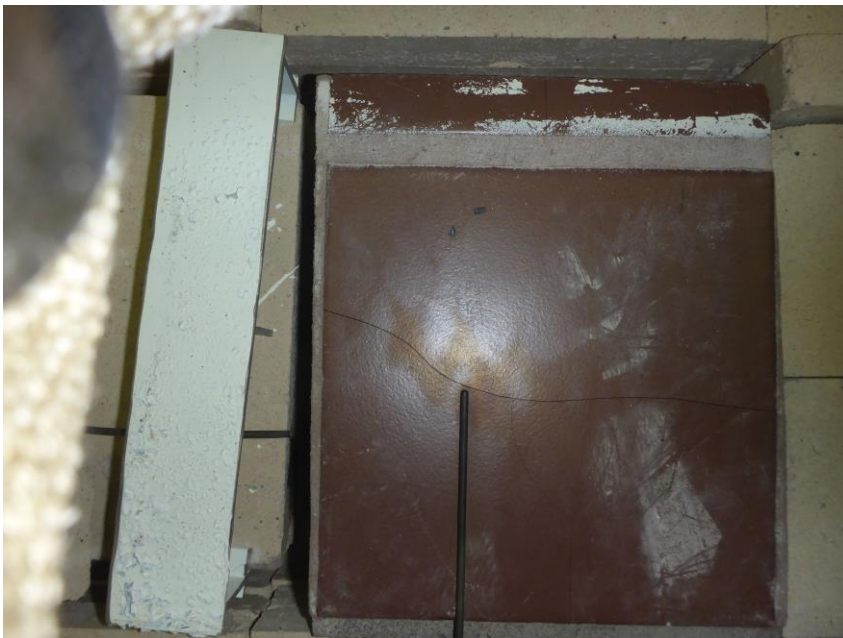
**Figure 7.27: Closeup of tile and aluminum wireway after heating**

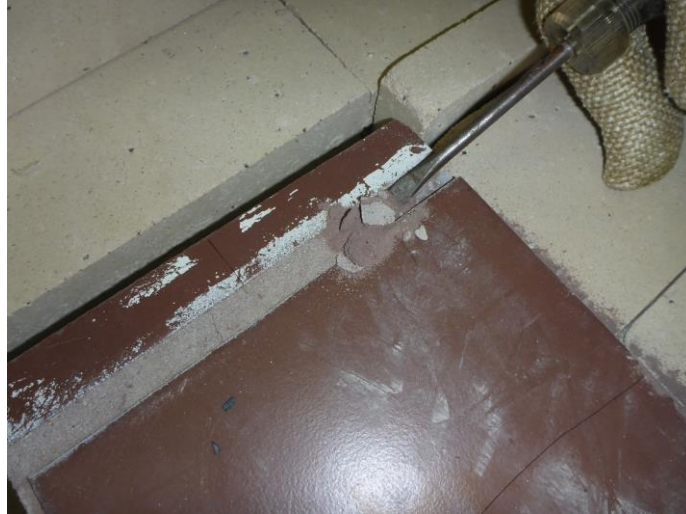
**Figure 7.28: Removal of grout with a screwdriver after heating**

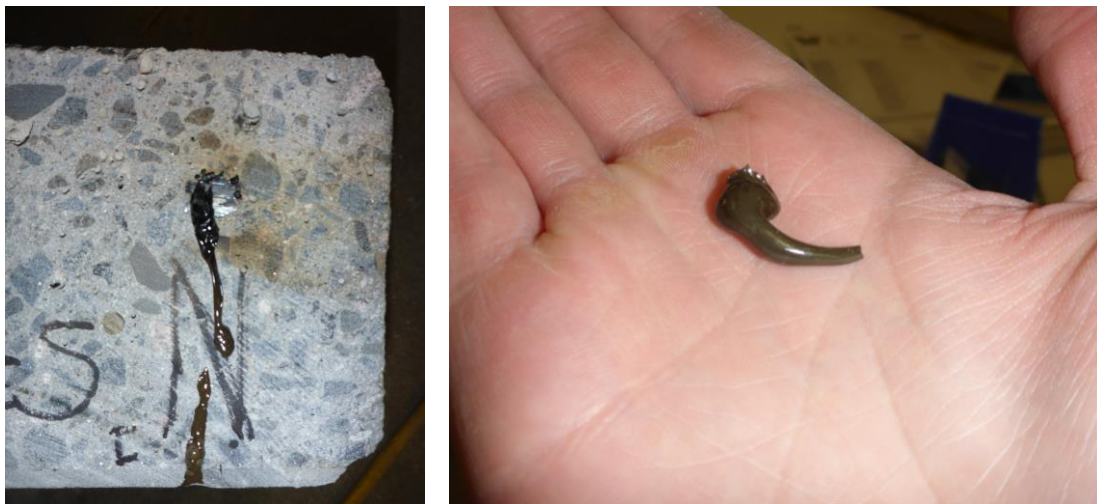
**Figure 7.29: Melting of epoxy reinforcement coating**

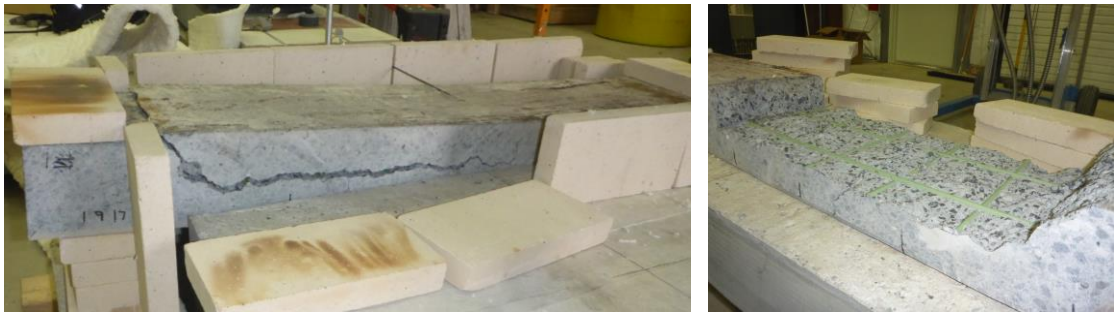
**Figure 7.30: Spalled minimally reinforced beam specimen after heating (left), after removal from setup (right)**

Three identical specimens were tested. One was not heated, to act as a comparison to the heated beams. The next was heated to 600°C. After 23 minutes at this temperature, the specimen suddenly spalled with significant loss of cross section (Figure 7.30, left). The specimen was cooled to room temperature and removed from the heater setup (Figure 7.30, right). In moving the specimen, a final portion of the cross section in the center of this photo became dislodged from the wire mesh, resulting in zero cross section remaining over a large portion of the specimen. This specimen has no flexural capacity by inspection, so was not tested further. The final specimen was also heated to 600°C and maintained at this temperature for approximately 180 minutes. This specimen showed no signs of spalling (Figure 7.31), though slight map cracking was observed on the heated face of the specimen.

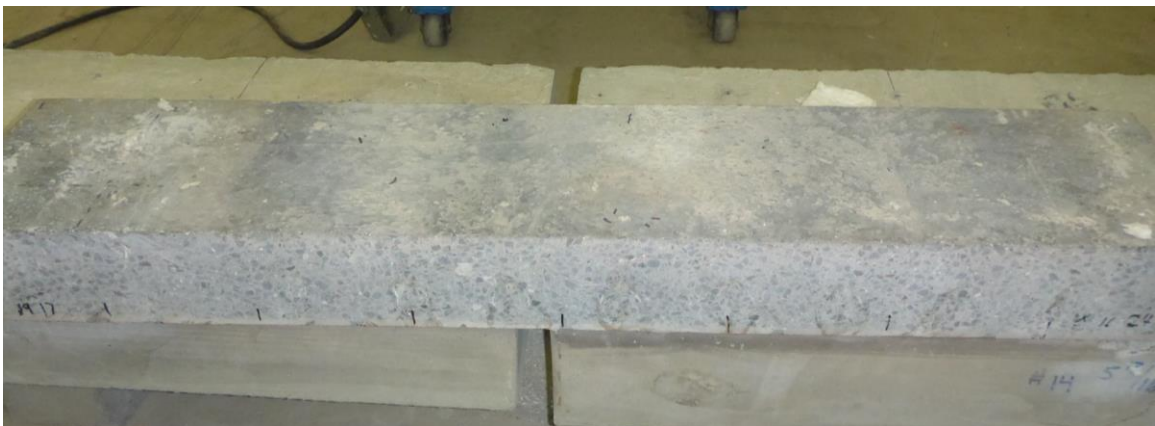
**Figure 7.31: Intact minimally reinforced beam specimen after heating**

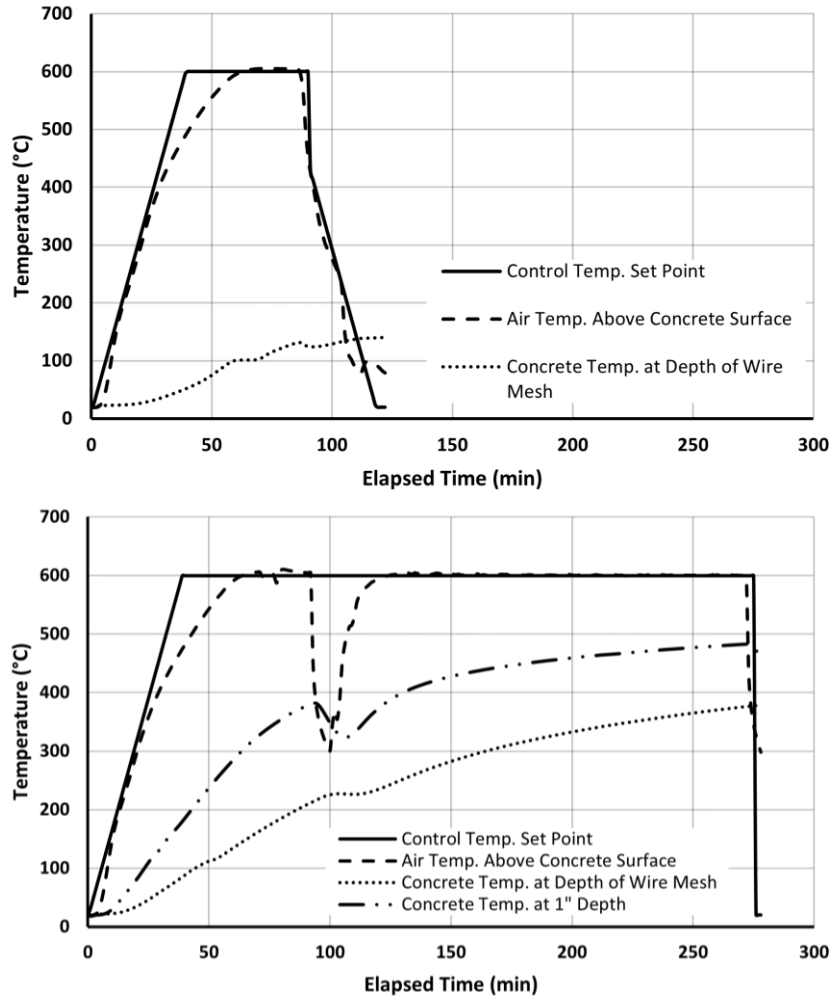
**Figure 7.32: Heating curve temperature vs. time plots: spalled specimen (top), intact specimen (bottom)**

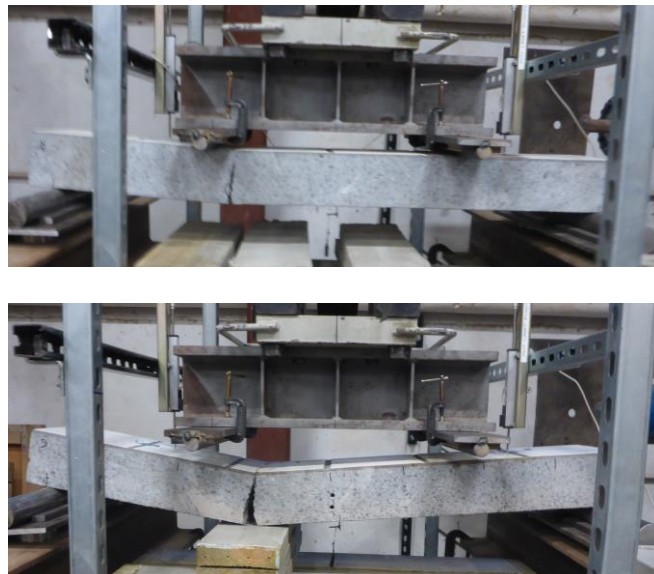
**Figure 7.34: Photo of minimally reinforced beam specimens during load testing. Propagation of crack in control specimen during load application (top), after failure of heated specimen (bottom)**

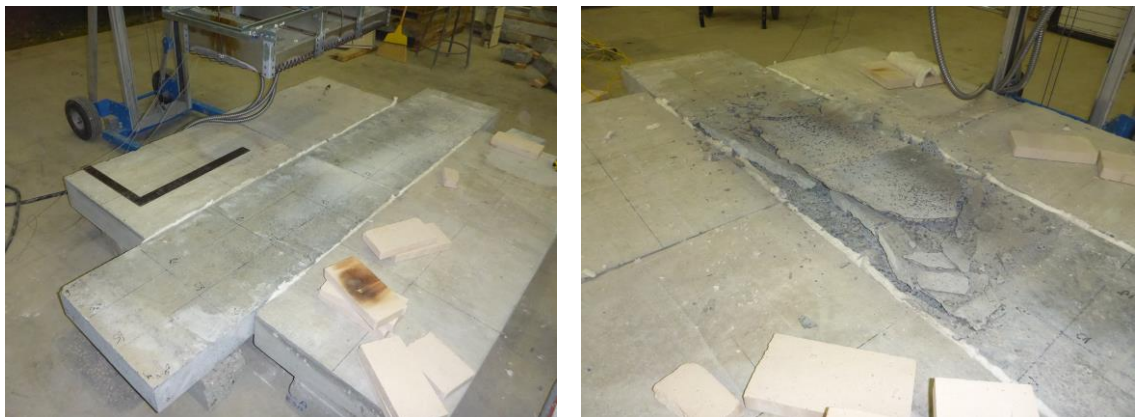
**Figure 7.38: Spalling of 600°C beam specimen prior to heating (left), post heating (right)**

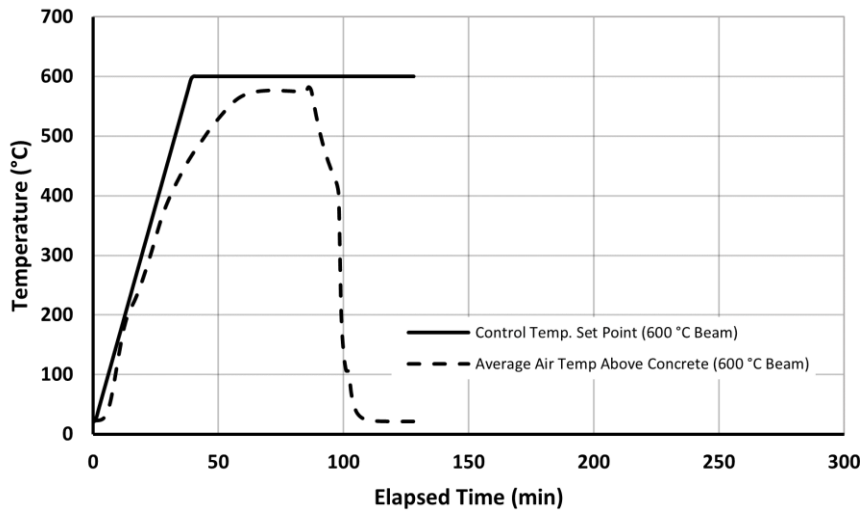
**Figure 7.39: Heating curve temperature vs. time plots: spalled specimen (top), Intact specimen (bottom)**
