## Post-Fire Assessment of Concrete Tunnel Structures

**POST-FIRE ASSESSMENT OF CONCRETE TUNNEL STRUCTURES**

MASTER OF SCIENCE IN CIVIL ENGINEERING

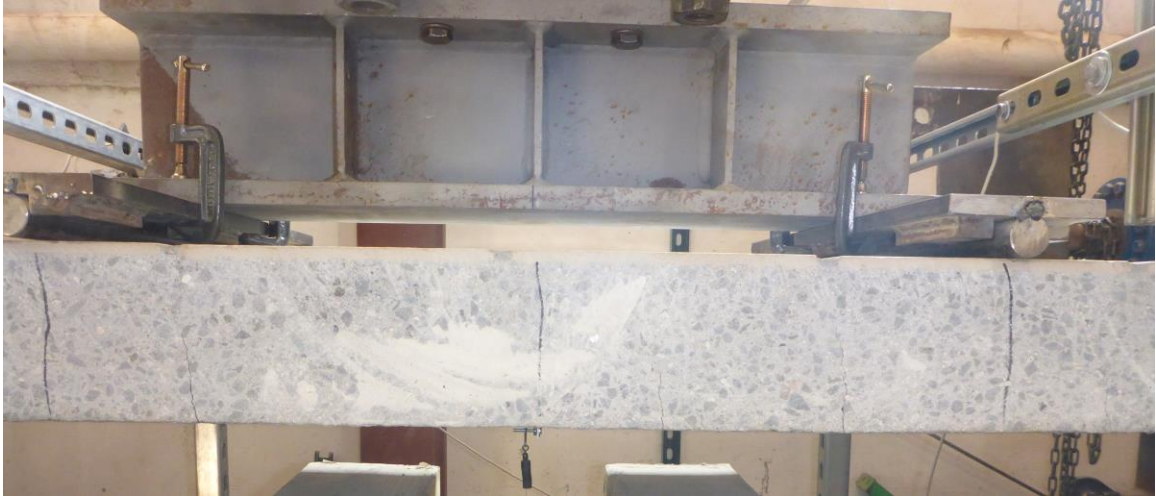
**Figure 7.43: Photos of 300°C intact specimen load testing. Multiple flexural cracks in constant moment region during load application (top and middle), after failure (bottom)**

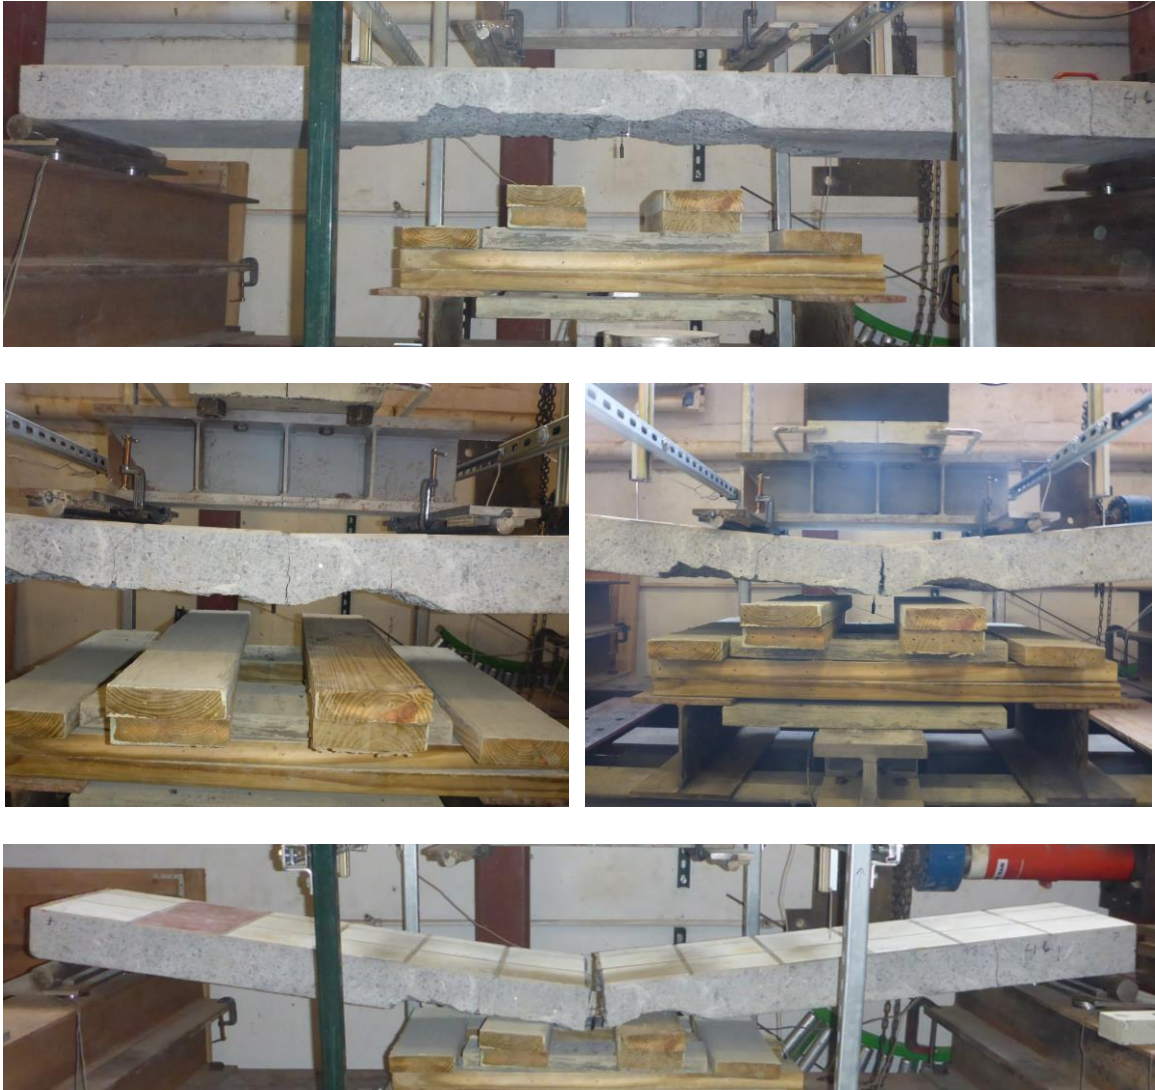
**Figure 7.44: Photos of 600°C spalled specimen load testing. Prior to loading (top), propagation of crack during load application (middle), after failure (bottom)**

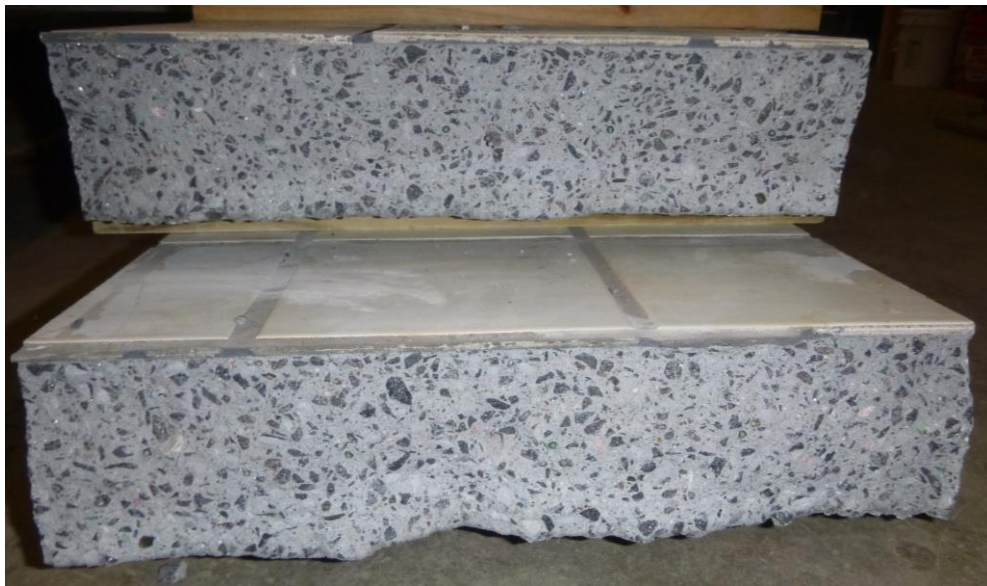
**Figure 7.46: Ruptured surface of 300°C heated specimen**

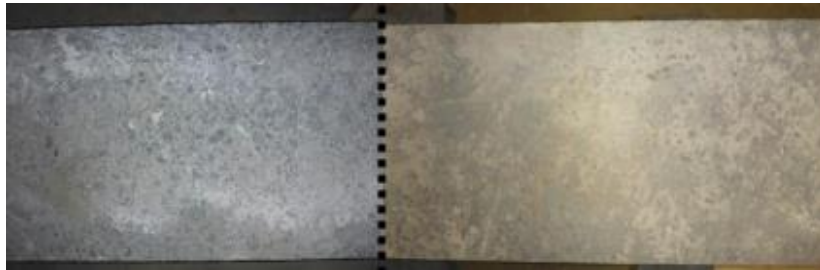
Concrete discoloration at 600°C (1,112°F)
