Durability and Performance Evaluations of SuperHydrophobic and Icephobic Coatings for Tube-Fin Heat Exchangers

Colin Lee
Electric Power Research Institute

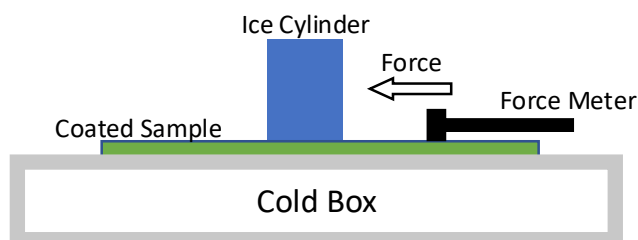
Figure 1: Schematic of Ice Adhesion Test Measurement

As a preliminary screening criterion for the research, the initial Ice Adhesion Test was performed on uncoated and coated aluminum coupons. This test measured the amount of shear force necessary to remove a block of ice frozen onto the surface sample. A force meter was used to gauge the amount of shear force required to dislodge the ice cylinder from the coated sample (see Figure 1 and Figure 2 for schematic and setup). While this is not a direct measure for frost formation rates, it serves as an indicator for the amount of energy required to remove ice from the surface of the heat exchangers fins. The lower the maximum shear force required, the more advantageous the coating could be for mitigating frost adhesion and removal from HX fin.

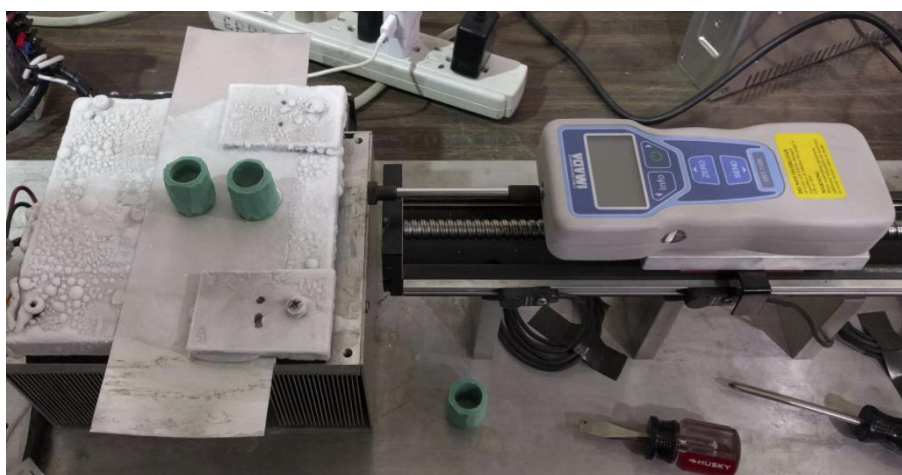
Figure 2: Ice Adhesion Laboratory Test Setup

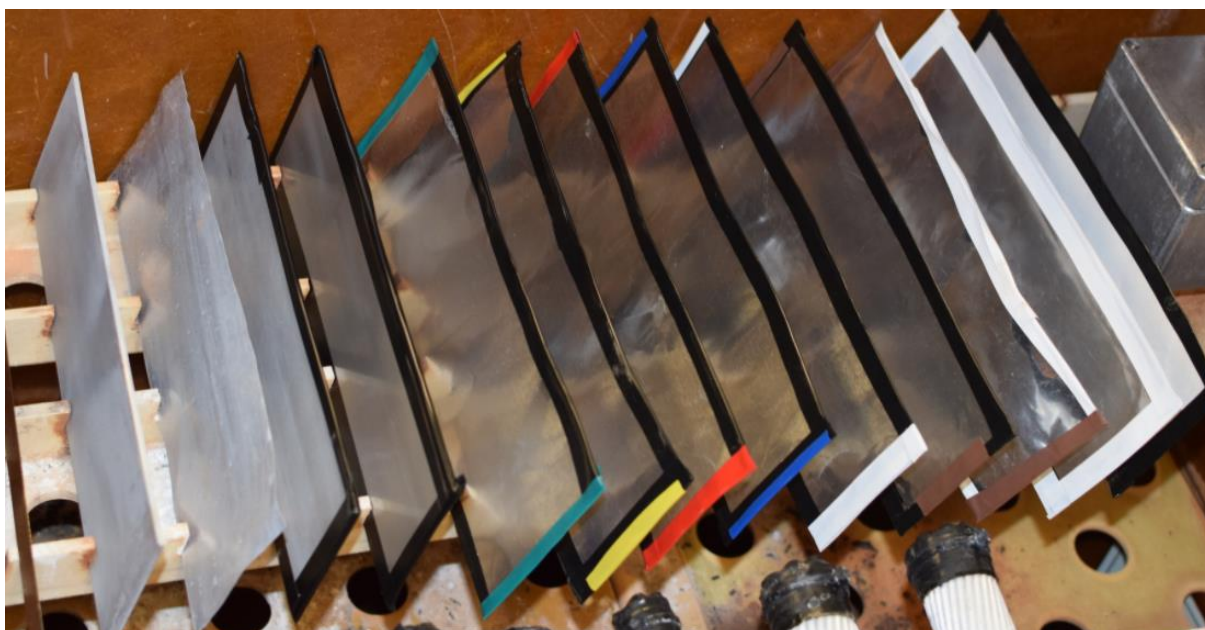
Figure 3: Coupon samples positioned for cyclic corrosion testing in salt-fog chamber.

A salt-fog corrosion chamber was used to simulate accelerated HX wear over time in harsh environments. Before being placed in the salt-fog chamber, the coupon samples were taped around the edges with electrical tape in order to avoid potential peeling due to the edge effects of the coated samples (see Figure 3). The salt-fog chamber exposed the coated samples to the CCT-4 Japanese Automotive Cyclic Corrosion Testing protocol. (Q-Lab, 2009) This protocol

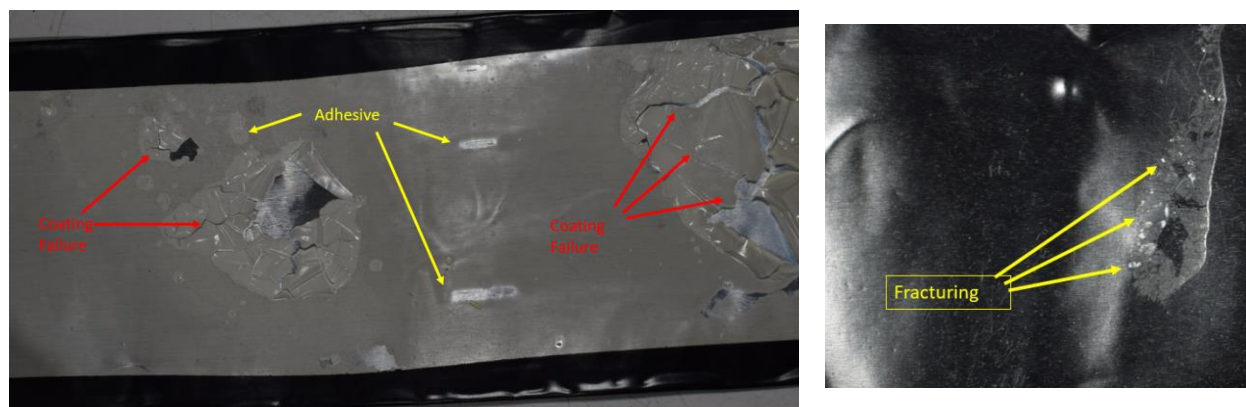
Figure 4: Qualitative assessment of coating degradation, such as adhesive failure or coating fracture, after cyclic corrosion testing in salt-fog chamber.

Qualitative observations showed that some coatings performed better than others under the environmental stress. Some coatings experienced adhesive failure and/or coating fracture. This may be due to the difference in chemical composition and additives used in the coatings.

With samples enduring the salt-fog corrosion test, all coatings exhibited discoloration. Yellow, or brown smudging was common with grey or white spotting. White or grey spotting may be due to salt build-up from the saline solution when droplets condense on the sample surface. Yellow or brown coloring could be from chemical reaction or oxidation, with possible polymerization and crosslinking of molecules due to the cyclical high temperatures and humidity in the process. Due to the repetitive temperature fluctuations and the thin sample size, there was likely repeated thermal expansion and contraction to the samples throughout the salt-fog corrosion process. This was likely to cause tensile and shear stresses that could result in adhesive and/or coating fracture to the samples. Coating sample #C4 experienced both adhesive and coating fracture (Figure 4). The excess stresses to the coating may have caused the coating to fracture, leading to further adhesive failure as fog can penetrate the cracks, with further contraction and expansion throughout the process. The wettability of the samples was also observed before and after the corrosion testing with food colored distilled water (Figure 6). There was no noticeable difference in the wettability state for all samples, before and after the cyclic corrosion testing. A summary of observations is shown in Table 3 below.

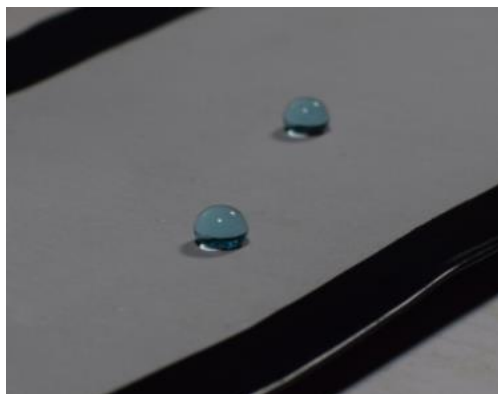
Figure 6: Surface wettability assessed with contact angle

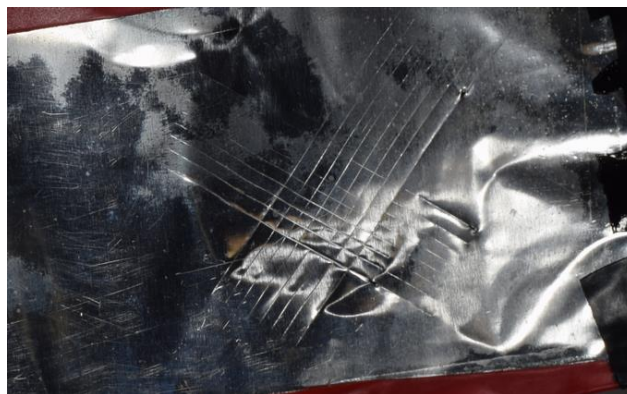
Figure 7: Adhesive testing on coated coupon

The ASTM D3359 protocol was used to test adhesion properties of the coating on the sample surface after corrosion testing. This involved first etching a 5cm x 5cm grid onto the surface of the sample and then applying an adhesive tape on the grid for 1 hour (see Figure 7). The tape is then ripped off and the samples are observed for the percent of area removed. Classifications were then given to the samples according to ASTM standards. Class 5B is the highest classification where edges are cut smooth with no squares detached. Class 4B is defined as when only a small amount of area is affected (<5%). (ASTM, 2011) All of the coatings were graded with the highest 5B ASTM classification, except for coating #C4 which received a 4B ASTM classification.
