# JOINT TRANSPORTATION RESEARCH PROGRAM

SPR-4221

## Post-Fire Assessment of Prestressed Concrete Bridges in Indiana

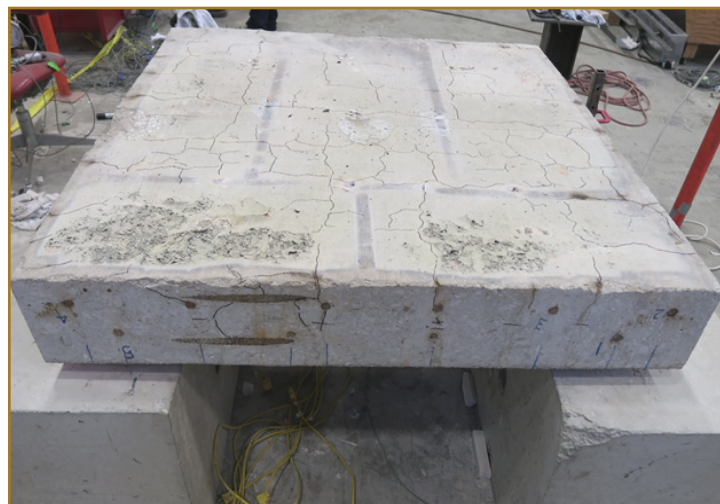
Deck specimen after heating.

Two concrete bridges from the I-469 bridge over Feighner Road were heated for different time durations (40–80 minutes) following the ISO-834 standard fire curve. Six prismatic specimens were designed and built to simulate the bottom flanges of prestressed bridge girders with different section layouts (two-strand and six-strand). Four (of the six) prismatic specimens were heated in the laboratory following the ISO-834 standard fire curve for different durations (30, 40, and 80 minutes) and heating conditions (two-sided and four-sided). Two (of the six) prismatic specimens built in the laboratory, and two AASHTO Type I girders, decommissioned from the bridge carrying I-469 over Feighner Road, were subjected to hydrocarbon pool fire tests conducted in the field for a duration of 48 minutes using approximately 135 gallons of kerosene.

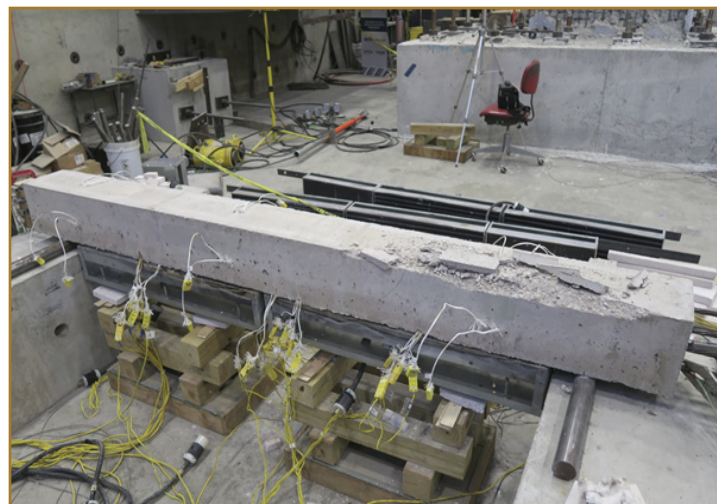
Prismatic specimen after heating.
