## Using Unmanned Aerial Vehicles to Quantify Erosion Control Measures on a Reclaimed Central Utah Coal Mine

A thesis submitted in partial fulfillment  
of the requirements for the degree

Range Science

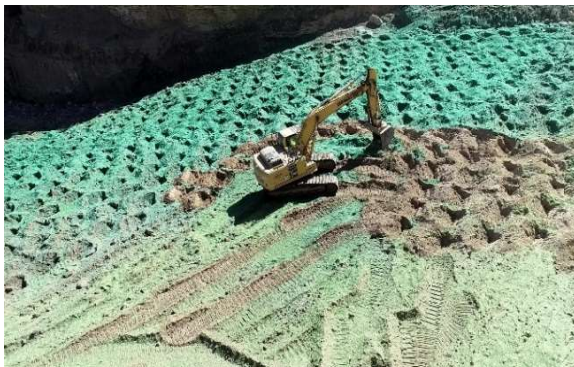
Figure 1. Pocked slope at the Deer Creek Coal Mine reclamation site, Emery.

To manage erosion on reclaimed lands in Central Utah, the Utah Division of Oil Gas and Mining within the Utah Department of Natural Resources has, over the past 20 years, utilized a deep gouging erosion control method referred to as “pocking” (C. A. Semborski et al., 2006; Utah Oil Gas and Mining, 2000). Pocks are created using an excavator which digs gouges at least half a meter deep and up to 1.2 meters wide across the reclaimed area. The soil from that hole is placed downslope of the gouge, and the process is repeated with pocks distributed in a semi-random, adjacent pattern across the slope (Figures 1 and 2).

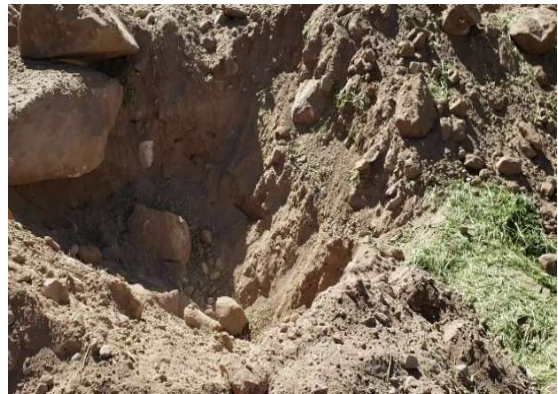
Figure 2. A single pock located at the Deer Creek Coal Mine reclamation site,

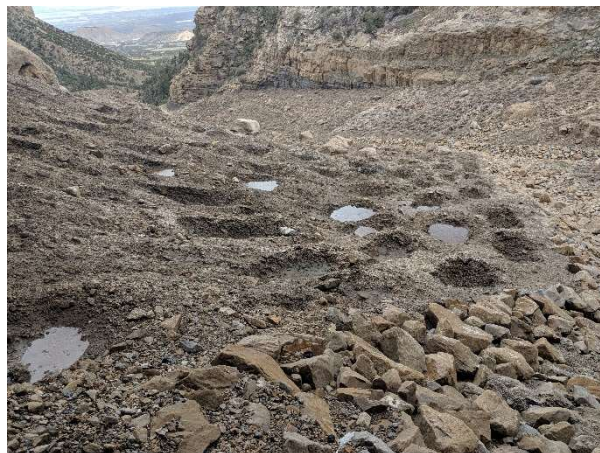
Pocks are designed to control overland runoff by effectively reducing the slope length and collecting water. Each individual pock acts as a small catchment basin to trap water (Figure 3) and provide moisture to help establish seeded vegetation. The UDOGM regards this method as an effective erosion control technique that encourages vegetation regrowth, but its effectiveness has never been quantified. The UDOGM has relied on anecdotal observation supported by limited vegetation and sediment measurements produced by bond release requirements. Due to this anecdotal observation and limited field sampling, mine operators have been discussing the possibility that pocking could eliminate the requirement for sediment catchment ponds commonly placed at the topographic “pour point” of the landscape. The intent of these ponds are to prevent sediment from exiting the site, which pocking appears to accomplish. To this end, a recent reclamation site at the Cottonwood coal mine in Emery County, Utah used pocking as the sole method of erosion control. Though pocking is regarded as an effective technique, the lack of an empirical evaluation of how pocks and their distribution across

Figure 3. Pocks retaining water after a storm.

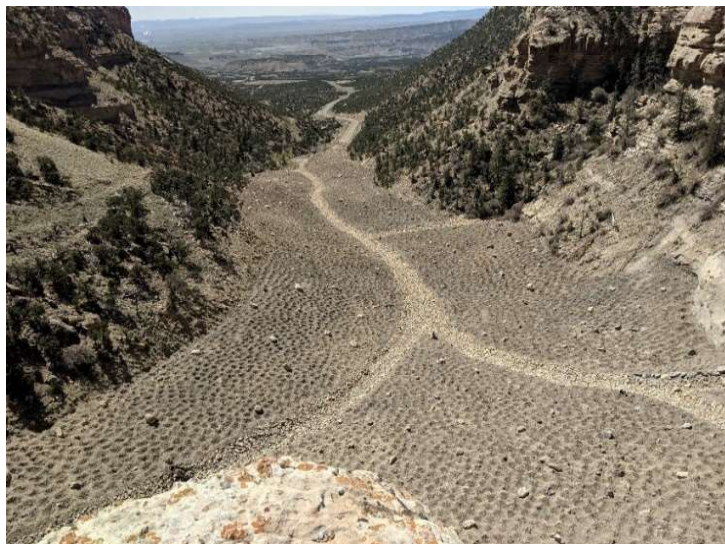
Figure 5. Cottonwood Reclamation site in May 2019.

The Cottonwood/Wilberg mine (hereafter the Cottonwood site) owned by PacifiCorp, was an underground coal mine complex opened in the 1890s and in operation until 2001. Following the mine closure, reclamation activities began in 2017 and were completed in March of 2018 (Figure 5).

The Cottonwood site sits within a narrow canyon that forks east and west midway up the reclaimed area. It has a surface disturbance area of approximately 8.5 hectares that spans the width of the canyon floor. Pocking combined with hydroseeding was used as the erosion control method. The site also has a riprap drainage channel 1.5 meters deep and 6 to 17 meters wide installed along the north-south extent and into each fork, allowing upslope water to flow through the site as well as capture sediments that reach the channel from the surrounding pocked landscape. The lowest elevation of the reclaimed area is 2188 meters above sea level (ASL), and the upper benches are over 2405 meters ASL. The reclamation starts at the road terminus (lowest elevation) of County Road 57, and stretches 874 meters up the west fork, and 727 meters up the east fork, with the reclaimed portion of the valley floor averaging 70 meters in width and a maximum of approximately 120 meters across the widest point.

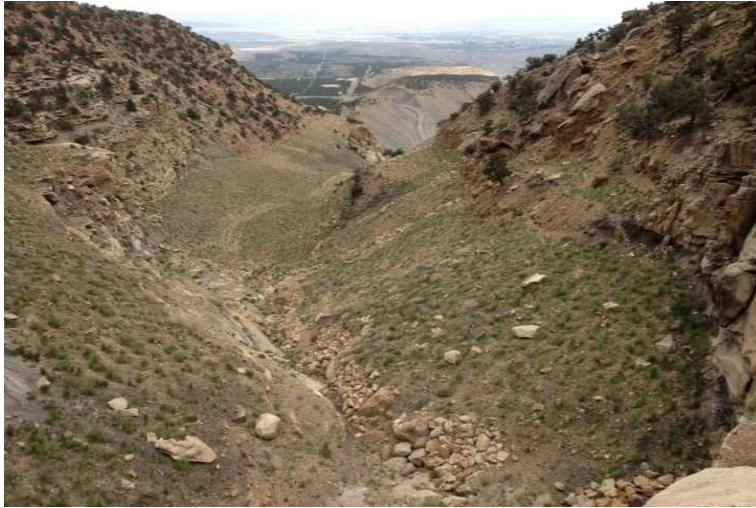
Figure 6. Des Bee Dove Reclamation Site 2017.

The Des Bee Dove mine reclamation site, which was used to characterize the long-term effects of pocking, is located in an adjacent canyon 1.5 km east of the Cottonwood site. Des Bee Dove was owned and reclaimed by PacifiCorp in 2003 and is considered successfully reclaimed by the state of Utah, with its bond being released in 2014. The site is also 8.5 hectares in size and provides a more than 17-year example of what the Cottonwood site will develop into (Figure 6). The highest elevation of the reclaimed area is at 2280 meters, and the lower elevation is around 2100 meters. The site features a similar riprap sediment trap channel present in Cottonwood and ranges from 4

to 12 meters wide. The native vegetation composition and topography is similar to the Cottonwood site.

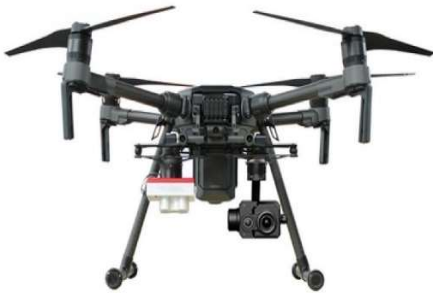
Figure 7. DJI M210 Drone (Dronefly, 2020).

Two UAV platforms were used for this project (Figures 7 and 8); the DJI – Phantom 4 Pro v2 (P4P), and the (DJI) M210 (M210). The P4P is a popular, low-cost commercial drone produced by Dà-Jiāng Innovations (DJI). It carries a 20-megapixel camera with a 1” CMOS sensor with a maximum field of view (FOV) of 84 degrees. The camera is equipped with an autofocus lens with a 1m minimum focal distance with an aperture range of f2.8 - f11.

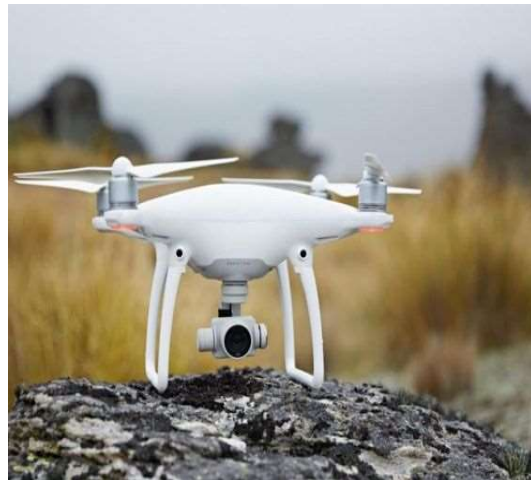
Figure 8. Phantom 4 Pro (Gizmochina, 2018).

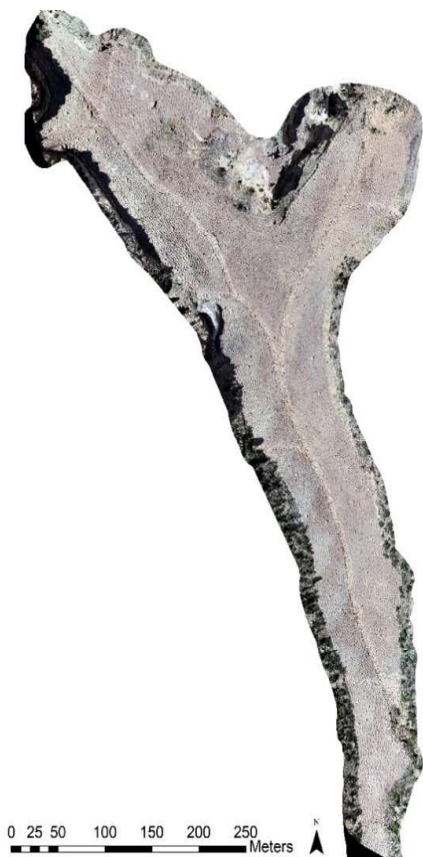
Figure 10. Orthomosaic of the Cottonwood Reclamation site

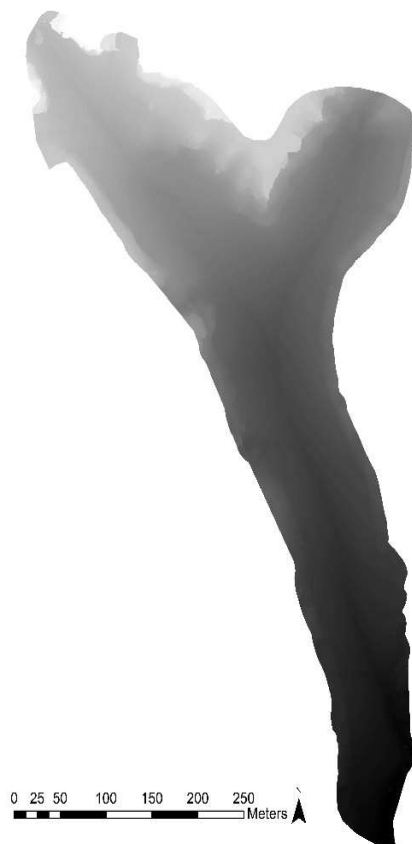
Figure 11. Digital surface model of the Cottonwood site

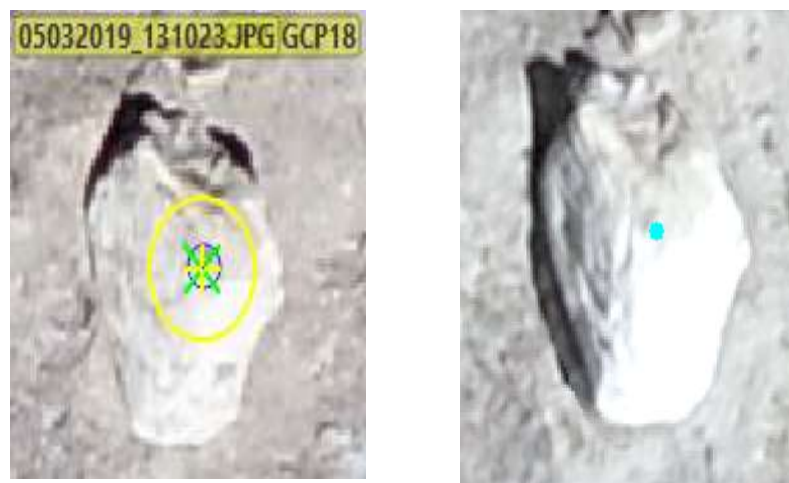
Figure 13. Ground control point selection between the original May, 2019 imagery and a subsequent overflight.

Therefore, to geographically correct our multi-date imagery so that relative between-image spatial error was minimized, we identified a set of 27 GCPs from our initial imagery located at pronounced edges of large boulders that were distributed across the reclaimed surface (Figure 12 and 13). These boulders were a minimum of 1-2 meters in size and located on relatively flat surfaces so that their movement over our study time

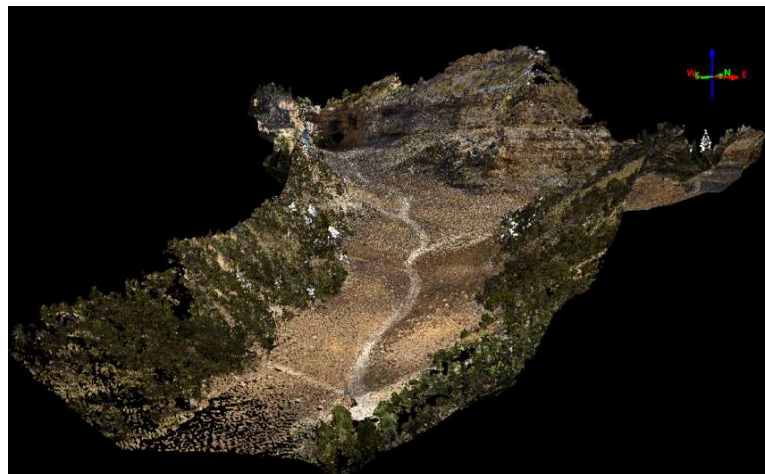
Figure 14. 3-dimensional rendition of ground-based 2018 Lidar Data.

Ground-based LiDAR data were collected (Figure 14) by the United States Department of the Interior’s Office of Surface Mining Reclamation and Enforcement (OSMRE) under the direction of UDOGM in both the spring of 2018 and fall of 2019 using a Riegl LiDAR system (RIEGL Laser Measurement Systems GmbH). The LiDAR emitter was located at the same locations each year. LiDAR sampling locations were marked with rebar inserted into the ground.

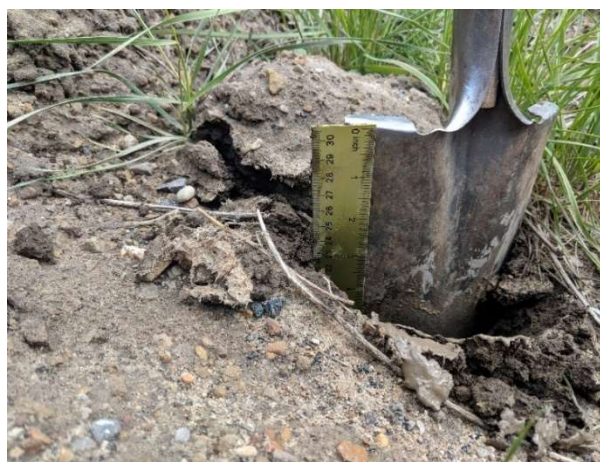
Figure 17. Evaluation of erosion at the bottom of a pock.

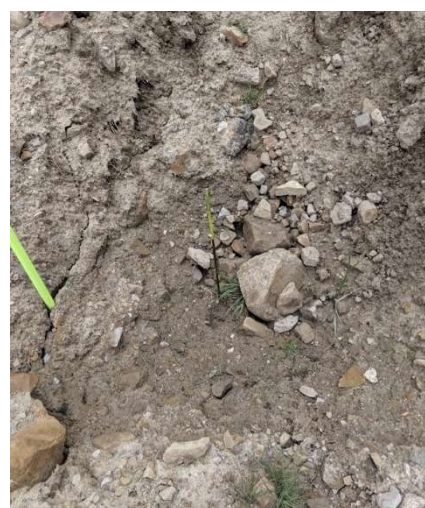
Figure 18. Rebar sediment staff.

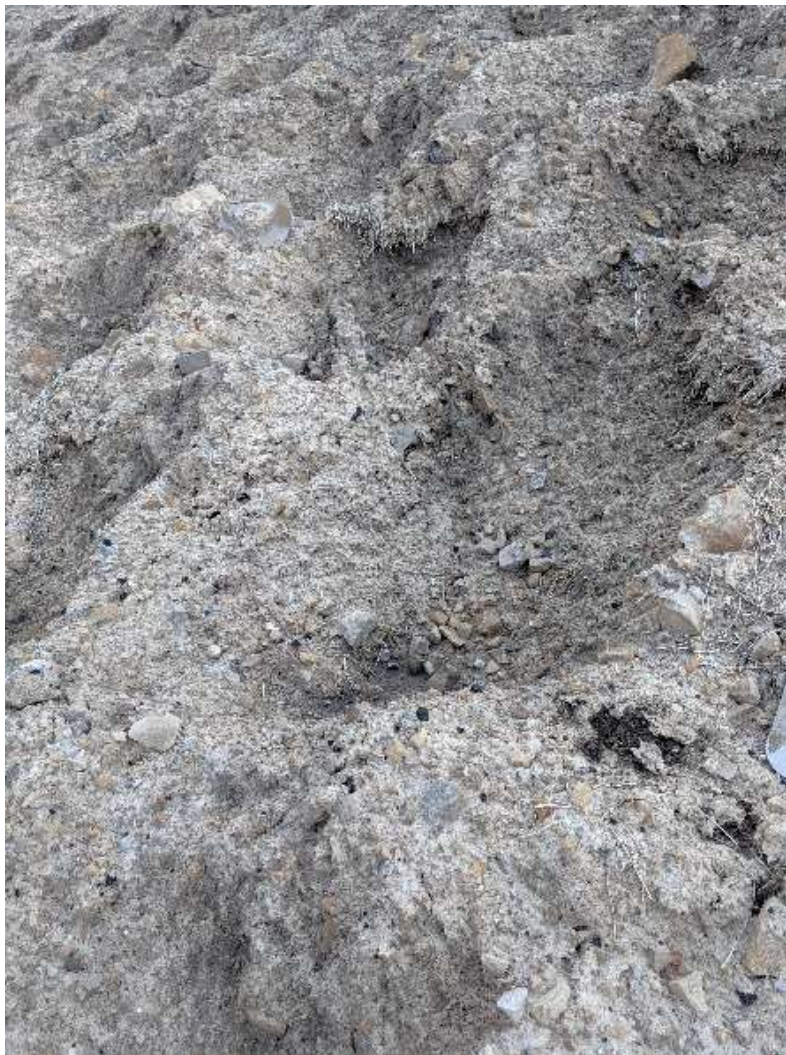
Figure 19. Typical evidence seen of the sloughing of pock walls found across the site

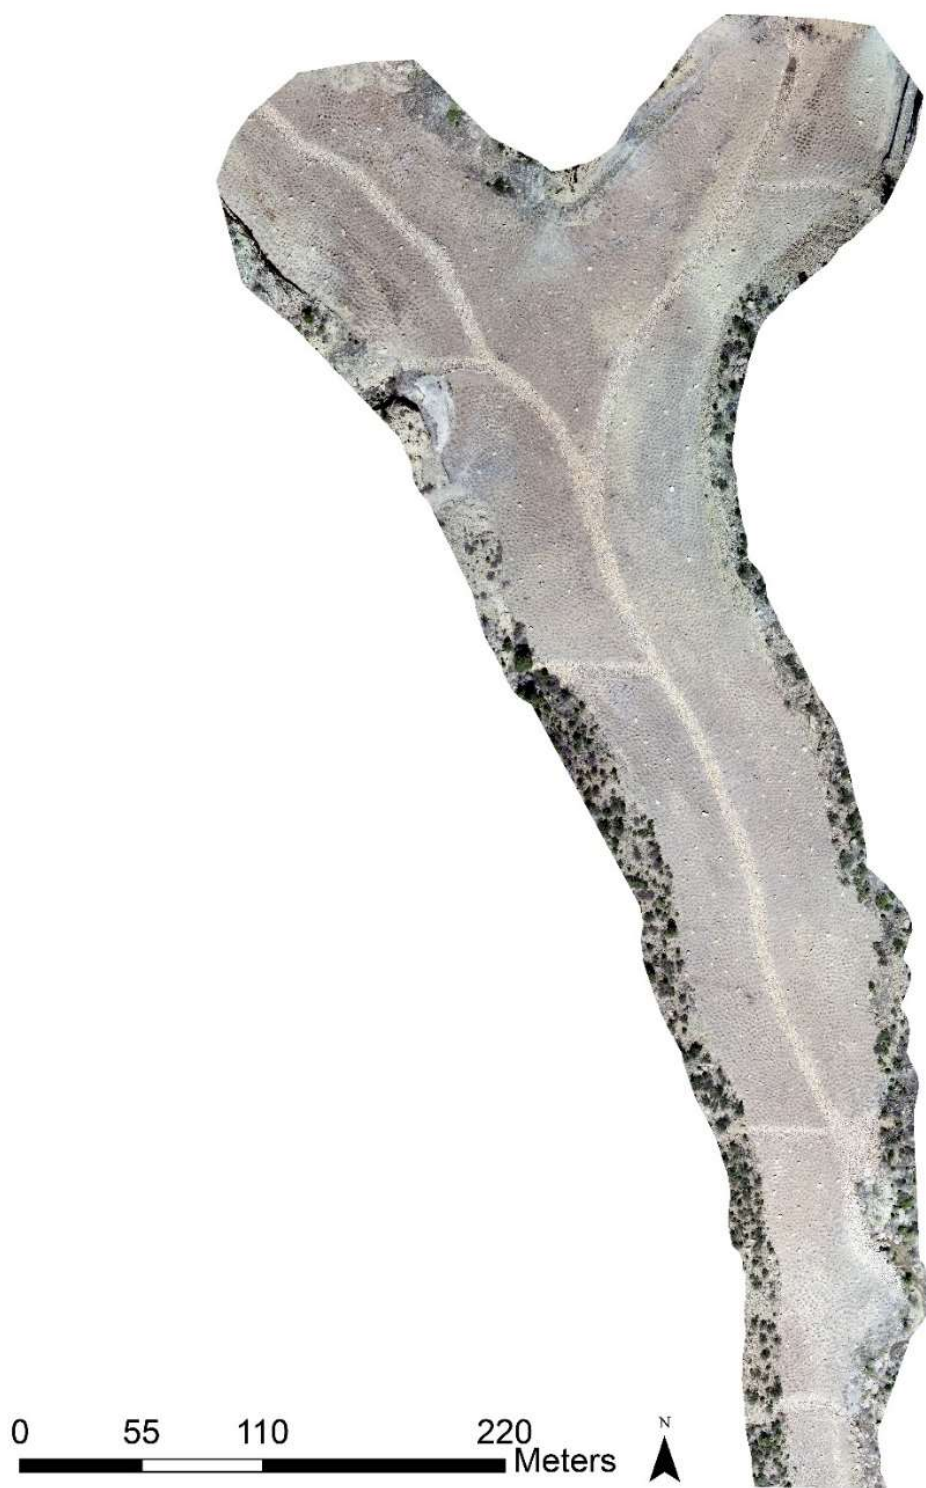
Figure 25. Cottonwood orthomosaic image for May 2019. The northwest arm of the canyon was not covered due to inability to safely collect enough overlapping images of the terrain while avoiding the canyon walls.

High-resolution orthomosaics and DSMs were generated for each individual flight (Figures 25-28). The June 2019 Cottonwood and the August 2019 Des Bee Dove multispectral imagery were flown and processed by the UDOGM (Figures 28-30).

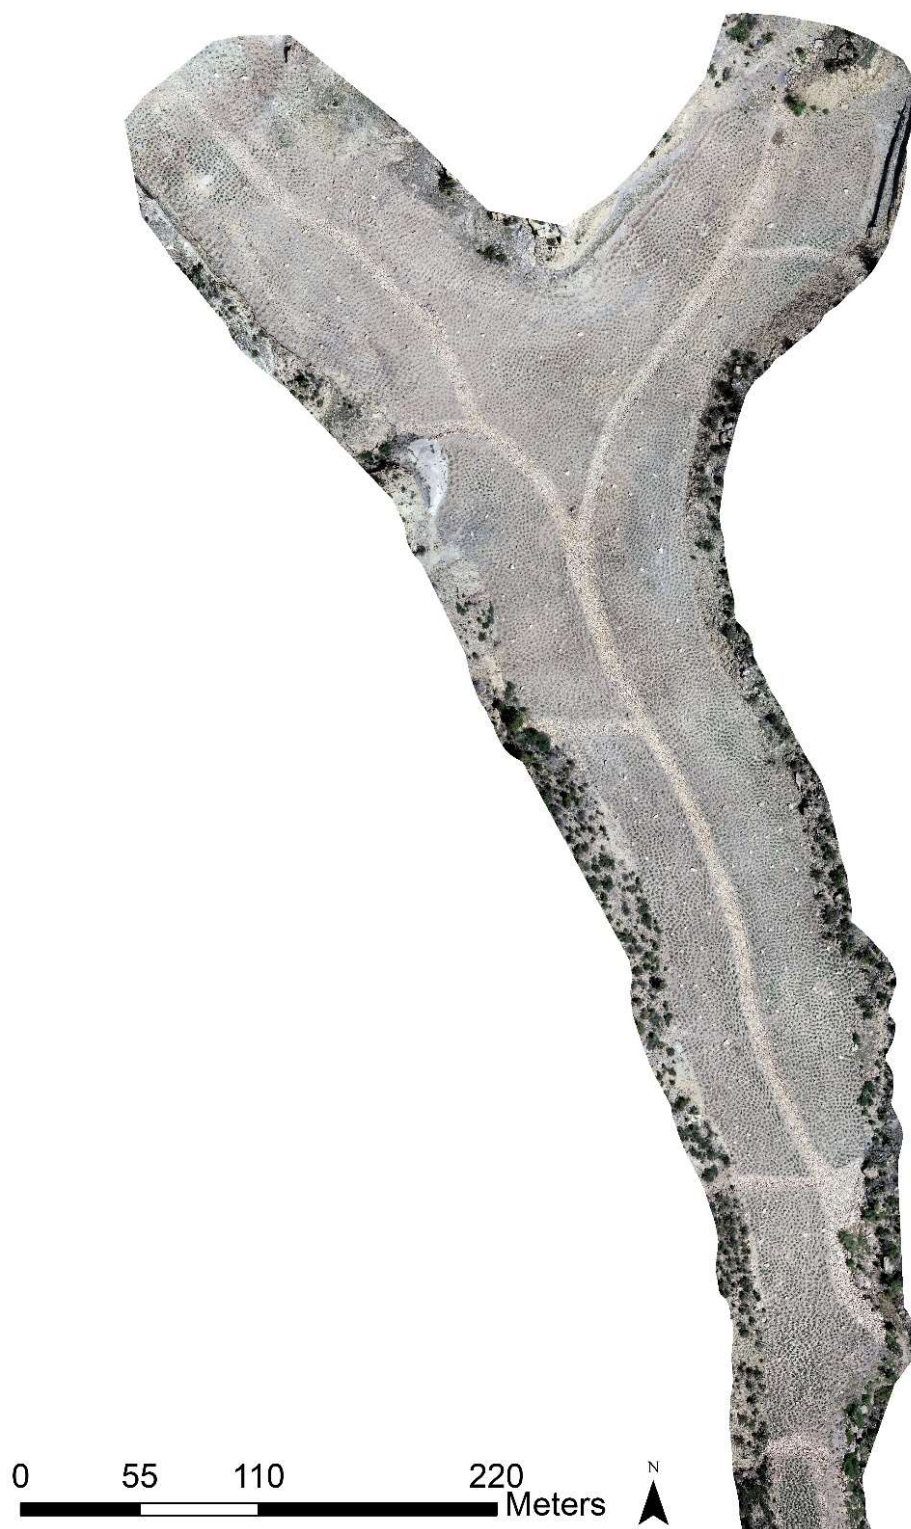
Figure 26. Cottonwood orthomosaic image from May 2020. Collected using identical flight parameters used for the May 2019 flight.

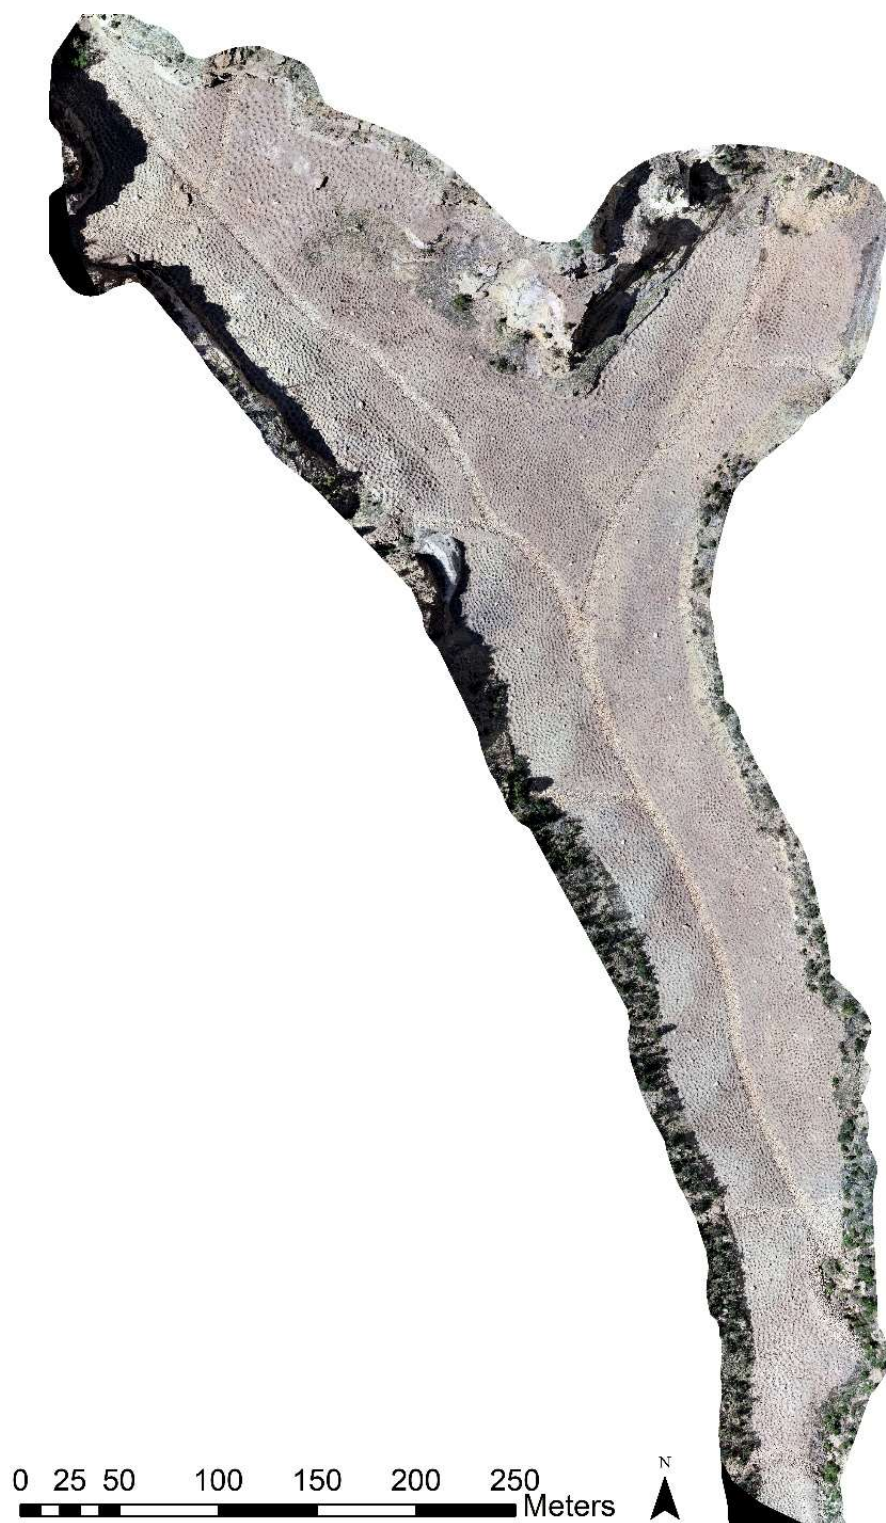
Figure 27. Cottonwood orthomosaic image from June 2019. This image was collected at a higher flight elevation compared to other flights using flight planning software that integrated a digital elevation model to maintain a standard height above ground and thus avoid cliff faces.

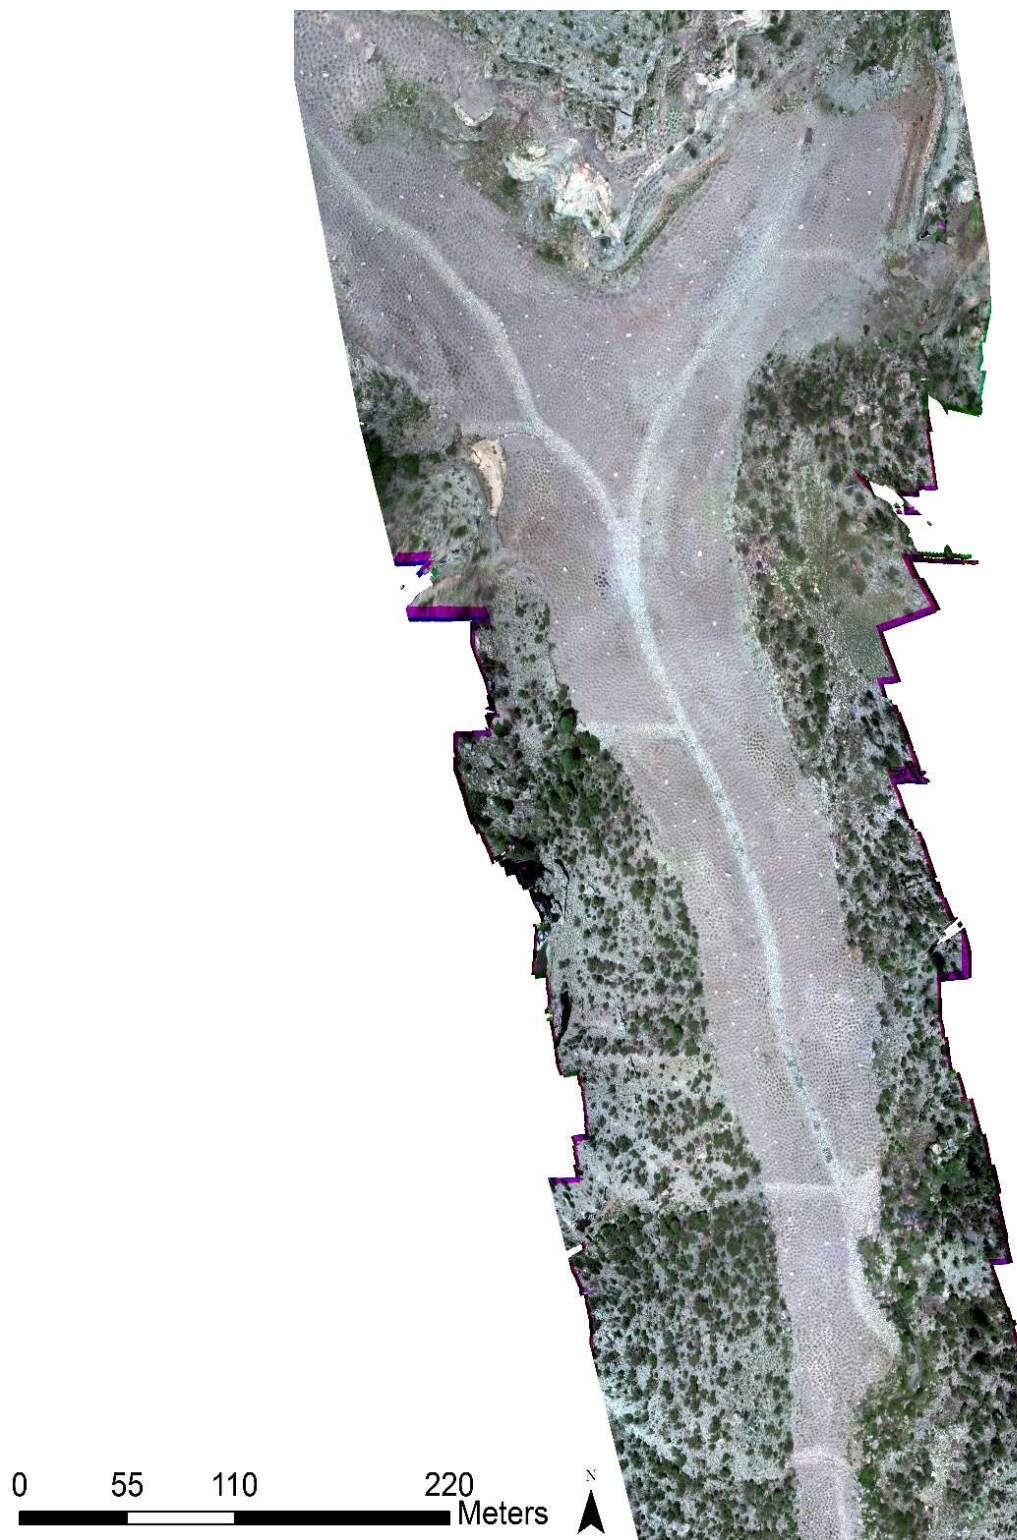
Figure 28. The June 2019 multispectral image orthomosaic collected by the UDOGM.

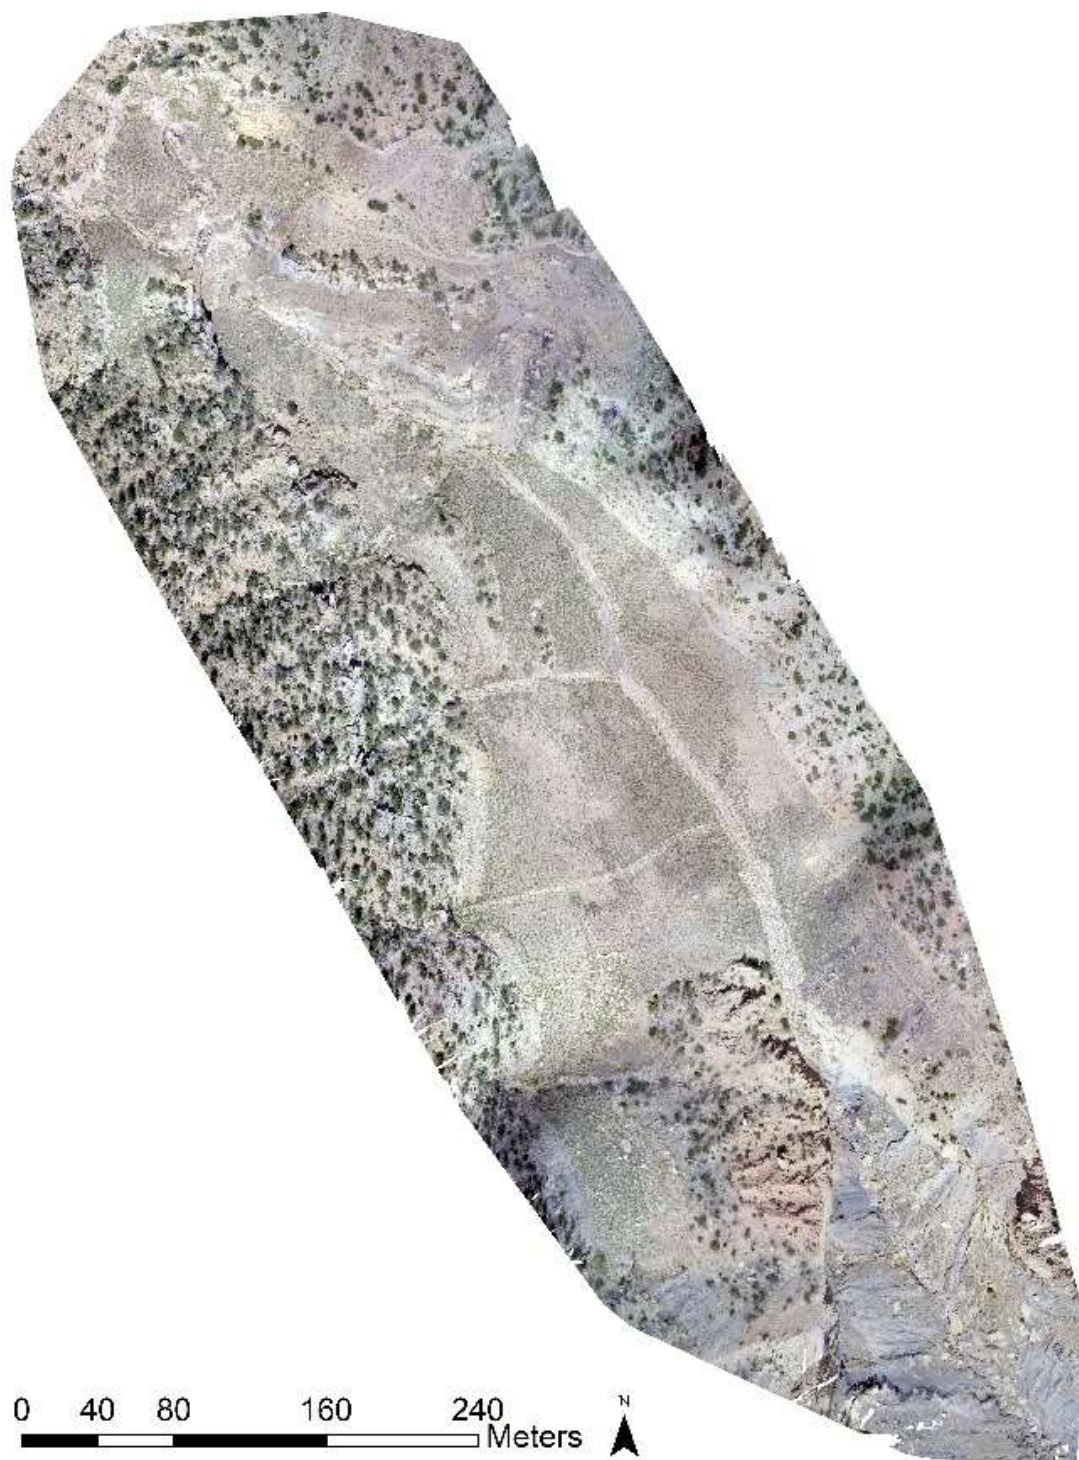
Figure 29. Des Bee Dove Ortho-image from August 2019 flights by UDOGM.

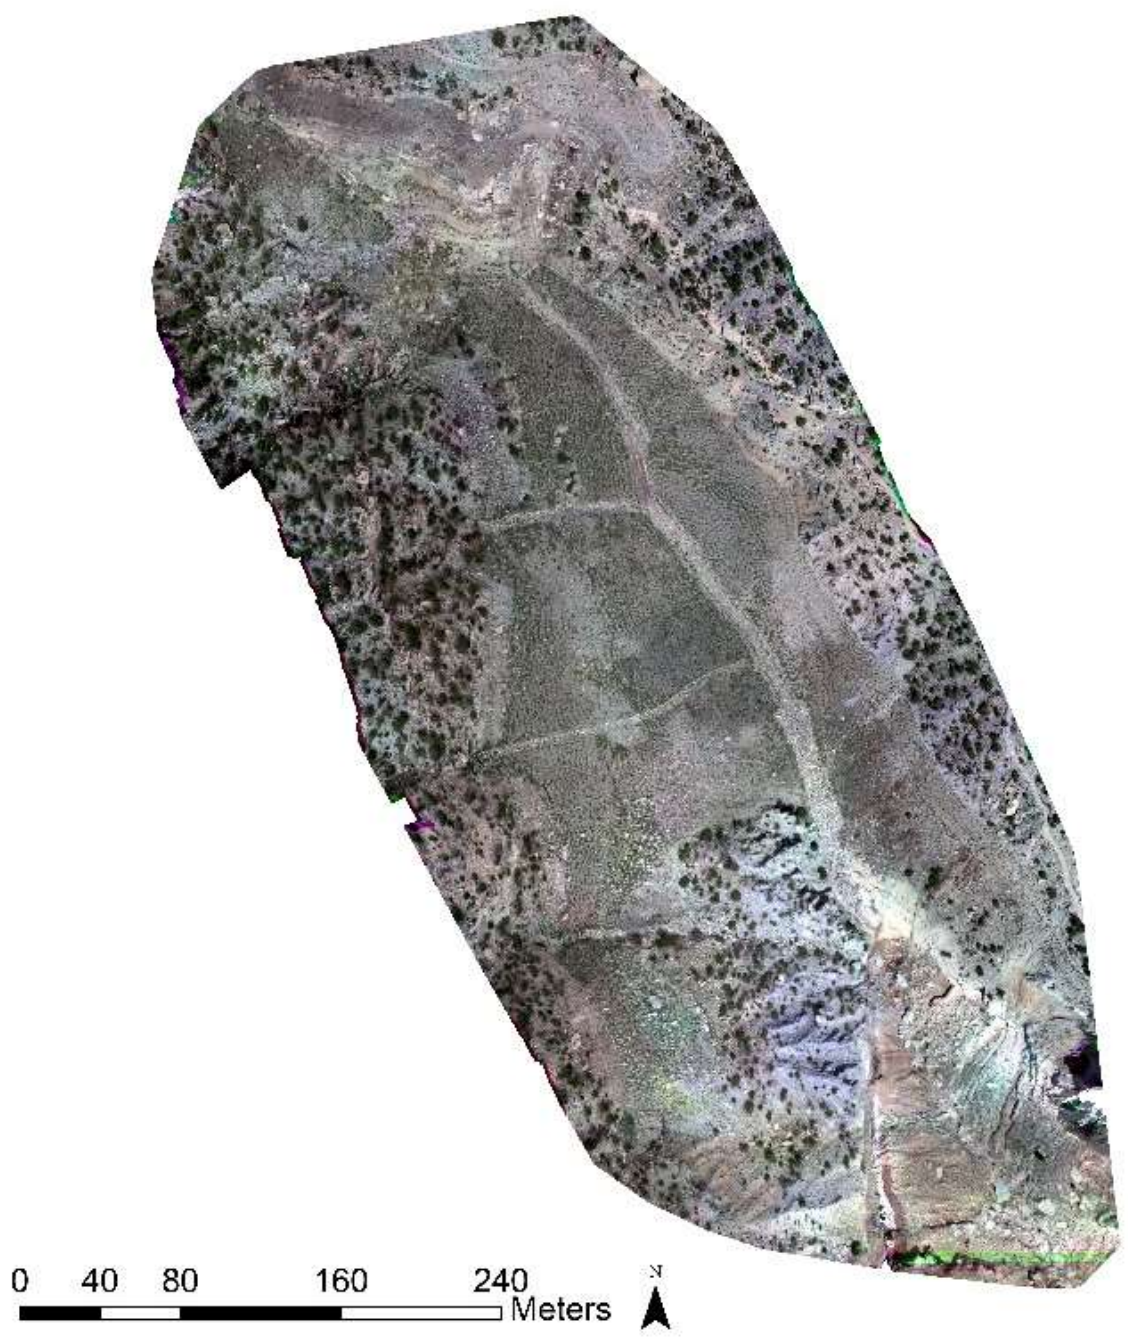
Figure 30. MultiSpectral Imagery collected from an August 2019 flight by UDOGM.

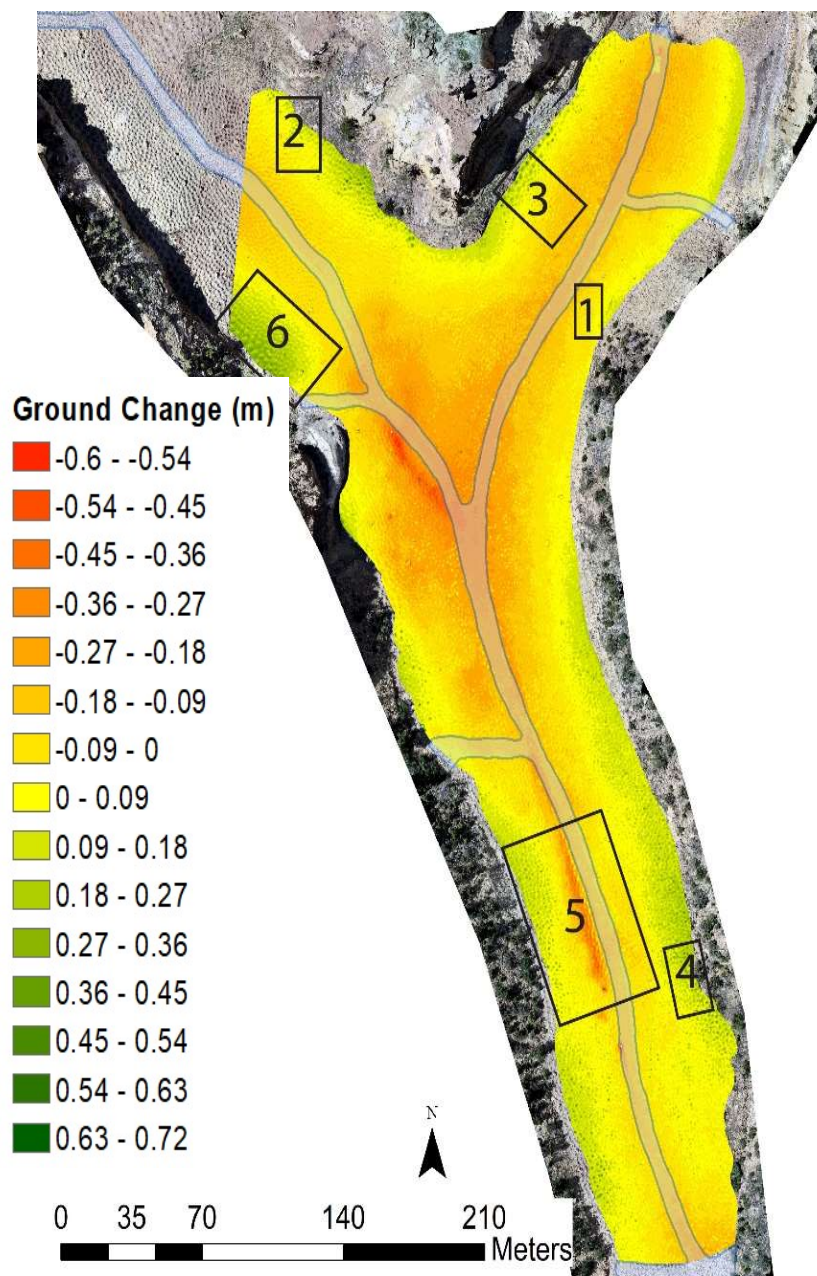
Figure 34 identifies six areas of interest (AOIs) that represent different areas of increased elevation (infilling), and areas of decreased elevation between 2019 and 2020. While decreases in elevation between the two years might signify surface erosion, we saw no evidence of significant surface erosion anywhere on the site.

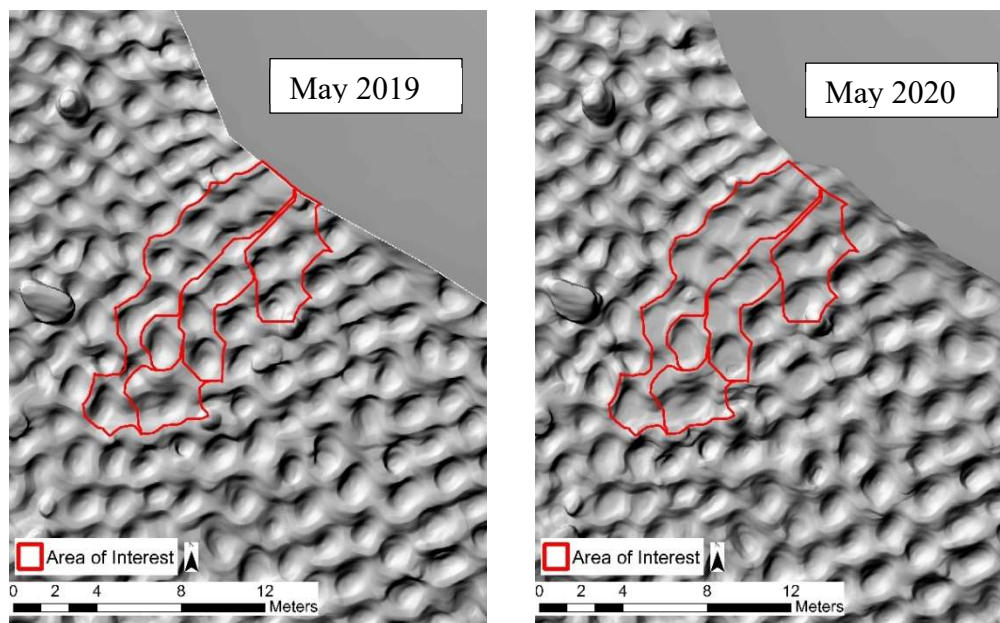
Figure 37. Shaded relief showing pocks filling over time at AOI #2 from 2019 to 2020.

AOI #2 shows greater infilling along the edge of the pocked landscape where we would expect increased overland flow from adjacent non-pocked areas. Additionally, pock boundary delineation using the 2020 imagery shows a pattern of coalescing pocks similar to what was observed at the Des Bee Dove site. This merging of pocks is found exclusively along the edges of the pocked landscape. These merging pocks are identified from the ground change evaluation and the aerial imagery confirmed what looked to be sediment change over the year (Figure 36). We can also identify the changed pocks using a shaded relief map of the site from the two years (Figure 37).

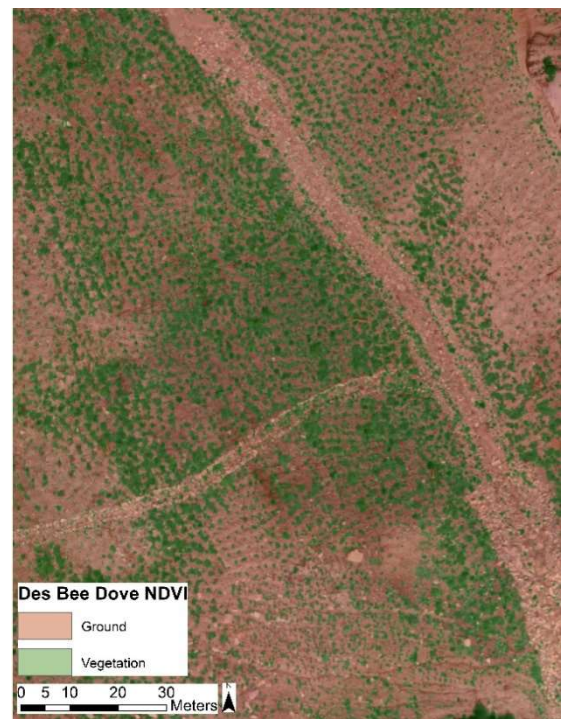
Figure 43. Vegetation identified by the NDVI at the Des Bee Dove site.

The NDVI derived from the Micasense imagery identified vegetation growing across both the Cottonwood and Des Bee Dove sites (Figures 42 and 43). The Cottonwood site showed vegetation growing at the bottom of each pock, while the Des Bee Dove site shows more vegetation growing across the original pocking structure. While the remnant pocking structure is visible in the imagery over Des Bee Dove, automated detection using the pocking tool was not possible due to the overgrowth of vegetation. The Des Bee Dove site, however, still shows vegetation distribution influenced by the distribution of pocks.

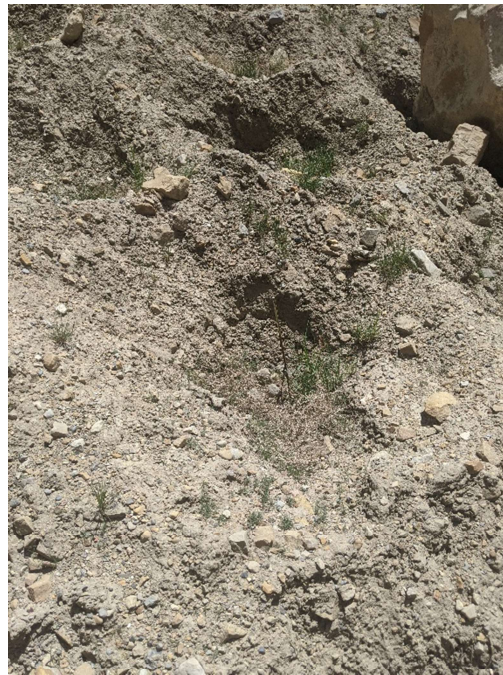
All randomly sampled pocks showed evidence of infilling, with the side walls being the source of most sediment (Figure 44). However, we had difficulty getting accurate measurements using the shovel method to identify sedimentation layers due to variation in materials at the bottom of pocks ranging from soft soil to large rocks (Figure 45). This variation, along with minimal sedimentation across a 12-month time span reduced confidence in a quantitative measurement, though visual inspection showed evidence of erosion from pock walls and deposition in pock bottoms. We were not able to measure the same pocks across both years due to GPS location error.

Figure 44. Erosion along the pock walls can be seen in the central and far pocks.

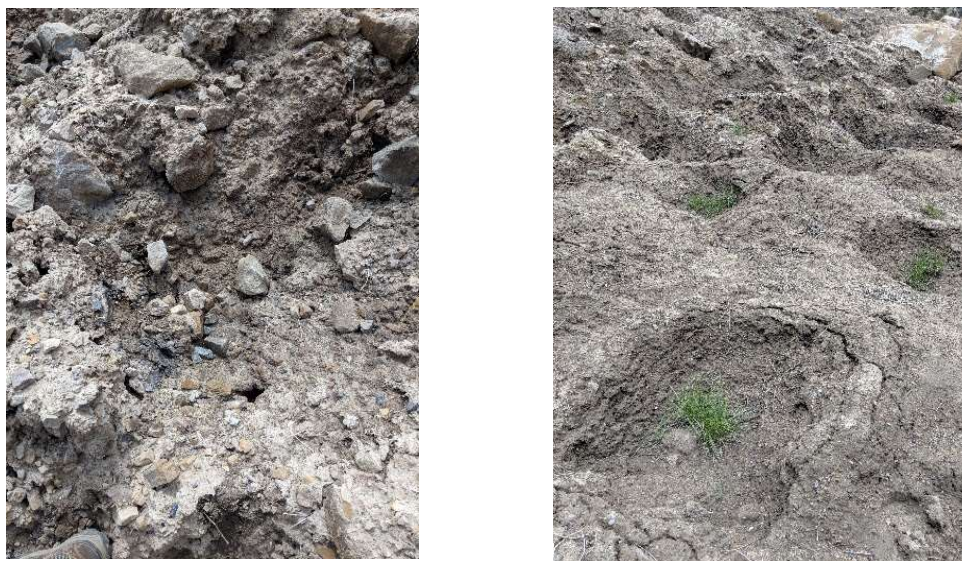
Figure 45. Variation of the pock material across the site inhibited a consistent method to evaluate sedimentation at the bottom of the pocks.

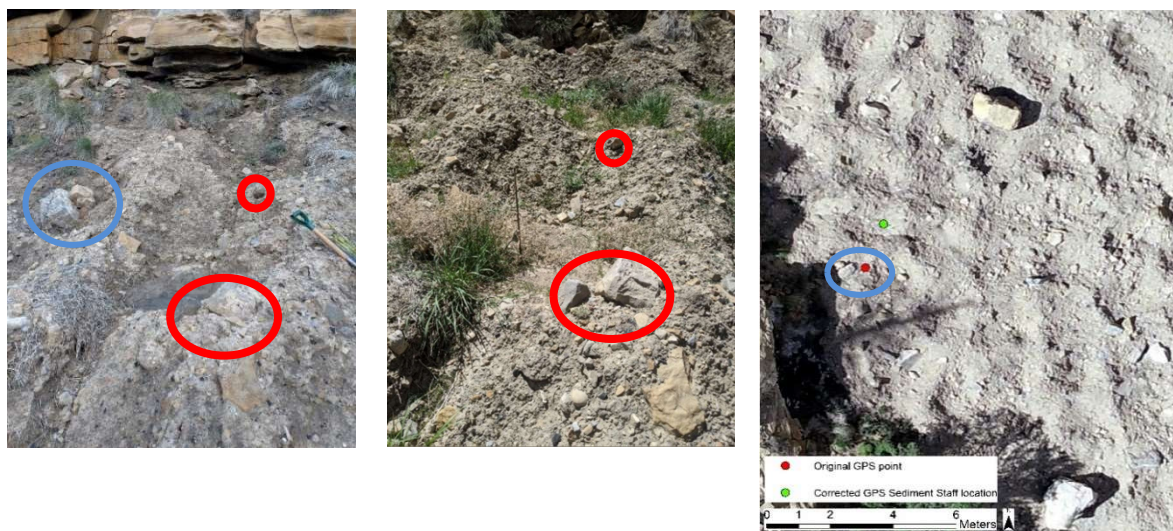
Sediment staff points were measured both years for the same pock. However, GPS location errors forced us to manually locate and place readings into the correct pock locations by interpreting the 2.5cm imagery and images of the sediment staff pocks (Figure 46). This allowed us to compare staff measurements to the DSM difference map.

Figure 46. Example of using the ground images and aerial imagery to correlate locations and correct sediment staff GPS points, with red and blue circles corresponding to each other across the images.

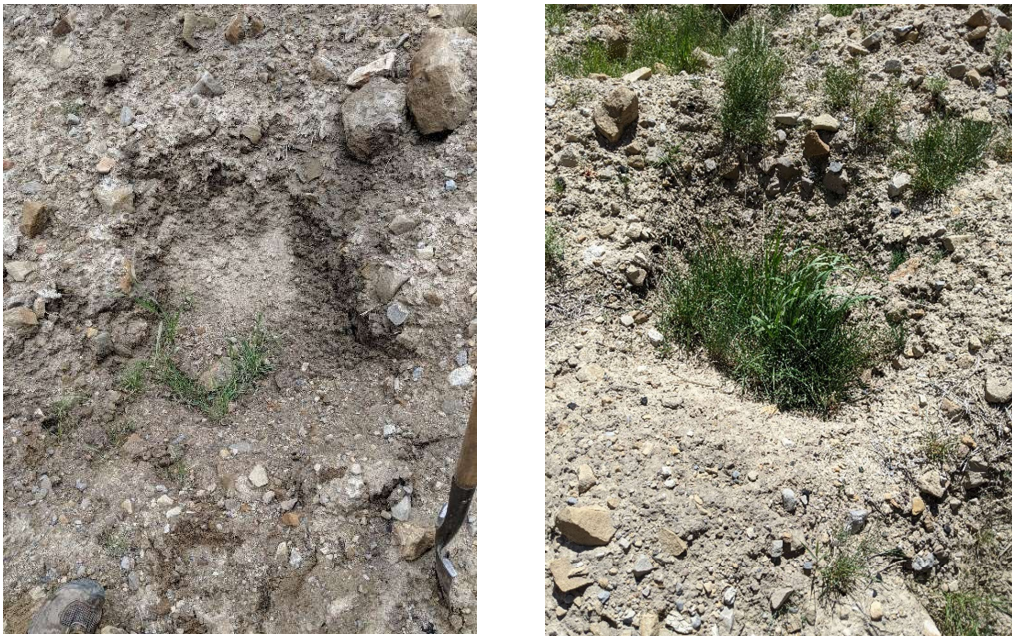
Field work conducted in 2019 found that 82% of the sampled pocks had actively growing vegetation. The 2020 field survey found that 100% of sampled pocks contained actively growing vegetation. Vegetation was growing generally at the bottoms of the pocks, but was also present along the ridges in many locations. Field-based estimates of vegetation canopy cover was not collected in either year. However, Figure 49 is representative of vegetation growth within and around pocks for both years.

Figure 49. Vegetation growing in separate pocks at Cottonwood in 2019 (Left) and 2020 (Right).
