Preliminary assessment of beaches and offshore sand resources of St. Eustatius, Netherlands Antilles : a report to the Government of St. Eustatius

PRELIMINARY ASSESSMENT OF BEACHES AND OFFSHORE SAND RESOURCES OF ST. EUSTATIUS NETHERLANDS ANTILLES

June 1989

Government of St. Eustatius

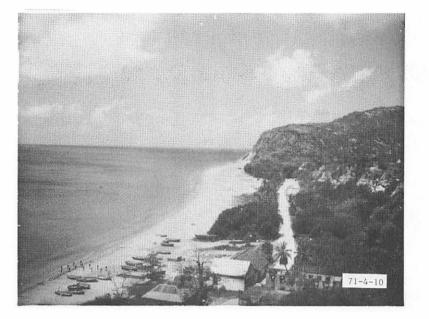
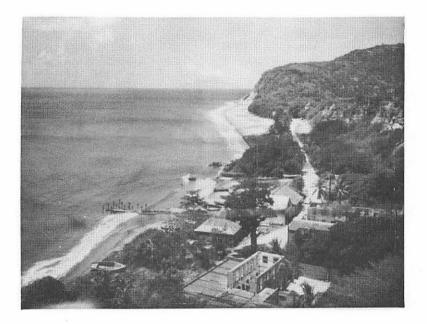
Figure 2a

ORANJESTAD BEACH APRIL 10 ,1971

ORANJESTAD BEACH SEPTEMBER 8 ,1971.

The limited photographic evidence in hand indicates that the beach at Oranje Baai, a well-protected, lee shore site where low-energy wave conditions prevail much of the time and swimming or bathing would normally be optimal, may have undergone a significant net loss of sand during the past two decades. A "sand-starved" condition now exists along the remaining beaches with rock exposures along almost all segments of the shoreline from the town landing of Oranjestad harbor to Windmill Beach and Interloper's Point (Figure 1).

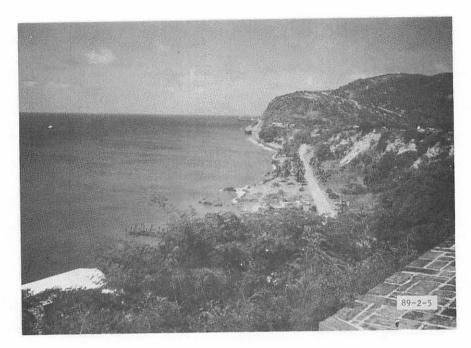
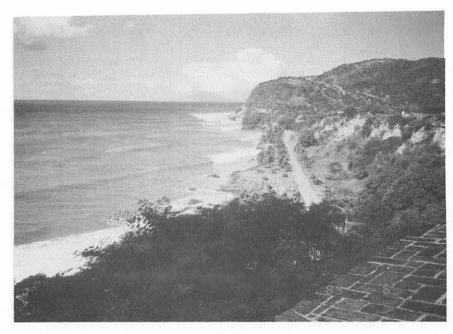
Figure 2b

ORANJESTAD BEACH FEBRUARY 5,1989

ORANJESTAD BEACH MAY 1, 1989.

Photographs taken of Oranje Baai Beach over a four-month winter period (10 October 1988 to 5 February 1989) have revealed almost no change in the volume of sand present, even though a variety of incident wave conditions and wave angles of approach have been observed, including large breaking waves from the northwest (Figure 2b) which should reverse the presumed northwest drift taking place under normal conditions. In essence, no seasonal change was detected in the winter of 1988 - 1989. Possible explanations for a long-term net loss include:

In a uniform flow field, these measures depict the path taken by an object floating neutrally buoyant near the bottom. In the present instance, the observed motion was consistently toward the northwest with small reversals at tidal periods occurring near the end of the measurement period. The net northwestward displacement was approximately 12 kilometers in 100 hours, suggesting an average drift rate of between 3 and 4 cm/s. During this time, the angle of wave approach was between 30 and 45 degrees opening to the southeast. Waves of low significant height (20 to 30 cm) and short period (5 to 6 seconds) were recorded which produced little, if any, observed sediment motion on the bottom except near the toe of the beach face. This pattern of observations may prevail much of the time but will almost certainly be interrupted by occasional high waves of long period coming from the northwest as noted on 16 December, 1988 and again on January 6, 1989 (Figure 2b).

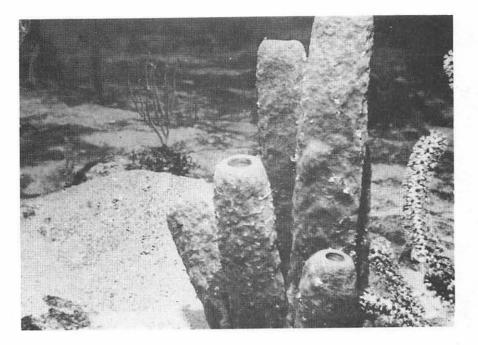
LOCATION A ROCK AND CORAL HEADS ON SAND BOTTOM
