Vegetative Erosion Control Project : Final Report

VEGETATIVE EROSION CONTROL PROJECT:

FINAL REPORT 1984

Virginia Institute of Marine Science
School of Marine Science
College of William and Mary
Gloucester Point, Virginia 23062

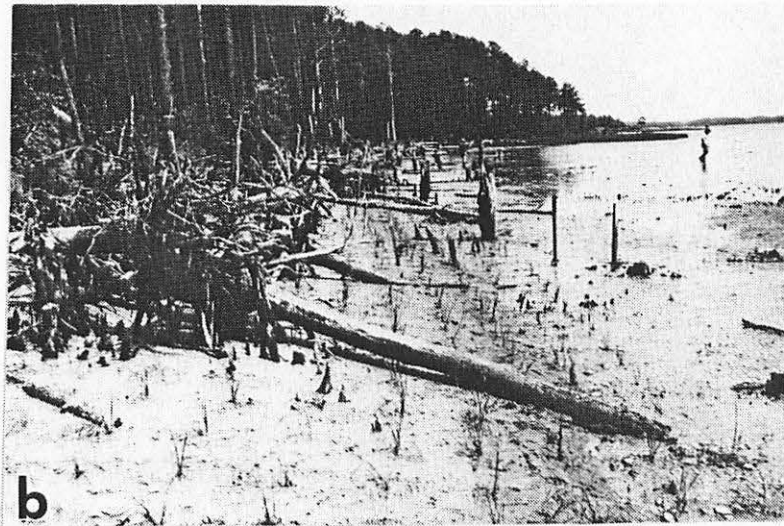
FIGURE 10

b. May 19, 1982
Looking east.

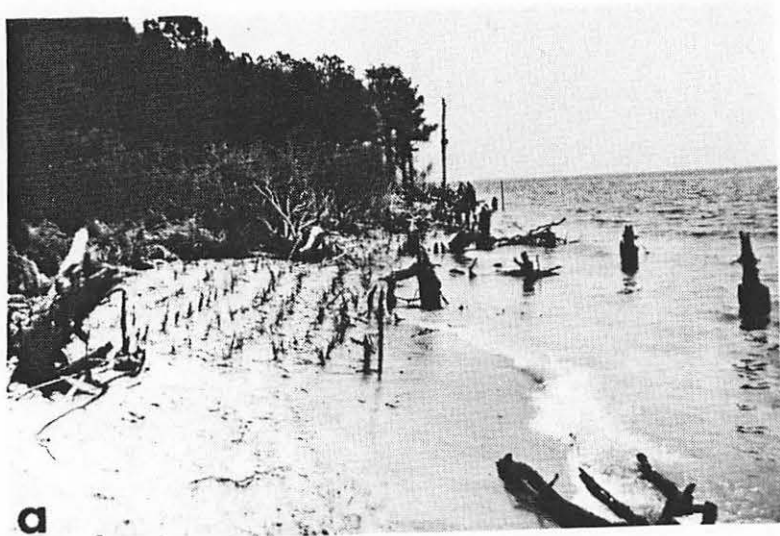
FIGURE 19
WINDMILL POINT

a. May 18, 1982

The Windmill Point site (Figure 18) suffered essentially the same fate as the Mountjoy site. In 1981 the plants died due to insufficient hardening. The site was replanted in 1982 but the plants were washed out by mid-summer (Figure 19). The 13.4 nautical mile fetch exposure was just too much for the young plants. It was not planted again but remains part of the overall data base. The cumulative erosion rate over three years is 4.5 feet per year (Figure 20).

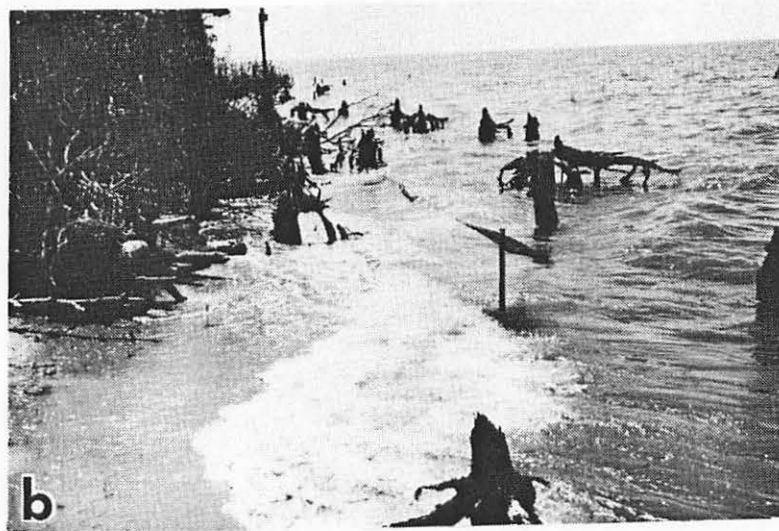
b. June 4, 1983

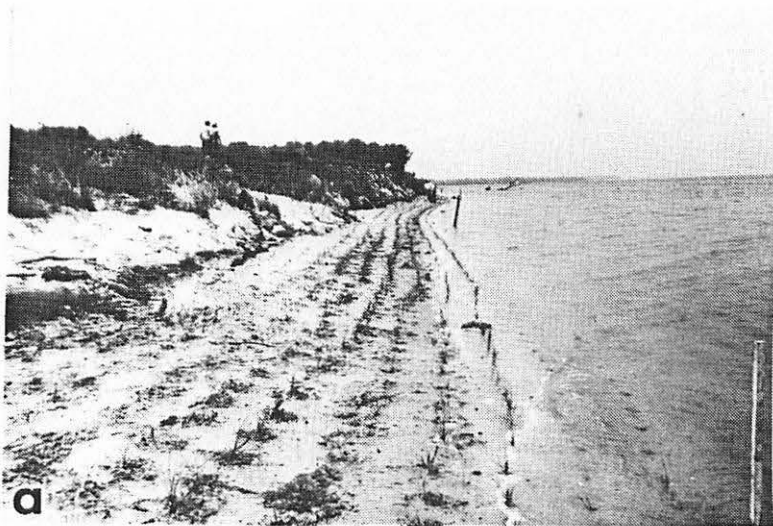
FIGURE 27

a. May 6, 1981
Looking northwest.

This site was completely washed out shortly after planting in 1981 by a moderate northeast wind (Figure 27). It was not replanted in 1982 but remains part of the project's data base. The erosion rate over three years has been 3.6 feet per year for the top of the bank and 4.6 feet per year for the base of the bank (Figure 28).

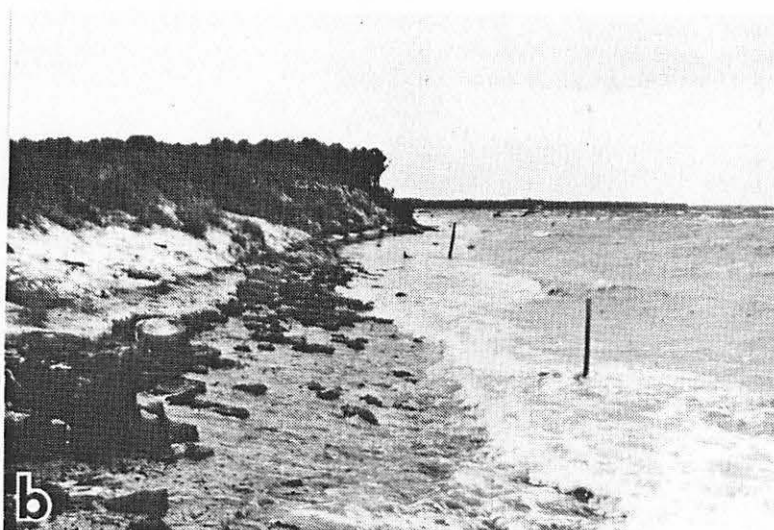
b. May 11, 1981
Looking northwest.

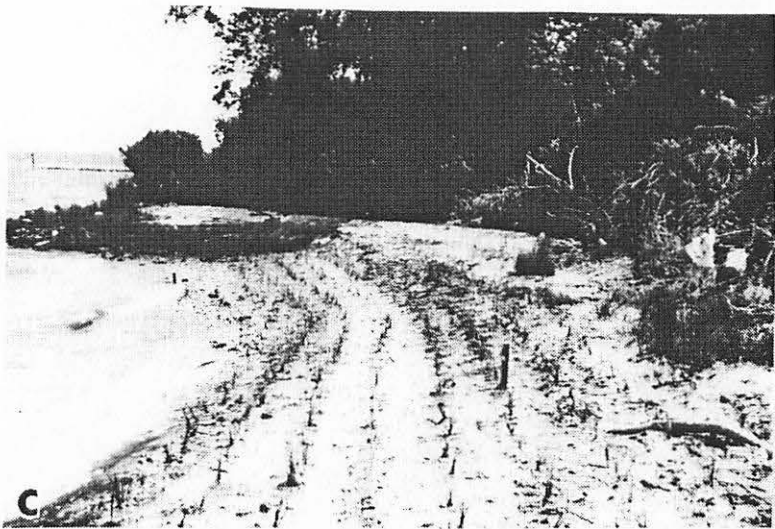
FIGURE 59

c. May 18, 1982
Looking southeast.

The site was maintenance planted in May 1982 (Figure 59c). Once again with both species of grasses. By November 1982 the planting had been reduced in area and erosion of the base of the bank was significant (Figure 59d). Most of these effects can be attributed to the northeast storm of October 25, 1982.

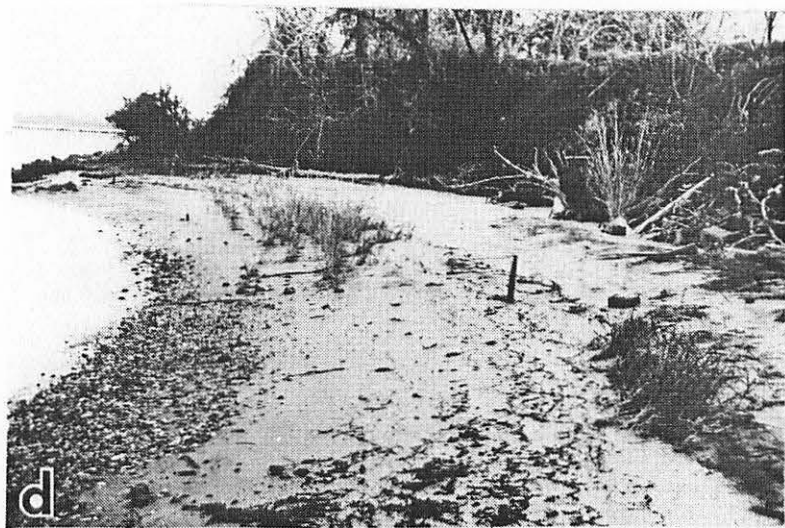
d. November 10, 1982
Looking southeast.

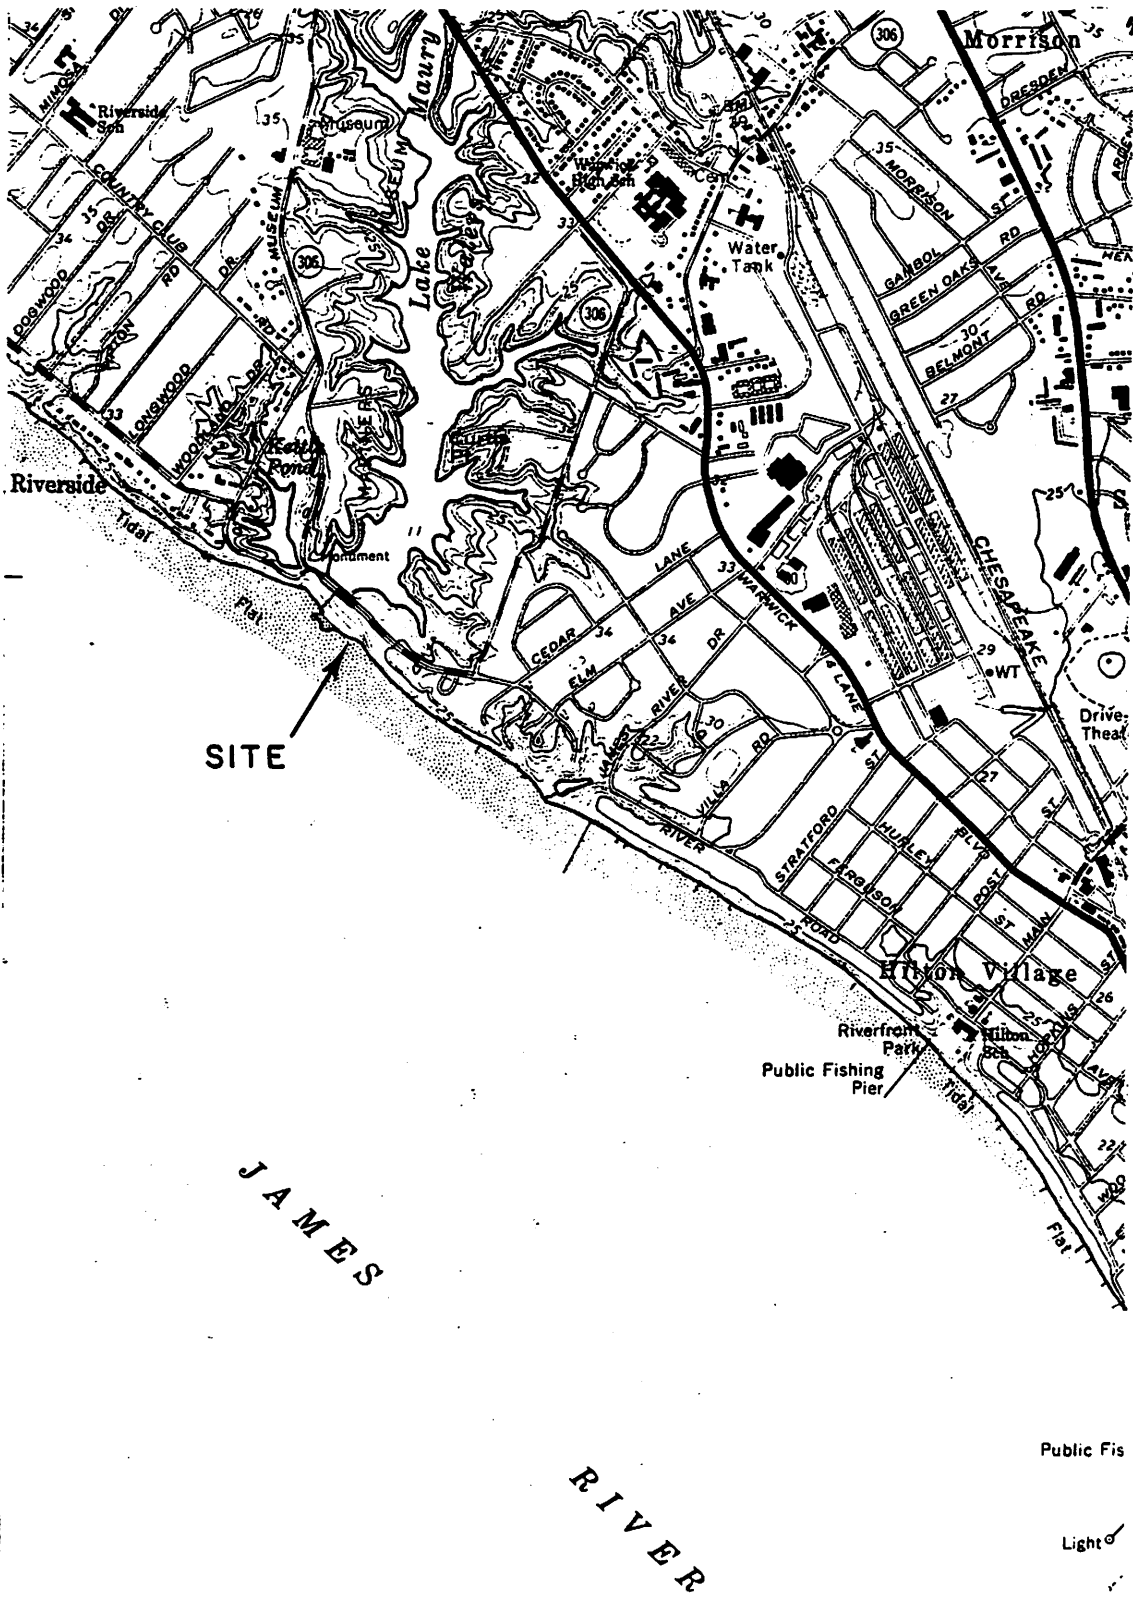
Figure 91. Mariners Museum Site - from Newport News North 7.5 minute quadrangle. Scale: 1 inch = 2,000 feet.

The Mariners Museum site is located adjacent to Lake Maury on the James River (Figure 91). The shore occurs as a low sand bank with a wave cut scarp. The low sand bank is part of a low sandy strand in front of a stable high fastland bank. The shore faces southwest with a 5.7 nautical mile average fetch. The low bank is about 5.5 feet above MTL. The bank face slopes into the backshore and is sparsely covered with upland vines, grasses and a few salt bushes. After a storm or high water event a wave cut scarp is created on the lows and bank but quickly slumps down to the angle of repose due to its sandy nature. The beach consists of clean, medium to coarse sand eroded from the adjacent low bank. The beach extends from the base of the low bank to about 10 feet beyond MTL.
