Step by Step: A Survey of the Hierarchy Found in Charleston Staircases with an Emphasis on Secondary Stairs

STEP BY STEP: A SURVEY OF THE HIERARCHY FOUND IN CHARLESTON
STAIRCASES WITH AN EMPHASIS ON SECONDARY STAIRS

A Thesis
Presented to
the Graduate Schools of
Clemson University and College of Charleston

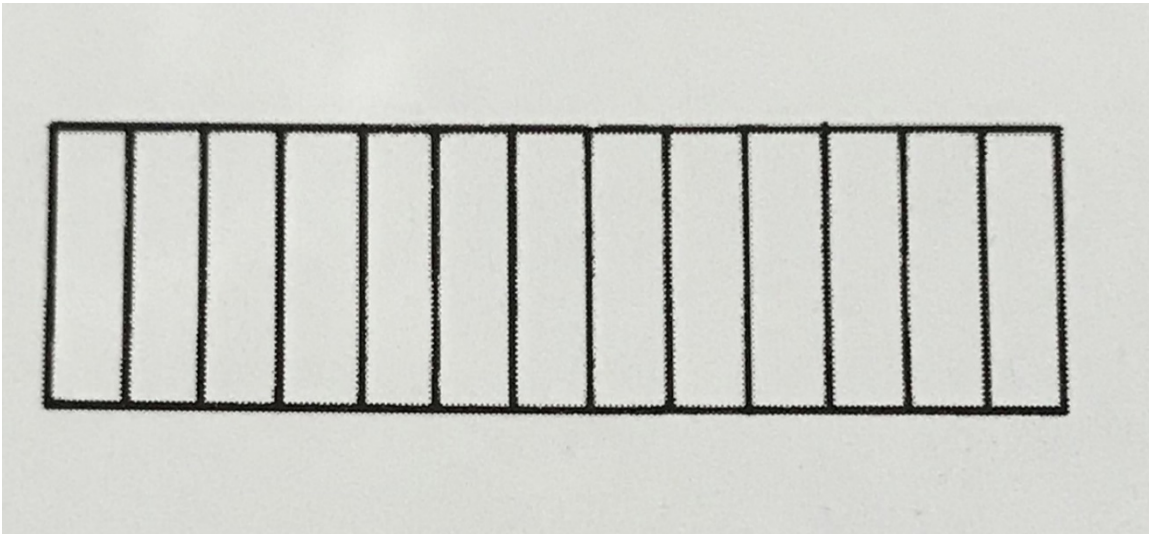
Straight Run Stairs: A straight run staircase will run from straight from floor to floor with no turns.

Figure 2: Straight run staircase, *Fundamentals of Building Construction*

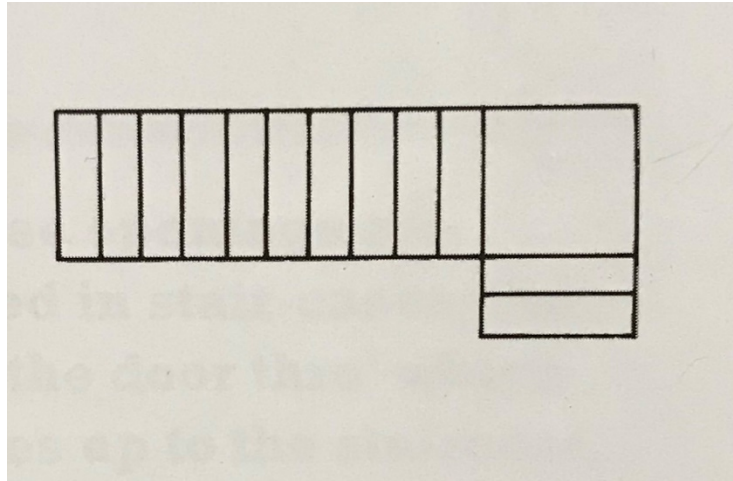
L Shaped Stair: An L shaped stair consists of two straight run staircases and may have a landing or winders in between.

Figure 3: L shaped stair, *Fundamentals of Building Construction*

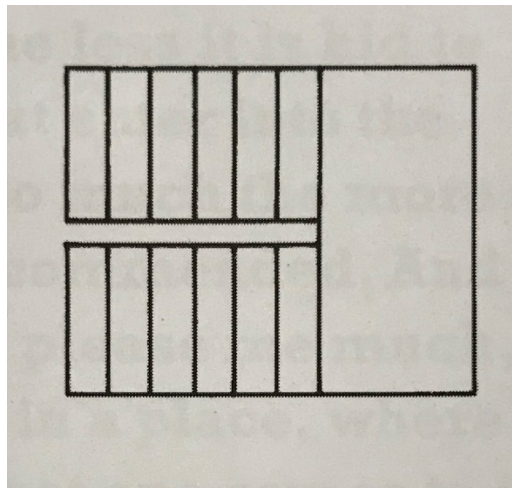
180-Degree Stair: Makes a 180-degree turn to the next level of the structure.³⁰

Figure 4: 180-Degree Stair, *Fundamentals of Building Construction*

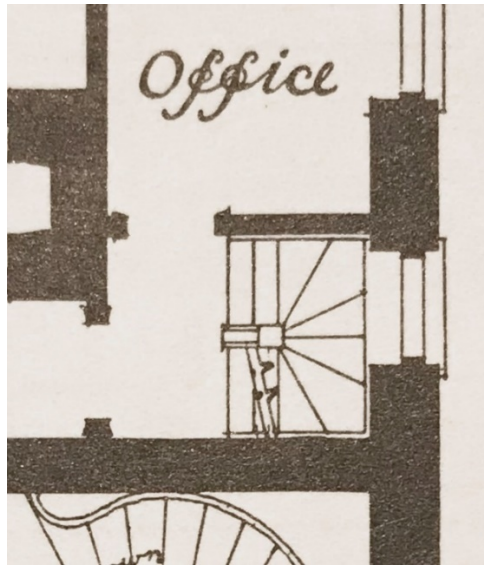
Winder Stair: A winder stair consists entirely of winders that are either curved or squared.

Figure 5: Winder Staircase, drawn by Albert Simmons for the Nathaniel Russel house in *Charleston Architecture*, page 264

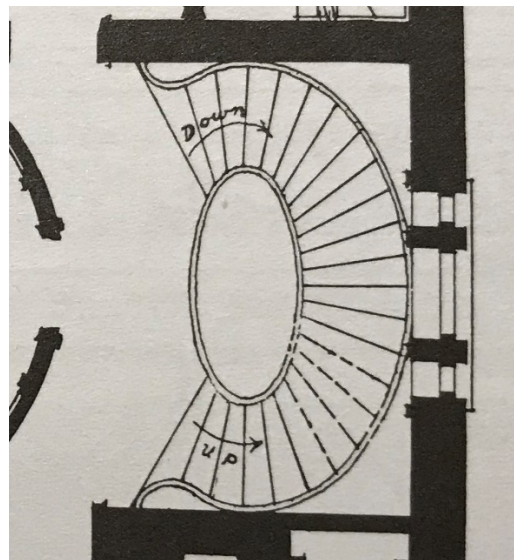
Elliptical Star: A staircase with a continuous run of winder stairs arranged around an elliptical opening between floors.

Figure 6: Elliptical Stair, drawn by Albert Simmons for the Nathaniel Russel house in *Charleston Architecture*, page 264

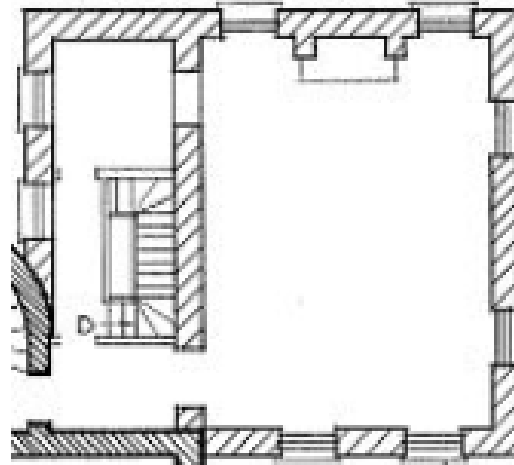
A “C” shaped stair has three runs of stairs connected by landings and 90-degree turns, ultimately making a 180-degree turn.³¹

Figure 7: “C” shaped staircase, drawn by HABS for the second floor plan of the Christopher Belser house

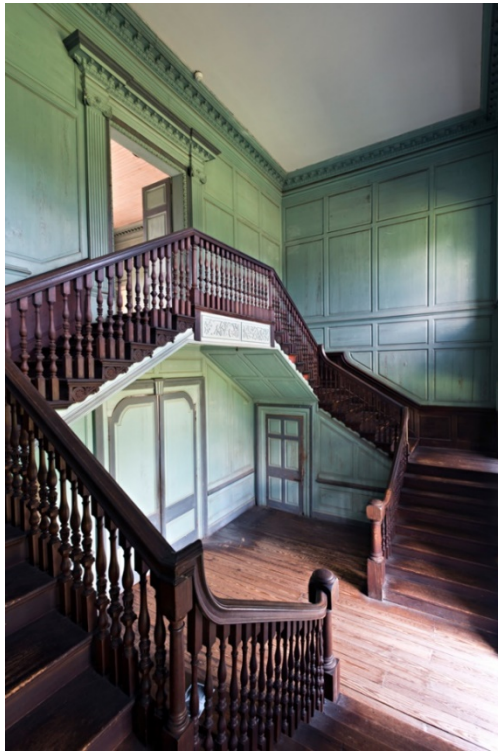
Figure 12 : Drayton Hall Stair Hall, Drayton Hall website

and windows that are evenly spaced and that are reminiscent of Roman and Greek architecture. These characteristics can be found within Drayton Hall, specifically with the primary staircase located in the northeast portion of the structure. The primary stair is L shaped, elaborated, and mirrored. The mirrored aspect of the staircase solidifies the Palladianism, as both sides of the rear hallway are symmetrical. The elaborated features found within the plan are the banister of the staircase, constructed of carved mahogany and a flared first tread.

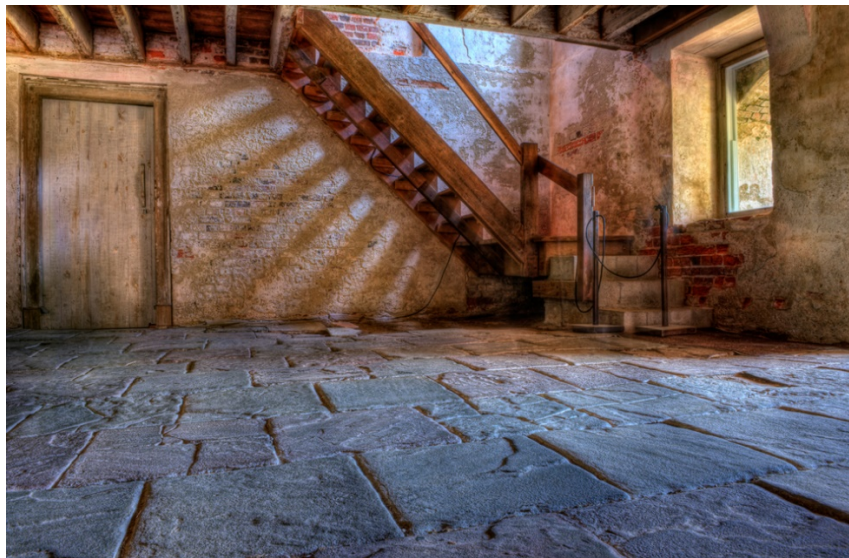
Figure 13: Basement of Drayton Hall with secondary staircase, photo by Tony

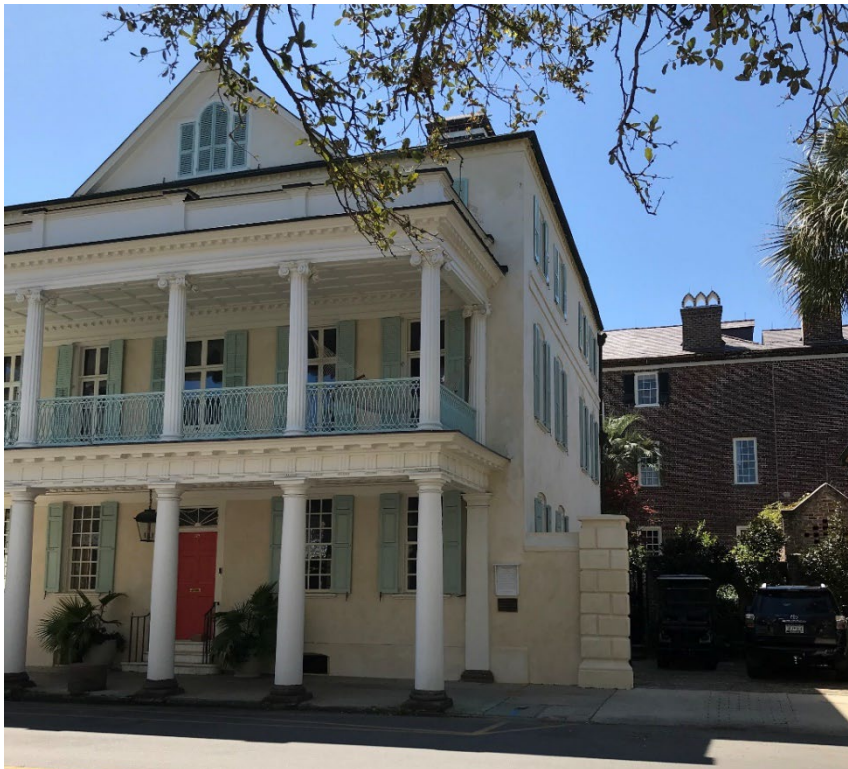
Figure 16: Bradford Horry north façade and side of east façade, photo by the author

The Bradford-Horry house, built in 1752, is an example of a three and a half story Georgian townhouse, also known as a “Double house”. Georgian style architecture includes rigid and symmetrical features. Georgian houses also contain Roman and Greek influence that can be noticed in the columns and cornices of the structure. More importantly, for the purpose of this thesis, is the Georgian form as opposed to the Georgian style. The Georgian plan includes no curvature, symmetrical windows and a five bay front façade. The dwelling has a double pile plan containing one large room and one smaller room on the second floor front, according to Jonathan Poston’s *The Buildings of Charleston*. The front elevation faces east and towards the street. The dwelling’s front and

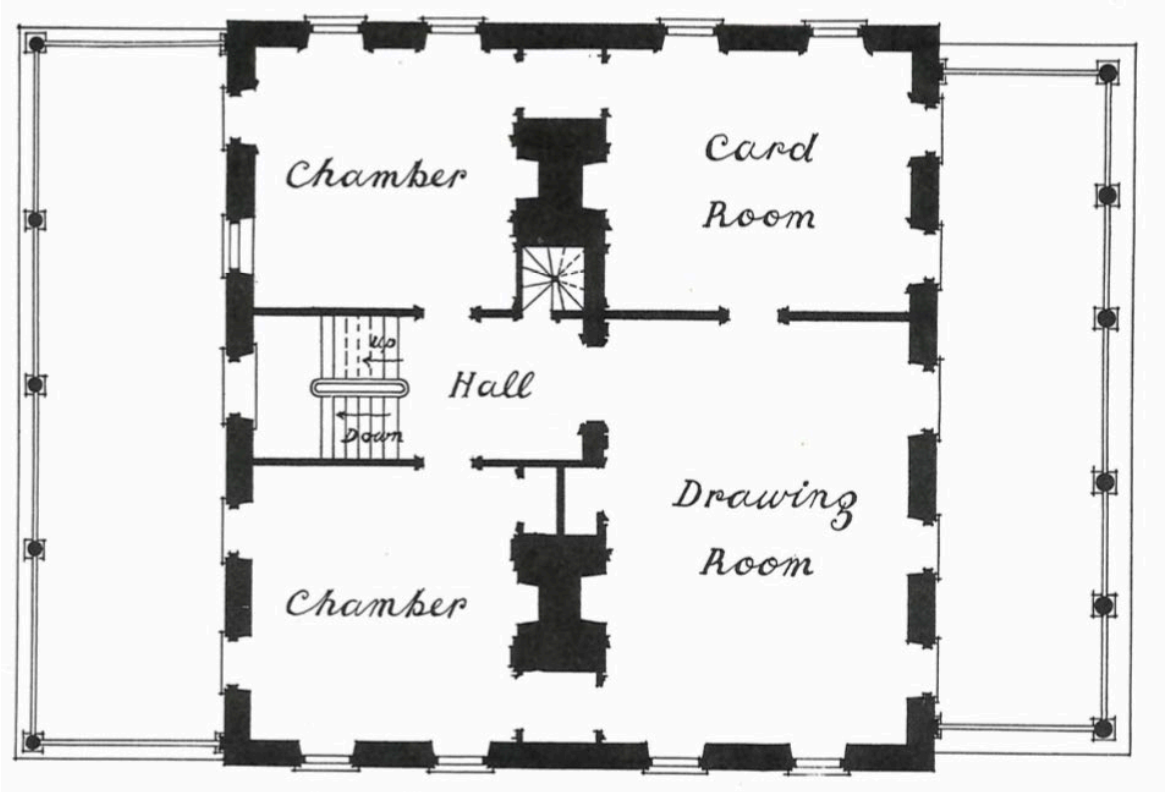
Figure 17: Second floor plan of the Bradford-Horry house, *Early Architecture of*

- Floors Reached: Primary stair reaches two stories and the secondary staircase reaches all three stories.
- Light (windows): For the primary staircase, a window located along the landing between the first and second floor. There are no windows lining the secondary staircase.
- Form: Georgian double house

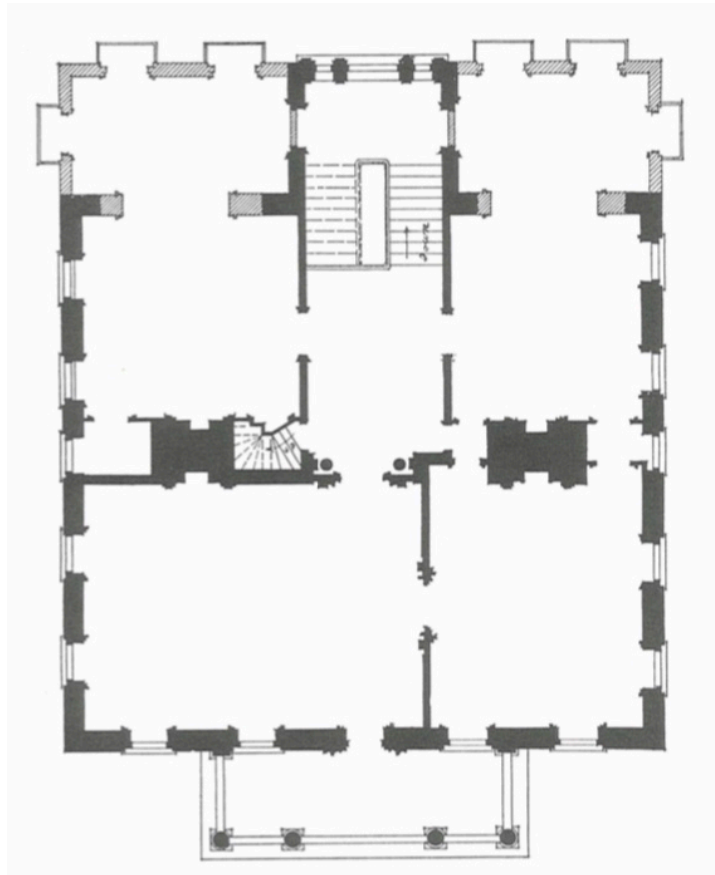
Figure 19: First floor plan of the Miles Brewton house, *Early Architecture of Charleston*

- Width: The width of the primary staircase is double the width of the secondary staircase.
- Tread Depth: The primary stair tread depth is more than double the size of the secondary stair tread depth.
- Floors Reached: The primary staircase goes from the first to second floor while the secondary staircase reaches all floors of the house.
- Light (windows): The primary staircase has three windows that line the landing between the first and second floor. The primary staircase does not have windows lining it.
- Form: Georgian double house

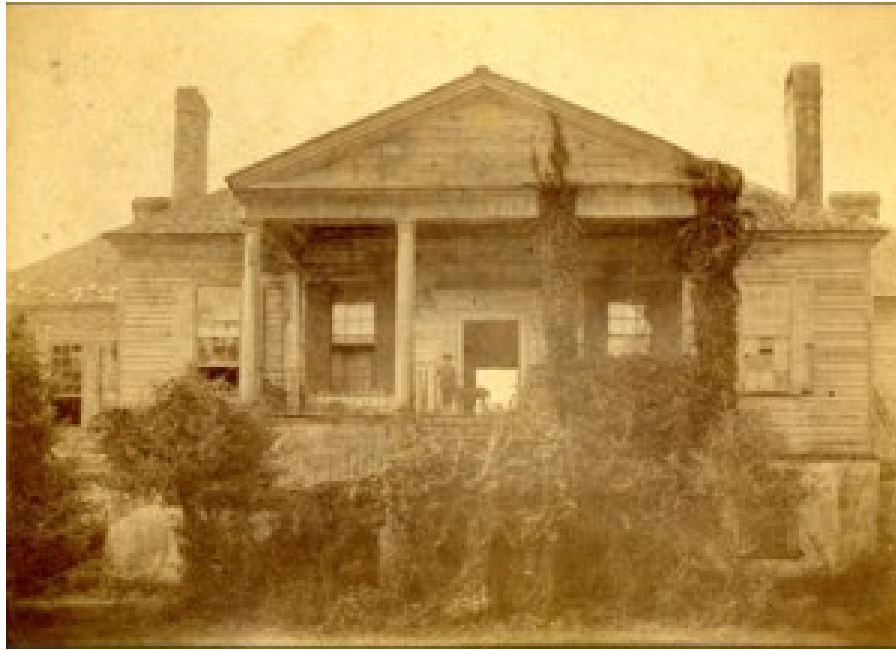
Figure 20: Only known photo of El Dorado before its destruction, Charleston Museum Archives

El Dorado was a plantation house built in the rural setting of Charleston County. The structure was built to be the home of Major General Thomas Pickney and his wife, Frances Motte Middleton. The structure was destroyed in a fire in 1897 and only exists in ruins at the time of this publication. The dwelling stood at just one and a half stories tall, consisting of a raised basement and a first floor only. Because the structure does not contain the same number of floors as the other structures and the form is unusual, it may not be considered a house with Georgian form, although there are Georgian features noticeable in the only photo of the house in existence. Georgian features include symmetry which can be found in the windows of the front façade and also in the symmetrical fireplace positions. The other feature that made the dwelling appear Georgian in its style is its columns which are commonly used in Georgian architecture. More importantly, for the purpose of this thesis, the unusual floor plan for El Dorado shows a central wing with two drawing rooms on either side with fireplaces located on the external wall. The central hall is flanked by two back sections that are identical. These sections mirror each other in the central placement of a fireplace and both contain staircases which are differing in their placement and configuration. Because this structure was very rural and no longer stands, it is not possible to determine the cardinal placement of the dwelling.

Because little literature exists on El Dorado and its architectural features, based upon the first floor plan it can be inferred that the primary staircase may have been located in the left most wing of the structure. This staircase is straight run and can be accessed from the front room of the side wing. It is possible that this staircase would have only accessed the basement of the structure.

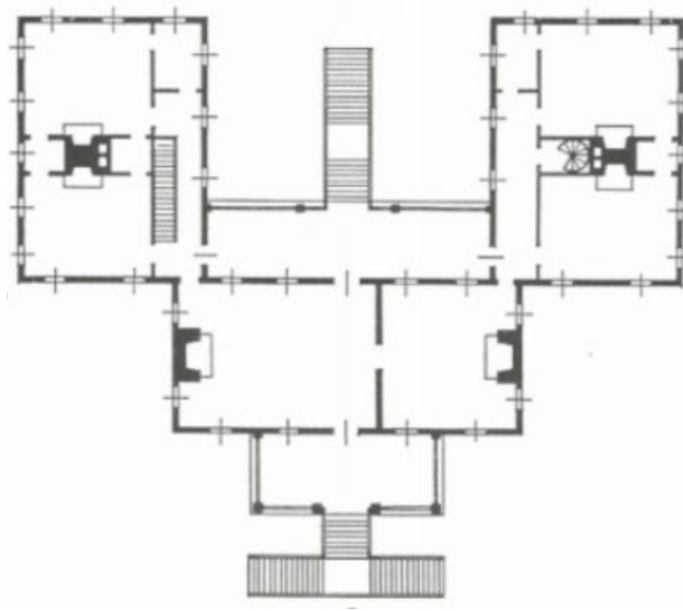
Figure 21: El Dorado Plantation first floor plan, *Charleston Architecture* page 262A

- Width: The width of the primary staircase is roughly the same width as the secondary staircase.
- Tread Depth: The primary staircase tread depth is double the tread depth of the secondary staircase.
- Floors Reached: The primary stair and secondary stair descended into the basement.
- Light (windows): The primary staircase had three windows lining it, while the secondary staircase had no windows lining it.
- Form: Possibly Georgian

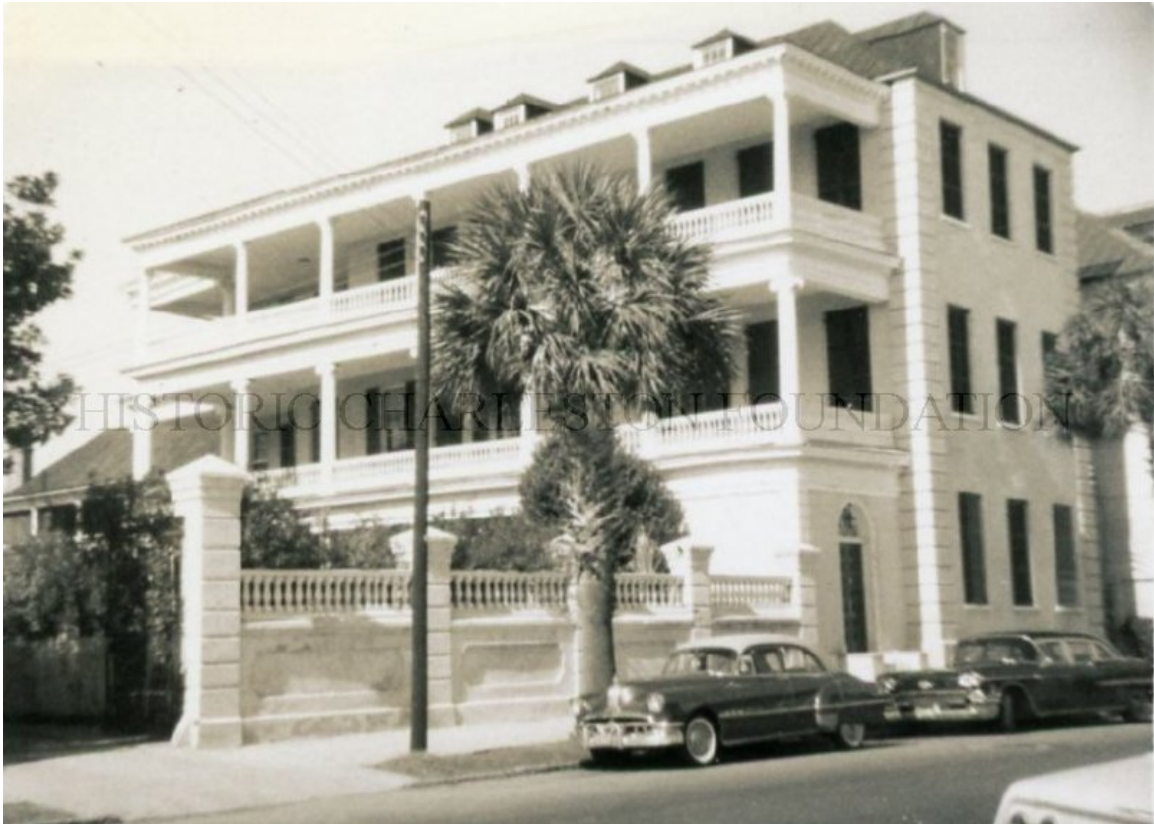
Figure 24: Casper Christian Schutt house circa 1940s, Historic Charleston Foundation

The Casper Christian Schutt house was built in 1802 as a large-scale single house. The structure is an urban townhouse that stands three stories tall with the front façade facing east towards the street. The east and south elevations maintain stucco while the north elevation is clad in original brick. The triple-tiered piazza has graduating orders of Doric, Ionic, and Corinthian columns. The dwelling is built in the Federal style, and aspects of this can be seen in the plaster freezes and cornices above the door architraves as well as in the curvature of the primary staircase.

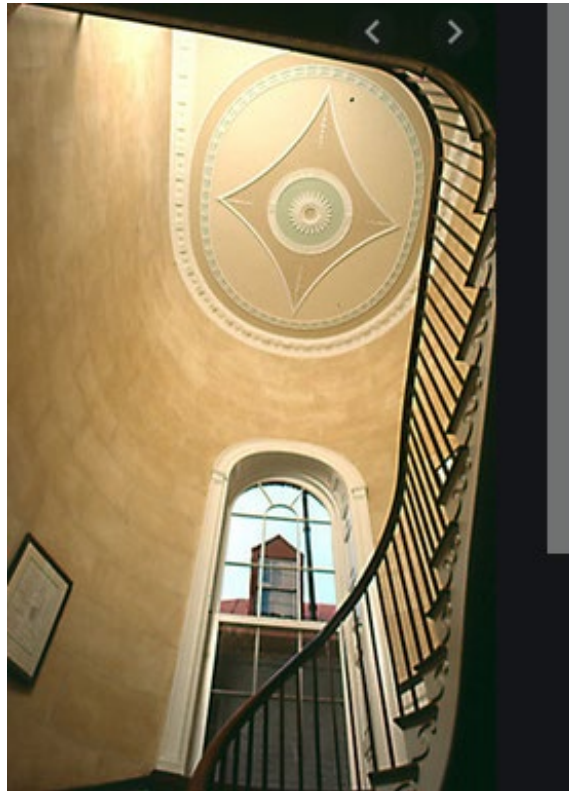
Figure 25: Primary staircase and plaster medallion of the Casper Christian Schutt house, photo by Glenn Keys Architects

The crown jewel of the Casper Christian Schutt house is the curved elliptical stair located in the north section of the dwelling. The staircase reaches three floors of the structure and is situated under a grand plaster ceiling.

single and double houses have 180-degree primary stairs, therefore this dwelling is a good example of the evolution of the sophistication of the character of the single house stair, as this highly decorative staircase appears to have replaced the typical 180-degree one.

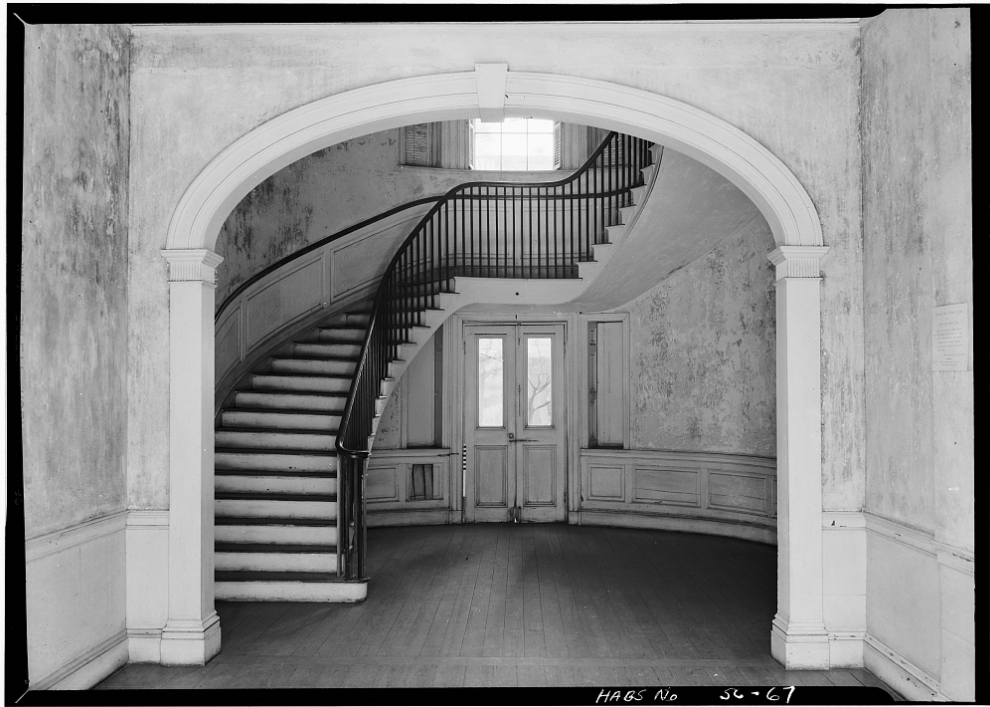
Figure 28: Joseph Manigault cantilevered staircase, HABS

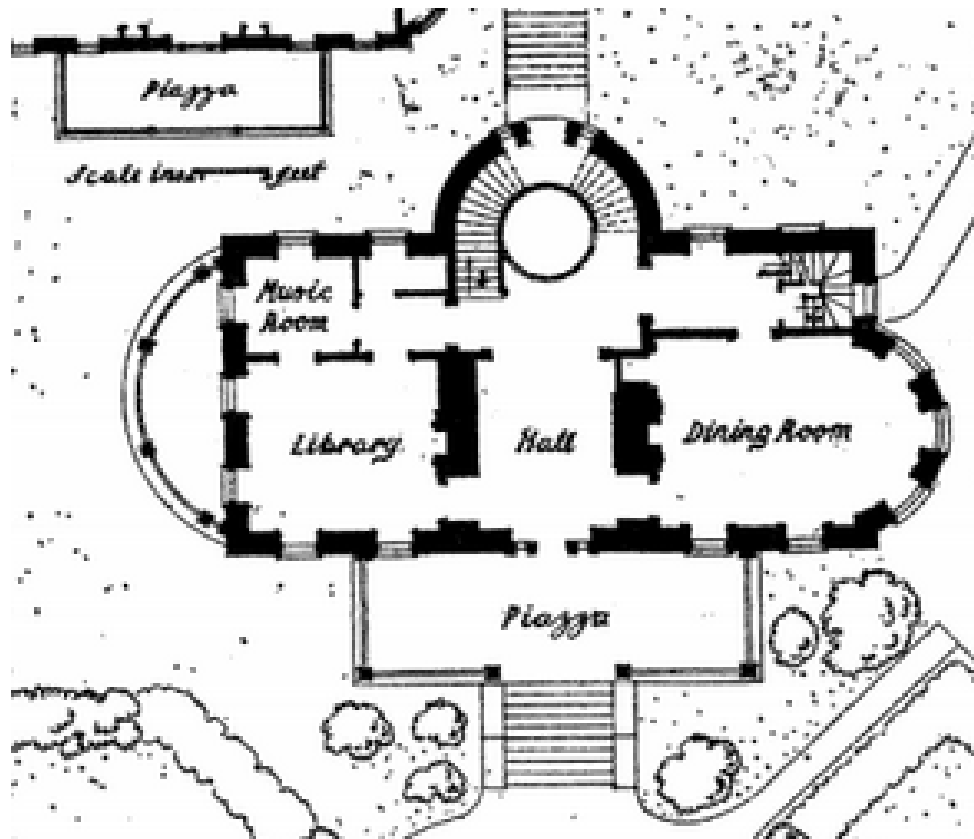
Figure 30: Joseph Manigault house first floor plan, *Charleston Architecture*

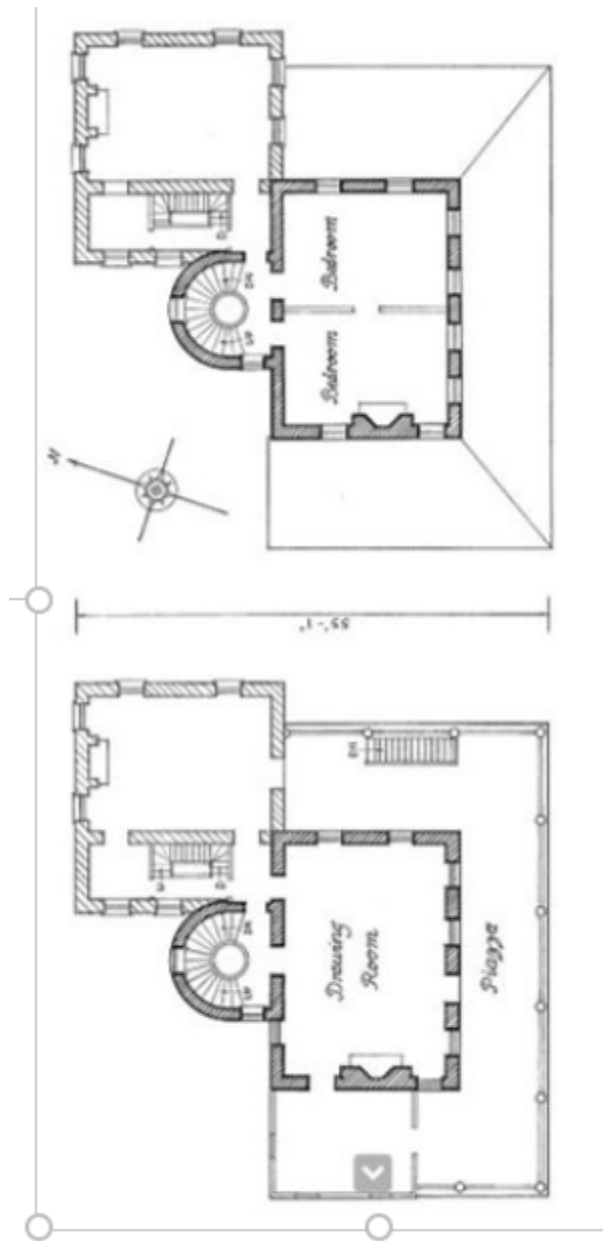
Figure 32: First and second floor plan of the Christopher Belser house, *Historic American Buildings Survey* (HABS)

- Width: The primary stair width is double the width of the secondary stair.
- Tread Depth: The tread depth of the primary stair is three times the tread depth of the secondary stair.
- Floors Reached: The primary staircase reaches from the first to second floor, and the secondary stair reaches all floors.
- Light (windows): The primary staircase has a large window lining it and the secondary staircase has one smaller window lining it.
- Form: Federal

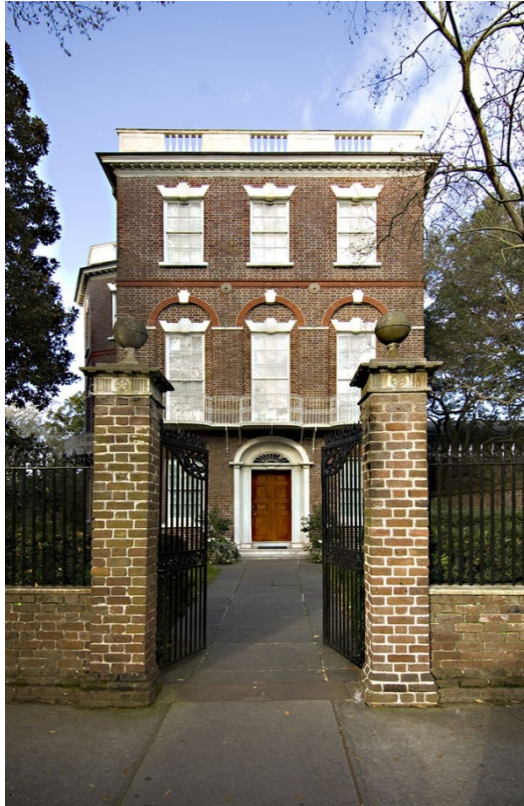
Figure 33 :Nathaniel Russel House, photo by Glen Keys Architects

The Nathaniel Russel house was built as the primary residence for wealthy Rhode Islander and merchant Nathaniel Russel in 1808. Standing at three stories tall and facing east, the Federal style structure is a rectangle in form with a projecting four-sided bay that rises all three stories of the structure. The most prominent Federal feature of the structure is the grandiose three story free flying staircase.

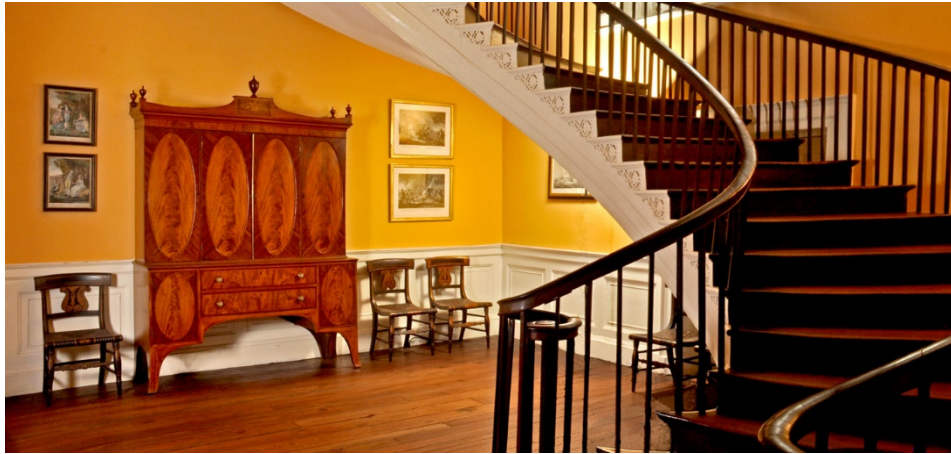
Figure 34: Primary staircase within the Nathaniel Russel dwelling, Historic

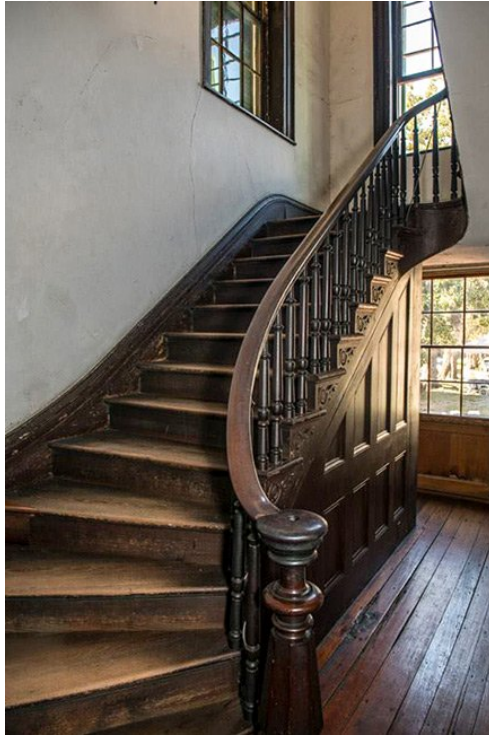
Figure 38: Aiken-Rhett dwelling secondary staircase, South Carolina Picture Project

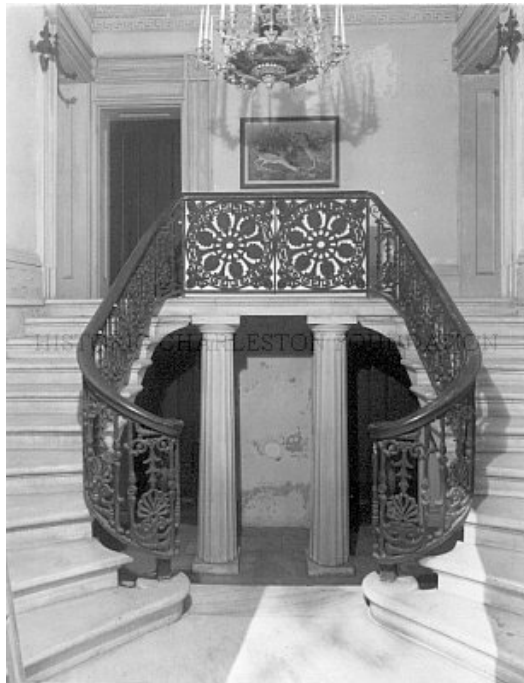
Figure 39: Aiken-Rhett house 1830's addition of entry staircase that reaches from first to second floor, HABS

reached 1.5 stories of the structure. The changes can be seen in the floor plan of the house below. It is certain that the secondary stair and the center marble stair are not original as their placement and configuration are not consistent with that of a typical configuration found in a single house. The additional marble staircase added on the west of the structure reaches from the modern entrance between the basement and first floors and reaches to the first floor only. More alterations to the structure were made in 1858 to construct an art gallery. The dwelling stands three stories tall and was originally built in the Federal style but was modified in 1836 to Greek revival style.

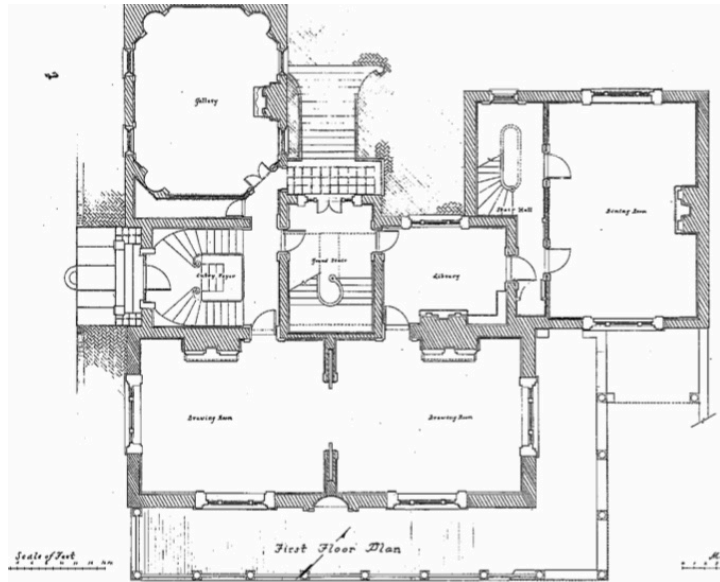
Figure 462A. Aiken-Rhett House; first floor plan (HABS SC 10-CHAR 177, sheet 3)

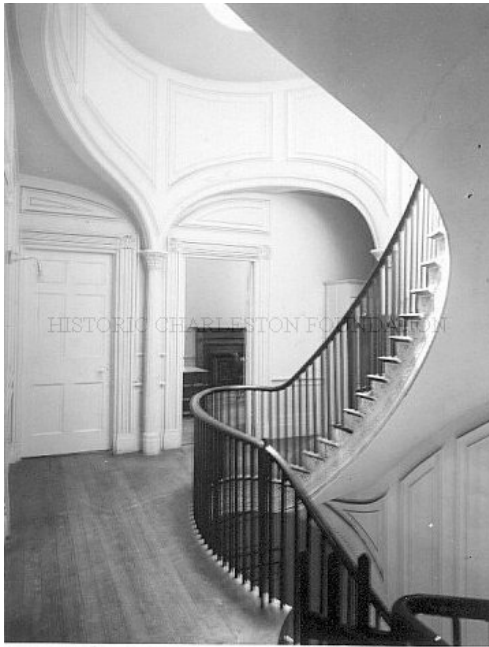
Figure 42: Primary Staircase of the Patrick Duncan house, Historic Charleston Foundation

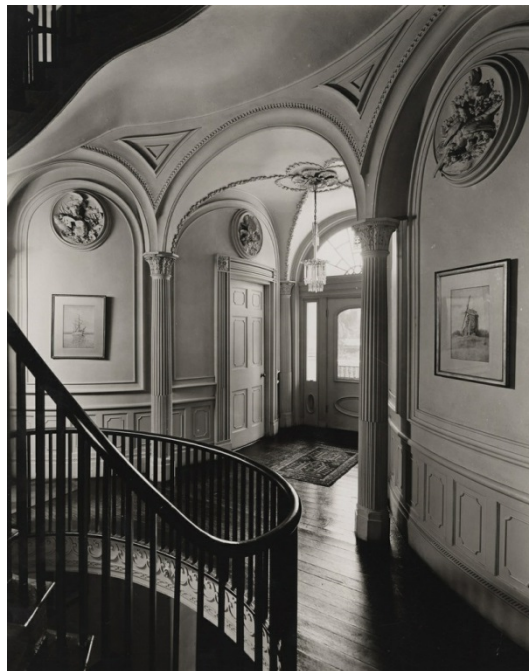
Figure 43: Second floor of the Patrick Duncan house, Historic Charleston Foundation

The primary staircase within the Patrick Duncan house is a three-story elliptical staircase. The elliptical configuration is very grand and visually pleasing, establishing a show of wealth for those who view it. Based upon the floor plan, it appears that many of the entertainment spaces were on the second floor, while the third floor was used as a more intimate space for bedrooms. The first floor may have been more utilitarian. The primary staircase is in the front entry way of the structure and is visible upon entry. The staircase is elaborated in the plan as well, as the decorative elements of the curvature of the balustrade is visible. The elaborate elliptical configuration and central placement establish that the builder of the dwelling wanted the staircase to be seen and admired.

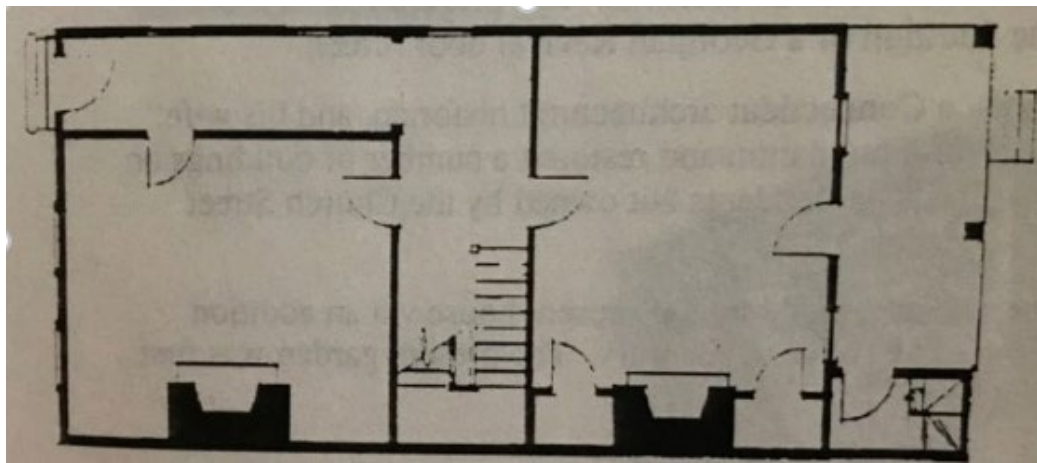
Figure 46: The Benjamin Philips house second floor plan, VAF guide page 155

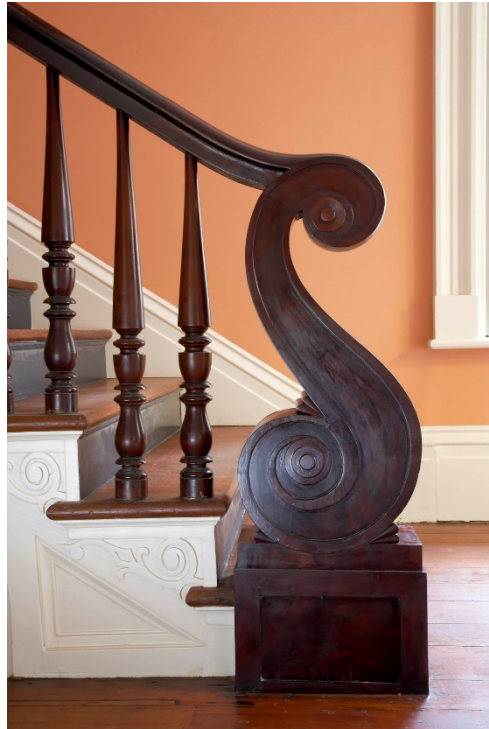
Figure 51: Detailing on the primary staircase within the Gatewood house, G.P. Schafer

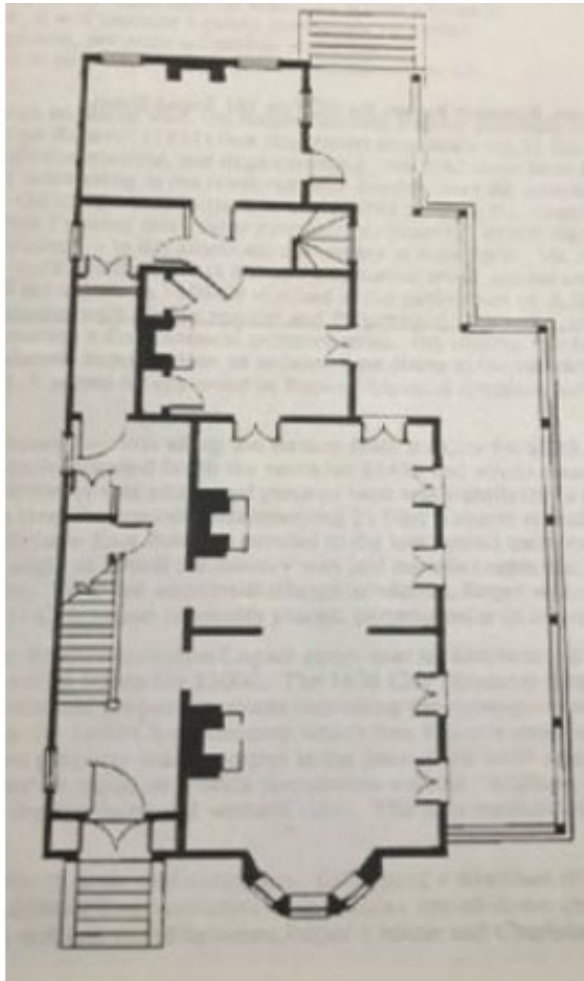
Figure 56: Edward G. Voight house first floor plan, VAF guide

- Width: The primary staircase width is double the width of the secondary staircase.
- Tread Depth: The primary stair tread depth is slightly more than double the depth of tread on the secondary staircase.
- Floors Reached: The primary staircase reaches the second floor from the first floor and the secondary staircase reaches all floors of the structure including the attic and the basement.
- Light (windows): There is one window lining the primary staircase and no windows lining the secondary staircase.
- Form: Single House

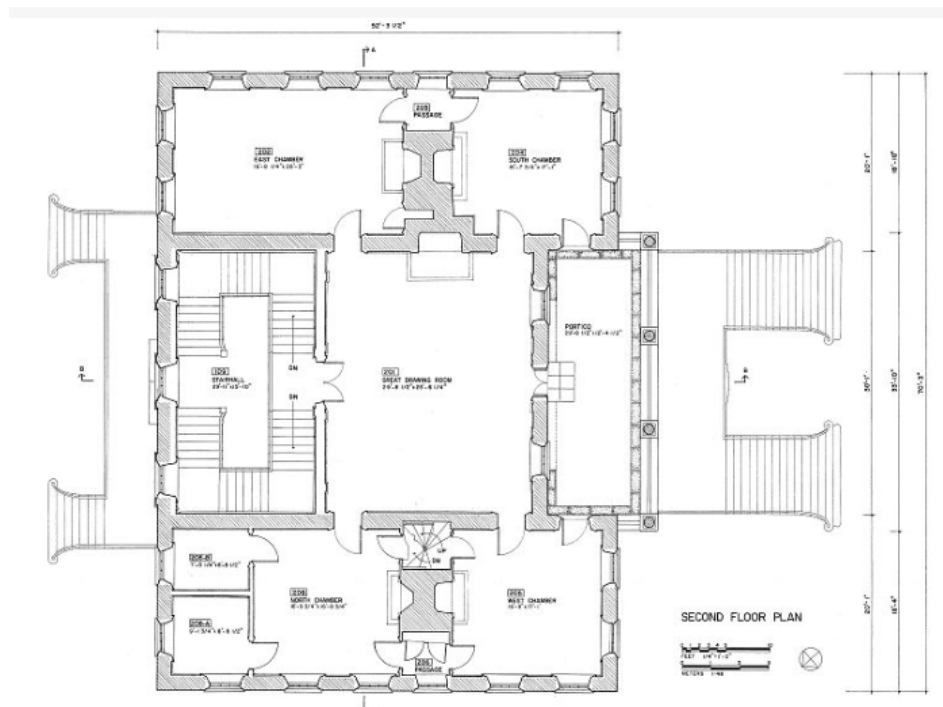
Below, the floor plans for Drayton Hall, Bradford-Horry house, Miles Brewton house, and El Dorado plantation show secondary staircases placed between a wall and fireplace.

Figure 57: Second floor plan of Drayton Hall, *Historic American Buildings Survey* (HABS)

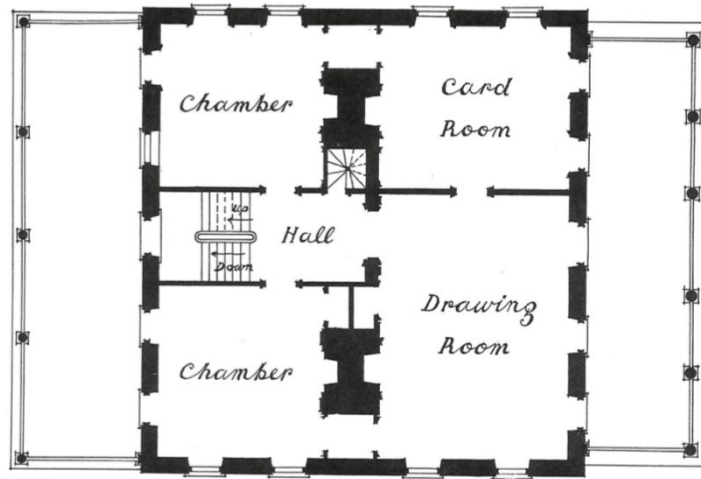
Figure 58: Second floor plan of the Bradford-Horry house, *Early Architecture of Charleston* page 52

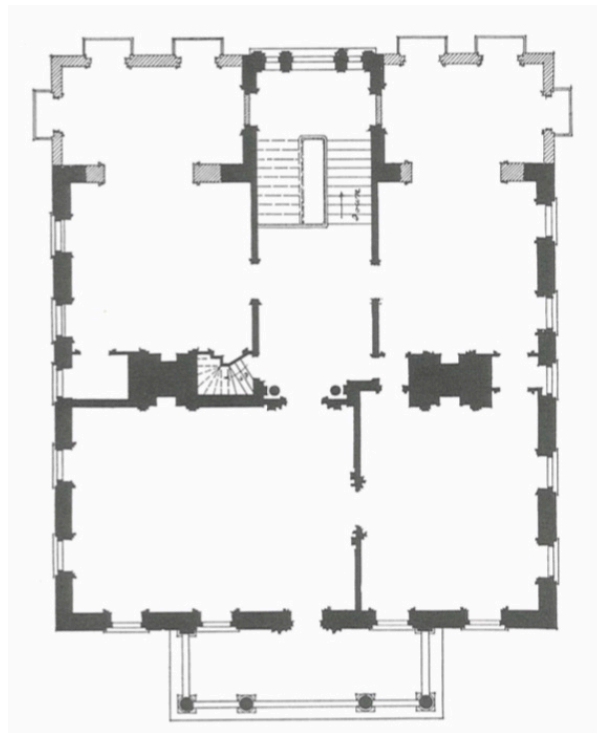
Figure 59: First floor plan of the Miles Brewton house, *Early Architecture of Charleston* page 51

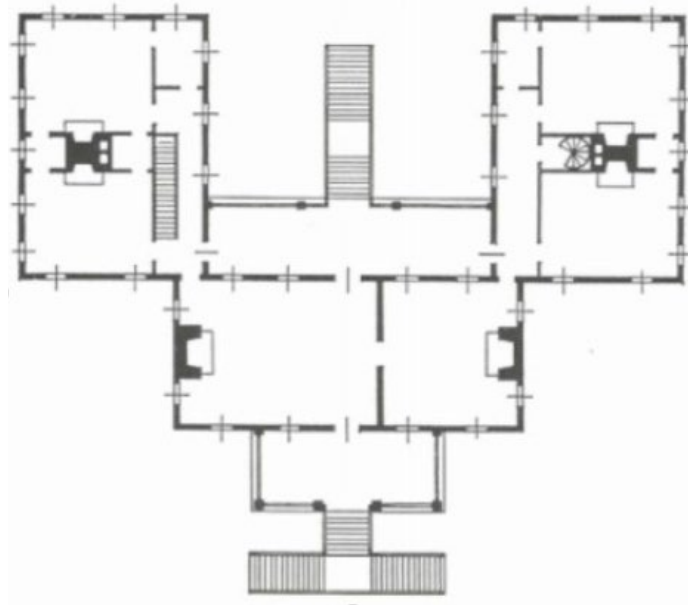
Figure 60: El Dorado Plantation first floor plan, *Charleston Architecture* page 262A
