AN ANALYSIS OF THE WINDOW REHABILITATION PROCESS TOWARDS ENERGY EFFICIENCY AT THE BAUHAUS DESSAU

A THESIS

MASTER OF SCIENCE IN HISTORIC PRESERVATION

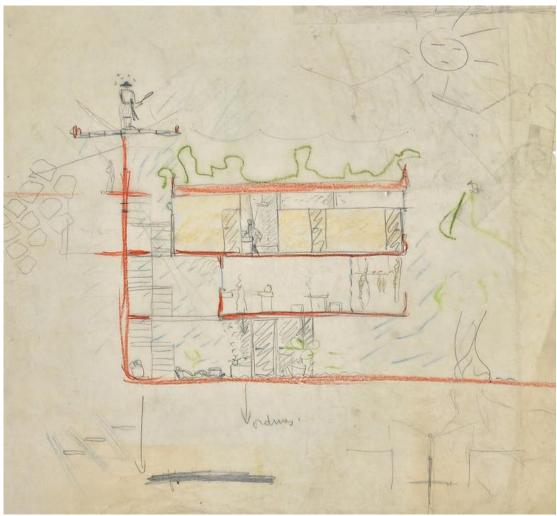
Figure 1. Le Corbusier, Lotissement concept drawing

Figure 1 shows Le Corbusier's sketch for the Barcelona *Lotissements*. His inclusions of the sun room and the roof vegetation are noteworthy, especially considering that he indicated the location of the sun with respect to the building in his drawing.¹¹ In his sketch in Figure 2 for *Immeuble Clarté* in Geneva, his considerations of climate conditions are clearer: He demonstrates the function of the brise-soleil by using a seasonal sun path diagram, including drawings for the different sun angles in winter and summer at the top right corner of the sketch.¹²

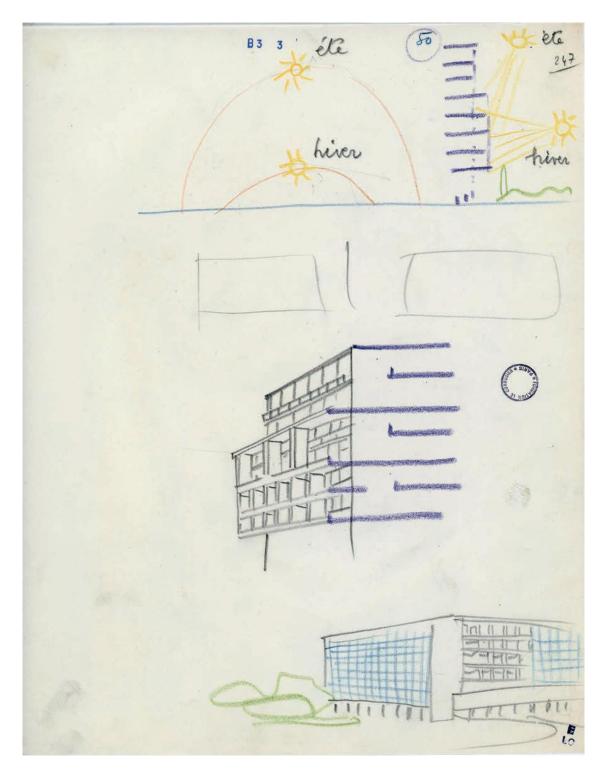
Figure 2. Le Corbusier, Immeuble Clarté sketch indicating the principles of relationship between the façade shading system (brise-soleil) and the seasonal path of the sun

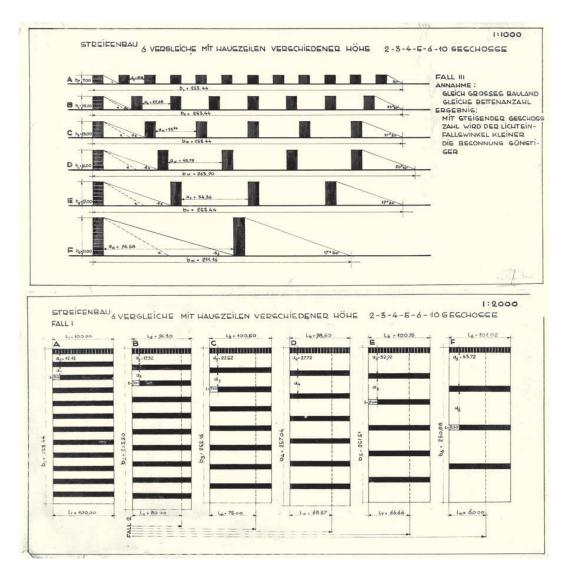
diagram that "the higher the number of floors [gets], the smaller the angle of incidence of the light [becomes]" and "sun exposure conditions become more advantageous".¹³

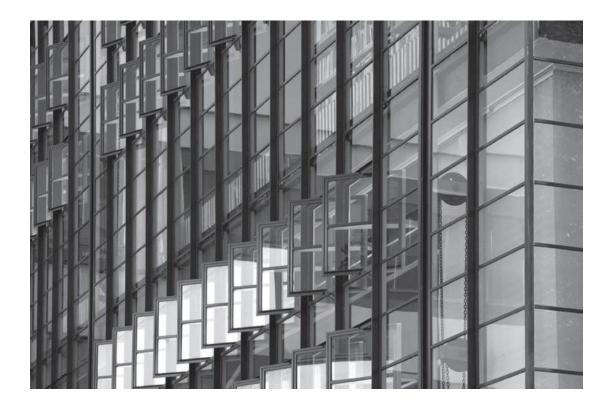
Figure 8. Part of the glass façade at the Workshop Wing photographed in 2006 (Bauhaus Dessau Foundation, Martin Brück 2006)

The 1976 reconstruction of the glass façade remains unchanged. Initially, the preservation architects considered the option of applying double glazing on the façade, but this was dismissed because the change in appearance and the loss of light reflectivity were intolerable for a listed character-defining element.

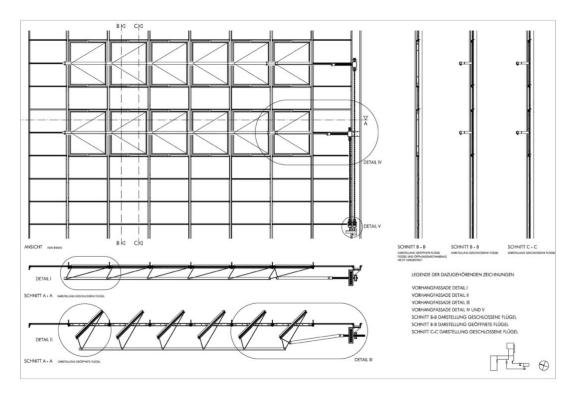
Figure 10. Reconstructed glass curtain wall

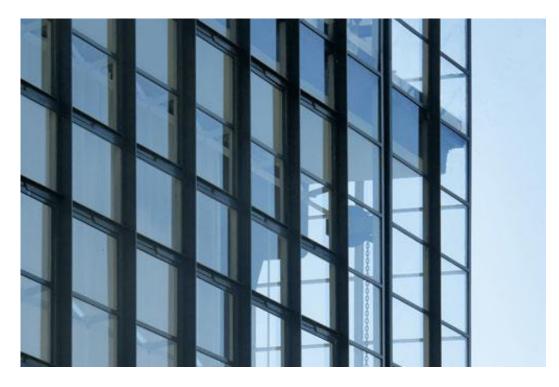
Figure 9. Reconstructed glass façade photographed in 2016

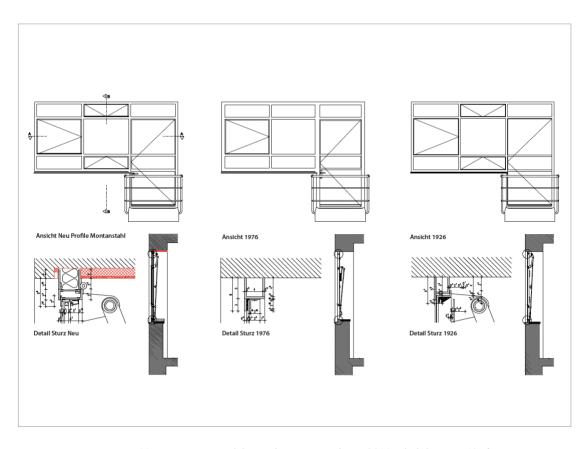
Figure 11. A comparison of the Studio Wing windows: 2011 rehabilitation, 1976 reconstruction and original construction in 1926

The renovations of the Studio Wing constitute a major part of the latest phase of interventions, which aimed to improve energy performance. As explained in the analysis of strategies, they were converted to their original operable state, allowing for natural ventilation, which decreased cooling loads. The most severe problem related to the energy performance of the Bauhaus Dessau was the excessive energy spent for heating the building, which is not surprising, considering the 24-hour usage of the dormitory.⁸⁷ The new double-glazing and the thermally-insulated hot-rolled steel frames were a significant solution that resulted in a reduction of 64% in the energy needed for heating.

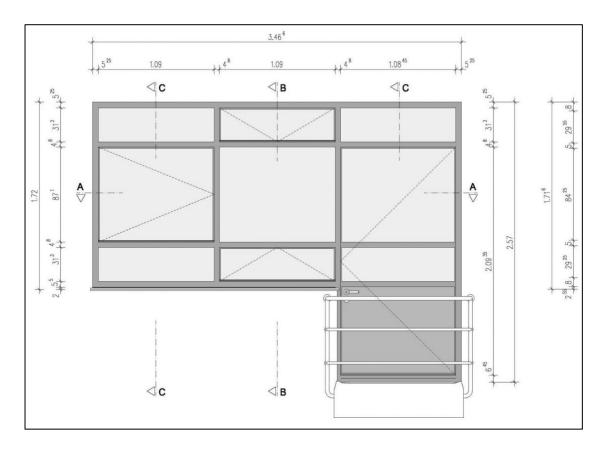
Figure 13. Operability of windows in the Studio Wing after 2011 renovations

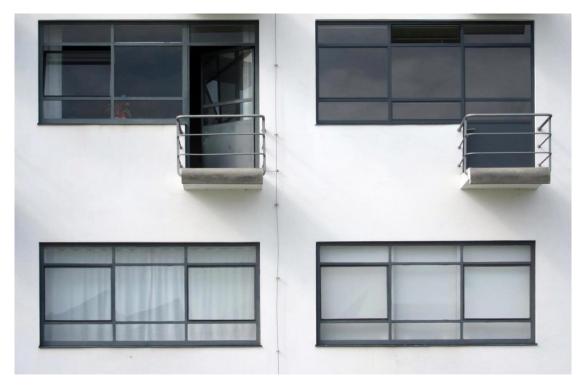
Figure 14. Studio Wing windows and balcony doors facing the east after the renovations in 2011

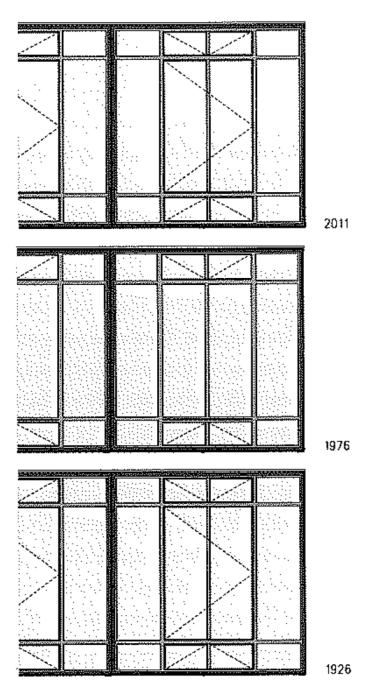
Figure 15. Changes in direction of operability of the North Wing windows. Note the fixed center windows in 1976, back in operable state in 2011.

(Brenne Architekten. 2012. Brenne Architekten, Berlin. Accessed 22 May 2021.) <u>https://www.brenne-architekten.de/bauhaus-dessau/</u> The North Wing window changes were the result of innovative thinking and a thorough market research process. The energy analyses showed a serious air infiltration issue throughout the North Wing façades. Therefore, after detailed calculations and modelling of thermal bridges, the preservation architects decided to use an insulating plaster on the steel frames as well as "electrical protection heating" on the exterior that consists of a copper strip.⁸⁸ The copper strips are not visible from the exterior and, along with the thermal breaks of the hot-rolled steel frames and double glazing, they generated a 58% reduction in the heating energy of the North Wing. Additionally, this provides an "optimized level of comfort in winter."⁸⁹ A summary of changes on the North Wing windows is given below in Table 6. Detail drawings of the North Wing windows and their modifications can be found in Figures 15 through 17 below.

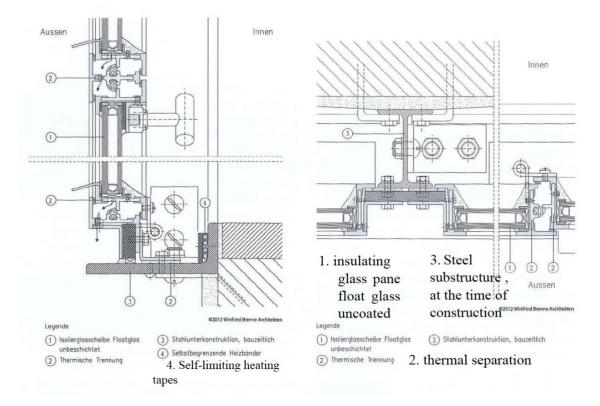
Figure 17. North Wing windows on the north façade, vertical and horizontal sections, respectively

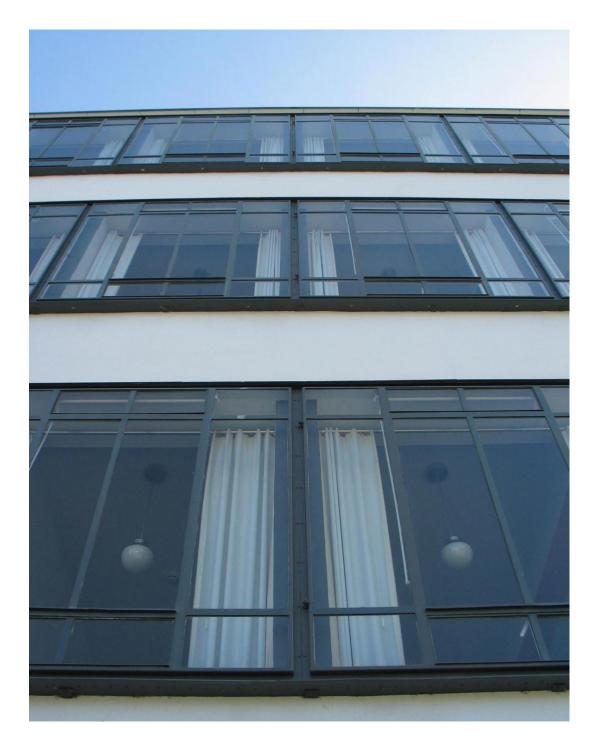
Figure 18. Window profiles of the North Wing

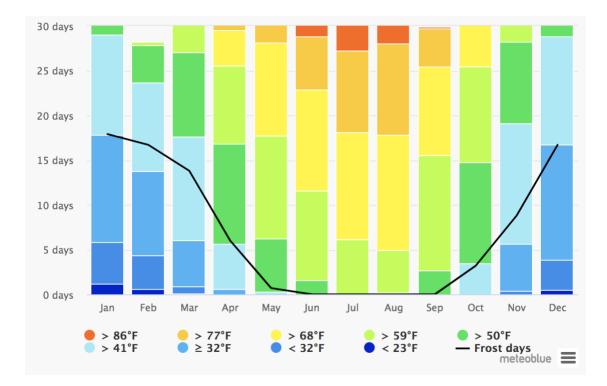
Figure 25. Maximum temperatures in Dessau – Roßlau

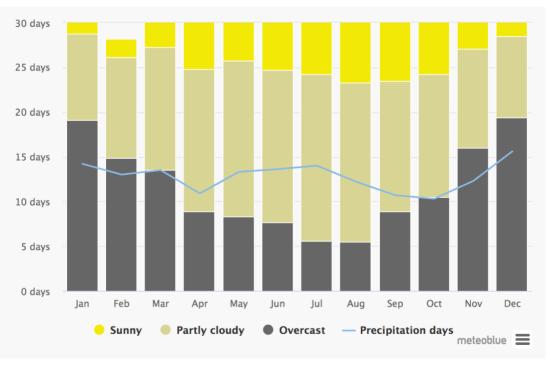
Figure 26. Cold, sunny and precipitation days in Dessau – Roßlau

Another essential aspect of the climate conditions is the number of sunny days in the area. The number of sunny days is highest during July and August, with an average of 6.8 sunny days in July and 7.7 sunny days in August, corresponding with the highest daily average temperature data.

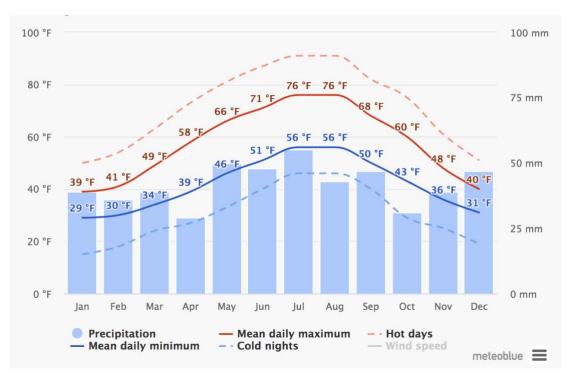
Figure 27. Average temperatures and precipitation in Dessau – Roßlau

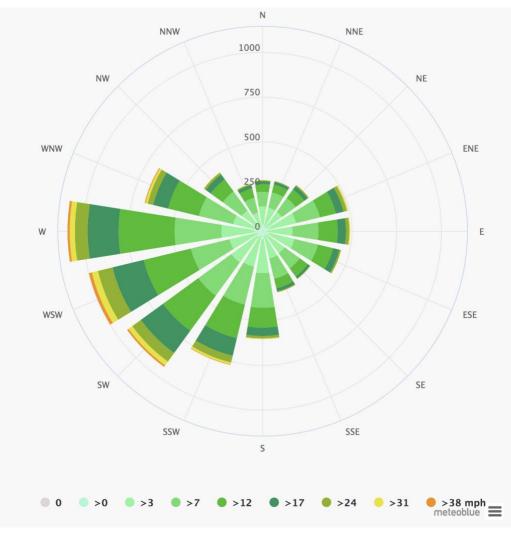
Figure 29. Wind rose for Dessau – Roßlau

As mentioned above, the dominant winds in the area come from the West, the West-Southwest and the Southwest. The humid winds are of larger force scale in these directions.³⁷ Noting the wind patterns of the area is important, considering the positioning of the glass curtain wall of the Studio Wing, which has operable windows facing the Southwest direction.

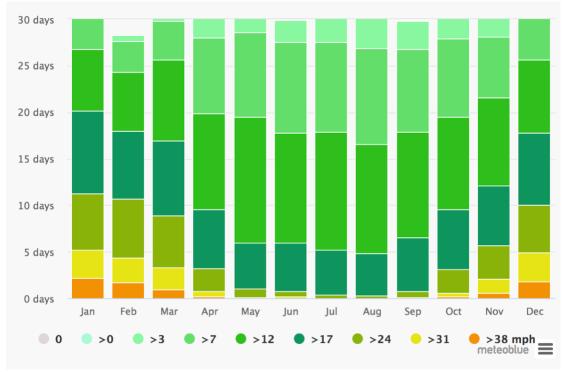
Figure 30. Monthly wind speed in Dessau – Roßlau

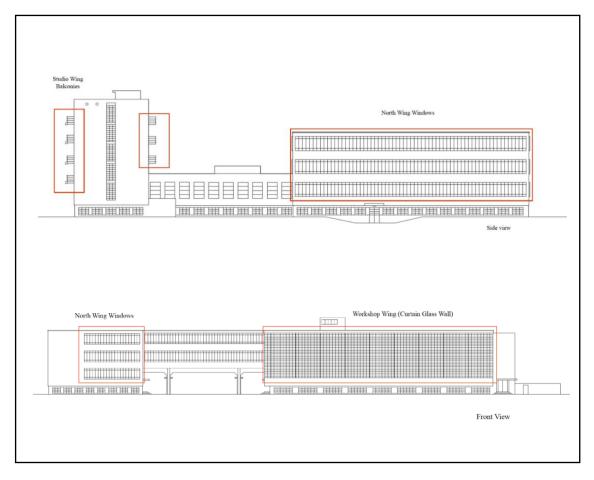
Figure 31. Side and front view elevations indicating locations of Studio Wing balconies and North Wing windows

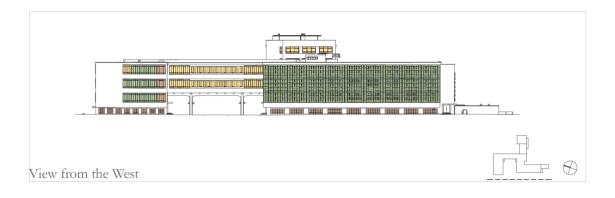
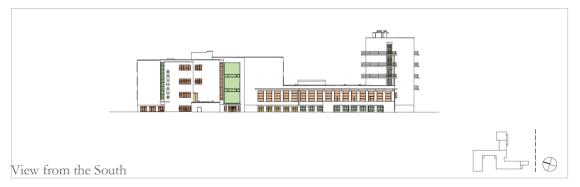
Figure 32. West and South views showing the coexistence of original windows from 1926 (red) with 1976 reconstructions (green) and 2006 reconstructions (yellow)

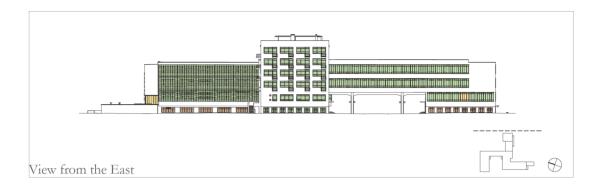
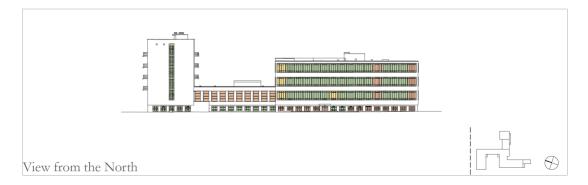
Figure 33. East and North views showing the coexistence of original windows from 1926 (red), 1976 reconstructions (green) and 2006 reconstructions (yellow)

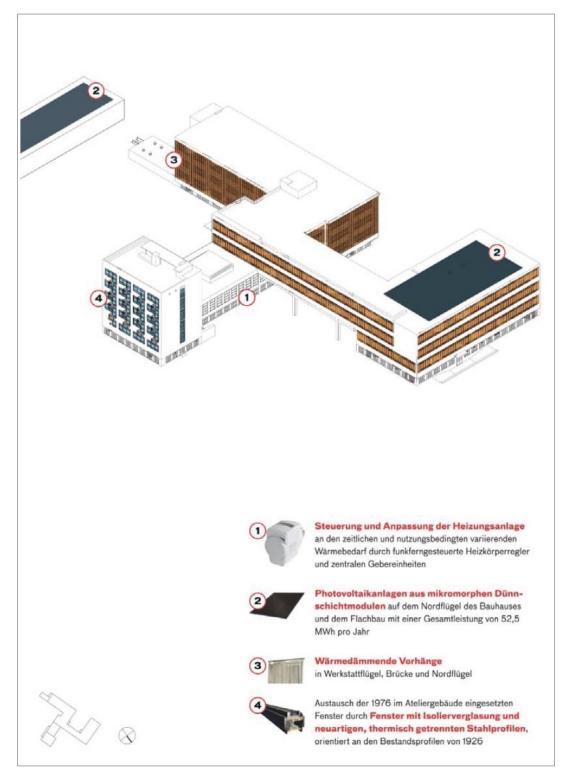
Figure 34. Energy efficiency improvement measures throughout the building Bauhaus Dessau Foundation, Petra Natho 2006, Yvonne Tenschert 2011

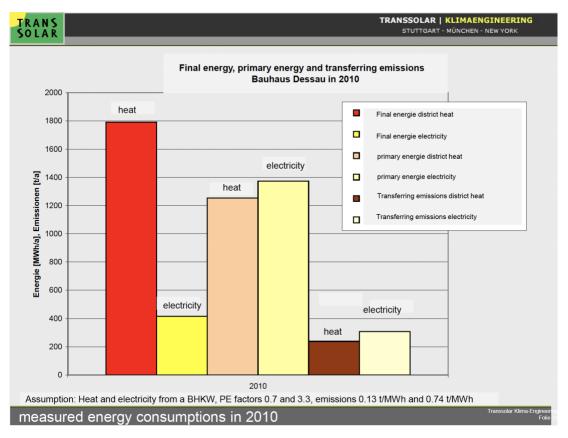
Figure 35. Energy consumption measurements at the Bauhaus Dessau, 2010

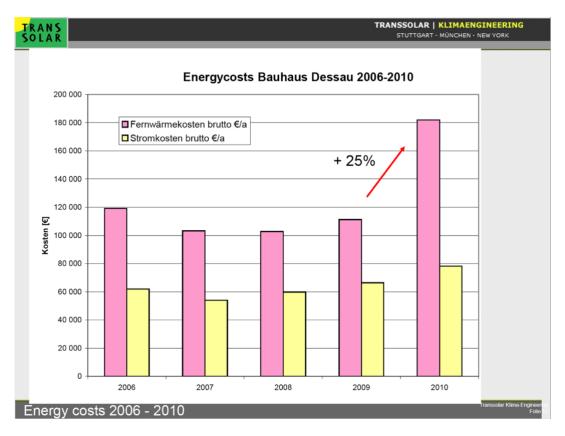
Figure 36. Energy costs of the building between 2006 – 2010

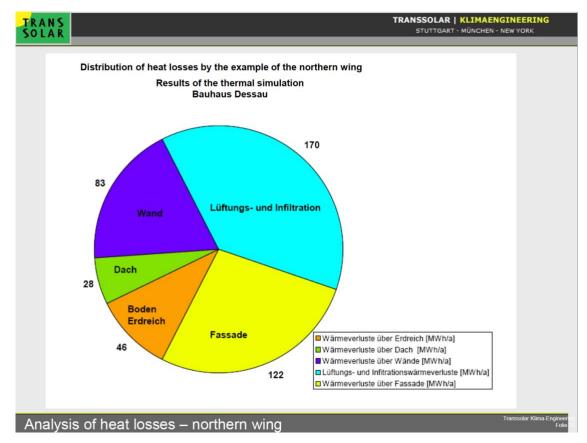
Figure 37. Results of heat loss analyses at the North Wing

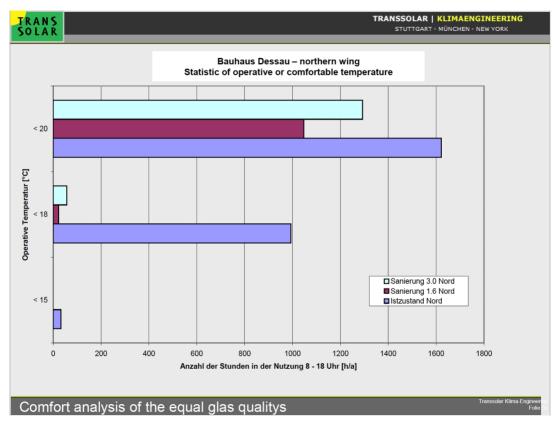
Figure 38. Thermal comfort analysis at the North Wing

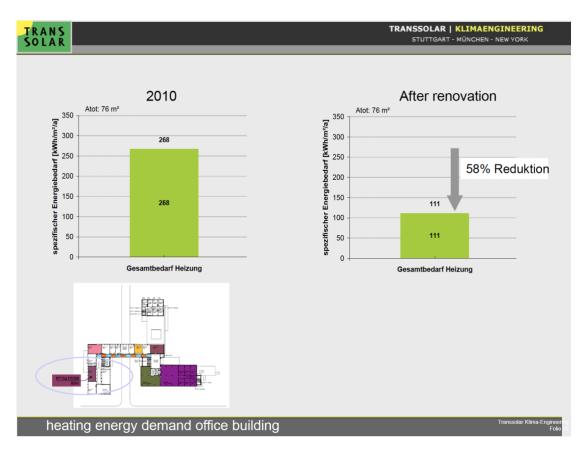
Figure 40. The demand for heating energy at the North Wing before and after the renovations

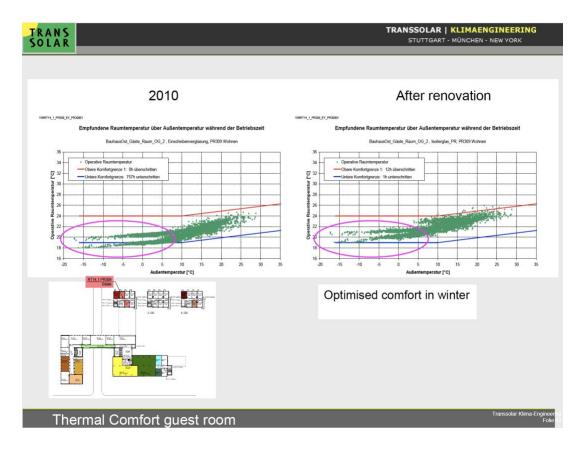
Figure 41. Thermal comfort analysis of the Studio Wing dorm rooms before and after the renovations

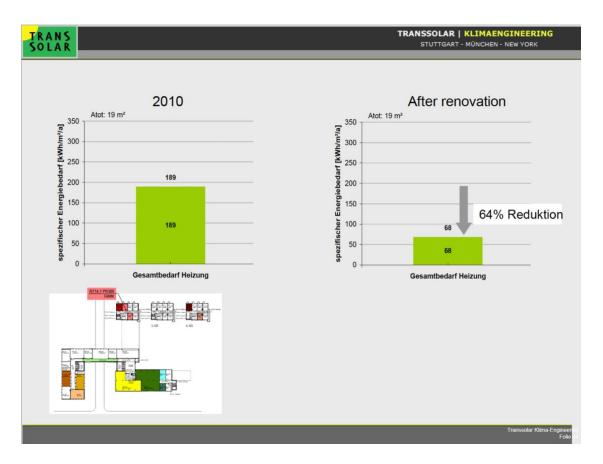
Figure 42. The demand for heating energy at the Studio Wing before and after the renovations
