# **Hydrogen Embrittlement in the overaged aluminium alloy 7040- T7651**

A dissertation submitted to the University of Manchester for the degree of

Master of Science by Research

**2020**

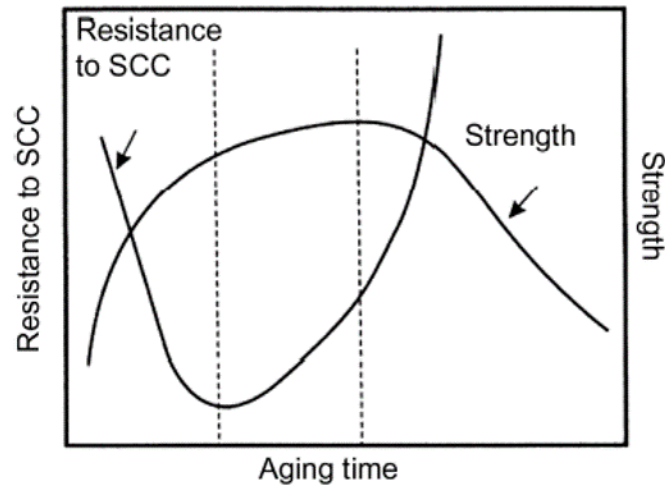
**Figure 2-3.** Relationship between ageing times and resistance to stress corrosion cracking in aluminium alloys (Speidel, 1975) [19]

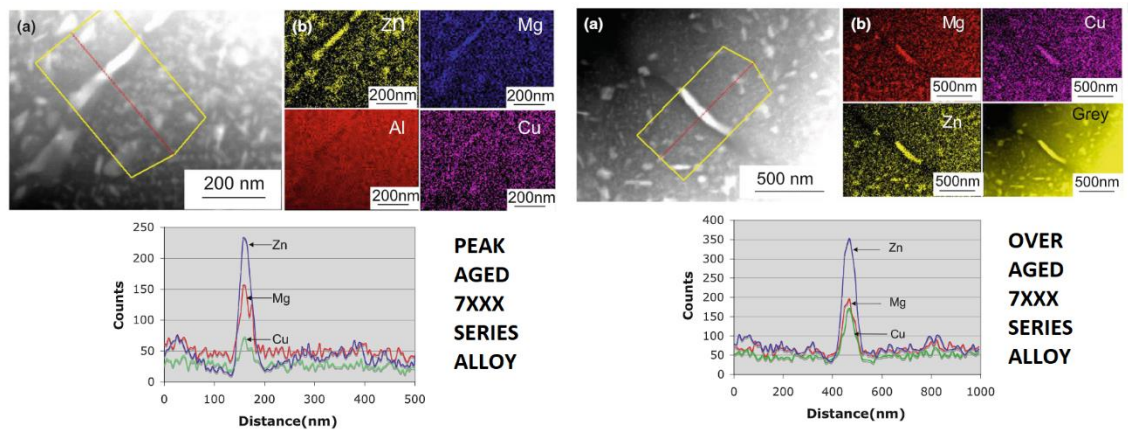
**Figure 2-6.** Grain boundary precipitates composition in a 7xxx series alloy i) in the left, composition of GBP in a peak-aged alloy with Cu counts below 100; ii) on the right, the composition of an over-aged alloy, where copper counts increase up to 190 counts approx., the changes in precipitates size and spacing is also appreciable. [39]

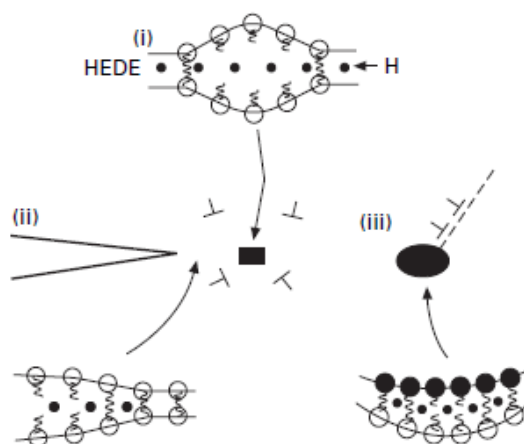
**Figure 2-9.** Illustration of HEDE mechanism where interatomic bonds are weakened by i) hydrogen lattice ii) adsorbed hydrogen iii) hydrogen at particle-matrix interfaces.

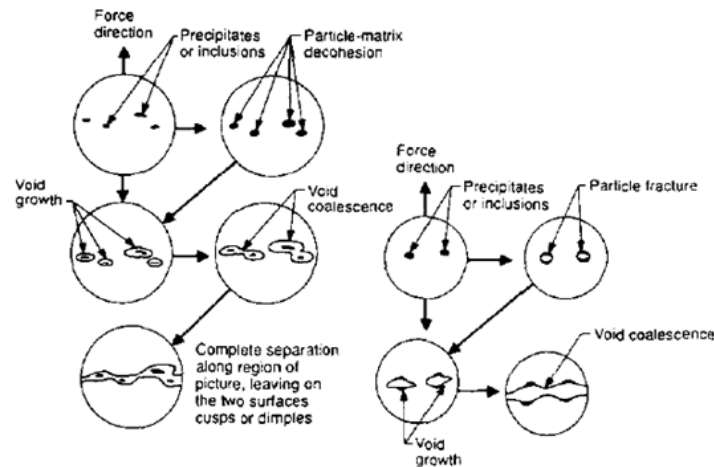
**Figure 2-18.** Illustration of formation of voids and posterior coalescence due to precipitates by i) particle-matrix decohesion (on the left) and ii) particle cracking (on the right) [68]

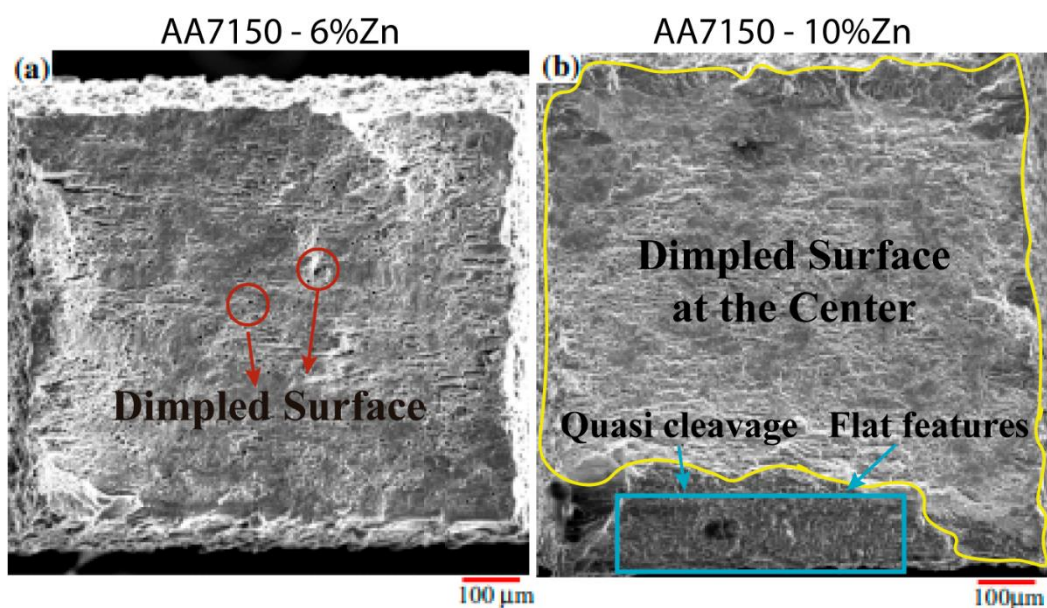
**Figure 2-21.** Hydrogen-induced 7150 aluminium alloy fracture surface at a) 6% and b) 10% Zn content. [73]

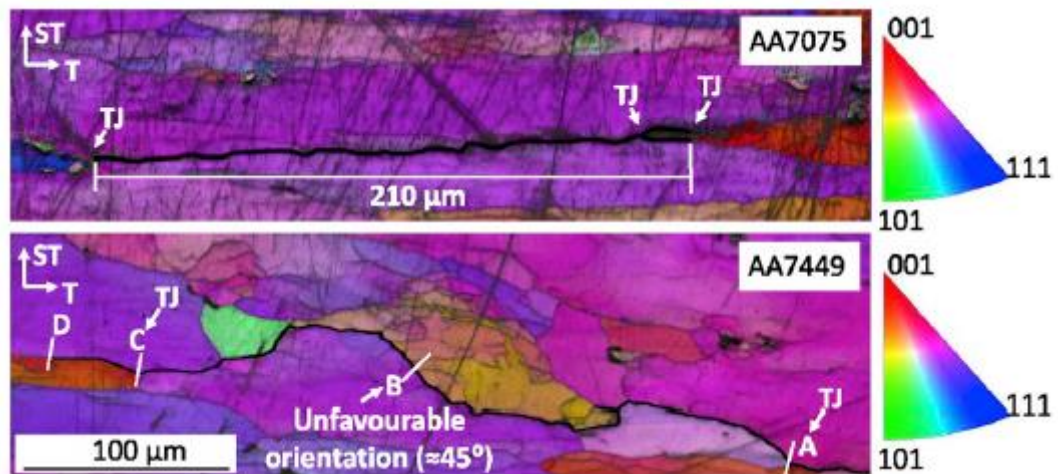
**Figure 2-23.** EBSD showing similar crack lengths were a) for the AA7075 the crack grows along the grain boundary and is arrested at a triple junction and b) crack in AA7449 keeps growing despite obstacles [74]

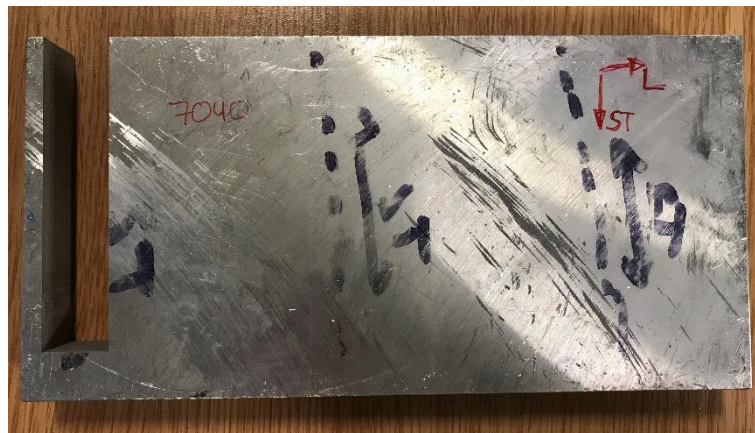
**Figure 4-1.** Blocks of the as-received wrought commercial alloy AA7040-T7651

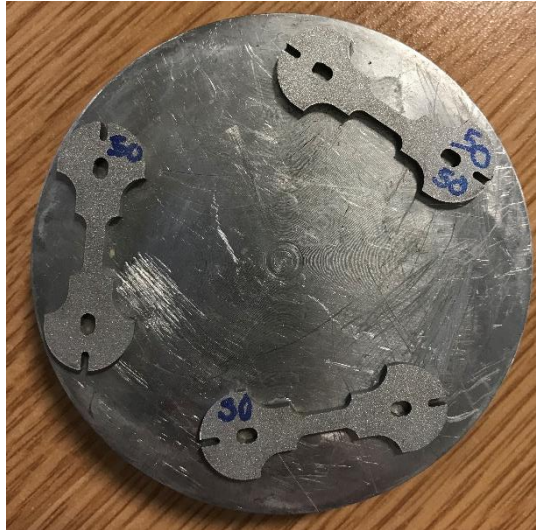
**Figure 4.4.** Samples stuck to a polishing wheel; this method ensures that all samples mounted will have a similar thickness for posterior analysis.

Samples used for obtaining the as-received mechanical properties of the material were used after cutting without further surface preparation. On the other hand, all samples employed in interrupted tensile tests were stuck in a polishing wheel, as displayed in figure 4-4; next, grinding started using silicon carbide paper *P600* followed by *P800*, *P1200* and *P2400* respectively using a rotating grinding machine set at *150 RPM*, ethanol was used instead of water as a lubricant. Subsequently, the polishing process was achieved with oil-based monocrystalline diamond suspensions beginning at *3 μm* and followed by *1 μm*, and  $\frac{1}{4} \mu\text{m}$  respectively that were applied to polishing cloths in rotating machines at *150 RPM*. Afterwards, OPS was diluted in distilled water (1:4 ratio) using OPS polishing cloths at *60 RPMs* for *10 min*, as it was critical to diminish specimens contact with water. It is essential to point out that in-between-steps, samples were cleaned using only ultrasonic baths with ethanol to avoid water contact. Finally, samples were removed from the wheel using ethanol ultrasonic baths at *40 degrees* and blow-dried immediately afterwards. Prepared samples were stored at a desiccator filled with silica gel at all times and samples transportation was realized in SEM boxes with silica gel to keep any possible exposition of the specimens to contamination and hydrogen intake to a minimum.

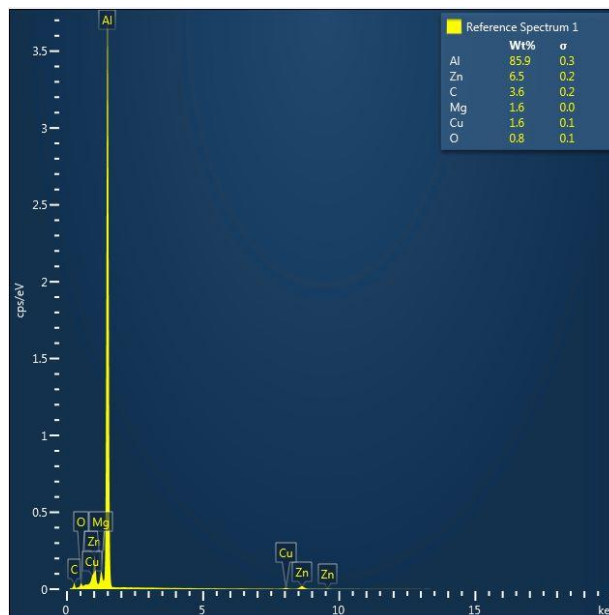
**Figure 4-8.** EDS chemical composition results for the commercial AA7040-T7651 in T/2.

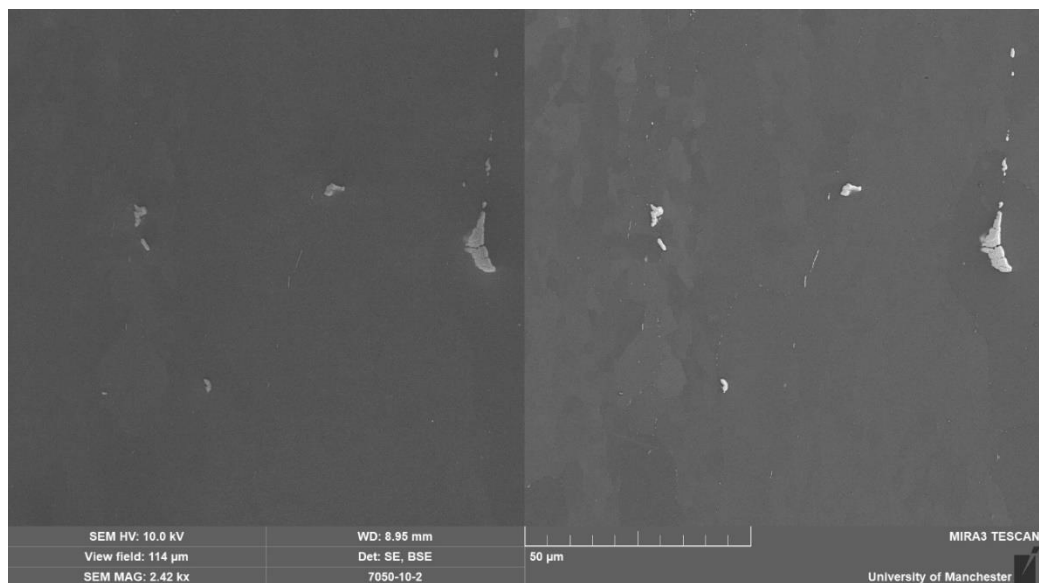
**Figure 6-7.** BSE-SEM image of sample 3 after polishing, and before tensile testing at high humidity. After this step, the surface is smooth, with no apparent corrosion products on the surface.

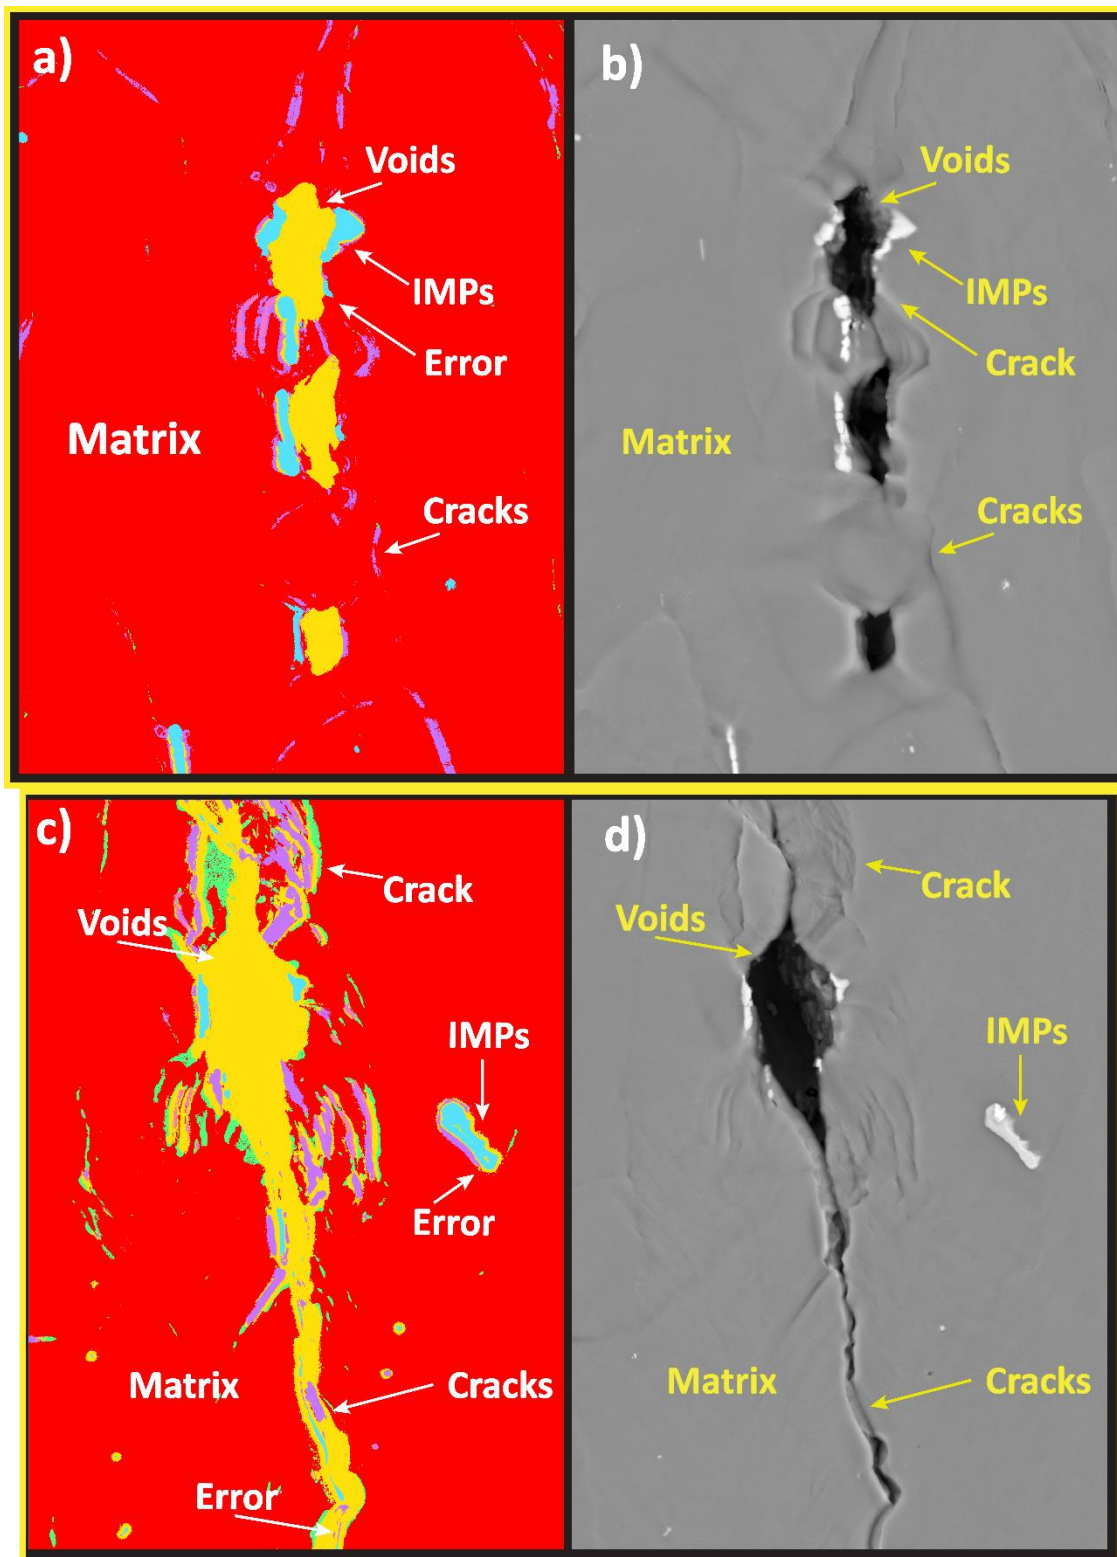
**Figure 6-9.** Segmentation illustration showing a detailed segmentation of microstructural features for sample 5 AA7040-T7651, the segmented image may be found in the left with the original BSE-SEM image on the right. In a) voids are correctly identified however the errors include particle/matrix interfaces and voids edges, and for b) voids in cracks look thicker than usual, in total error is lower than 4%.
