Multiscale Integral Assessment of Habitability in the Case of El Raval in Barcelona

Abstract: The understanding of habitability conditions of existing housing stock plays a central role in the quantification and qualification of sustainability from the architectural field. This research assessed habitability as a fundamental social benefit by means of a multiscale approach to the case study of the Raval neighborhood that can be replicated in other settings. We described a sample of six hundred dwellings located in two urban blocks spatially and typologically. This analysis of architectural features incorporated information on the current occupancy and use of spaces and the assessment of the state of conservation and maintenance of building envelopes and common elements. Although the scale of most analyzed aspects was larger (building, urban block or urban fabric), the discussion of results by housing unit provided a close picture of the existing diversity and heterogeneity of socio-spatial and architectural realities within buildings and urban blocks. Results from this paper allow for the valuation and discussion of substandard housing cases that call for an immediate improvement

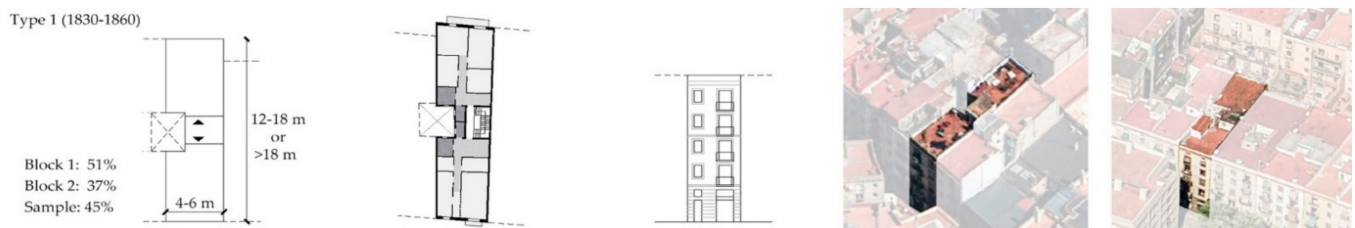
Figure 2. Workers' rental housing with two dwellings per landing.

Figures 2–9 display a typological characterization of buildings in the sample based on bibliographical information [92,93,98,116–118], the Cadaster and ICGC [35,111], municipal archives [112,113], and fieldwork. Although the sample includes a wide range of typologies, this selection is not intentional or statistically representative. Rather, they are included in the sample simply because of their location in the two city blocks analyzed. From left to right, Figures 2–9 present a generic urban plan [35,111], an example of a typical floorplan and façade (Drawings by S. Vima-Grau, redrawn from archival and bibliographic research during work on her PhD dissertation [64]) and two pictures of examples of each building type (Picture modified by S. Vima-Grau. Source: Bing Maps [114]).

As can be seen in Figures 2–9, many buildings from the sample were built as workers' rental housing around 1860, particularly in block 1. Block 2 is located in one of the first areas of the Raval to be urbanized; as a result, there is a much wider range of building types—this makes our sample much more diverse. Some were built before 1830, others were built as workers' rental housing from around 1860, and others are bourgeois rental buildings from after 1890. Type 1 (workers' housing with narrow façades and two apartments per landing) (Figure 2) is the most common in the sample and in both blocks—particularly block 1, where it constitutes over 50% of all dwellings. The next most common type (making up less than 15% of residences) is the bourgeois rental building with an ample façade (Figure 6), a precedent of Barcelona's Eixample neighborhood [104,118]. Finally, we find a considerable

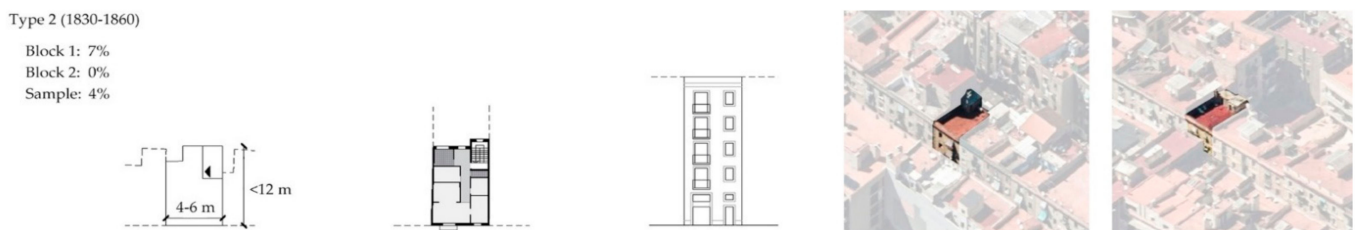
Figure 3. Workers' rental housing with one dwelling with two façades per landing.

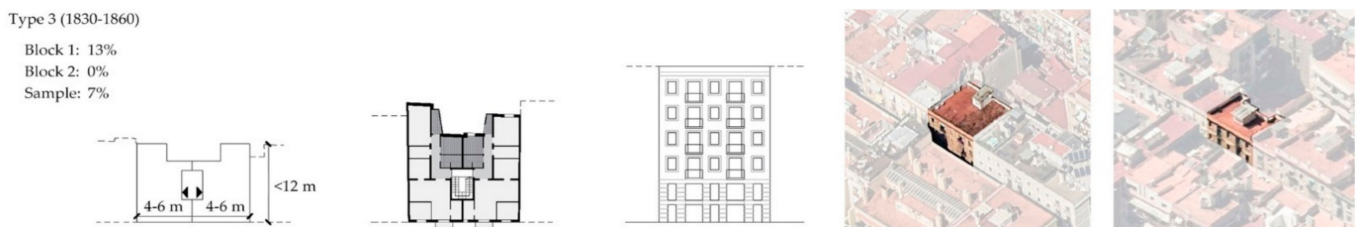
Figure 4. Workers' rental housing with two dwellings per landing, both of which have two façades.

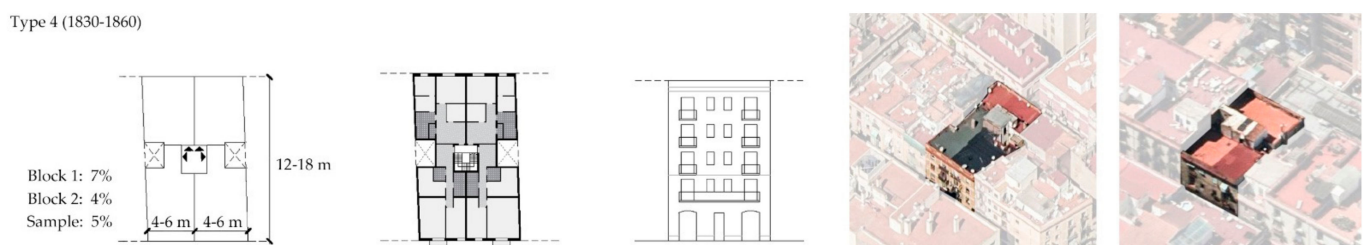
Figure 5. Workers' rental housing with four dwellings per landing, two of which open onto the public street while the other two open onto the inner urban courtyard.

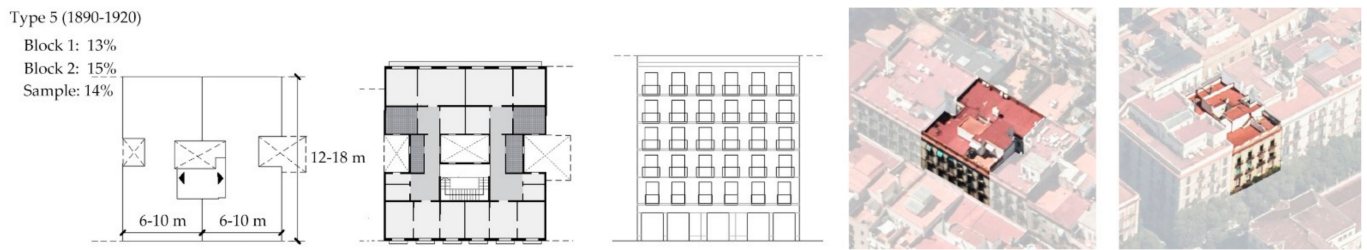
Figure 6. Bourgeois rental housing with two dwellings per landing, both of which have two façades.

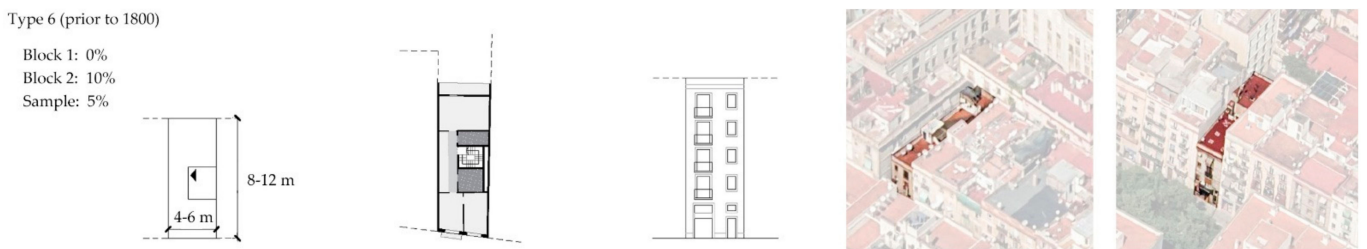
Figure 7. Workers' rental housing with one dwelling with two façades per landing, built before 1800 and transformed during the 19th century.

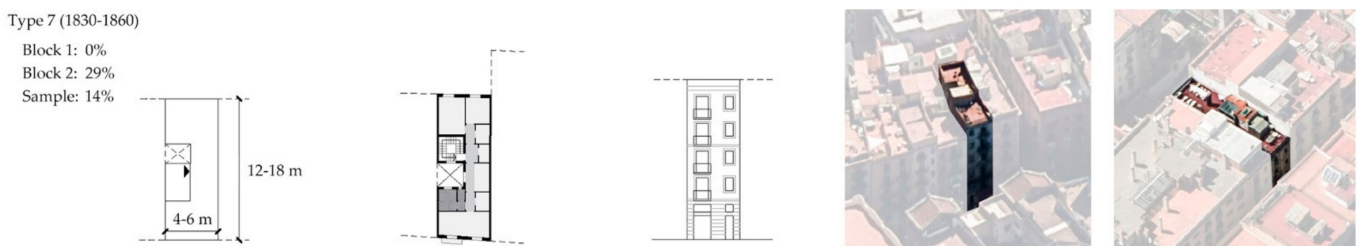
Figure 8. Workers' rental housing with one dwelling per landing with two façades.

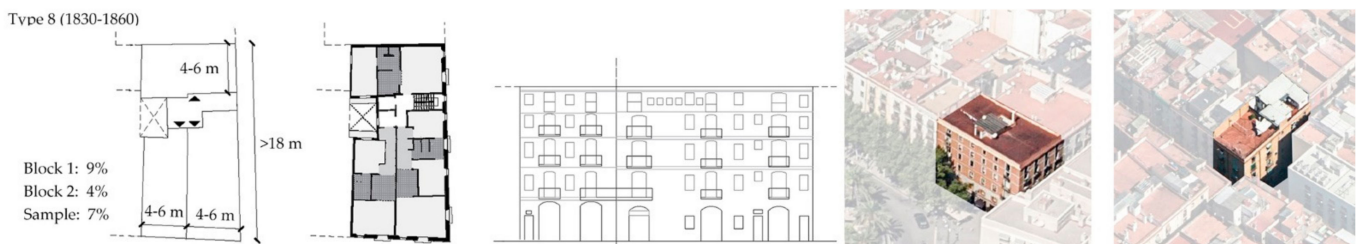
Figure 9. Special cases of workers' rental housing located mostly on street corners, with two to six dwellings per landing and a variable number of façades per dwelling.

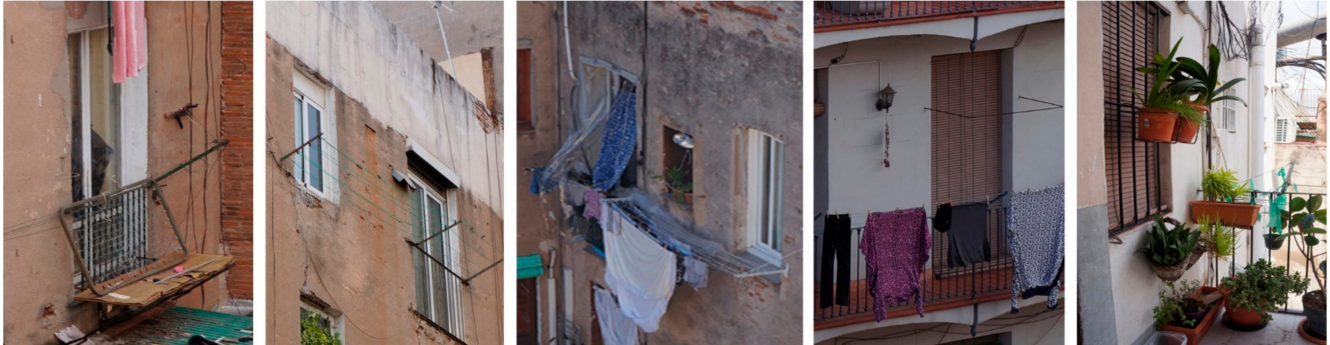
Figure 10. From left to right, five images of dwelling exterior spaces given different scores for appropriation (1, 2, 4, 5, 6). Source: pictures taken by S. Vima-Grau in fieldwork for her Ph.D. dissertation [64].

- Similarly, in subgroups C3 and C4, dwellings are considered substandard when poor maintenance or imprudent appropriation may endanger the safety of individuals. Dwellings are considered inadequate when a lack of maintenance or bothersome appropriation may lead to the discomfort or dissatisfaction of residents or may make

proper maintenance impossible. Dwellings are deemed adequate when maintenance or appropriation improves the state of repair, residents' comfort or the active, possibilist use of both private and shared spaces (Figure 10).

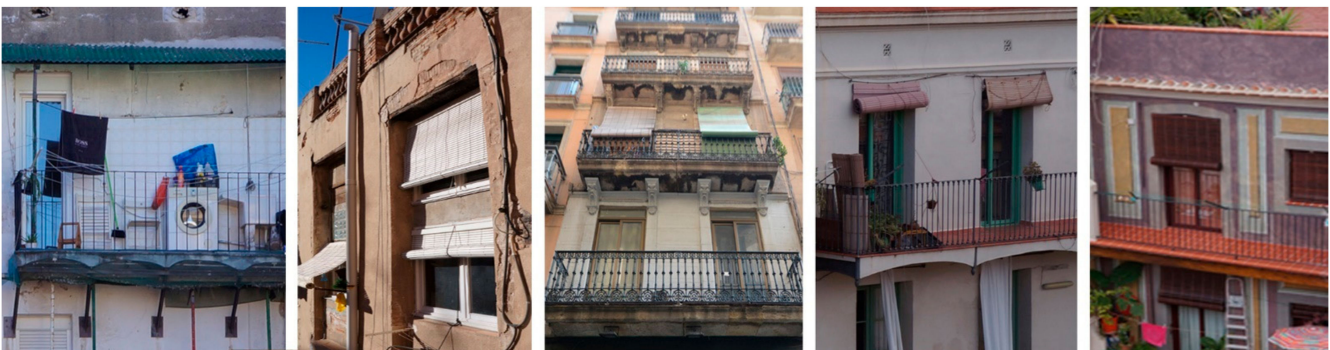
Figure 11. From left to right, five images of dwelling façades, balconies and woodwork given different scores for the state of repair of individual dwellings (1, 2, 3, 5, 6). Source: pictures taken by S. Vima-Grau, in fieldwork that is part of her Ph.D. dissertation [64].

- Subgroups C1 and C2 consist primarily of qualitative indicators. Although they are not based on formal living standards, current regulations do refer specifically to the state of repair of dwellings [67]. As we have noted in previous publications [52,122], substandard housing refers to cases where significant building damage—regardless of its origin—places the security of individuals at risk. Housing is considered inadequate when building damage is less significant but widespread in the watertight building enclosure, causing significant discomfort for residents. Dwellings are only considered adequate when there is no visible damage to the building enclosure, or when such damage is the result of a lack of maintenance but does not yet seem to affect either the comfort or safety of residents (Figure 11). Although this article does not provide detailed descriptions of observed damage, we have addressed this issue in previous publications [28,105,122,123].

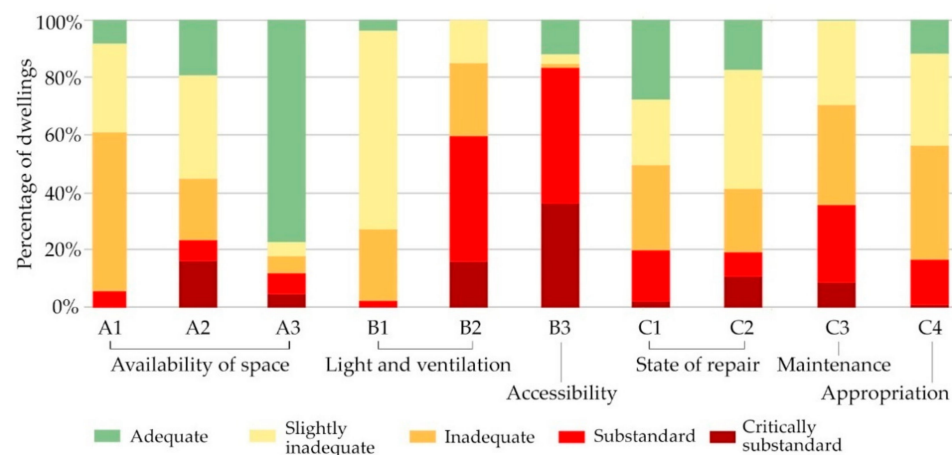
Figure 12. Evaluation of the sample according to ten dimensions of habitability measured by ten subgroups of indicators (A1–C4).

The results of the evaluation are presented in Figure 12 according to the different dimensions of habitability studied.

In most cases, the usable space—regardless of occupancy—was inadequate (over 60%), although relatively few cases could be considered substandard housing (5%). If we also consider occupancy, the percentage of dwellings that are critically substandard increases significantly, accounting for over 20% of the sample, while the percentage of dwellings with an acceptable surface area also increases. The coincidence between the proportion of substandard housing according to indicators of available area per resident (Subgroup A2) and the proportion of observed signs of overoccupancy (Subgroup A3) confirms that the results are robust. The results of this dimension allow us to note that we can better pinpoint both serious habitability problems and places where the available housing is adequate by taking occupancy into account, in addition to morphological aspects; these results also better match what can be observed in the field.

conditions, we found that 92% of homes are slightly inadequate, 25% are inadequate and only 5% are substandard. Meanwhile, 60% of dwellings were in buildings where the stairwell and entranceway entirely lacked light and ventilation. In the remaining 40%, the illumination and ventilation of these shared spaces was inadequate. However, in 90% of cases, ventilation and illumination could be improved in shared spaces with interventions that do not require functionally or structurally important modifications. There are no contemporary data studies on the quality of ventilation and illumination in housing units in the area, or on the spatial qualities of shared spaces. Results from studies carried out three decades ago [87,88,92,93,98] provide estimations of potentially substandard and inadequate housing, and they also note the illumination and ventilation weaknesses of most historical building types present in the Raval (see discussion in Section 3.3).

In terms of accessibility, over 80% of the sample could be considered substandard housing because of its failure to meet applicable housing standards (four floors or more without an elevator). However, it is important to set apart cases where the dwelling's position in the building affects its accessibility. Only 13.6% of the sample dwellings are in buildings with an elevator. Although many buildings did not comply with current regulations, it is worth noting the high percentage of cases where the installation of an elevator would be feasible within existing common spaces and property plots (50%). However, it would be impossible to install an elevator in a lightwell or stairwell in 35% of cases, meaning changes to the interior of residences or the surrounding spaces would be necessary. Previous studies along these lines note that residents' lack of resources, difficulty managing communities or reaching agreements, and the unequal distribution of subsidies for rehabilitation (which are concentrated in wealthier areas of the city) are the fundamental reasons the immense majority of buildings in the Raval still have no elevator [45,125]. Regulations protecting historic buildings and, in some cases, their typological constraints, are additional obstacles [126].

The state of repair of dwellings is the area with the highest level of diversity and the most evenly distributed results. Twenty percent of homes are in very poor condition and up to 70% are inadequate, while only 30% are adequate. Nevertheless, if we take into account the state of repair of shared spaces, the percentage of dwellings in good condition drops to just 17%. Although the number of critically substandard residences increases, the general percentage of substandard housing does not.

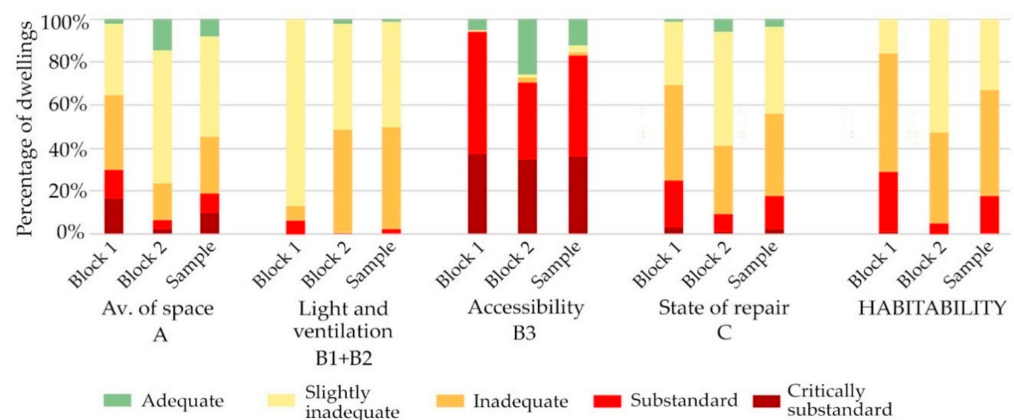
Figure 13. Four dimensions and overall habitability of the sample, divided by block.

The four dimensions of habitability (available space, ventilation and illumination, accessibility, and state of repair) as well as overall habitability are presented in segments in Figure 13. This allows us to compare the results from block 1 (321 dwellings), block 2 (282 dwellings) and the total sample (603 dwellings).

Due to the absence of elevators, the dimension with the highest percentage of substandard dwellings is accessibility. Of the remaining dimensions, shortcomings in available space are particularly significant (both because of insufficient space and overoccupancy, as explained in the previous section). There are also a significant number of residences in a seriously poor state of repair. Ventilation and illumination seem to be less pressing, although they are inadequate in almost all cases. As a result, the overall analysis of habitability places the study sample below the threshold for adequate housing: 35% of dwellings are slightly inadequate, and 50% are inadequate; 17% could be considered substandard, and of these, 3% are critically substandard.

If we look at the results from each block, we can clearly see that block 1 has a higher percentage of inadequate and substandard dwellings in nearly all of the analyzed dimen-

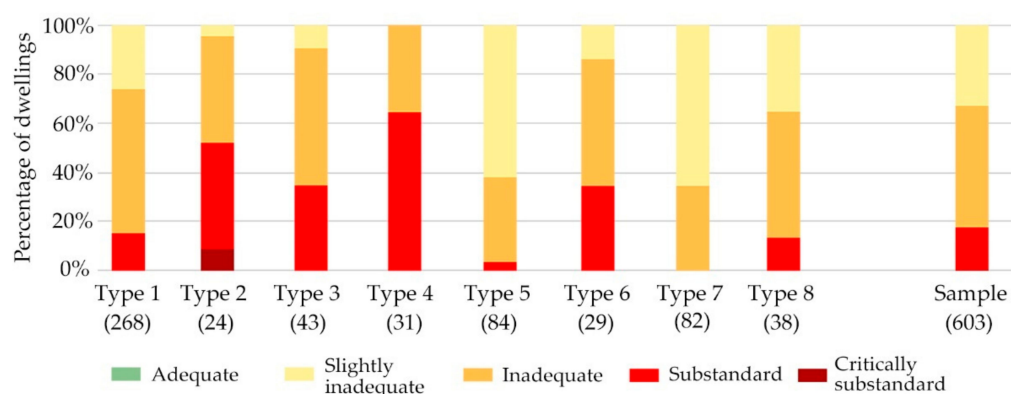
Figure 14. Overall habitability of the sample by type of building.

The evaluation of overall habitability is divided by type of building in Figure 6 and type of dwelling in Figure 14. This allows us to determine whether, as noted in previous research [92,93], there are any connections between these types of constructions and the habitability issues present.

It is worth noting that some of the building types analyzed make up such a small proportion of the sample that the results obtained are inconclusive: they may be more affected by the contextual aspects of the handful of examples studied than by the type of building. This is the case with types 2, 4 and 6. However, there are enough of types 1, 3, 5, 7 and 8 to come to certain conclusions. Housing conditions are much worse in Type 6 (buildings built before 1830 with one dwelling on each landing that opens to the front and back, without lightwells, located mostly in deep lots with a narrow façade) than any other. Surprisingly, the Type 1 buildings (rental housing for workers with a narrow façade and two apartments per landing that only open onto one side) studied in this sample are not where the worst housing conditions are found. They do, however, include some substandard housing, in the same proportion as Type 8 (buildings in the “Special cases” category, located mostly on street corners). As is to be expected, housing conditions are better in Type 5 buildings (those built as bourgeois rental housing); nevertheless, the housing conditions in these buildings are still inadequate, and they include some substandard housing. Unexpectedly, habitability conditions are best in Type 7 buildings (rental housing for workers with a narrow façade and one apartment per landing that opens onto both sides, as well as a lightwell connected to the stairwell).

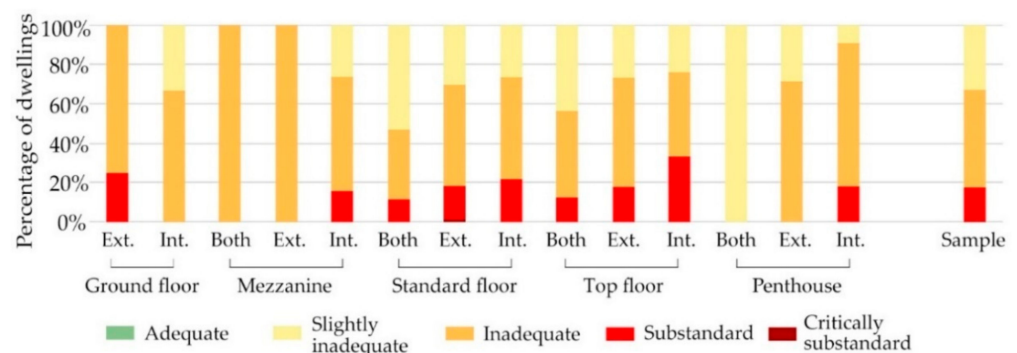
Figure 15. Overall habitability of the sample by type of dwelling (ground floor, mezzanine, standard floor, top floor, penthouse) and whether it opens onto the street (Ext.), onto the urban courtyard (Int.) or both.

When results are divided by type of dwelling as presented in Figure 15, the patterns are much clearer. No matter where in the building an apartment is located, poorer conditions are found in dwellings that only open onto the rear façade. Of these, apartments located directly beneath the roof are particularly poor, making up over 35% of substandard dwellings.

Ground floor dwellings also show a higher concentration of inadequate housing and a very high proportion of substandard housing. Surprisingly, no particularly serious cases were found among mezzanine apartments. Although these homes are generally smaller, some have large private patios at the rear of the building. However, it is important to mention that the façade and openings of interior mezzanine apartments are hidden, and the same is true of interior ground-floor dwellings. Among penthouses, the results vary widely depending on whether the apartment opens onto the front façade, the rear façade, or both. Those that only open onto the rear façade tend to be in a much worse state. This confirms the importance of whether a dwelling opens onto the front or rear façade, and suggests that existing penthouses can be divided into two classes: renovated penthouse apartments built on private rooftops, and poorly maintained, self-built apartments that fail to meet housing standards and lack private exterior space.
