The Impact Study of the Exchanges between the Microorganism Communities on the Surfaces from Constanta Roman Mosaic and Anthropic Interactions

Verginica Schröder, Daniela Turcanu-Carutiu, Adina Honcea, Sorin Grigore and Loreley-Dana Jianu

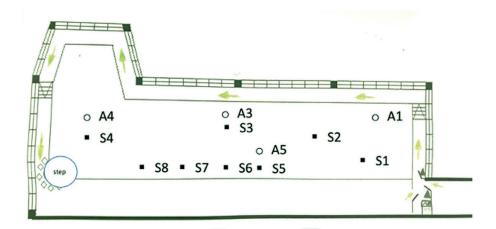
Figure 1.

The Roman mosaic museum samples map and codifications (A1-A4 air contamination, S1-S8 surfaces biocontamination assessment, the green arrow is the route of tourists).

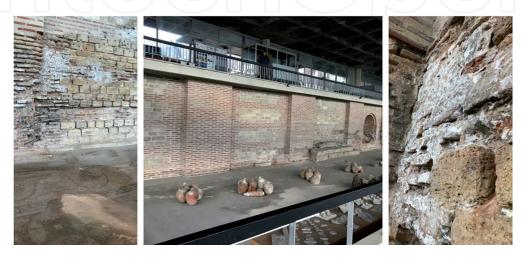
Areas from the mosaic, as well as from adjacent parts, such as the eastern wall, built of brick and with an obvious biological contamination and degradation, were identified as relevant points for analysis (**Figure 2**).

Figure 2.
The details of wall built of brick analyses.

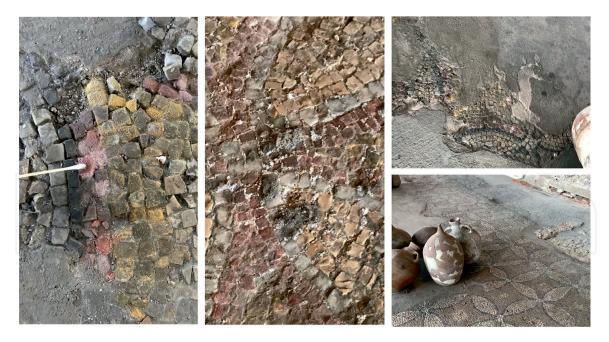
To identify the biodegradation, sampling for laboratory analysis was performed from the affected portions, (**Figure 3**) but the techniques were minimally invasive, avoiding the production of new colonization points or deterioration.

Figure 3. *Appearance of the biological attack on tesserae.*

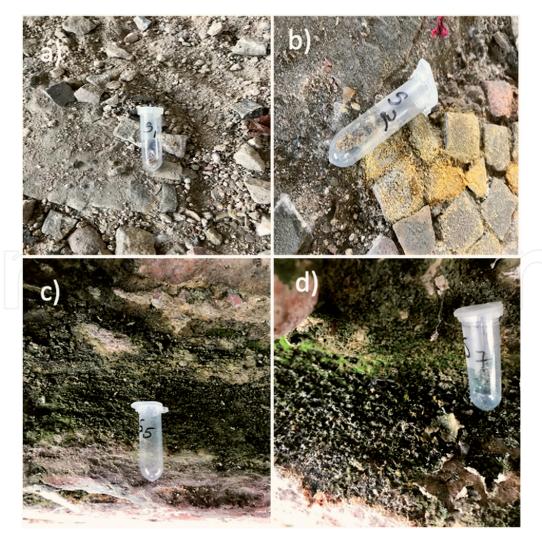
Figure 4.

Relevant areas for analysis were identified as affected areas of the mosaic (**Figure 4a** and **b**) and adjacent parts, such as the eastern wall, built of brick and with obvious biological contamination and degradation (**Figure 4c** and **d**). The autotrophic biofilm was noticed at this level, arranged in successive layers, parts with intense processes of fungal contamination, in the upper area, as well as mineral deposits.

Microalgae are commonly found on calcareous substrates and can induce degradation by release of acids, accumulation of ions and alteration by pigmentation, fragmentation of the substrate and the formation of crusty, dark or patinated-looking surfaces [23].

The affected areas of the mosaic by chromatic alteration and destructions (a, b), the biodegradation of wall surfaces (c, d).

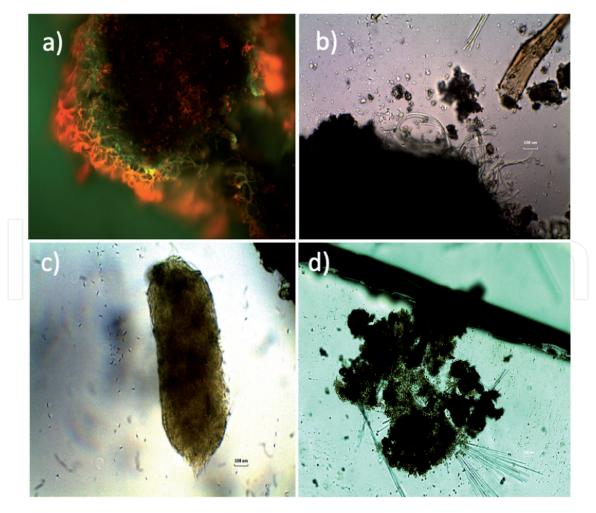
Microscopic analysis shows lichen-like structures with an upper cortex formed exclusively by tightly woven and welded hyphae, as well as a gonidial layer with algal symbiosis indicating chlorophyll activity (red coloration) (**Figure 5a**). The middle layer (medullary) consists exclusively of mycelial hyphae, loosely braided (green coloration), (**Figure 5a**).

The biological activity by substrate attachment is very evident (**Figure 5**), as well as the formation of mobile structures, detached from the substrate or colony,

of the goniocyst type, which include photobiont cells surrounded by hyphae arranged in a single layer (**Figure 5c**).

Figure 5. The microscopical examination of biological samples a) autotrophic forms, in epifluorescence with acridine orange staining, b) biological associations in light microscopy images, c) goniocyst, d) fungal contamination, optical microscopy, bar = 100 μ m (x400 magnification).

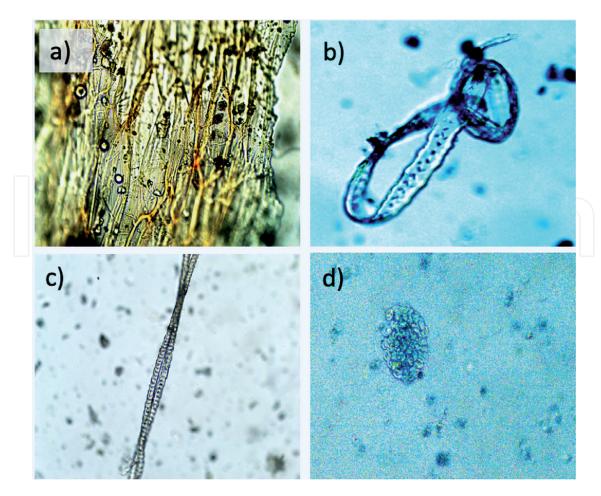
In the S 8 sample (**Figure 6**) intense biological activities were identified, including various colonies of microalgae (**Figure 6d**) as well as fungal activity (**Figure 6a–c**).

The massive microorganisms colonization, highlighted in the samples, explains the various depigmentation, or changes in shades, or the biogenic pigmentation that was identified on the analyzed surface. Bacteria induce changes by discoloration as well as by dissolving various materials generating biodegradation of the substrate through specific metabolism [24].

Figure 6.The microscopic details of fungal morphotypes (a, b, c) and microalgae (d).

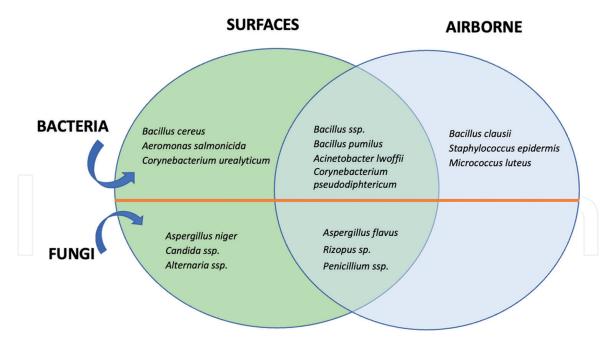
degradation factors for the exhibited museum objects, mosaic and other vestiges of the museum complex (**Figure 7**).

Figure 7.The common and specific microbiota for surfaces and airborne samples diagram.

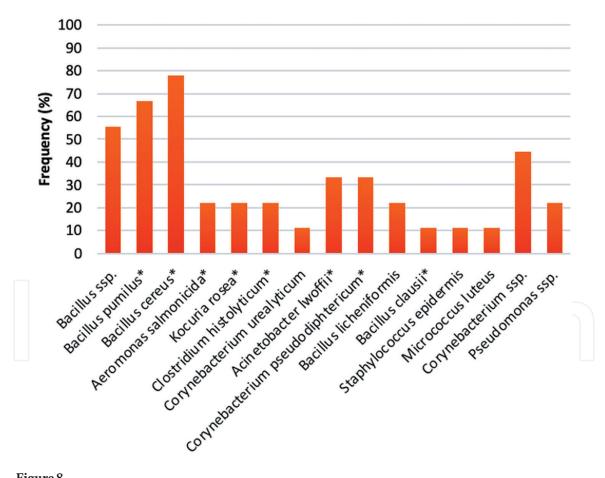
Figure 8.Bacterial frequency (%) isolated all samples; * VITEK microbial identification system used.

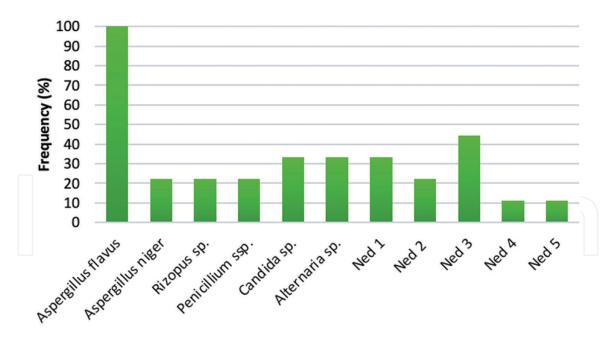
Figure 9.
Fungal frequency (%) isolated from all samples (ned 1-ned 5 unidentified species).
