# Predisposing and triggering factors of large-scale landslides in Debre Sina area, central Ethiopian highlands

A large number of landslide events have repeatedly struck the border zone of the northwestern plateaus of Ethiopia. Debre Sina area is one of the most tectonically active areas located along the western margin of the Afar depression, which is frequently affected by landslides. Despite that, urban and rural development is currently active in almost the entire area. It is crucial, therefore, to understand the main causes and failure mechanisms of landslides in the Debre Sina area and its surroundings. The present study investigated landslides using field mapping of geological and geomorphological features, remote sensing, geomorphometric analysis, structural analysis, rainfall data, landslide inventory, and earthquake data. The results of the study indicate that large-scale and deep-seated landslide problems appear to be caused by complex geological settings and rugged topography. In particular, the location and morphology of the Yizaba Wein and Shotel Amba landslides are strongly controlled by geological structures. Their flanks are bounded by high angle faults, and their

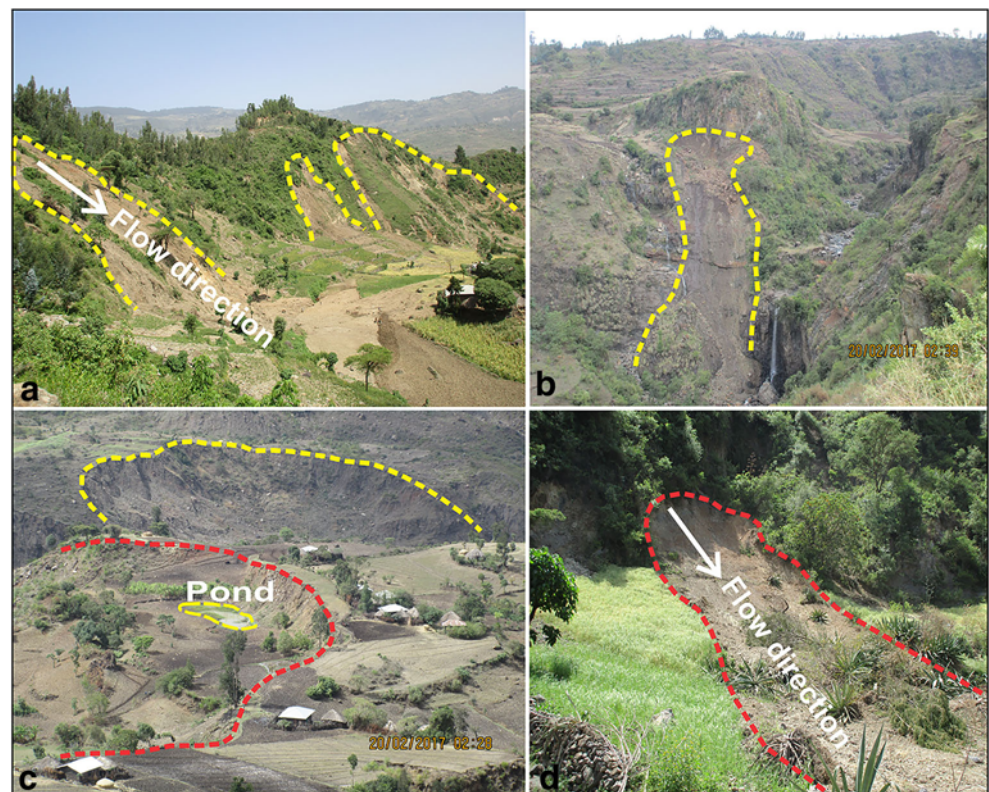
The Nib Amba area is widely affected by active and dormant landslides of different types and sizes including translational and rotational slides, debris/earth slides and flows, and rockfalls. Superimposed landslide bodies confirm that the spatial distribution of the recent landslides is frequently influenced by the presence of older landslides. The 2005–2007 events were characterized by multiple retrogressive translational slides in the upper part and multiple advancing rotational slides in the lower part, especially along the stream banks (Fig. 8b, c). In May 2016, rainstorms triggered an earth flow with a volume of several cubic kilometers and other landslides such as debris flow, shallow slides, and rockfalls which caused damage to dwellings, agricultural lands, and the natural environment (Fig. 8a, d).

abundant rainfall. In 2005–2007, reactivated landslides destroyed farmland and dwellings in the gorge of the Koda Menkeriya river (Fig. 8b). Outcropping lithology and bedrock structure together with the rugged topography were responsible for slope instability in this locality. The landslides were mostly associated with soft interlayered pyroclastic sediments (tuff and pumice) and black cotton soil. A quasi-rotational slide created a stagnant pond at the frontal part of a slope movement (Fig. 8c).

**Fig. 8** **a** Debris flow demolished agricultural land in Nib Amba. **b** Rockslide in Nib Amba. **c** Deep-seated rotational slides form a pond at the lower part of the slide zone. **d** Earth flow demolished farmland
