Title of Document: QUANTITATIVE ANALYSIS OF MICROCRACKS IN
CONCRETE FROM DELAYED ETTRINGITE
FORMATION BY AUTOMATED PROCESSING OF
LASER SHEAROGRAPHY IMAGES

Shivam Sharma, Master of Science 2021

Thesis submitted to the Faculty of the Graduate School of the
University of Maryland, College Park, in partial fulfillment
of the requirements for the degree of
Master of Science

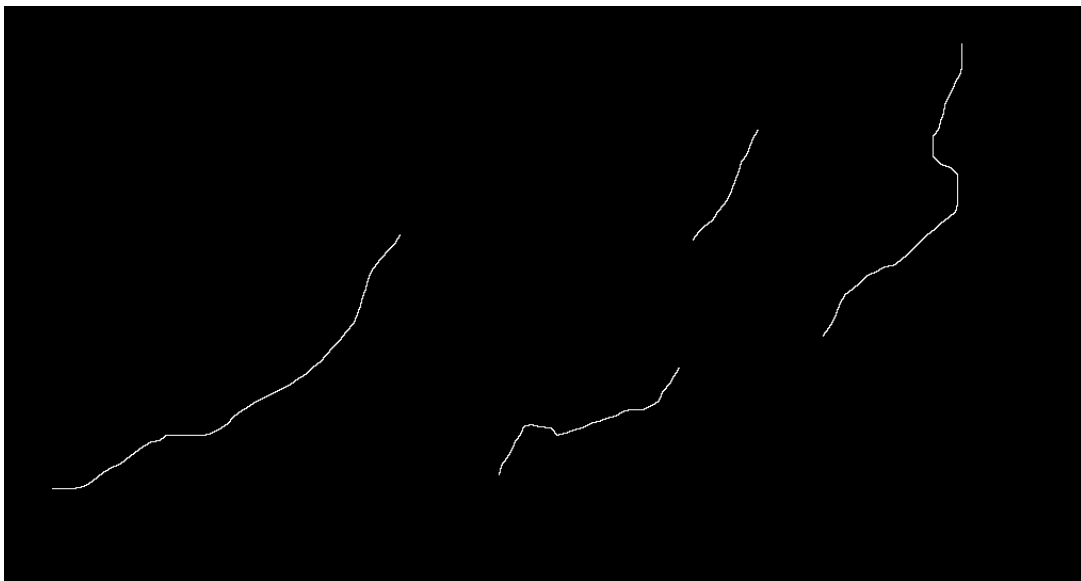
Figure 32 Tx2 traced Crack Mask Image X direction

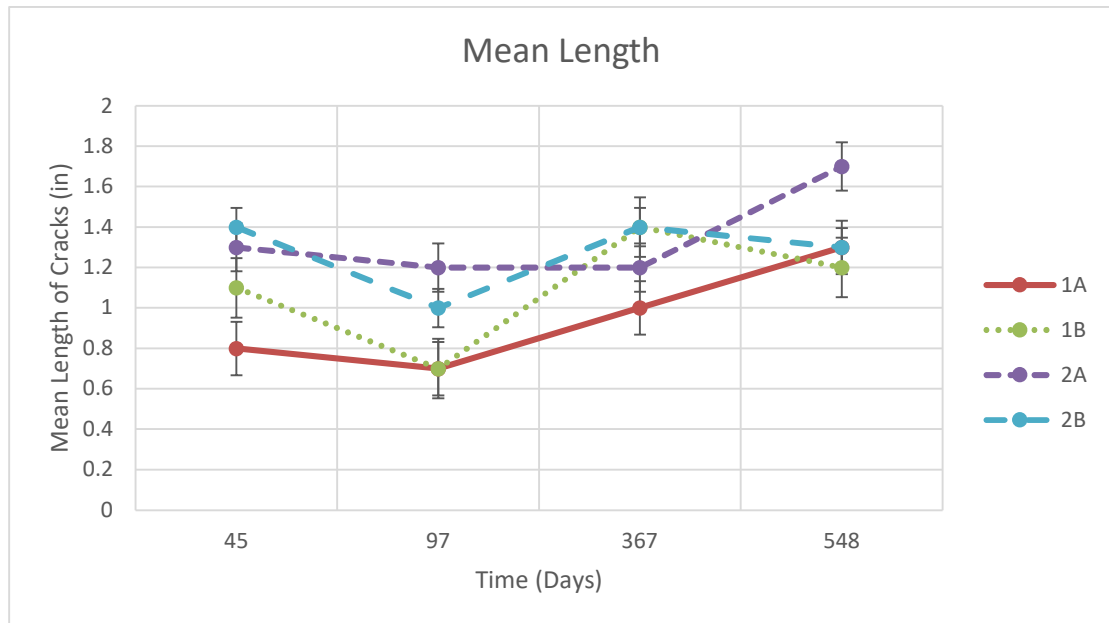
Figure 34 Scatter plot of side average crack length vs time

Days	Side Average				Prism Average	Std.dev.
	1A	1B	2A	2B		
45	0.8	1.1	1.3	1.4	1.1	0.2
97	0.7	0.7	1.2	1	0.9	0.2
367	1	1.4	1.2	1.4	1.3	0.2
548	1.3	1.2	1.7	1.3	1.4	0.2

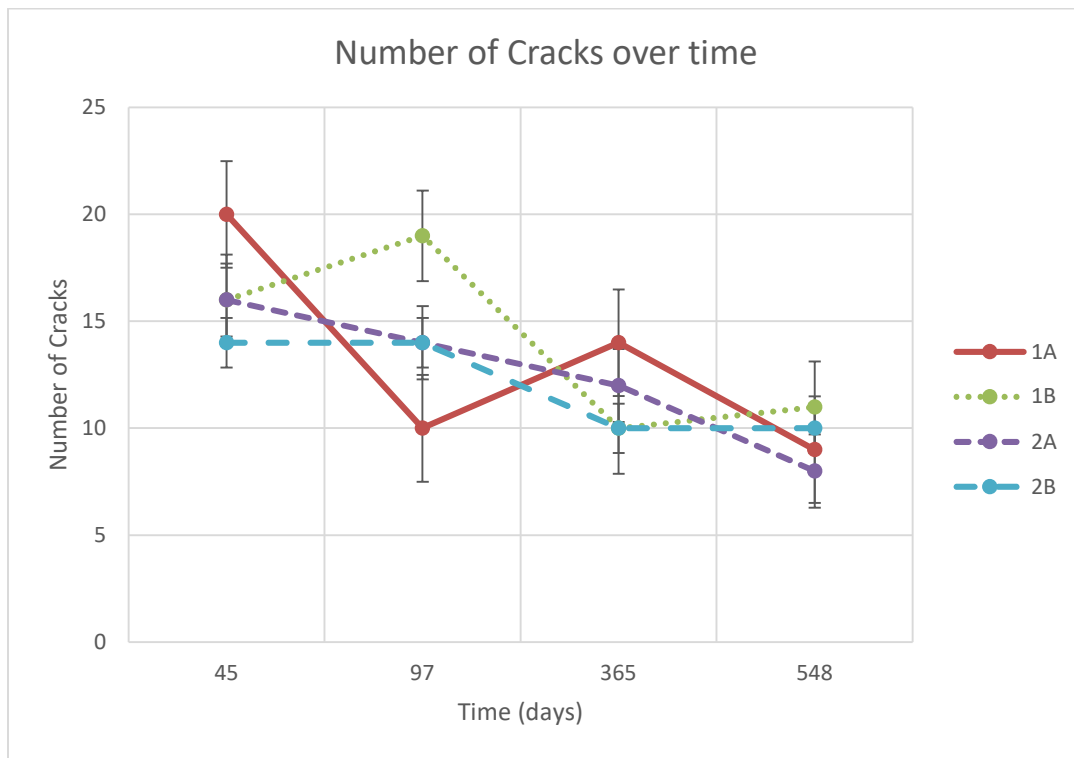
Figure 35 Scatterplot of number of cracks TX1

Days	Number per Side				Prism Average	Std.dev.
	1A	1B	2A	2B		
45	20	16	16	14	17	2
97	10	19	14	14	14	3
365	14	10	12	10	12	2
548	9	11	8	10	10	1

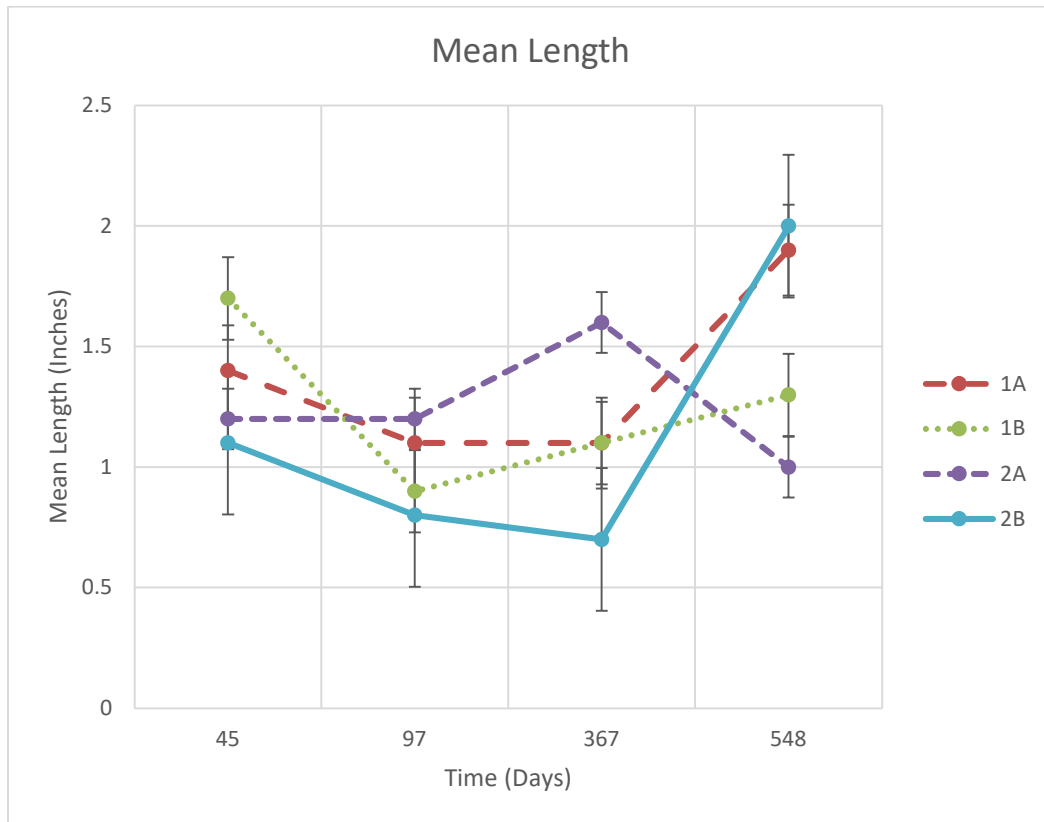
Figure 36 Scatter plot of side average length of cracks vs time sample TX2

Days	Side Average				Prism Average	Std.dev.
	1A	1B	2A	2B		
45	1.4	1.7	1.2	1.1	1.4	0.2
97	1.1	0.9	1.2	0.8	1	0.2
367	1.1	1.1	1.6	0.7	1.1	0.3
548	1.9	1.3	1	2	1.6	0.4

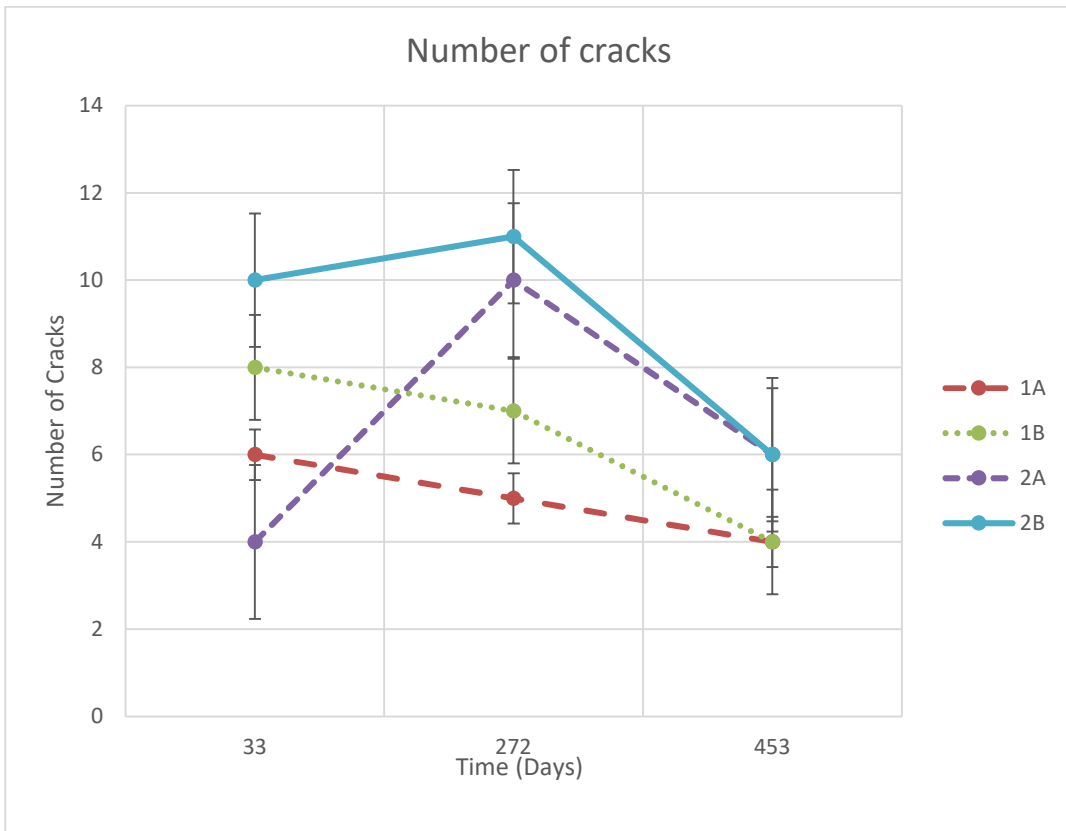
Figure 41 Scatter plot of side number of cracks vs time sample TX4

Days	Number per Side				Prism Average	Std.dev.
	1A	1B	2A	2B		
33	6	8	4	10	7	2
272	5	7	10	11	8	2
453	4	4	6	6	5	1

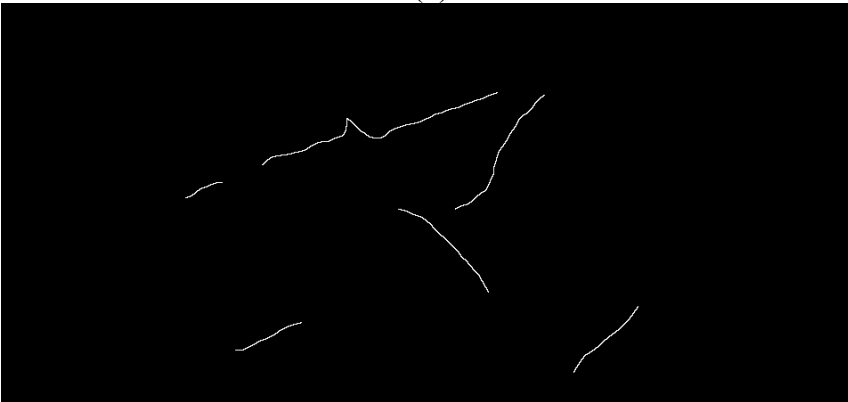
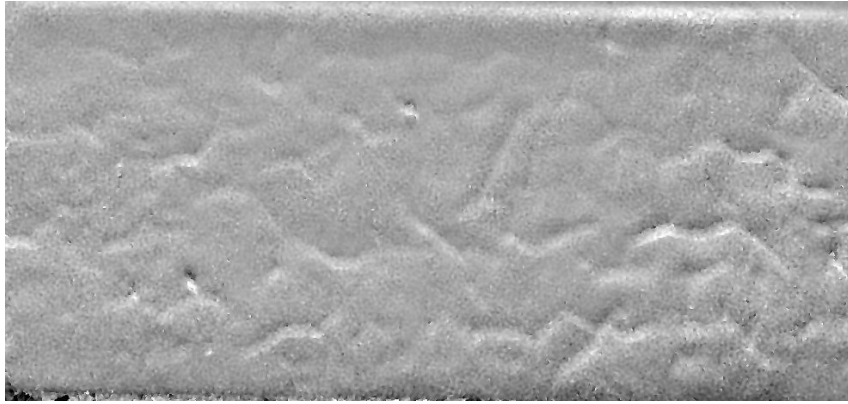
Figure A.1 Tx3 Section 1 A-X at 33 days after cast (a) original image (b) Image after filtering (c) Image after tracing and Mask

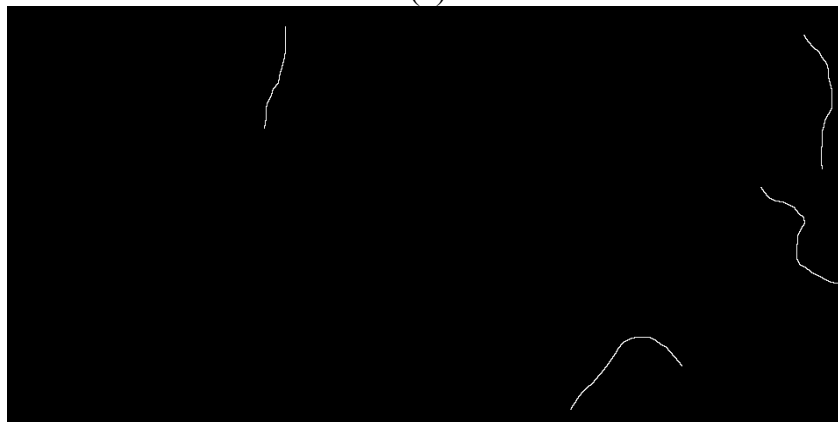
Figure A.3 Tx3 Section 1 A-X at 272 days after cast (a) original image (b) Image after filtering (c) Image after tracing and Mask

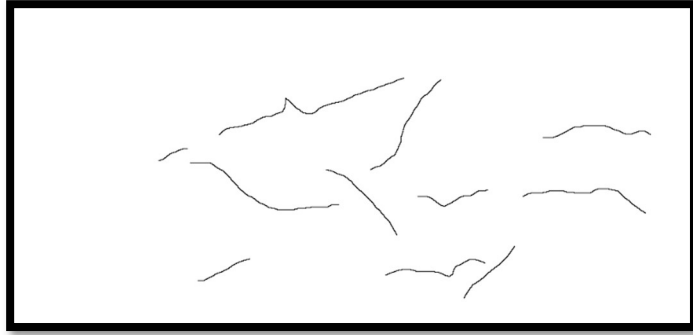
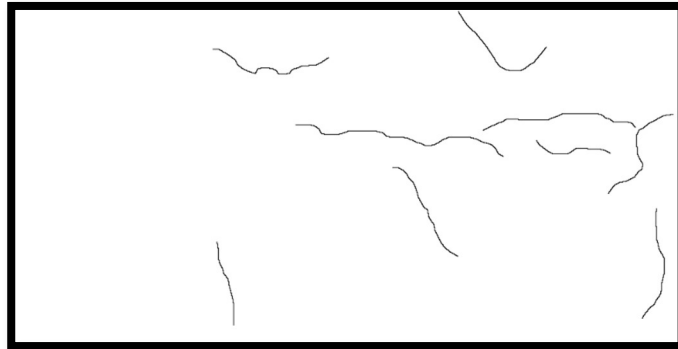
Figure A.7 Section 1A Tx3 Mask X and Y shear direction combined traced cracks and inverted (a) 45 Days (b) 272 Days (c) 453 Days

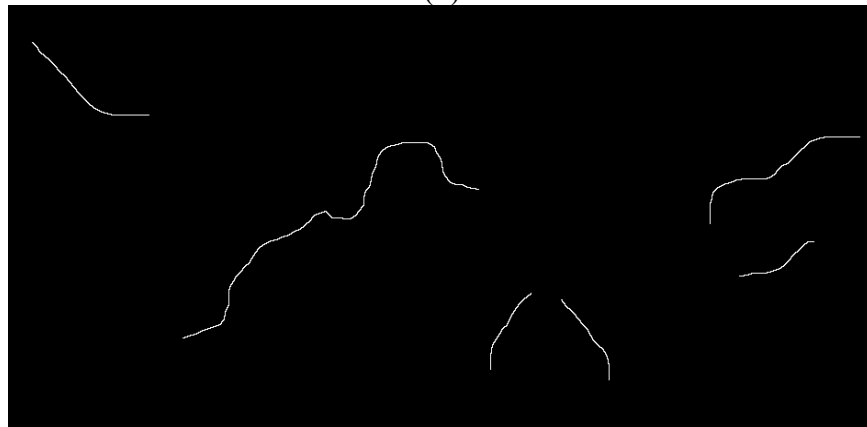
Figure A.10 TX3 Section 1 B-Y at 33 days after cast (a) original image (b) Image after filtering (c) Image after tracing and Mask

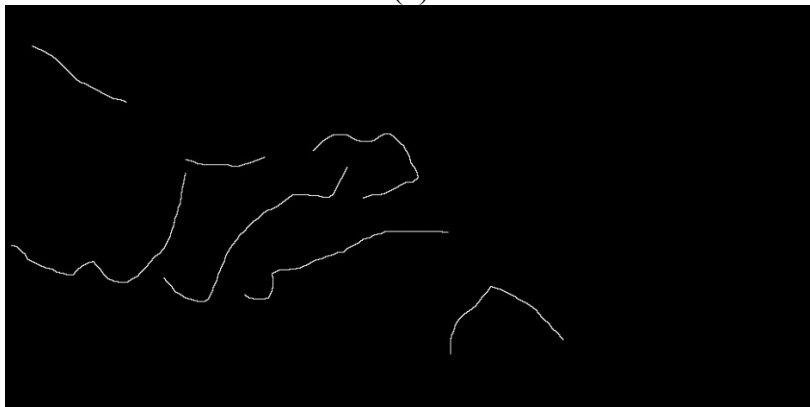
Figure A.12 TX3 Section 1 B-Y at 272 days after cast (a) original image (b) Image after filtering (c) Image after tracing and Mask

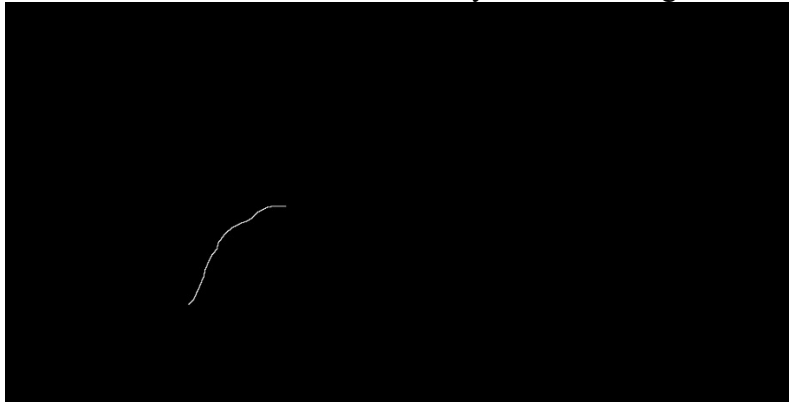
Tx3 Mask of the traced cracks after manual tracing

Figure A.13 TX3 Section 1 B-X at 453 days after cast (a) original image (b) Image after filtering (c) Image after tracing and Mask

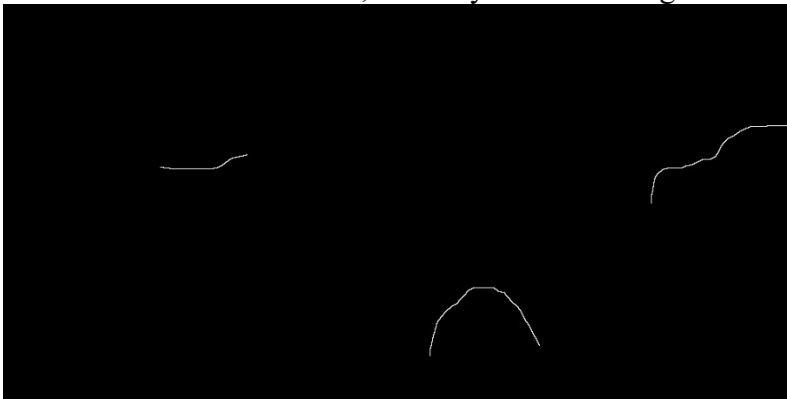
Tx3 Mask of the traced cracks after manual tracing

Figure A.14 TX3 Section 1 B-Y at 453 days after cast (a) original image (b) Image after filtering (c) Image after tracing and Mask

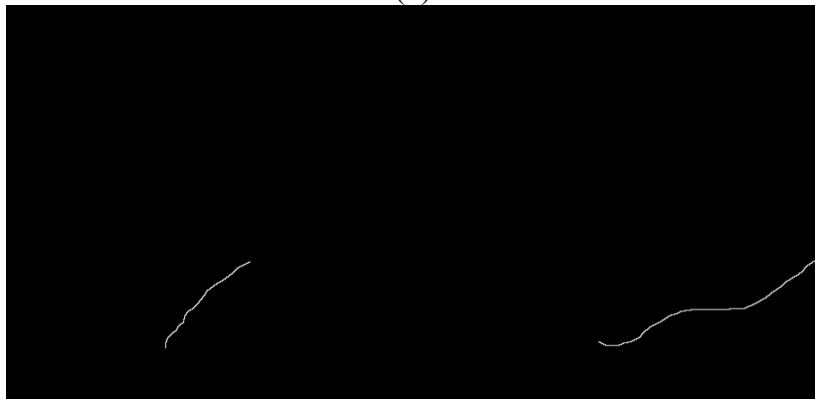
Figure A.17 TX3 Section 2 A-X at 33 days after cast (a) original image (b) Image after filtering (c) Image after tracing and Mask

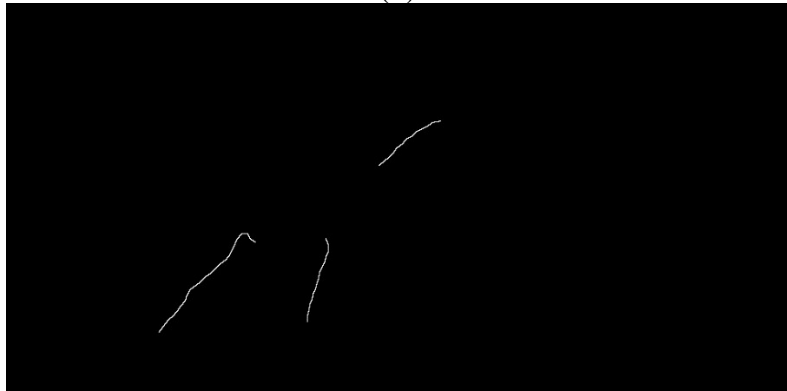
Figure A.19 TX3 Section 2 A-X at 272 days after cast (a) original image (b) Image after filtering (c) Image after tracing and Mask

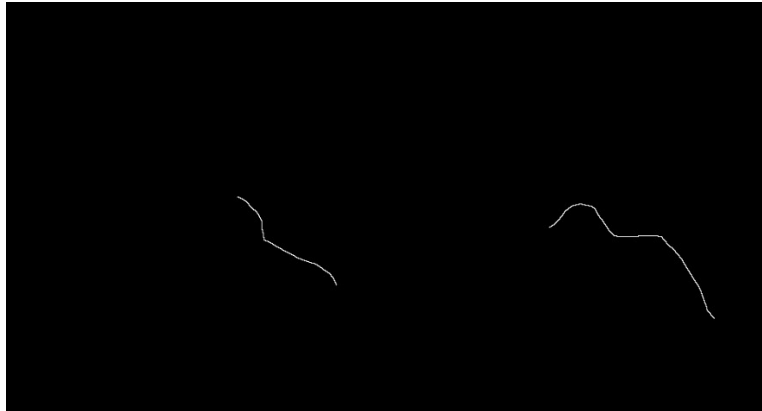
Figure A.22 TX3 Section 2 A-Y at 453 days after cast (a) original image (b) Image after filtering (c) Image after tracing and Mask

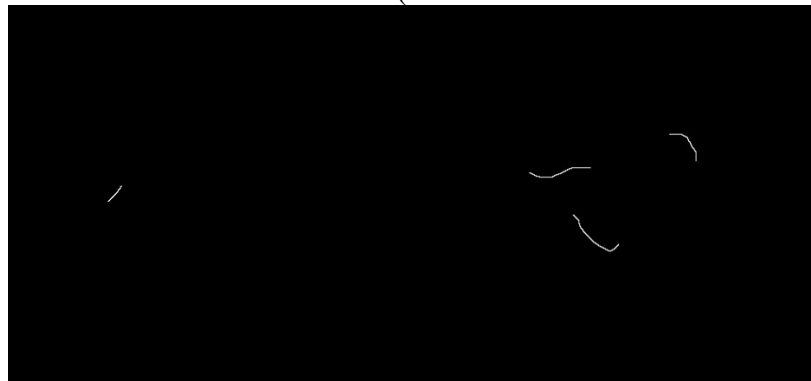
Figure A.34 TX4 Section 1A-Y at 33 days after cast (a) original image (b) Image after filtering (c) Image after tracing and Mask

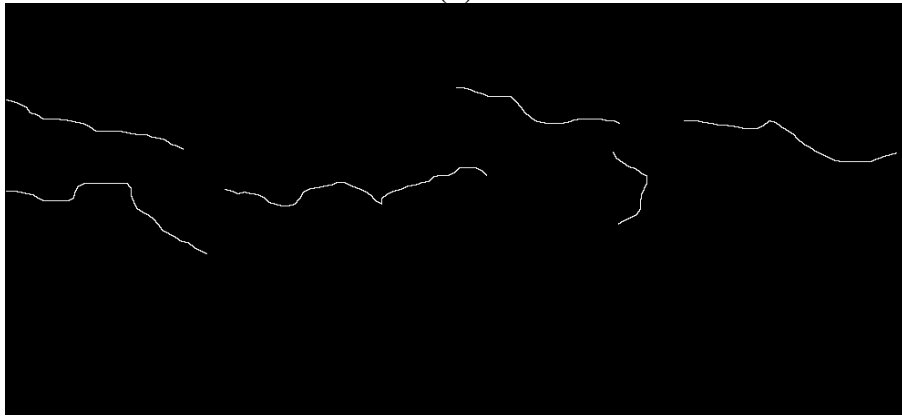
Figure A.98 TX1 Section 2B-Y at 97 days after cast (a) original image (b) Image after filtering (c) Image after tracing and Mask

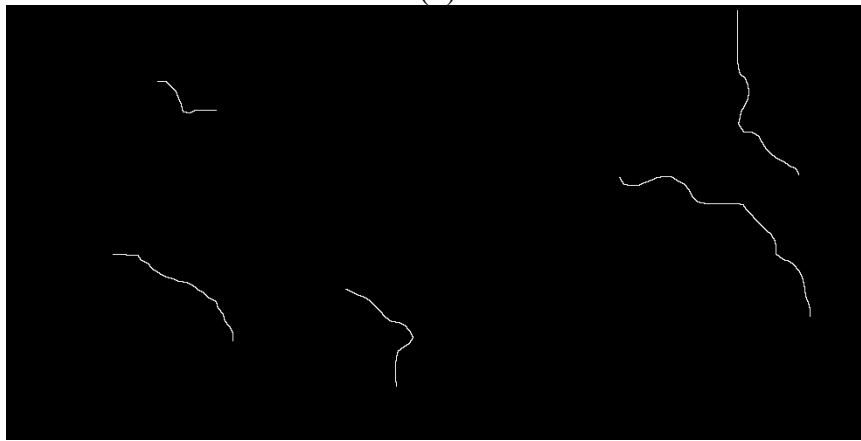
Figure A.99 TX1 Section 2B-X at 367 days after cast (a) original image (b) Image after filtering (c) Image after tracing and Mask

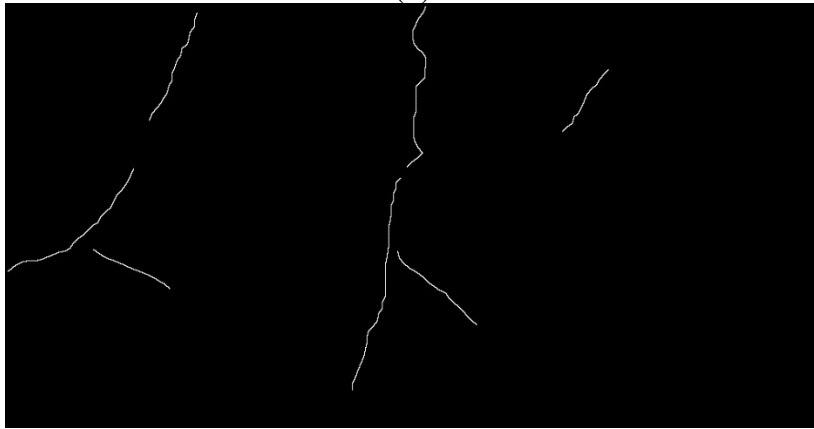
Figure A.101 TX1 Section 2B-X at 548 days after cast (a) original image (b) Image after filtering (c) Image after tracing and Mask

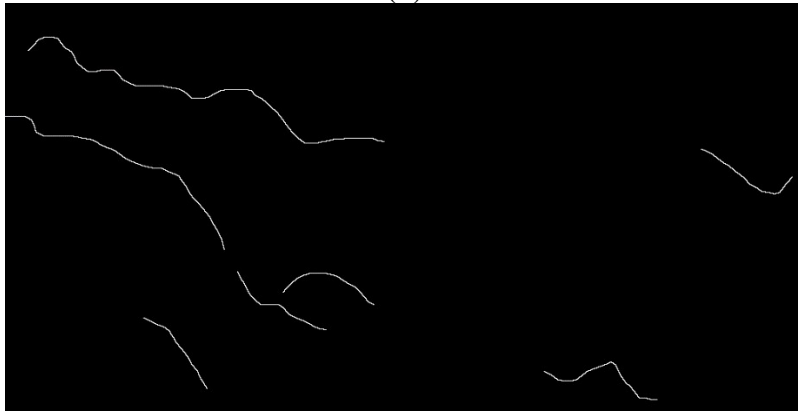
Figure A.106 TX2 Section 1A-Y at 45 days after cast (a) original image (b) Image after filtering (c) Image after tracing and Mask

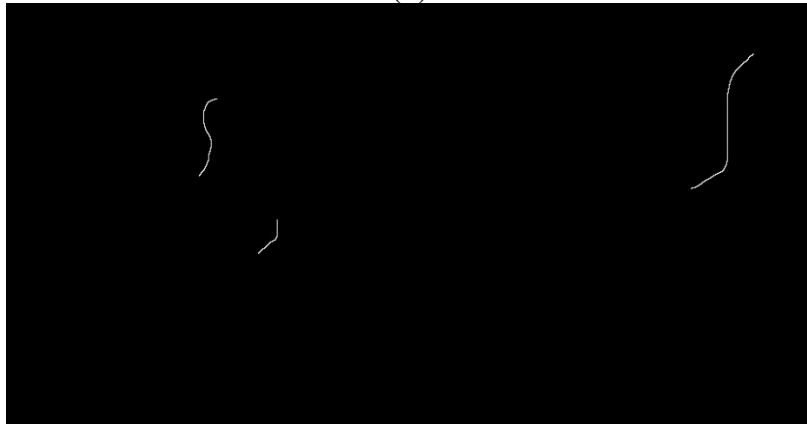
Figure A.107 TX2 Section 1A-X at 97 days after cast (a) original image (b) Image after filtering (c) Image after tracing and Mask

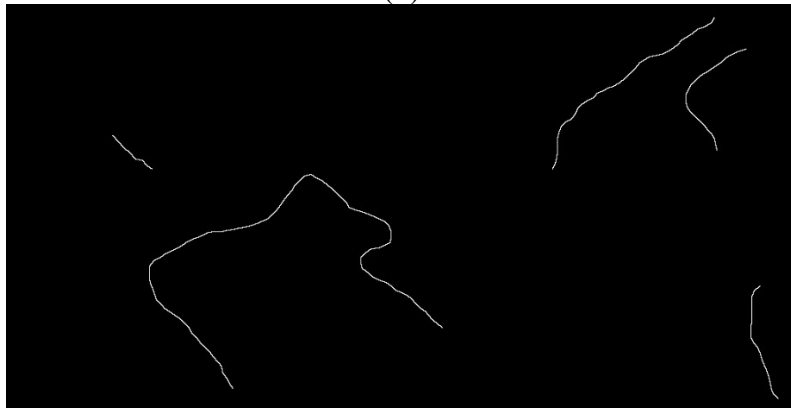
Figure A.111 TX2 Section 1A-X at 548 days after cast (a) original image (b) Image after filtering (c) Image after tracing and Mask

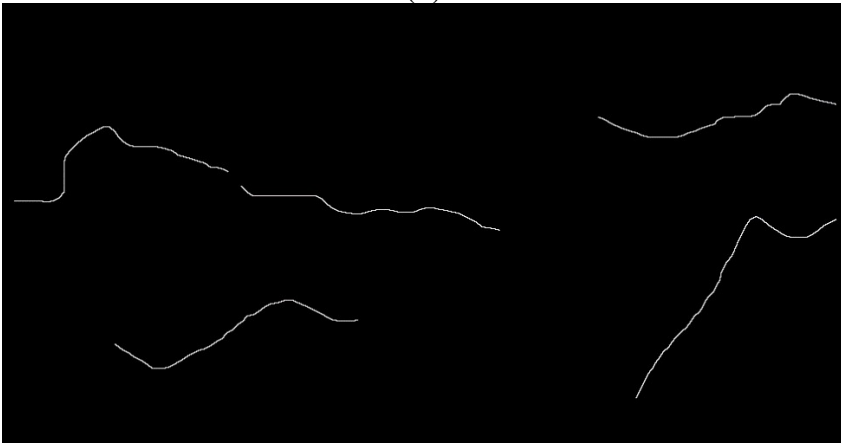
Figure A.116 TX2 Section 1B-Y at 45 days after cast (a) original image (b) Image after filtering (c) Image after tracing and Mask

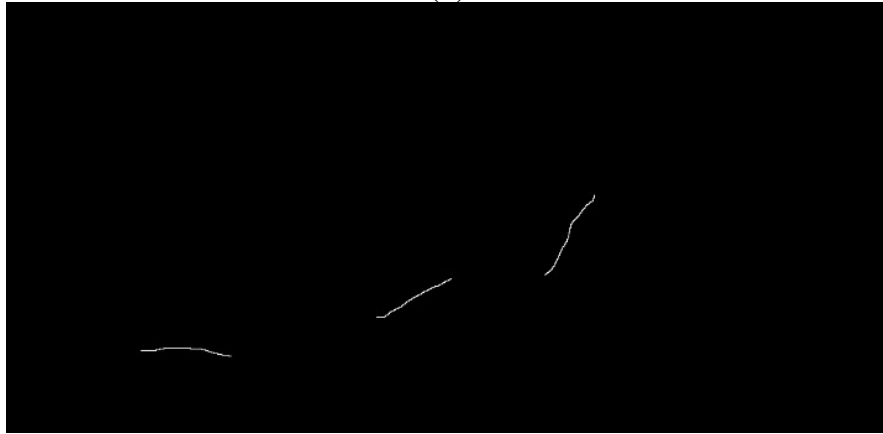
Figure A.117 TX2 Section 1B-X at 97 days after cast (a) original image (b) Image after filtering (c) Image after tracing and Mask

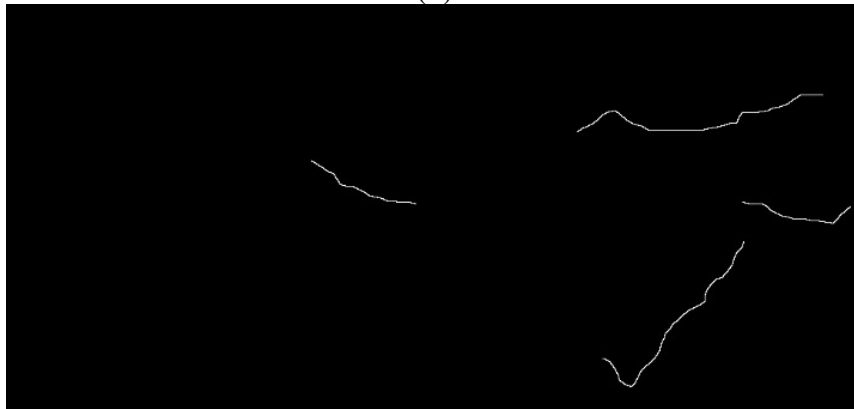
Figure A.118 TX2 Section 1B-Y at 97 days after cast (a) original image (b) Image after filtering (c) Image after tracing and Mask

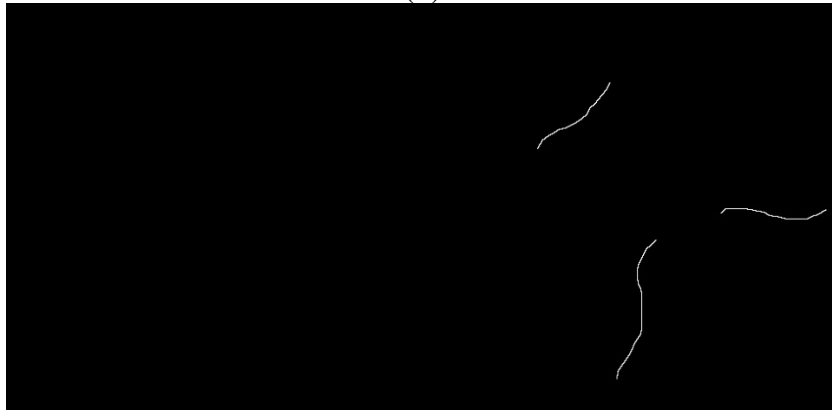
Figure A.119 TX2 Section 1B-X at 327 days after cast (a) original image (b) Image after filtering (c) Image after tracing and Mask

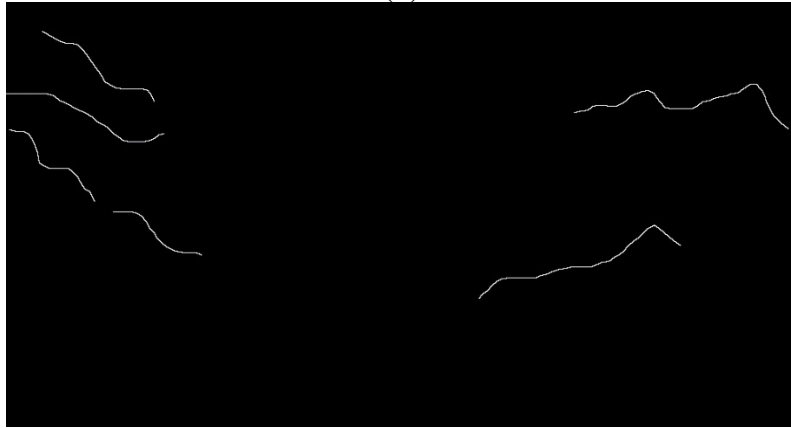
Figure A.126 TX2 Section 2A-Y at 45 days after cast (a) original image (b) Image after filtering (c) Image after tracing and Mask

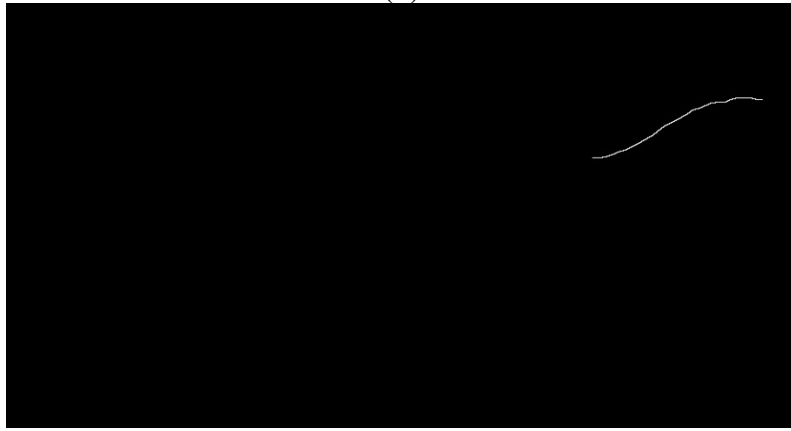
Figure A.127 TX2 Section 2A-X at 97 days after cast (a) original image (b) Image after filtering (c) Image after tracing and Mask

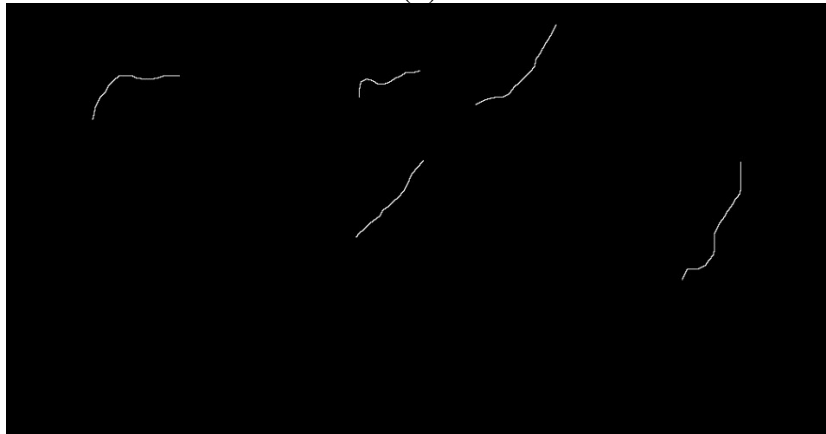
Figure A.135 TX2 Section 2B-X at 45 days after cast (a) original image (b) Image after filtering (c) Image after tracing and Mask

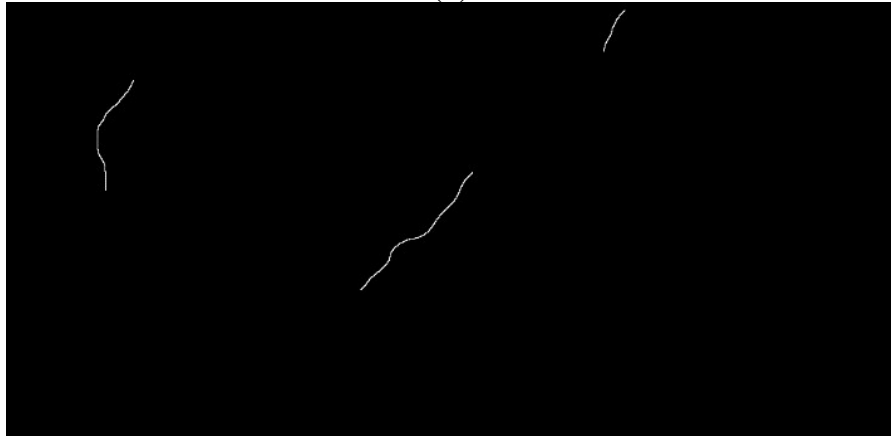
Figure A.137 TX2 Section 2B-X at 97 days after cast (a) original image (b) Image after filtering (c) Image after tracing and Mask

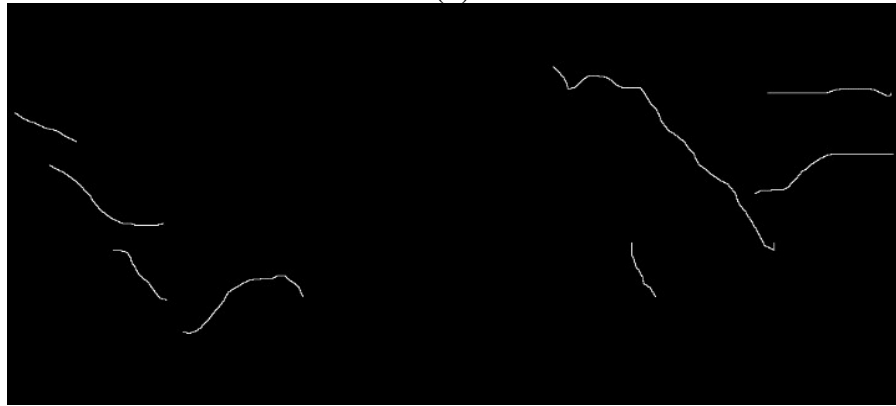
Figure A.138 TX2 Section 2B-Y at 97 days after cast (a) original image (b) Image after filtering (c) Image after tracing and Mask

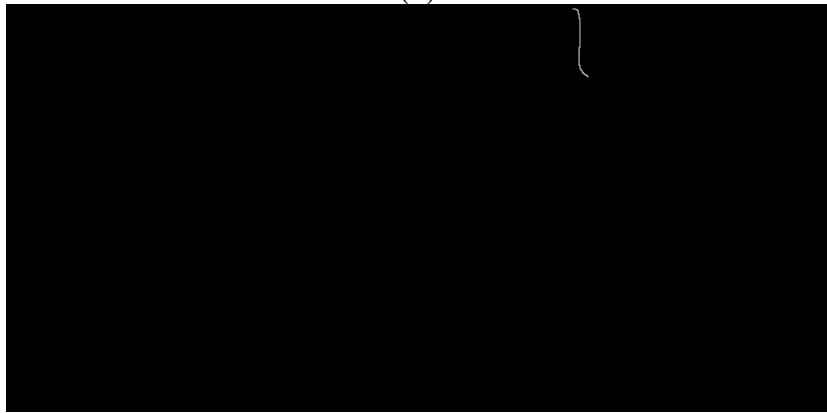
Figure A.141 TX2 Section 2B-X at 548 days after cast (a) original image (b) Image after filtering (c) Image after tracing and Mask

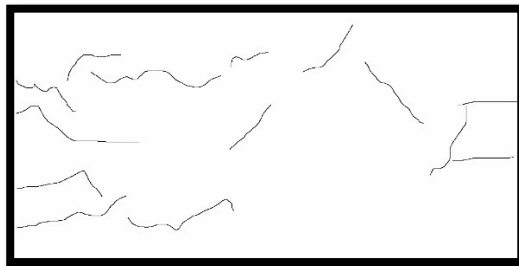
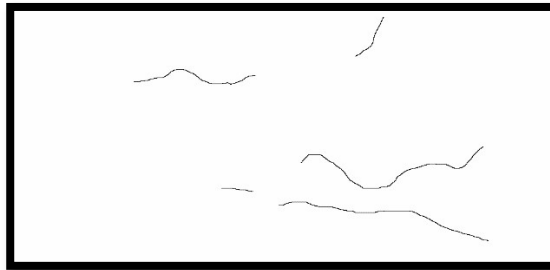
Figure A.143 Section 2B TX2 Mask X and Y shear direction combined traced cracks and inverted (a) 45 Days (b) 97 Days (c) 467 Days (d) 548 Days
