**Comparison study of precise monitoring  
techniques applied to engineering specimens  
tested under dynamic loading**

**Anna Maria Metheniti**

Department of Civil, Environmental & Geomatic Engineering

University College London

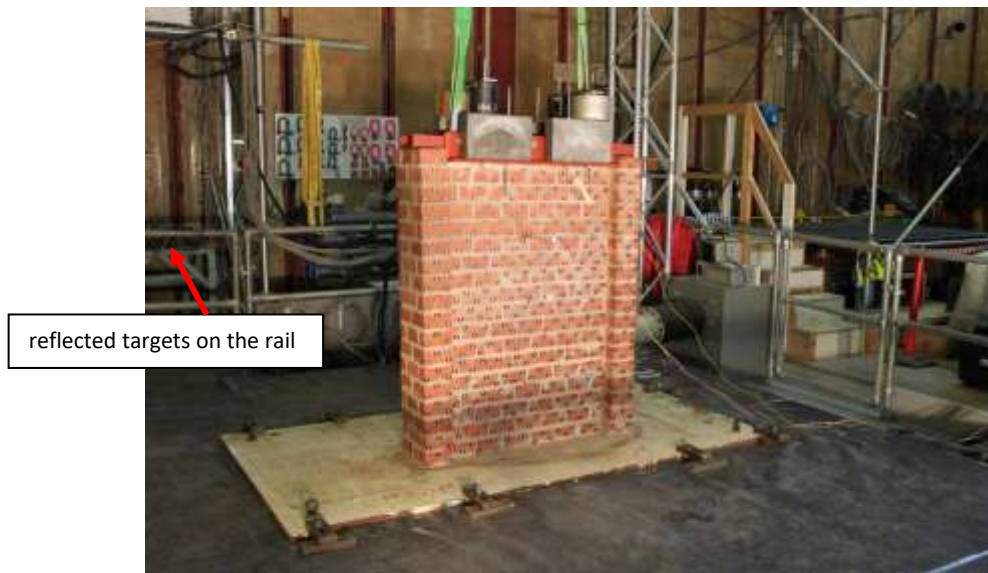
Figure 3.17: Large-wall specimen positioned on the large shaking table along with the loadings fixed at the top of the large wall with the use of the stainless-steel loading case and the appropriate steel rods, at the University of Bristol

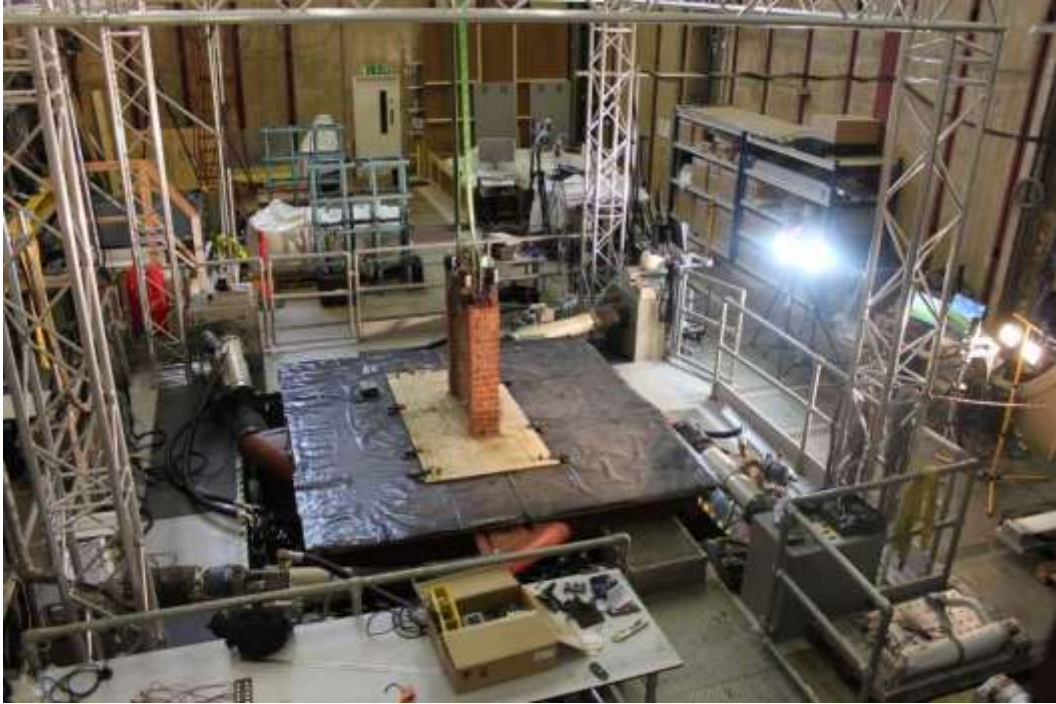
Figure 3.18: Large-wall specimen positioned on the large shaking table along with the loadings; headlights, cameras and computers placed on a desk opposite to the shaking table, at the University of Bristol

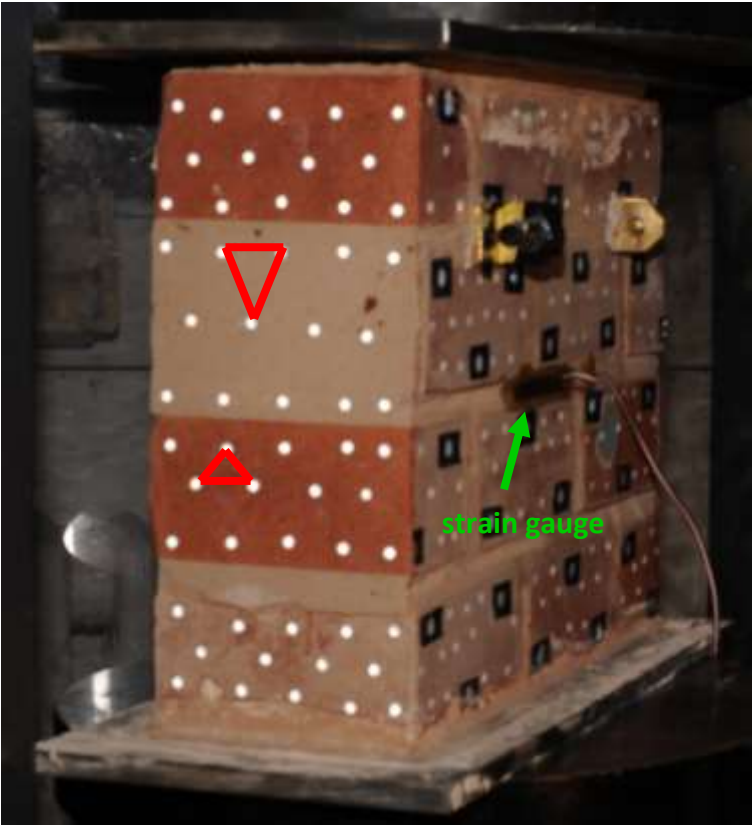
Figure 4.30: uncracked specimen – exp 2

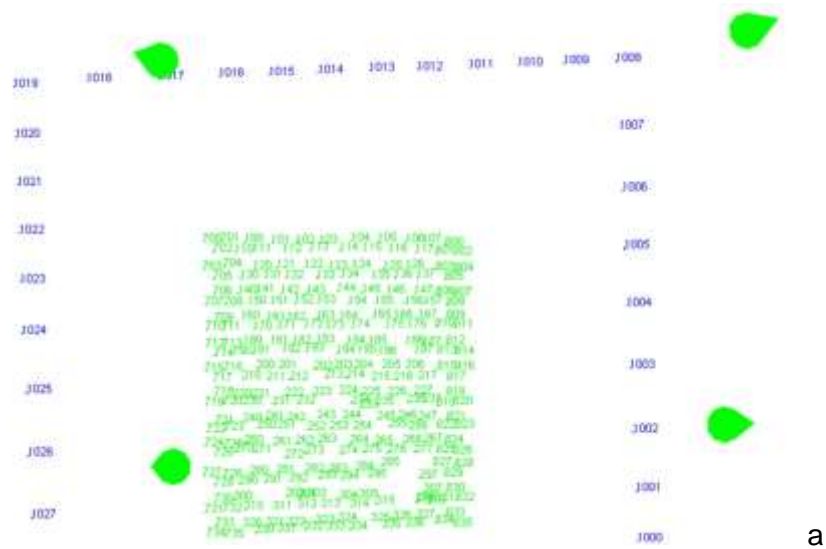
object view with target IDs and cameras in 2D

Figure 5.1.4a shows the numbered reflected targets (targets ID) on the specimen (green numbers) and on the wooden frame attached to the wall (blue numbers – control points) and the four cameras (green cones). Figure 5.1.4b is the same as figure 5.1.4a along with the observations from the cameras. Figure 5.1.4c is similarly the same as figure 5.1.4a, but on 3D space. Figure 5.1.4d shows the four pictures of the specimen as captured by the three cameras in the VMS software. Figure 5.1.5 presents the additional epoch, creating 5 epochs in total for the second method, similarly in the VMS environment.

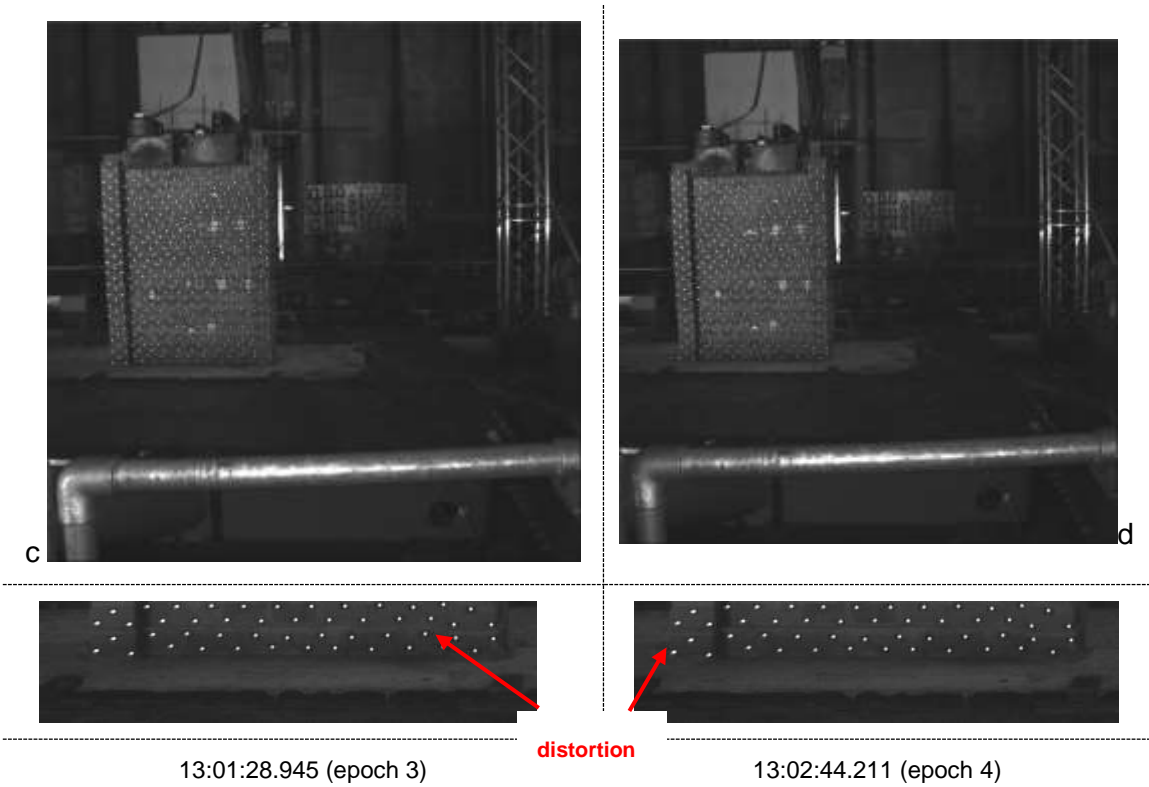
Figure 6.1.2: Images' sequences capturing the actuated tested wall – exp 7

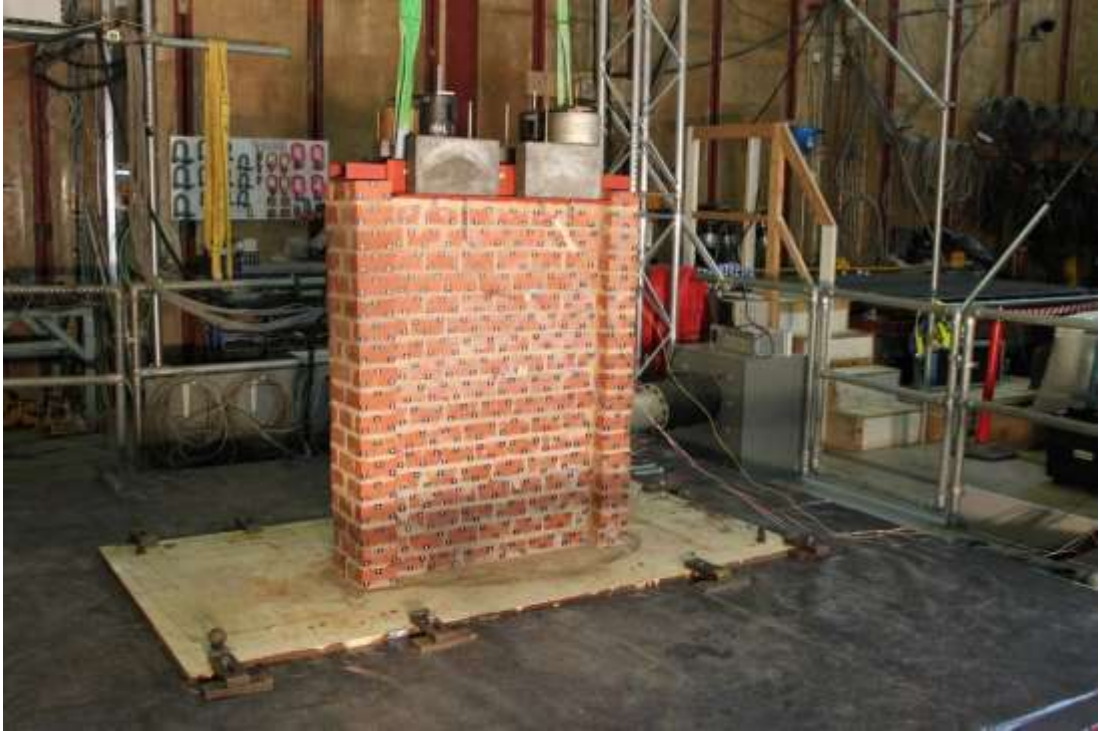
Figure App. III – 8: First large-wall specimen positioned on the shaking table along with the loadings fixed at the top of the large wall with the use of the stainless-steel loading case and the appropriate steel rods, at the University of Bristol

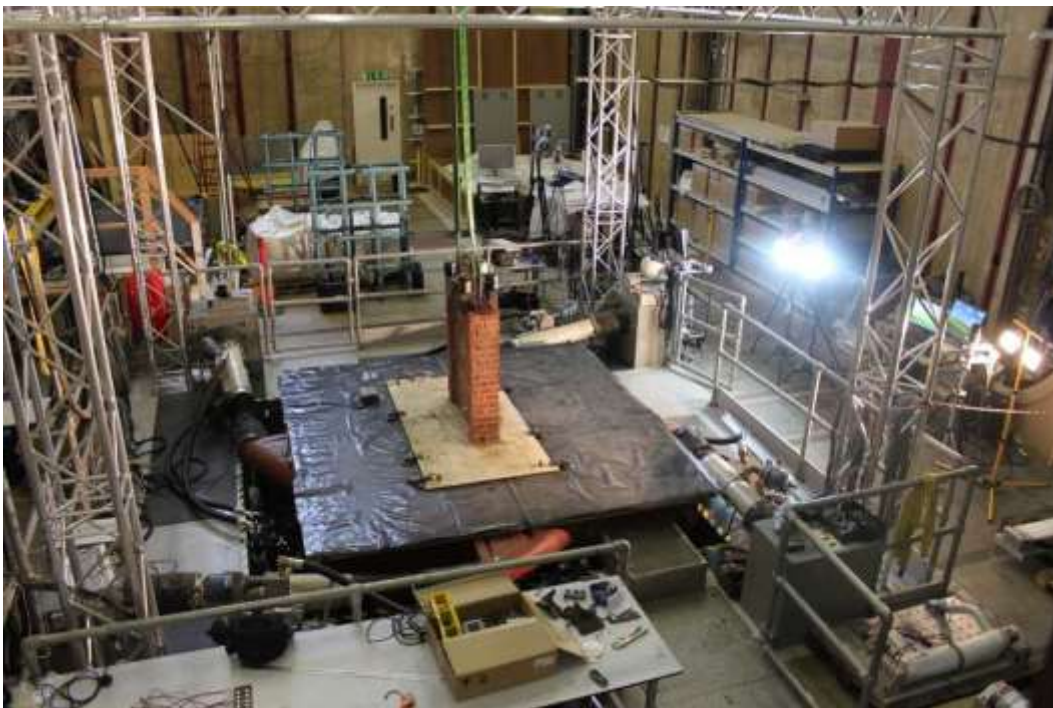
Figure App. III – 9: First large-wall specimen positioned on the shaking table along with the loadings; head-lights, cameras and computers placed on a desk opposite to the shaking table, at the University of Bristol
