Experimental Investigation on Shear Resistance Behaviour of RC Precracked and Non-Precracked T-Beams using Discrete CFRP Strips

J. Jayaprakash^{1,*}, A.A. Abdul Samad², A.A. Ashrabo³ and K.K. Choong⁴

^{1, 4} School of Civil Engineering, Universiti Sains Malaysia, Malaysia

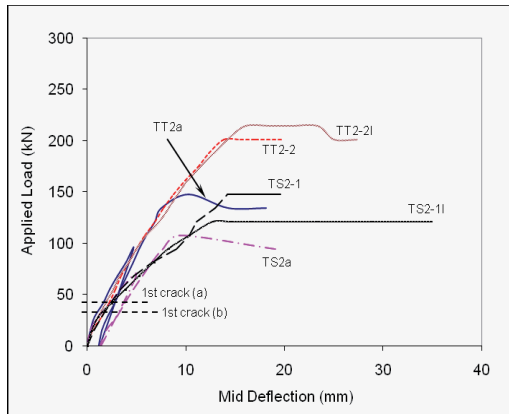
Fig. 3(b) Load-Mid Deflection curves for precracked-repaired and initially strengthened T-beams in categories TT2 and TS2

Figures 3(a) and 3(b) show the applied load versus mid deflection for specimens in categories TT1 & TS1 and TT2 & TS2, respectively. In precracked-repaired and initially strengthened beams, the load was initially carried by concrete (i.e. before first crack) and followed by the contribution of the longitudinal reinforcement after

the initiation and propagation of flexural cracks. Subsequently, the steel stirrups and CFRP reinforcement began to carry the load after the formation of shear crack. All the precracked-repaired and initially strengthened specimens were failed in flexure and thus increased the ductility of the beams. It can also be seen in Figures 3(a) and 3(b); the load deflection curves of the precracked-repaired and initially strengthened beams in categories TT1, TS1, TT2, and TS2 were similar with respect to their control beam. This trend was due to the effect of internal steel stirrups however, in the investigation of CFRP wrapped rectangular beams [14], they found that there was significant difference was attained in the precracked-repaired and initially strengthened beams due to the absence of internal shear reinforcement.

The stiffness of the precracked-repaired and initially strengthened beams in categories TT1 & TT2 was greater as compared to the categories TS1 & TS2, respectively. Perhaps, this was attributed to the percentage of longitudinal tensile reinforcement ratio. The initial stiffness of the precracked-repaired and initially strengthened beams in categories TT1 and TS1 were almost similar prior to the formation of crack in concrete. Afterwards, there was a deviation in displacement curves for strengthened specimens in category TS1 due to the decrease in amount of tensile reinforcement. Similar trend was also observed in the CFRP strengthened specimens from categories TT2 and TS2. From this, it was concluded that the stiffness of the strengthened specimen increased with the increase in amount of tensile reinforcement. It was also observed that the mid deflections in subgroups TT2 and TS2 were more when compared to the

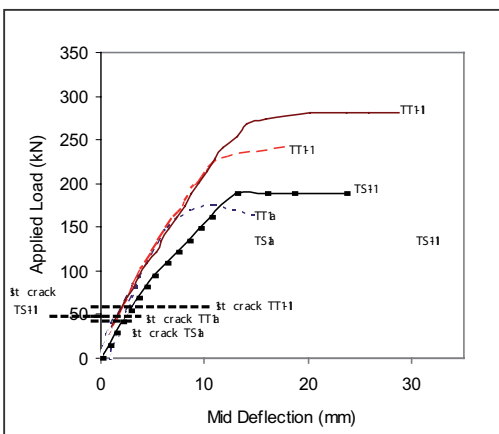
Fig. 3(a) Load-Mid Deflection curves for precracked-repaired and initially strengthened T-beams in categories TT1 and TS1
