The sepulchre of the Blessed Ramon Llull is a XV century monument located in Palma (Mallorca, Spain). During the studies developed for the restoration project, remains of the original polychrome were discovered. Prolonged exposure to high levels of humidity and leaks were the main causes of the deterioration of the monument's polychromies. The plaster layers lost cohesion and adhesion from the support, so they had to be treated.

The sepulchre of Blessed Ramon Llull is located in the church of San Francisco, in Palma de Mallorca. The construction, in gothic style, began in 1460 and remained unfinished in 1492.

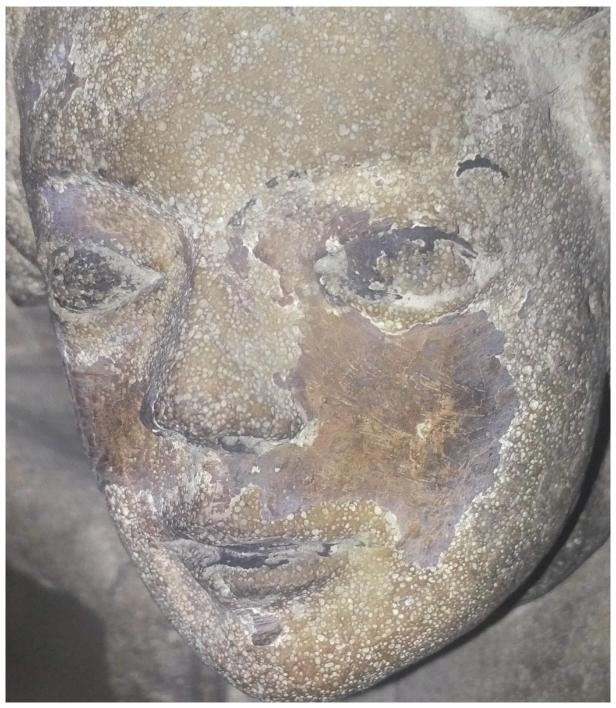
The main tonalities of the polychromies identified *de visu* are black, red, crimson, blue and gold, applied with plain colors. The pigments are natural earth, lead white and iron oxide with pure gold leaf sheet for gilding. The preparation layer was a mixture of calcite and calcium sulfate inerts, while the binders are animal glue and occasionally casein, therefore the polychromy could be defined as tempera.

Figure 4 – Polychromies of de sepulcre.
