VALUE ASSESSMENT AT THE INTERSECTION OF NATURE AND
INDUSTRY
THE CASE OF ÇAMALTI SALTERN

A THESIS SUBMITTED TO
THE GRADUATE SCHOOL OF NATURAL AND APPLIED SCIENCES
OF
MIDDLE EAST TECHNICAL UNIVERSITY

IN PARTIAL FULFILLMENT OF THE REQUIREMENTS
FOR
THE DEGREE IN MASTER OF SCIENCE
IN CONSERVATION OF CULTURAL HERITAGE
IN
ARCHITECTURE

AUGUST 2016

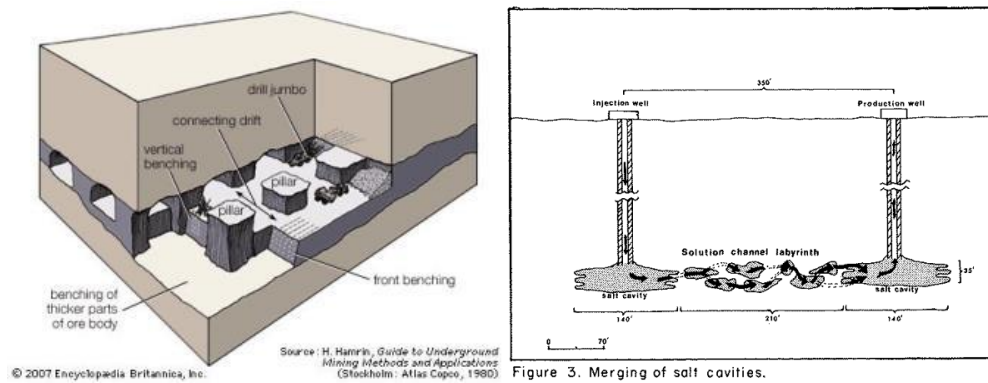
Figure 14 Room-Pillar Mining¹¹⁸ and Solution Mining Scheme¹¹⁹

Rock salt can be easily found almost everywhere. They are formed by the evaporation of seas of closed inland basins in geological eras.¹¹⁵ The extraction of rock salt can be done via two different methods; room-pillar mining and solution mining.¹¹⁶ In room pillar mining the bed is divided into regular rooms and pillars.¹¹⁶ Solution mining is applicable to the defined salt beds with known capacity. A borehole is drilled towards the source and a pipe is inserted within. Then limnetic water is injected into the pipe. Upon encountering the rock salt, saturated brine is obtained in the salt bed. The brine is then withdrawn towards the surface and evaporation process is applied to it.¹¹⁷

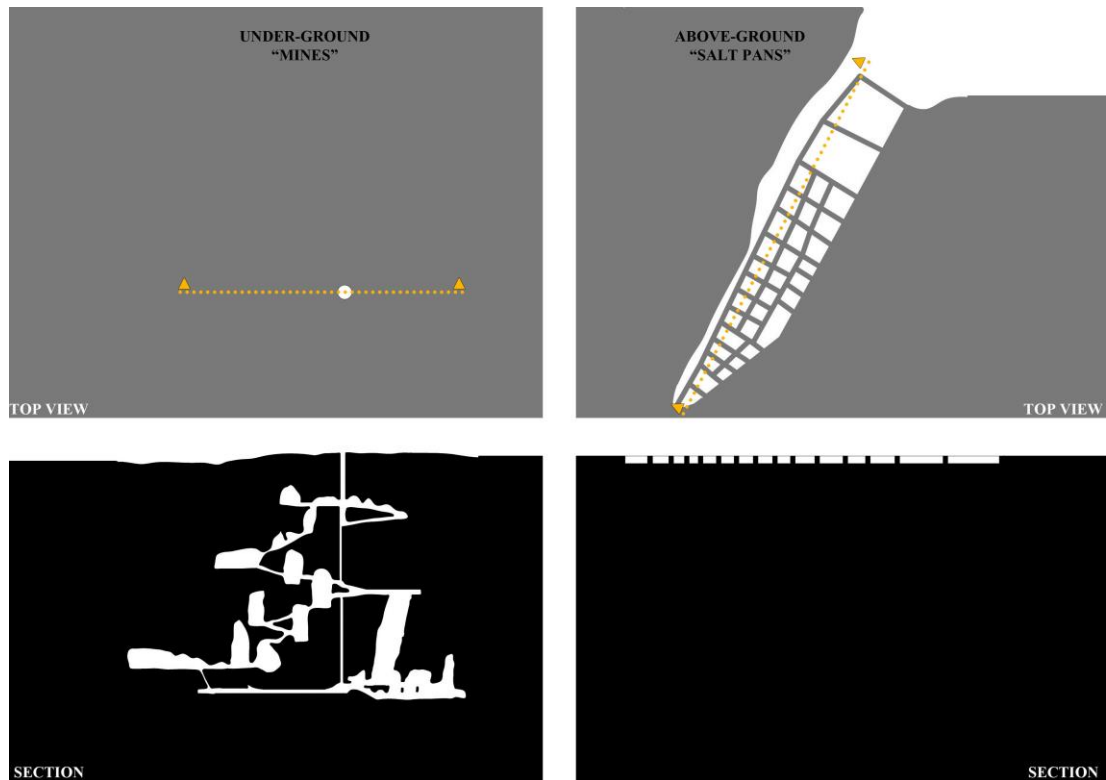
Figure 19 Illustration of salt landscapes (Author¹³²)

Salt, as mentioned previously, is one of the most vital elements in life. Wherever it is gathered, it creates a unique structure and landscape. These landscapes can either be found under ground or above ground in accordance with their production technique. Salt or salty water can be mined or obtained through evaporation of salty water creating two different types of landscapes. First one expands underground and understandable in sections mostly, while the second one sprawls above the ground level and is experienced by views from the top.

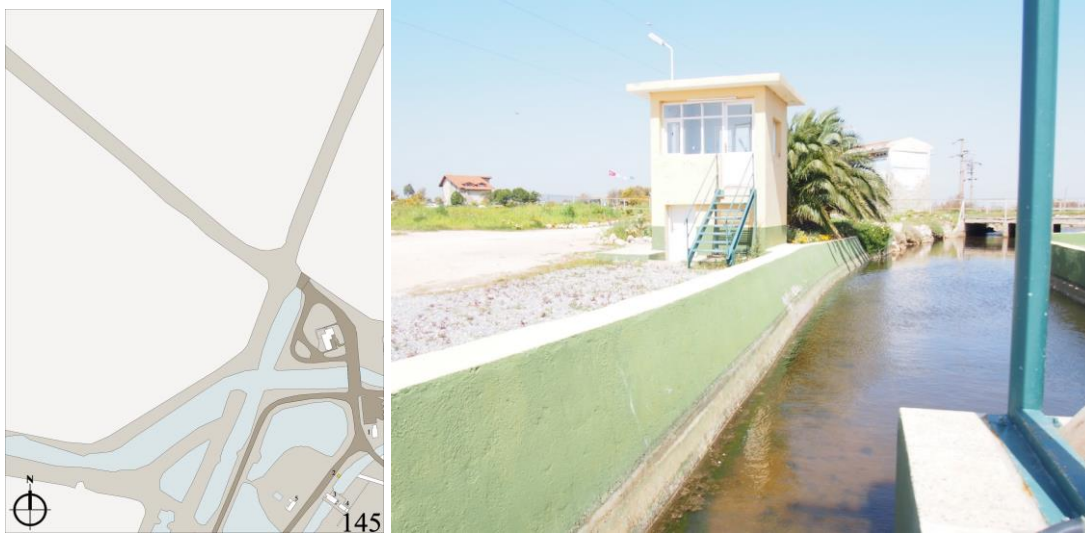
1. Watchbox (145/2) (Appendix K, Sheet No:1)

Figure 99 Site plan and southwestern facade of the watchbox (Author, April 2016)

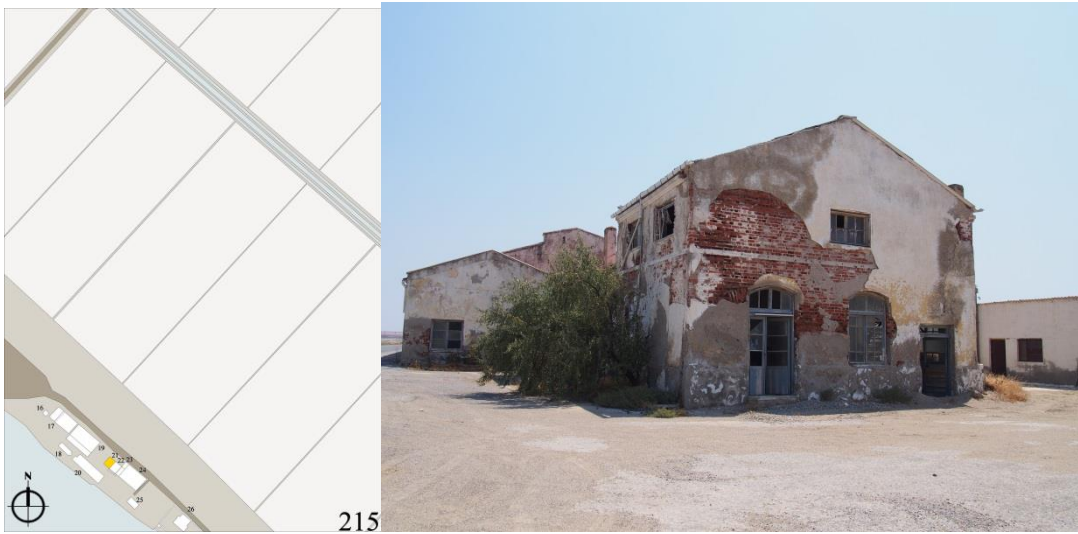
9. House? 1 (215/21) (Appendix K, Sheet No:9)

Figure 107 Site plan and view from the northern corner of the house? 1 (Author, April 2016)

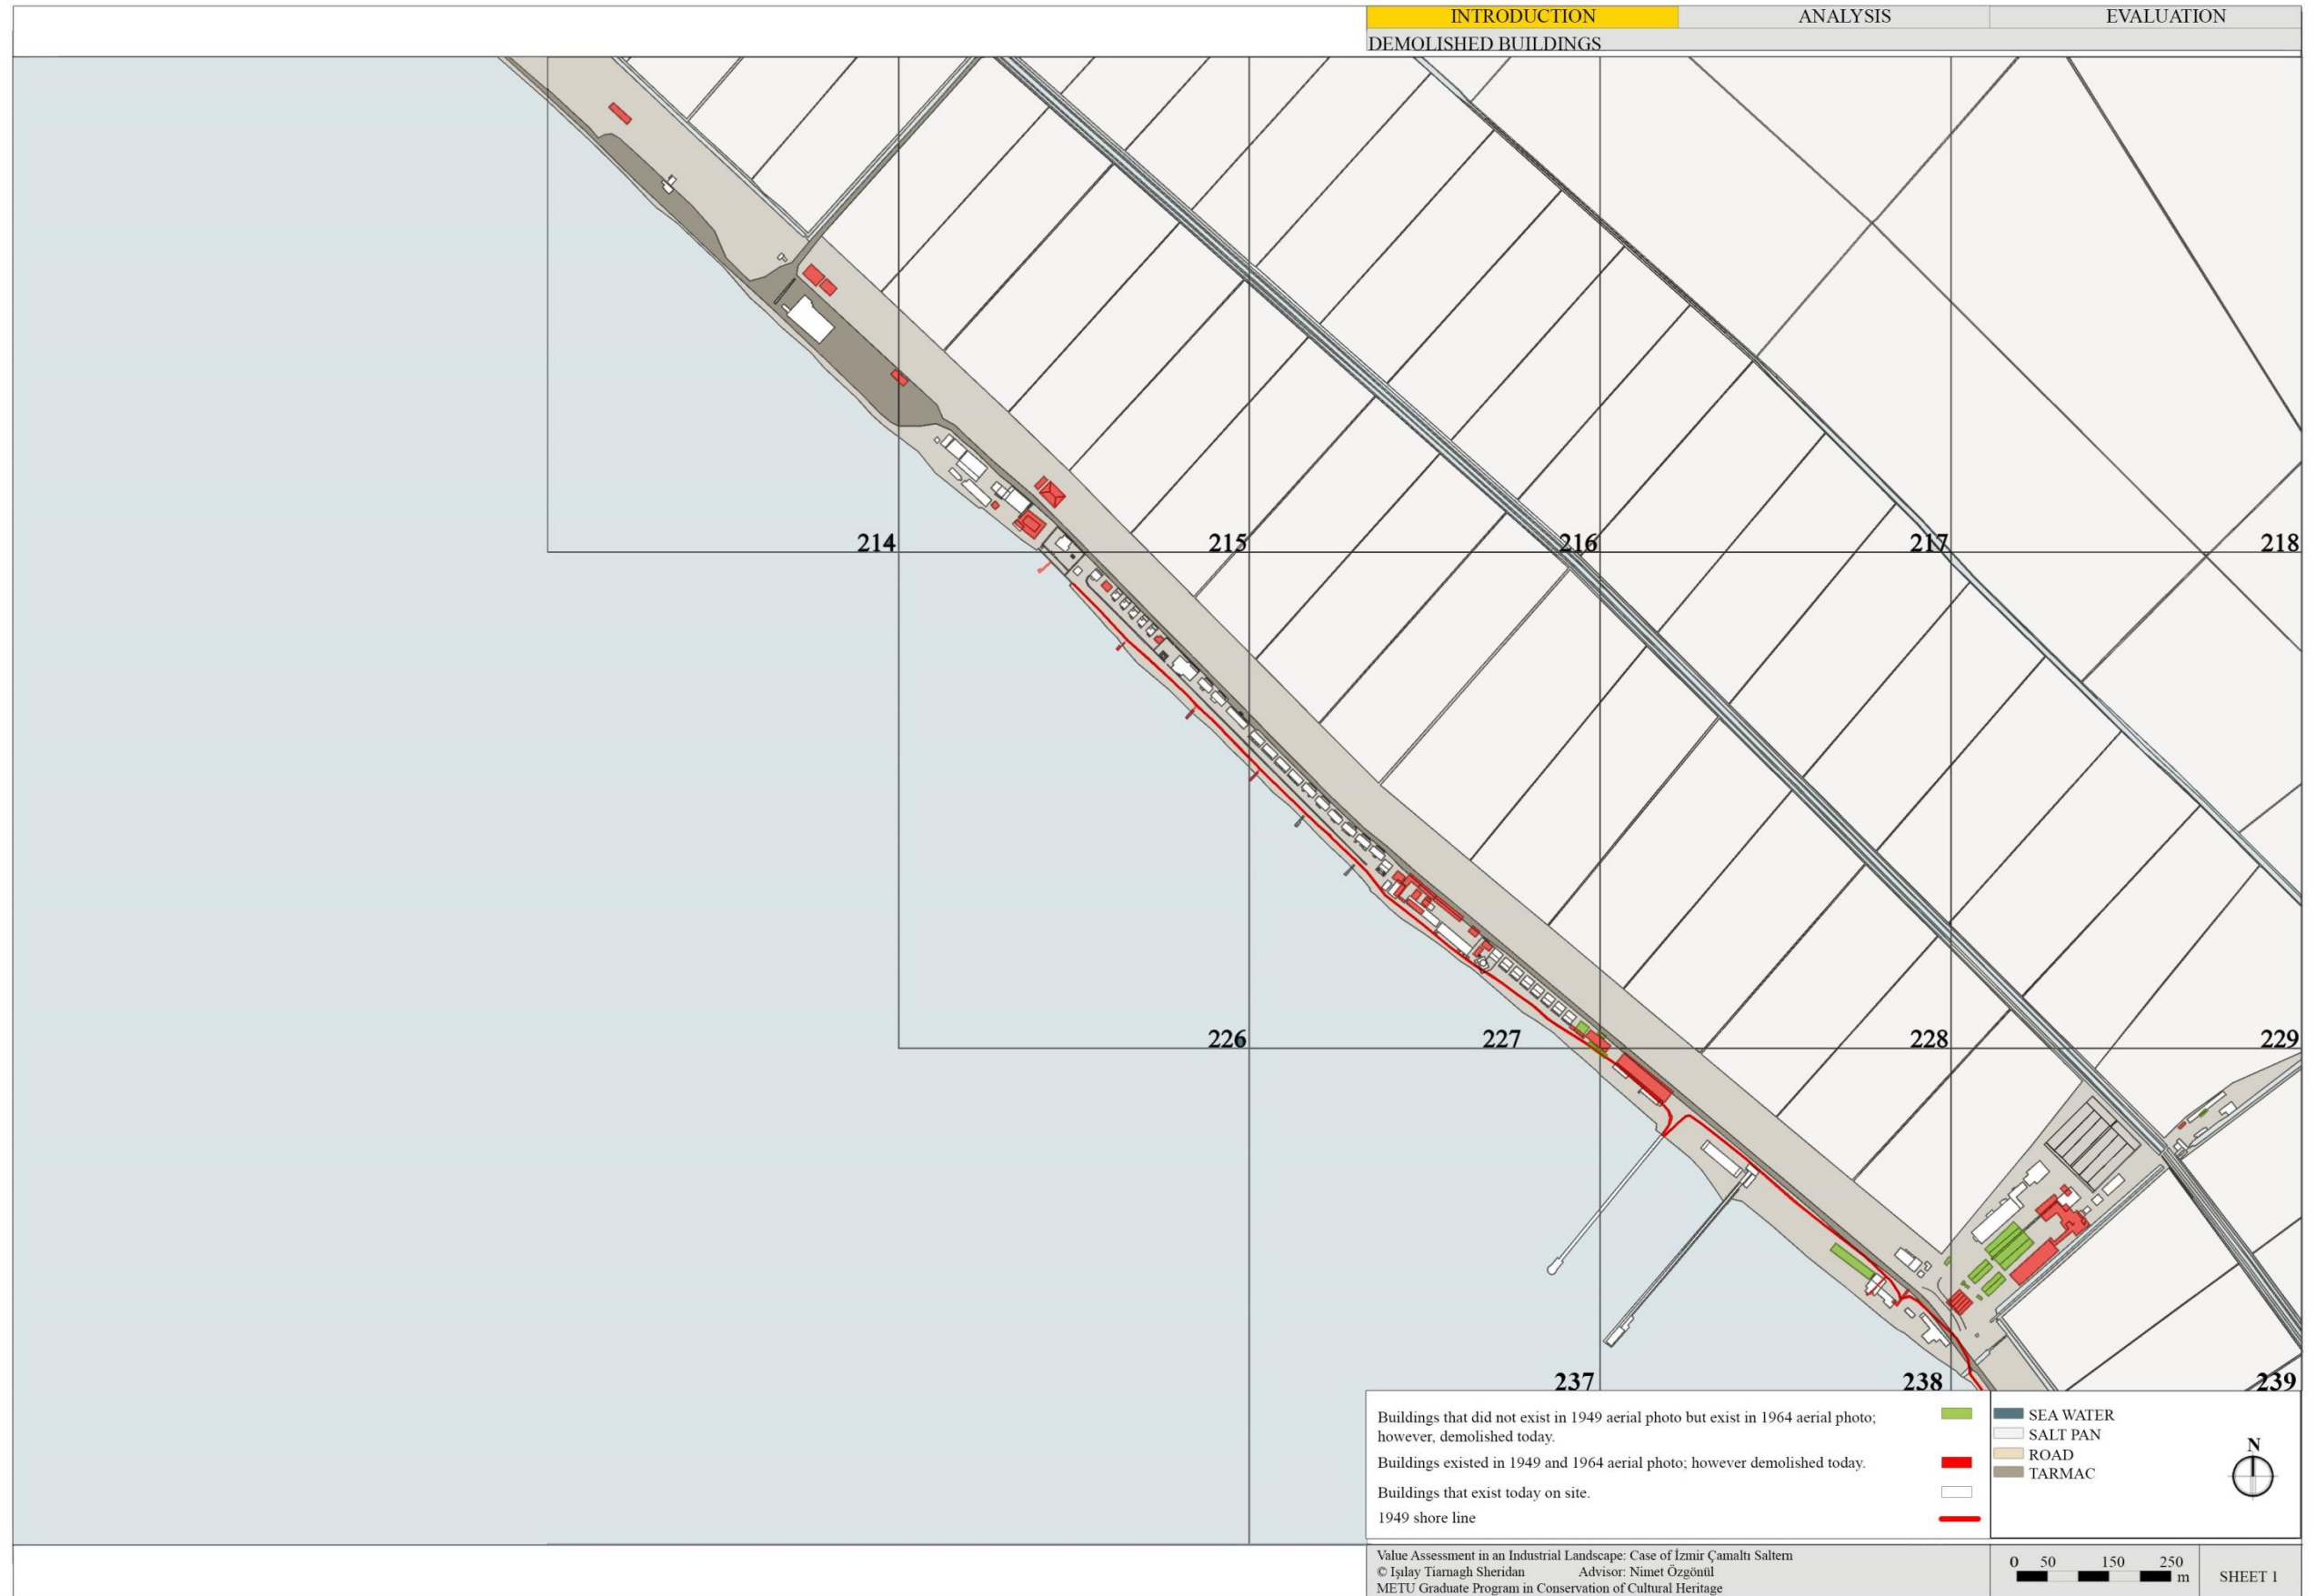
Figure 138 Demolished buildings

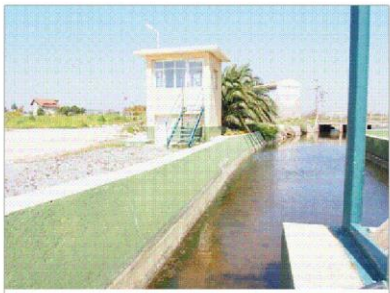
Original Func.	Watchbox	Current Func.	Empty														
Status	Restored <input checked="" type="checkbox"/>	Not Restored	Number of floors: 2														
SITE/GENERAL LAYOUT /PLAN CHARACTERISTIC/FACADE CHARACTERISTIC The edifice is situated just outside of the northern end of the 1950 expansion. It was probably built with the expansion project in 1950-1952. It has thicker ground floor walls and on the first floor the walls get thinner. Therefore, this small square-ish edifice possibly has stone masonry and solid brick loadbearing walls. It has dimensions of 2.45 x 2.90 m. The entrances to the two levels are located on its southwestern facade.

STRUCTURAL SYSTEM - CONSTRUCTION MATERIAL																	
FLOORS	MASONRY		MT.FRAME		SLAB		ROOF		ROOF COVER		FINISHING						
							PITCH	FLAT	(IF HIPPED)								
	Cut Stone	Rubble Stone	Solid Brick	Other(or UJ)	Solid Brick	Hollow Brick	Other(or UJ)	Wooden Structure	Concrete Slab	Steel Structure	Other(or UJ)	Corrugated Roof Panel	Roof Tile	Other(or UJ)	Exposed	Plaster+ Paint	Other(or UJ)
Gr.F.	<input checked="" type="checkbox"/>	<input checked="" type="checkbox"/>					<input checked="" type="checkbox"/>								<input checked="" type="checkbox"/>	<input checked="" type="checkbox"/>	
1st F.								<input checked="" type="checkbox"/>							<input checked="" type="checkbox"/>	<input checked="" type="checkbox"/>	
OVERALL DESCRIPTION																	
CONDITION	GOOD	1	In good condition in terms of structure&material whereas minor problems in finishing materials.														<input checked="" type="checkbox"/>

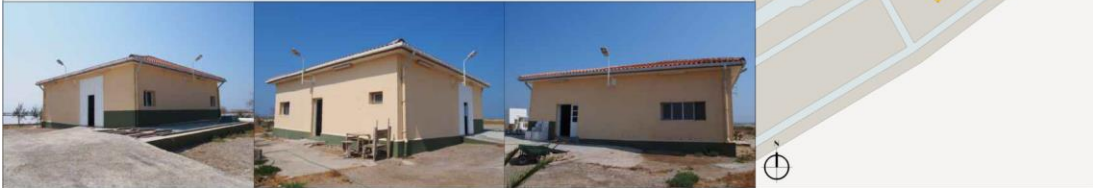
INTRODUCTION		ANALYSIS		EVALUATION																
IDENTIFICATION																				
INVENTORY SHEET FOR ÇAMALTI SALTERN					S SURVEY															
Date: 04/04/2016		ID: Tympanum 1		Site Plan																
Address: 187/8		Construction Date/Source of Information:		1863-1923																
Original Func.	Tympanum	Current Func.	Tympanum																	
Status	Restored <input checked="" type="checkbox"/>	Not Restored	Number of floors: 1																	
SITE/GENERAL LAYOUT /PLAN CHARACTERISTIC/FACADE CHARACTERISTIC																				
<p>The edifice is located at the northern edge of the pre-modernization border of the saltern, in between the two rows of crystallization pools. In the earliest map of the area, the 1925 map, the building can be seen. Therefore, it was probably built between 1863 and 1923. It is accessed from the road that is available to the fishermen of the Homa fishpond. On the other side of the water channels there are shelters of these fishermen. The edifice is connected to these water channels and has a garden on its southwestern side for growing different plants. It is a one-storey high square (10 x 10 m) masonry mass covered with a wooden hipped roof. Moreover, it is the only tympanum that doesn't have a mass addition. It has two entrances, one in south-east and one in north-east.</p>

STRUCTURAL SYSTEM - CONSTRUCTION MATERIAL																				
FLOORS	MASONRY <input checked="" type="checkbox"/>		MT.FRAME		SLAB		ROOF		ROOF COVER		FINISHING									
							PITCH <input checked="" type="checkbox"/> FLAT		(IF HIPPED)											
	Cur Stone	Rubble Stone	Solid Brick	Other(or UJ)	Solid Brick	Hollow Brick	Other(or UJ)	Wooden	Concrete	Other(or UJ)	Wooden Structure	Concrete Slab	Steel Structure	Other(or UJ)	Corrugated Roof Panel	Roof Tile	Other(or UJ)	Exposed	Plaster+ Paint	Other(or UJ)
Gr.F.	?																			
1st F.																				
OVERALL DESCRIPTION																				
The edifice was built with a masonry structure. However, it is not possible to detect its materials.(wall thickness points out to stone though) The slab is covered with concrete today. It has a wooden hipped roof covered with wooden panels underneath. The roof is covered with roof-tiles. Its facade is plastered and painted.

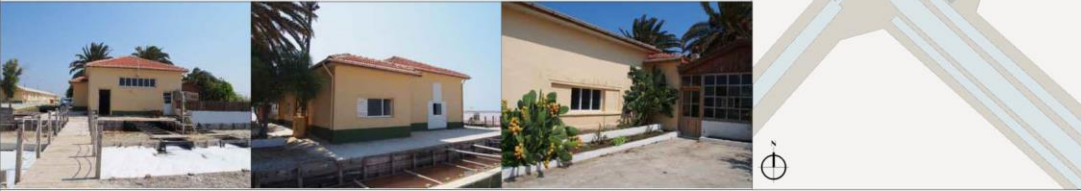
INTRODUCTION		ANALYSIS		EVALUATION												
IDENTIFICATION																
INVENTORY SHEET FOR ÇAMALTI SALTERN					S SURVEY											
Date: 04/04/2016		ID: Tympanum 2		Site Plan												
Address: 202/12		Construction Date/Source of Information:		1863-1923 Addition 1923-1949												
Original Func.	Tympanum	Current Func.	Tympanum													
Status	Restored <input checked="" type="checkbox"/>	Not Restored	Number of floors: 1													
SITE/GENERAL LAYOUT /PLAN CHARACTERISTIC/FACADE CHARACTERISTIC																
<p>The edifice is the second tympanum from top left to bottom right. It is accessed through a road perpendicular to the sea shoreline and located in between the two rows of crystallization pools. In the 1925 map the building was indicated. Therefore, it was probably built between 1863 and 1923. The edifice is connected to water channels and has a garden on its south side for growing different plants. It is originally a one-storey high masonry mass with dimensions 6.60 x 7.20 m. It is covered with a reinforced concrete slab on which there is a wooden hipped roof. The extension is a one-storey high rectangular masonry mass covered with a wooden hipped roof. The dimensions of this extension are 15 x 4 m. The greenhouse was built with a wooden frame and a gable roof. This complex has three entrances; one from the garden to the greenhouse, one on the southwestern facade and one on the northeastern facade.</p>

STRUCTURAL SYSTEM - CONSTRUCTION MATERIAL																
FLOORS	MASONRY		MT.FRAME		SLAB		ROOF		ROOF COVER		FINISHING					
							PITCH		(IF HIPPED)							
	Cut Stone	Rubble Stone	Solid Brick	Other(or UJ)	Solid Brick	Hollow Brick	Other(or UJ)	Wooden Structure	Concrete Slab	Steel Structure	Other(or UJ)	Corrugated Roof Panel	Roof Tile	Other(or UJ)	Exposed	Plaster+Paint
Gr.F.	?	?														
1st F.																
OVERALL DESCRIPTION																
<p>These edifices were built with a masonry structure. However, it is not possible to detect its materials. The slabs are covered with concrete today. The two masses have separate wooden hipped roofs covered with roof tiles. Its facade is plastered and painted.</p>																
CONDITION	GOOD	1	In good condition in terms of structure&material whereas minor problems in finishing materials.													
	FAIR	2	No structural problem, but surface deterioration in material.

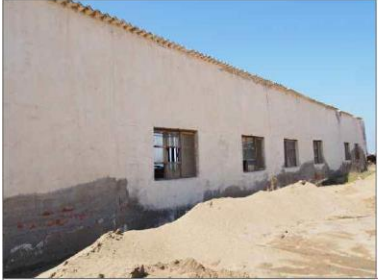
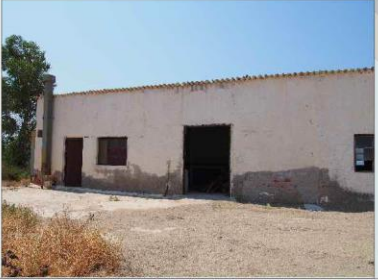
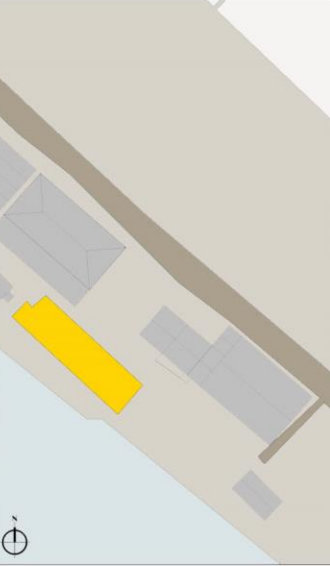
INTRODUCTION		ANALYSIS		EVALUATION																
IDENTIFICATION																				
INVENTORY SHEET FOR ÇAMALTI SALTERN					S SURVEY															
Date: 05 / 04 /2016		ID: Refectory		Site Plan																
Address: 215/20		Construction Date/Source of Information:		1923-1960 (?) Design Inference																
Original Func.: Old Power Plant	Current Func.: Empty																			
Status: Restored	Not Restored		<input checked="" type="checkbox"/> Number of floors: 1																	
SITE/GENERAL LAYOUT /PLAN CHARACTERISTIC/FACADE CHARACTERISTIC																				
<p>The edifice is the third building from top left to bottom right organization and it is not in line with the rest of the other buildings. It is located behind the old factory?, near the sea side. It is a one-storey high edifice with steel structure and has an elongated rectangular mass in north-west to south-east direction with dimensions of 38 x 10 meters. It is covered by a flat roof. It has four entrances; one in the north-west, two in the north-east and one in the south-east.</p>

STRUCTURAL SYSTEM - CONSTRUCTION MATERIAL																				
FLOORS	MASONRY		MT.FRAME <input checked="" type="checkbox"/>		SLAB		ROOF		ROOF COVER		FINISHING									
							PITCH <input checked="" type="checkbox"/> FLAT		(IF HIPPED)											
	Cur Stone	Rubble Stone	Solid Brick	Other(or UJ)	Solid Brick	Hollow Brick	Other(or UJ)	Wooden	Concrete	Other(or UJ)	Wooden Structure	Concrete Slab	Steel Structure	Other(or UJ)	Corrugated Roof Panel	Roof Tile	Other(or UJ)	Exposed	Plaster+ Paint	Other(or UJ)
Gr.F.				<input checked="" type="checkbox"/>									<input checked="" type="checkbox"/>							
1st F.																				
OVERALL DESCRIPTION																				
<p>The edifice has metal frame structure, with metal posts, beams and diagonals filled with solid bricks. Its slab is covered with concrete. There are steel posts inside the edifice in shape of small ladders that are nowhere to be found at the site. The roof is formed with metal beams covered with corrugated roof panel. The walls are plastered and painted.</p>

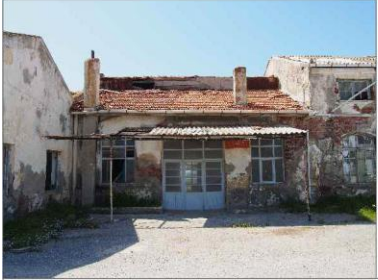
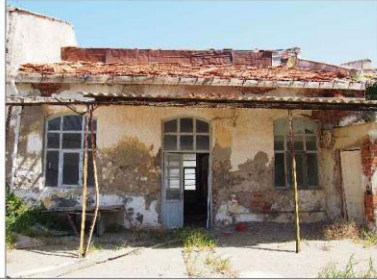
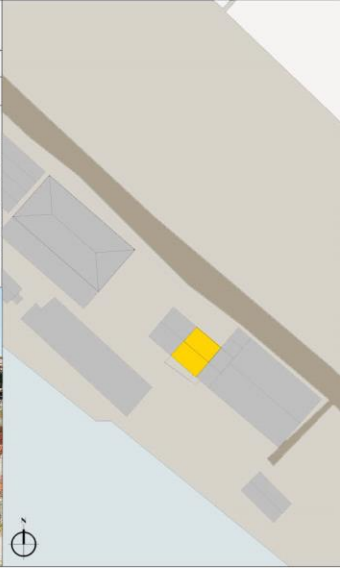
INTRODUCTION		ANALYSIS		EVALUATION																
IDENTIFICATION																				
INVENTORY SHEET FOR ÇAMALTI SALTERN					S SURVEY															
Date: 05/04 /2016		ID: Fire Station		Site Plan																
Address: 215/22		Construction Date/Source of Information:		1863-1923 Design Inference																
Original Func.	House?	Current Func.	Empty																	
Status	<input checked="" type="checkbox"/> Restored	<input type="checkbox"/> Not Restored	<input checked="" type="checkbox"/> Number of floors: 1																	
SITE/GENERAL LAYOUT /PLAN CHARACTERISTIC/FACADE CHARACTERISTIC																				
The edifice is adjacent to the house 1 in the north-west and house 2 in the north-east. Although it is not clear without an individual project at the building scale to show its relations with the adjacent masses, its current dimensions are 8.5 x 10 meters. It is a one storey high brick masonry building with a gable roof. It forms a group with house 1, house 2 and cinema. It has two entrances along the same axis from the southwestern facade and northeastern facade. Although not visible today, in the aerial photographs until 1970 there existed a small dock in front of the building.

STRUCTURAL SYSTEM - CONSTRUCTION MATERIAL																				
FLOORS	MASONRY		<input checked="" type="checkbox"/> MT.FRAME	SLAB		ROOF		ROOF COVER		FINISHING										
						PITCH	<input checked="" type="checkbox"/> FLAT	(IF HIPPED)												
	Cur Stone	Rubble Stone	Solid Brick	Other(or UJ)	Solid Brick	Hollow Brick	Other(or UJ)	Wooden	Concrete	Other(or UJ)	Wooden Structure	Concrete Slab	Steel Structure	Other(or UJ)	Corrugated Roof Panel	Roof Tile	Other(or UJ)	Exposed	Plaster+ Paint	Other(or UJ)
Gr. F.		<input checked="" type="checkbox"/>																		
1st F.																				
OVERALL DESCRIPTION																				
The edifice was built with brick masonry structure (each brick having 6 hollow cores inside). The slab was constructed with reinforced concrete and there are railways on the ground. The roof is composed of metal trusses covered with corrugated roof panel. Its facade is plastered and painted.

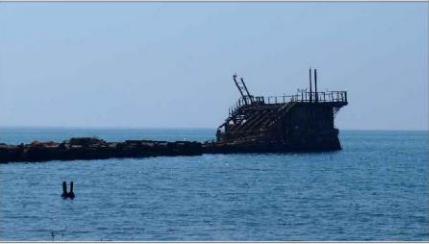
Original Func.	Port	Current Func.	Empty																	
Status	Restored	Not Restored	Number of floors: -																	
SITE/GENERAL LAYOUT /PLAN CHARACTERISTIC/FACADE CHARACTERISTIC The edifice is situated at the end of a port way delivery line in the sea. It is a one-storey high rectangular mass with a circular platform on top along southwest to northeast direction. It is approximately 205 meters long from the shoreline till its end point. It is not covered today and also it is not clear whether the mass under the platform was used as a space. The edifice is unreachable today.

STRUCTURAL SYSTEM - CONSTRUCTION MATERIAL																				
FLOORS	MASONRY		MT.FRAME <input checked="" type="checkbox"/>	SLAB		ROOF		ROOF COVER		FINISHING										
						PITCH		(IF HIPPED)												
	Cut Stone	Rubble Stone	Solid Brick	Other(or UJ)	Solid Brick	Hollow Brick	Other(or UJ)	Wooden	Concrete	Other(or UJ)	Wooden Structure	Concrete Slab	Steel Structure	Other(or UJ)	Corrugated Roof Panel	Roof Tile	Other(or UJ)	Exposed	Plaster+Paint	Other(or UJ)
Gr.F.																				
1st F.																				
OVERALL DESCRIPTION																				
The edifice has metal frame, with posts, beams and diagonals, with an undetectable infill. It also has stone masonry filling between two of its slabs. It has a metal platform on top and rails until the shoreline. The facades are plastered.																				
CONDITION	GOOD	1	In good condition in terms of structure&material whereas minor problems in finishing materials.

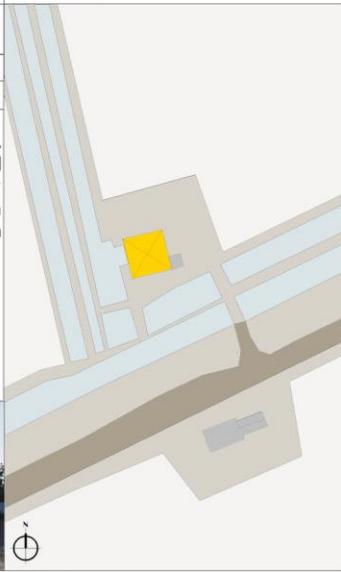
INTRODUCTION		ANALYSIS		EVALUATION												
IDENTIFICATION																
INVENTORY SHEET FOR ÇAMALTI SALTERN					S SURVEY											
Date: 04/04 /2016		ID: Tympanum 4 (and 5)		Site Plan												
Address: 258/105		Construction Date/Source of Information:		1863-1923 Addition 1970-2000												
Original Func.	Tympanum	Current Func.	Tympanum													
Status	Restored <input checked="" type="checkbox"/>	Not Restored	Number of floors: 1													
SITE/GENERAL LAYOUT /PLAN CHARACTERISTIC/FACADE CHARACTERISTIC																
The edifice is located at the southern edge of the pre-modernization border of the saltern. The edifice is connected to water channels and has a garden on its northeastern and southeastern sides for growing different plants. It is a one-storey high square-ish masonry mass covered with a wooden hipped roof. It has a small mass addition in the northeastern facade. This mass has its own entrance. The main building has five entrances; one on north-east, one on north-west, one on south-east and two on the southwestern facade.

STRUCTURAL SYSTEM - CONSTRUCTION MATERIAL																
FLOORS	MASONRY		MT.FRAME		SLAB		ROOF		ROOF COVER		FINISHING					
							PITCH	FLAT	(IF HIPPED)							
	Cur Stone	Rubble Stone	Solid Brick	Other(or UJ)	Solid Brick	Hollow Brick	Other(or UJ)	Wooden Structure	Concrete Slab	Steel Structure	Other(or UJ)	Corrugated Roof Panel	Roof Tile	Other(or UJ)	Exposed	Plaster+ Paint
Gr. F.		?	?													
1st F.																
OVERALL DESCRIPTION																
The edifice was built with a masonry structure; however, it is not possible to detect its materials(wall thickness points out to stone though). The spaces were covered with a reinforced concrete slab and a wooden hipped roof was constructed above. The roof was covered with roof-tiles. Its facade is plastered and painted.																
CONDITION	GOOD	1	In good condition in terms of structure&material whereas minor problems in finishing materials.
