Analysis of a Middle Mississippi Structure at the Denmark Site (40MD85)

ANALYSIS OF A MIDDLE MISSISSIPPI STRUCTURE AT THE DENMARK
SITE (40MD85)

A Thesis

Major: Earth Sciences

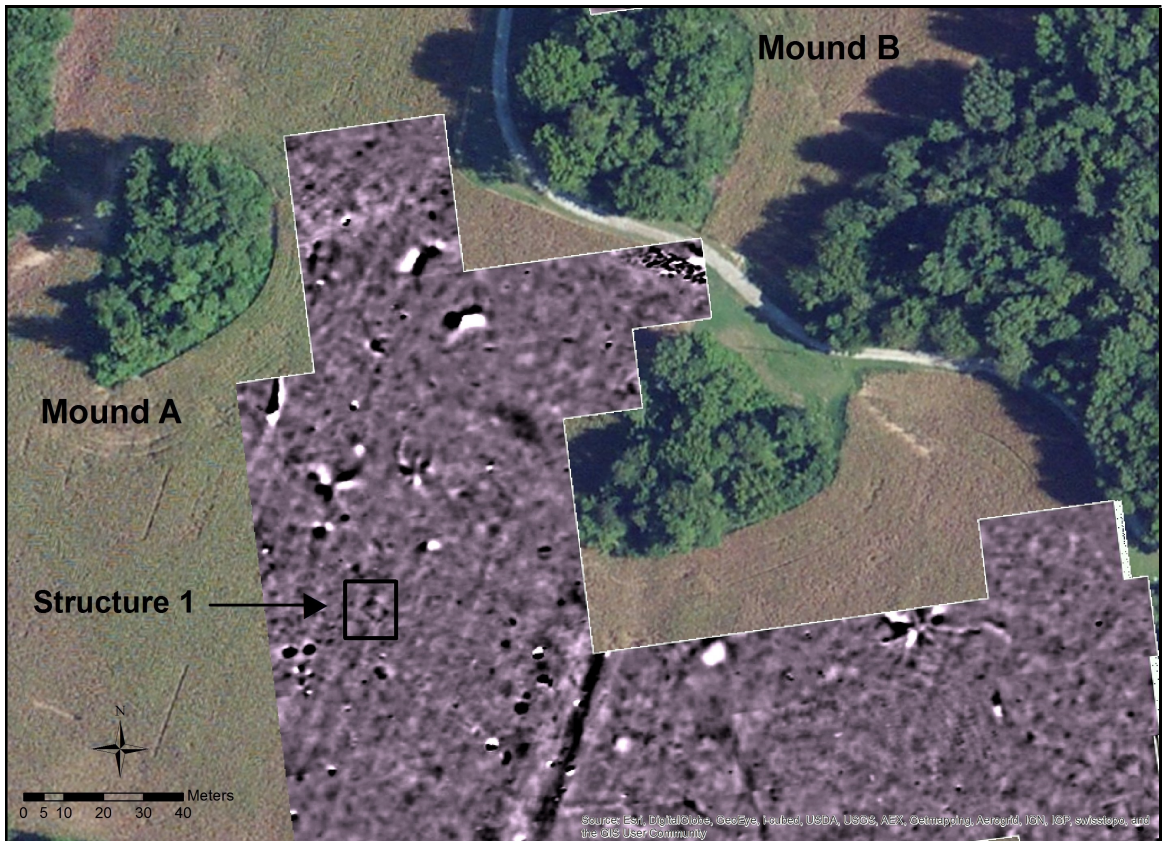
Figure 2. Magnetometry data showing location of Structure 1.

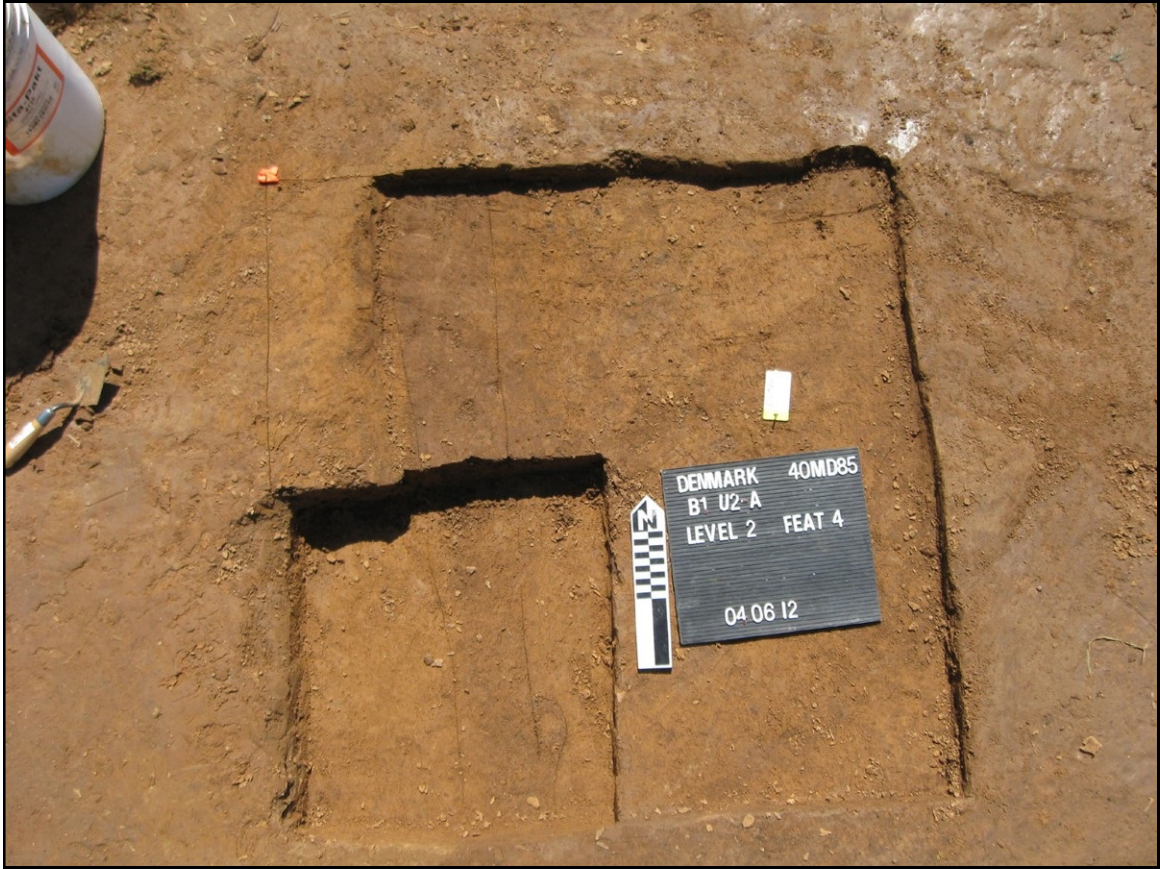
Figure 6. Original window confirming presence of wall trench in Structure 1.

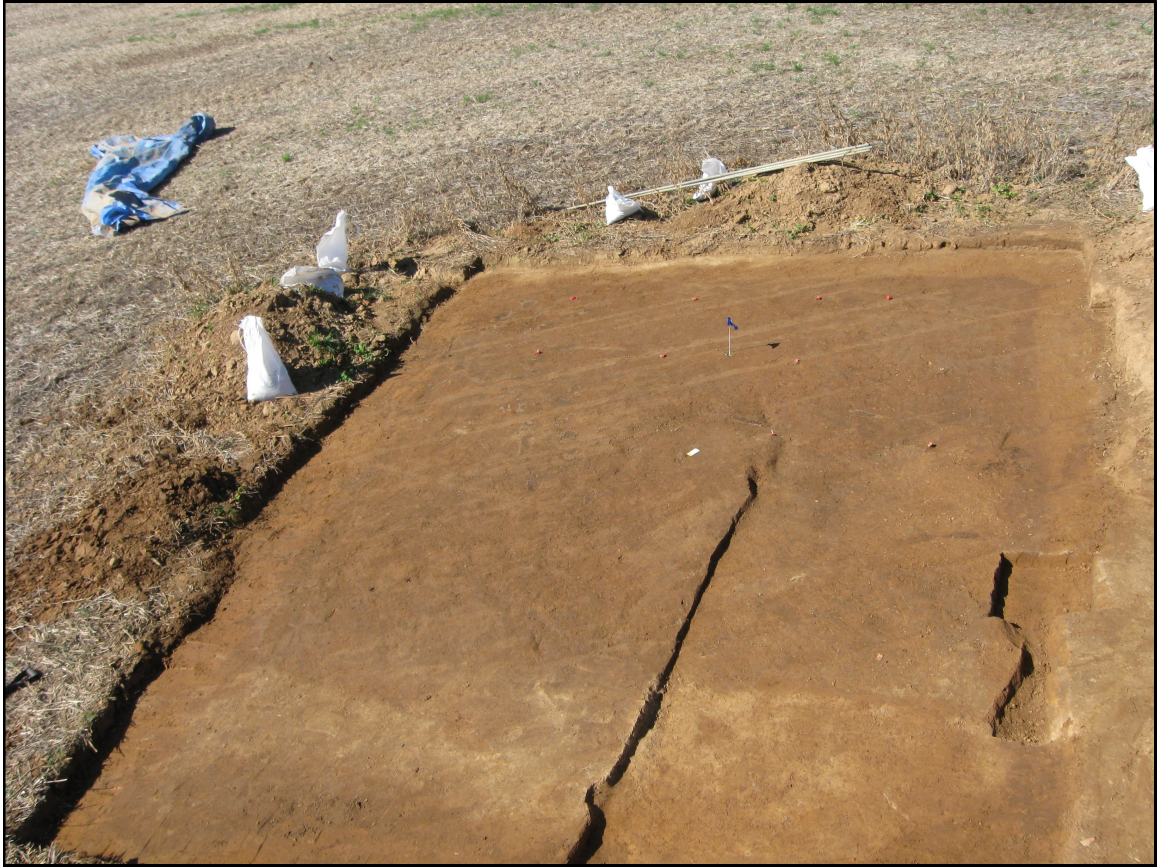
Figure 7. Rectangular footprint of Structure 1 showing darkened soil determined to be burned fill.

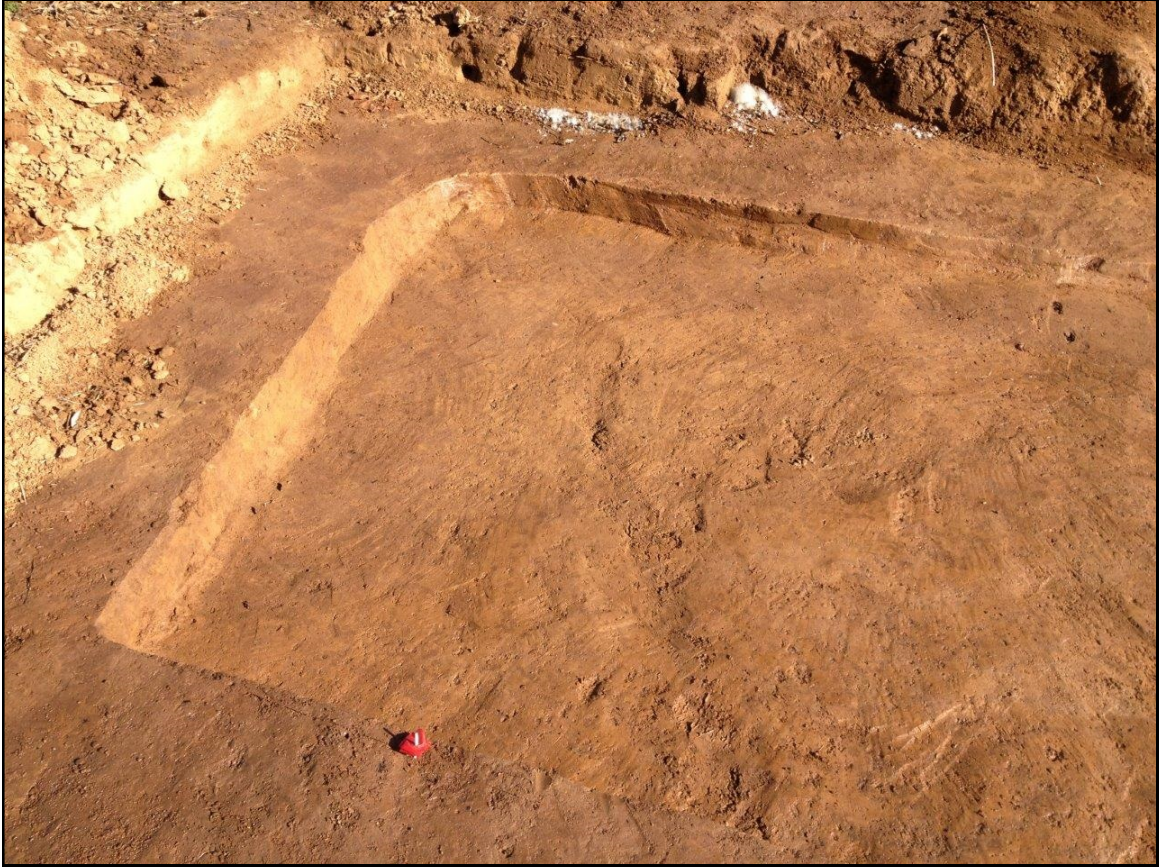
Figure 8. Northwest corner of Structure 1 showing a semi-subterranean foundation.

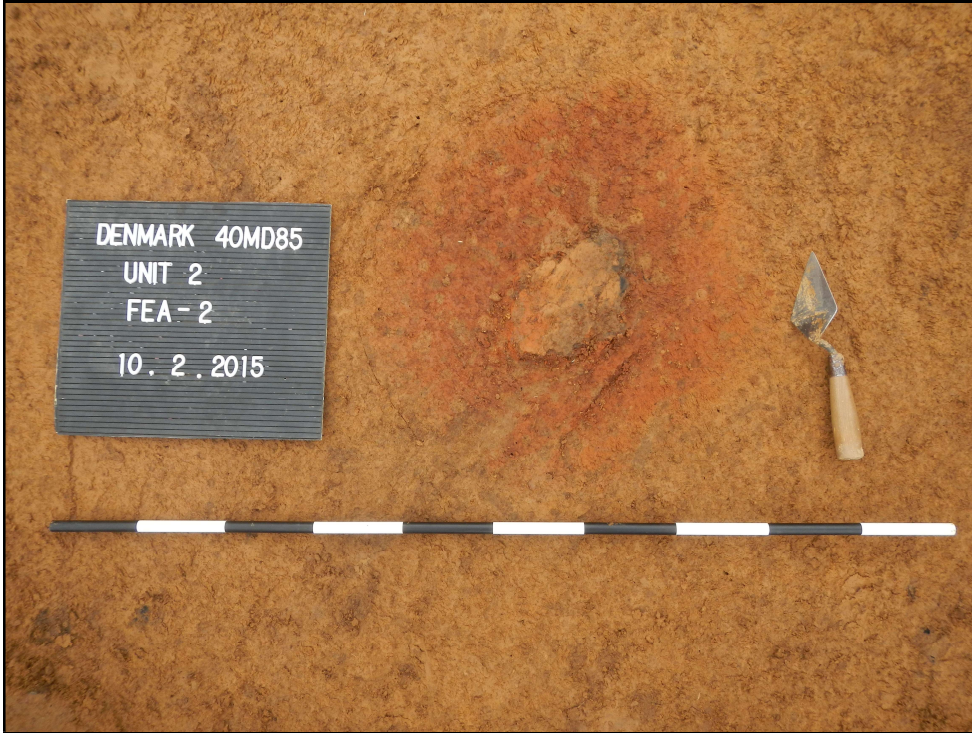
Figure 9a. Feature 11 (incorrectly identified as Feature 2 in photo), round hearth uncovered in Structure 1.

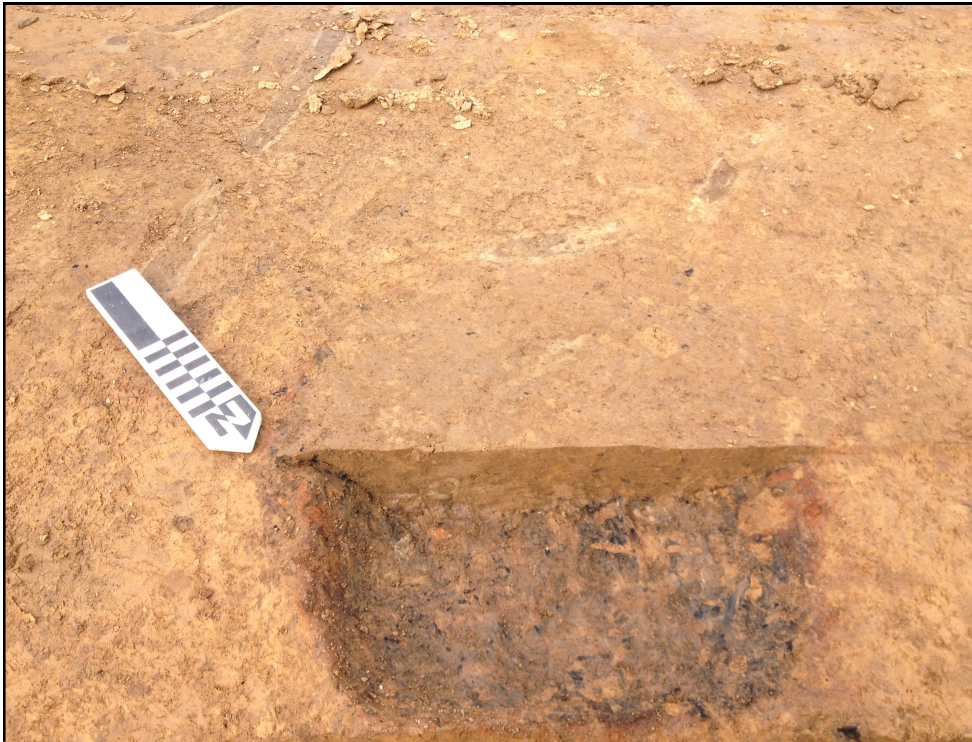
Figure 9b. Bisection of Feature 12, square hearth uncovered in Structure 1.

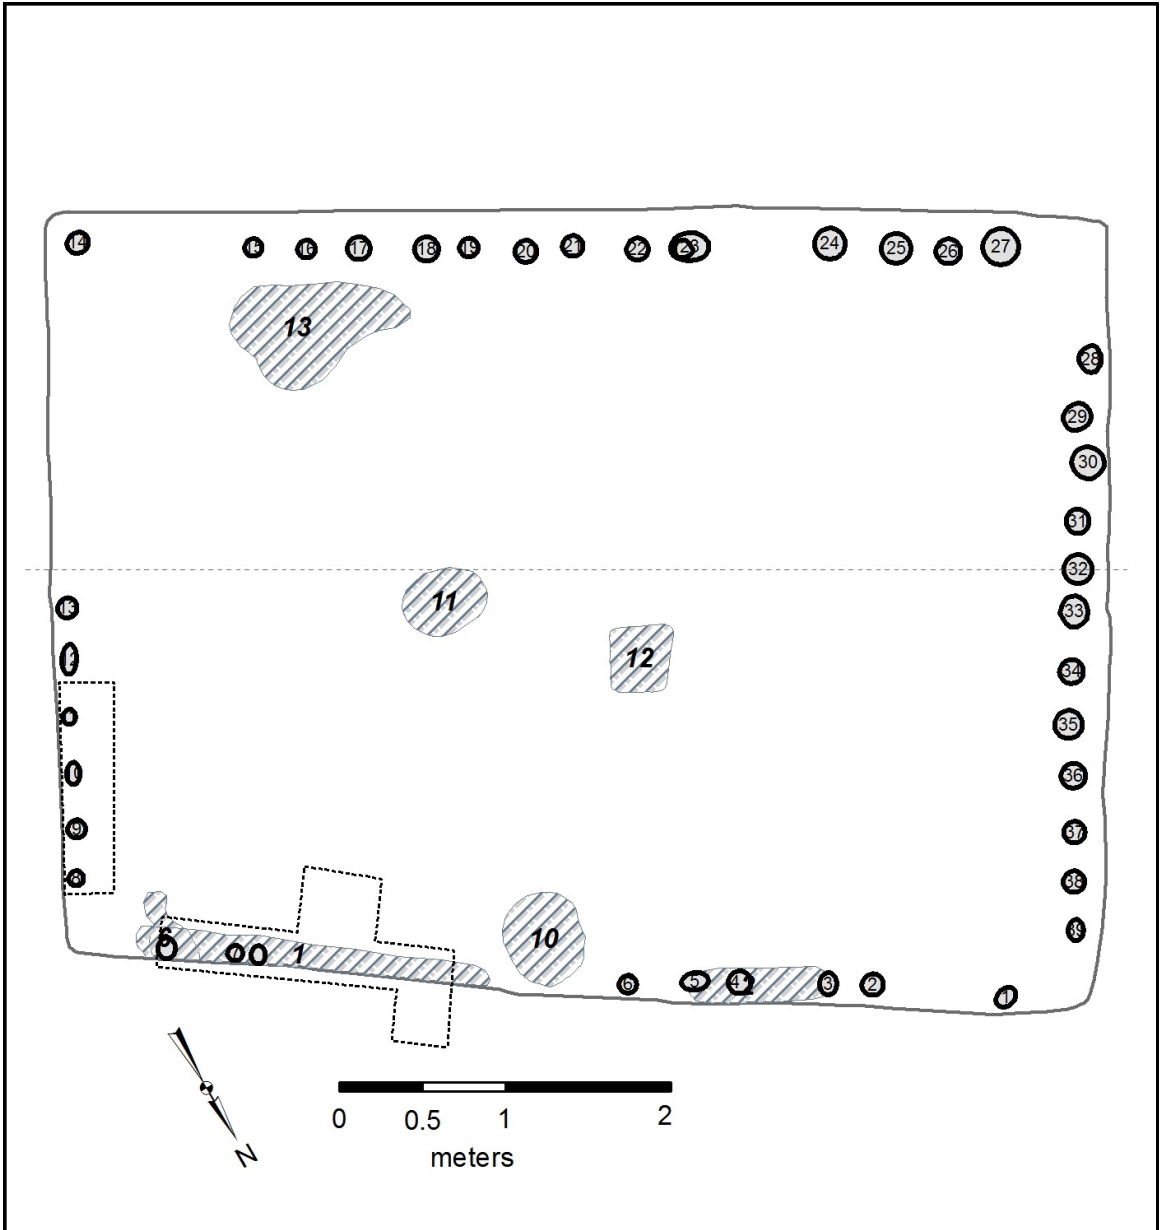
Figure 10. Digitized feature map of Structure 1.

A total of 41 post molds were identified, 39 of which were excavated and numbered (Figure 10). One post mold, identified as number 30, was only partially excavated because the soil staining that originally identified the post mold disappeared a few centimeters below the surface. Post mold patterning is inconsistent, especially along the north wall (the long axis of Structure 1) where only seven posts have been identified. The opposing, south wall contains 13 post molds. The east and west walls have seven and 12 post molds, respectively. It should be noted that wall trench visibility was also inconsistent, more so than the post molds. The only section where the wall trench was continuously evident was in the window that was excavated when Structure 1 was first uncovered. Smallest post mold diameter is 8 cm, largest is 20 cm, and the average is 12.2 cm. Regarding depth, the most shallow post mold is 16 cm, the deepest is 43 cm, and the average is 30.2.

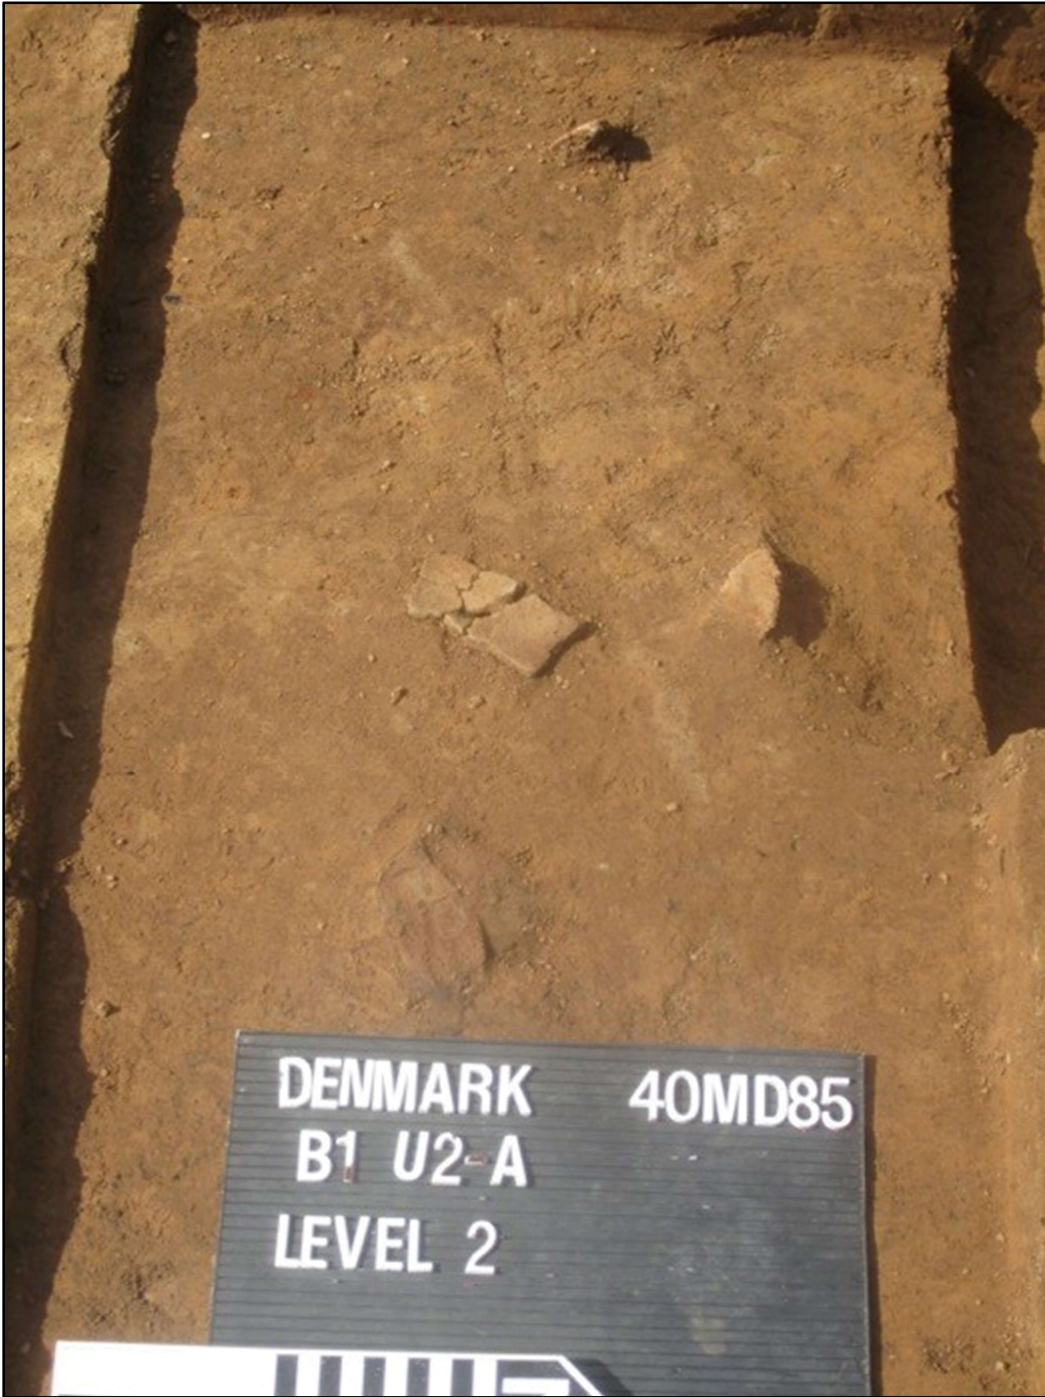
Figure 11. *In situ* pottery sherds and charred material used to obtain a radio-carbon date.

Radiocarbon samples were obtained from charred wood at the bottom of a post and *in situ* under a piece of broken pottery on the structure's floor (Figure 11). They produced nearly identical uncalibrated conventional radiocarbon assays of 690 ± 30 B.P. (Beta 363966) and 700 ± 30 B.P. (Beta 320578), respectively. These dates firmly place Structure 1 in the Middle Mississippi period at ca. cal 1290 A.D.

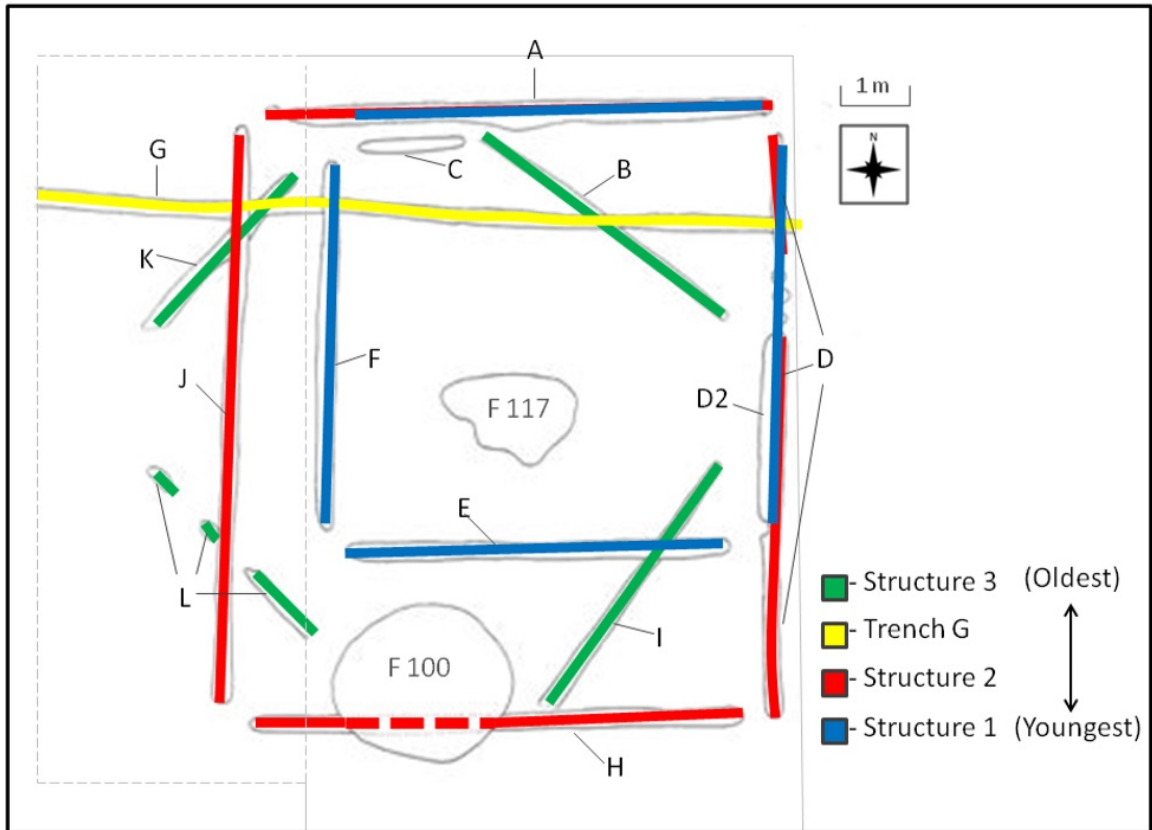
Figure 13. Graphic representation of overlapping structures at the Ames site (Guidry 2013:Figure 8).

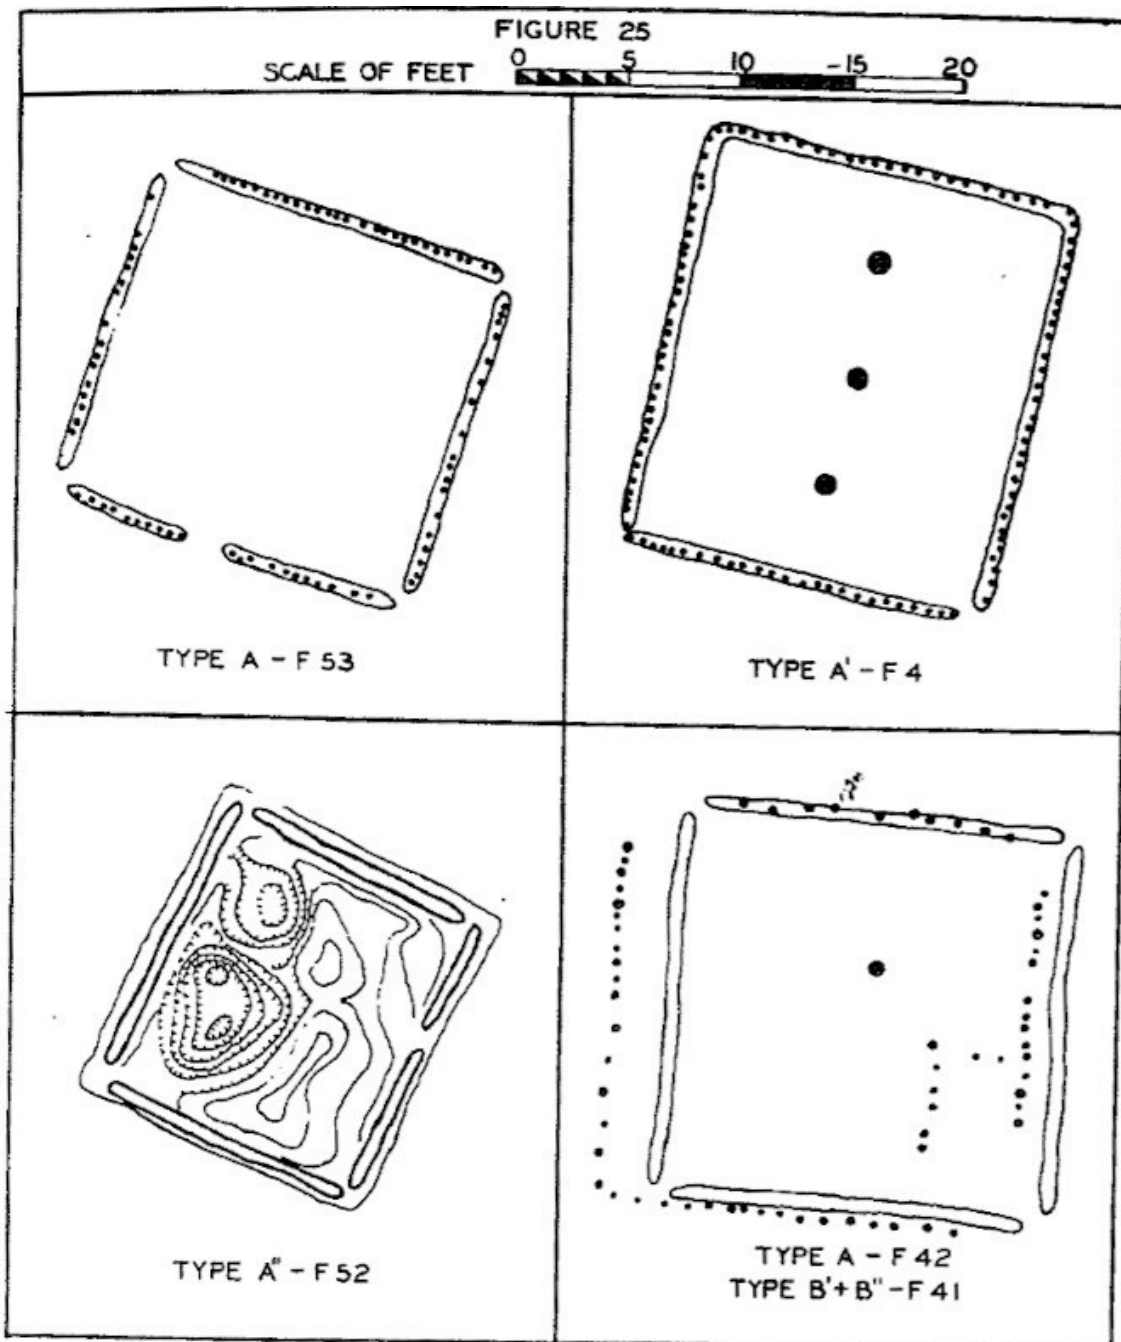
Figure 16. Three types of wall trench structures at the Jonathan Creek site as identified by Webb (1952:Figure 25)

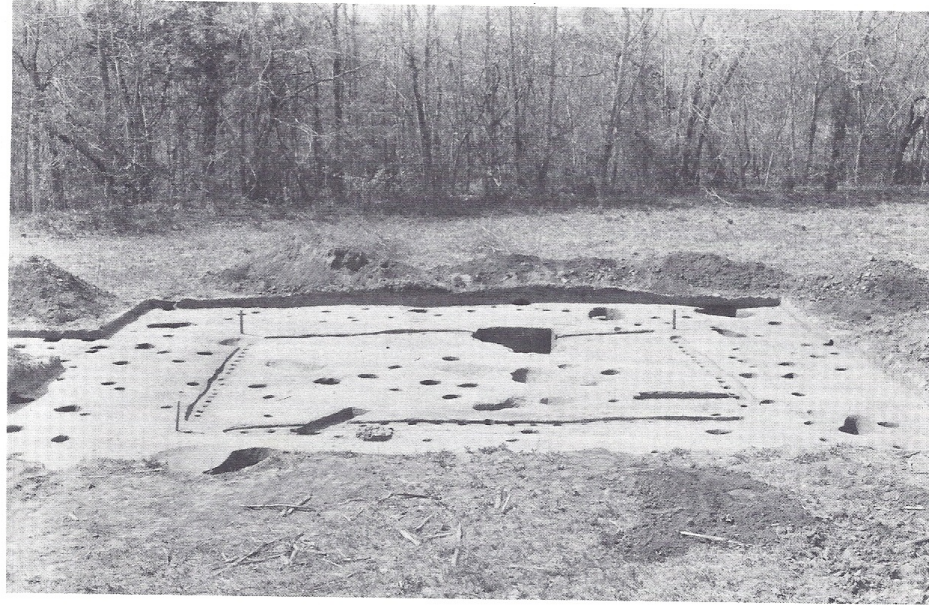
Fig. 95. Mound 14 sector. Excavation area.

Fig. 96. Mound 14 sector. Plan view, Test Pit 1.

Figure 18. Photograph and sketch of a Mississippian house excavated in the Mound 14 sector at Pinson Mounds (Morse 1986:Figures 95, 96).

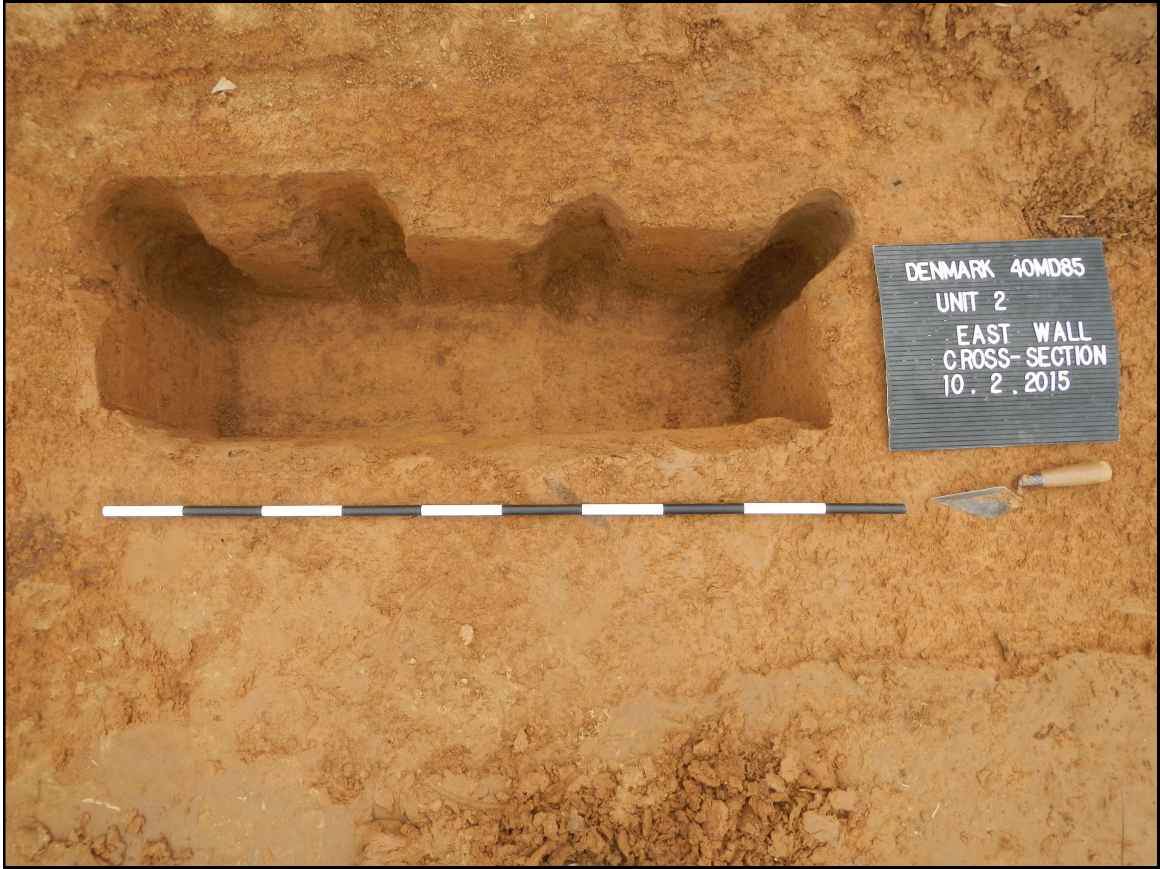
Figure 19. Window confirming vertical orientation of four post molds along the north end of the east wall in Structure 1.

Post placement of this type does not appear to be the case at Denmark. Trench visibility was highly erratic and soil staining was light making it hard to determine the placement of most of the post molds within the trenches, but post molds in the trench segment visible in the original window opened along the north wall were nearer to the center. A second window was opened at the north end of the east wall in which four post molds were cross sectioned. This window was excavated specifically to ascertain trench depth and post mold orientation. Unfortunately, trench visibility was non-existent, but post mold orientation was discovered to be vertical, rather than tilted (Figure 19).

A window was excavated at the north end of the east wall in Structure 1 for the purpose of exposing subsurface wall trench and post mold features. Trench features were nonexistent, but post molds were found to be vertical in orientation. Vertical posts may indicate a different type of above-ground construction since posts leaning inward are thought to be evidence of bent pole construction (Blanton and Gresham 2007:34, Brennan 2007:75, Lewis and Kneberg 1946:50). Buildings constructed using a rigid post (also called rigid roof) method would have had separate, hipped or gabled roofs

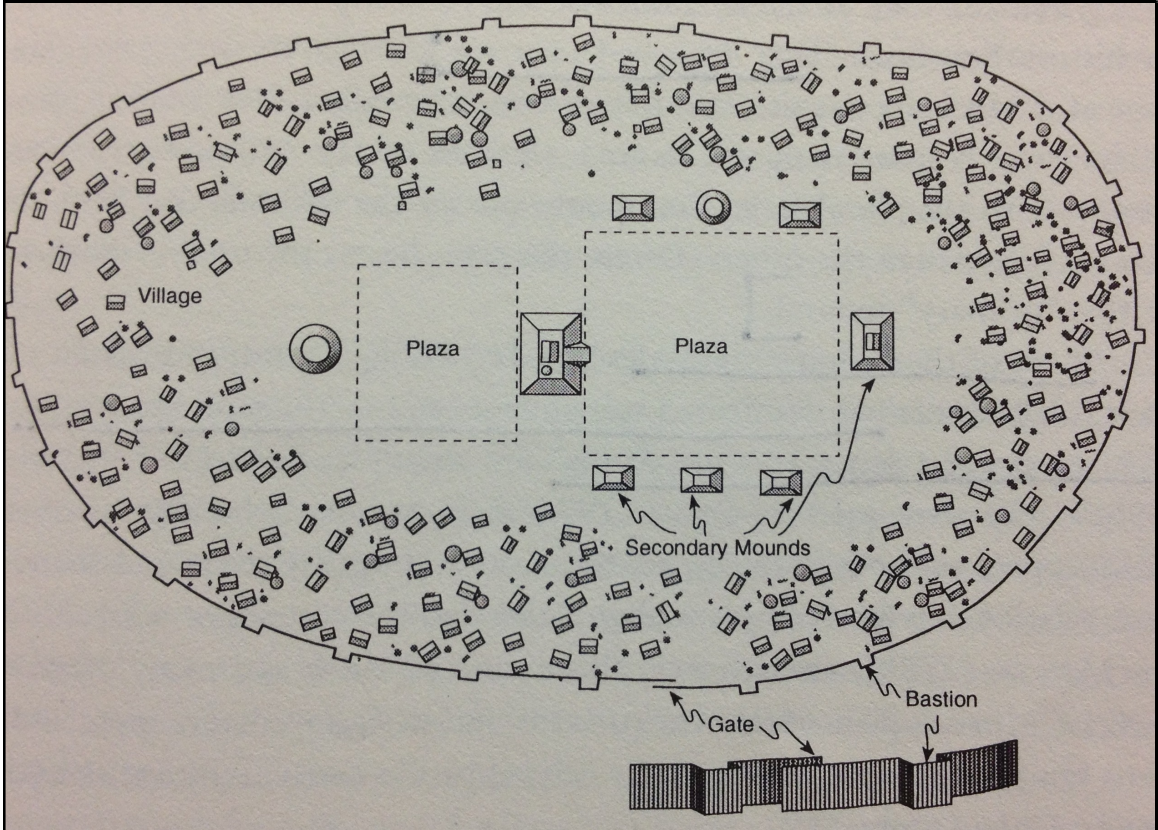
Figure 21. Key elements of Mississippian architectural grammar (Lewis and Stout 1998:Figure 1.2).

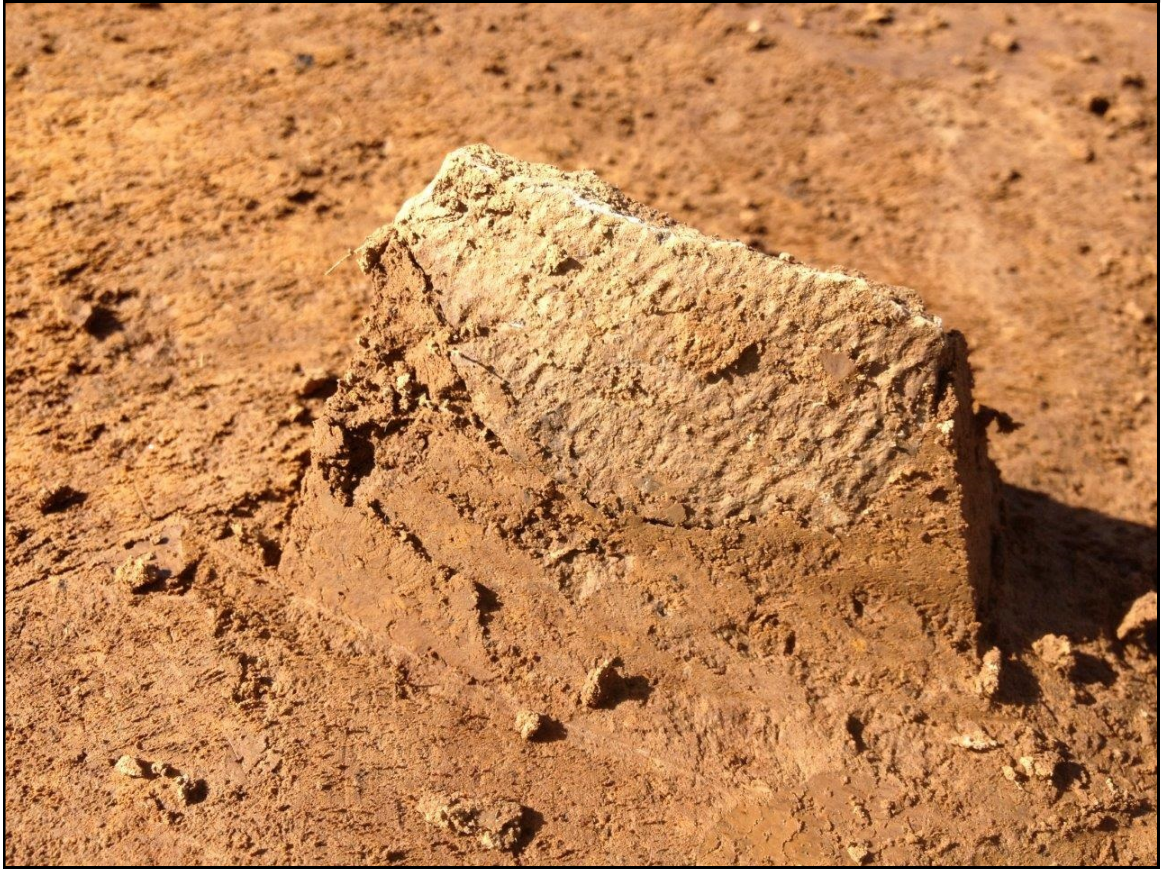
Figure 25. Fabric impressed pottery sherd *in situ*. Note vertical orientation in ca. 5 cm deep of floor deposit.

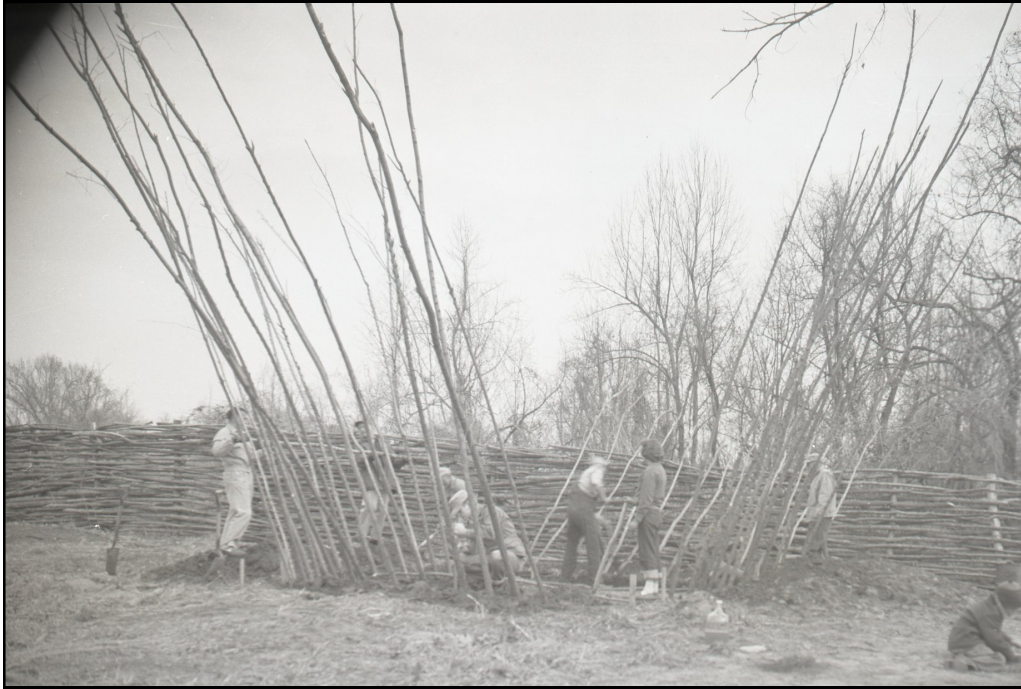
Figure 27a. Beginning of construction of an open corner, bent pole structure at Chucalissa in 1955. Courtesy of the C. H. Nash Museum at Chucalissa.

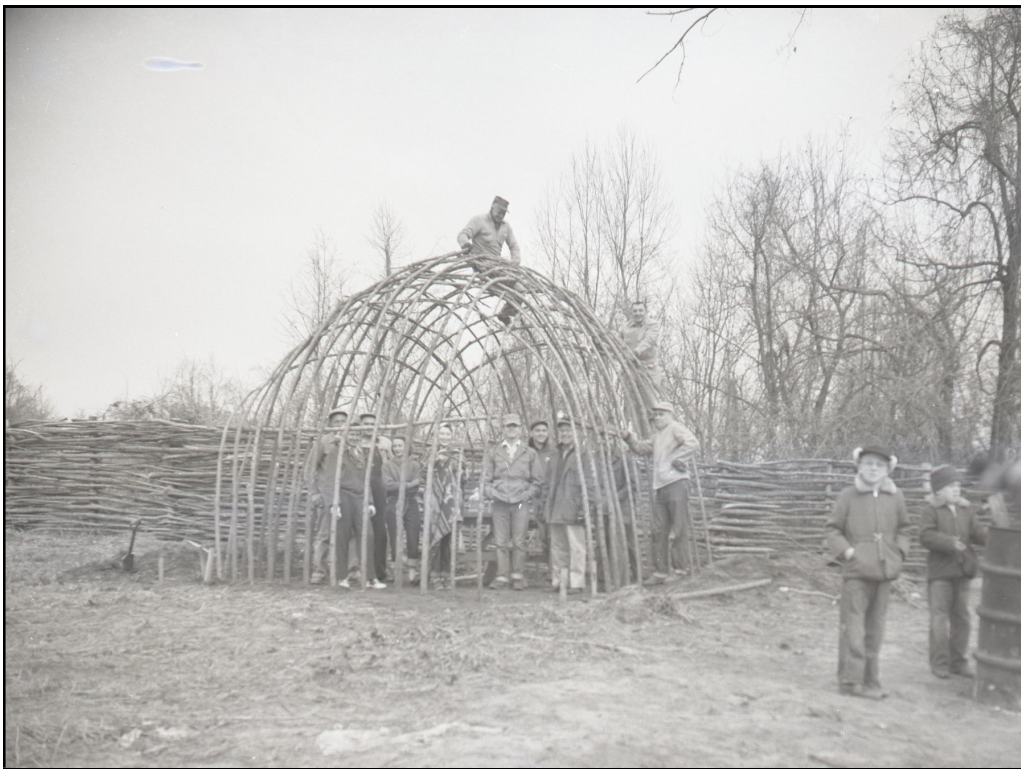
Figure 27b. Completed construction (pre-thatching) of the same open corner, bent pole structure at Chucalissa in 1955. Courtesy of the C. H. Nash Museum at Chucalissa.
