Assessment of The Seismic Vulnerability of West Tennessee School Buildings

ASSESSMENT OF THE SEISMIC VULNERABILITY OF WEST TENNESSEE SCHOOL BUILDINGS

Major: Civil Engineering

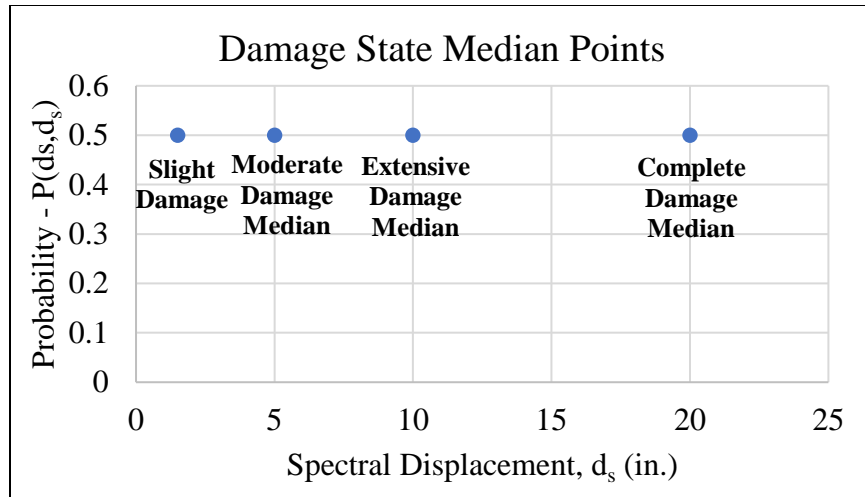
Figure 4. Example Calculation of Damage State Probability

A fragility curve is made up of two components: the damage median and the lognormal standard deviation value, β (FEMA-AEBM, 2012). The final fragility curve shows the probability of a structure falling into a damage state given a spectral displacement. First, the probability that a building will suffer slight, moderate, extensive, or complete damage given a spectral displacement is plotted; where each probability is equal to 0.5 is defined as the “damage state median”. An example of the damage state median points is shown in FEMA’s AEBM User and Technical Manual (2012), and Figure 4. After the damage state median is found, the slope is determined by the lognormal standard deviation value, β .

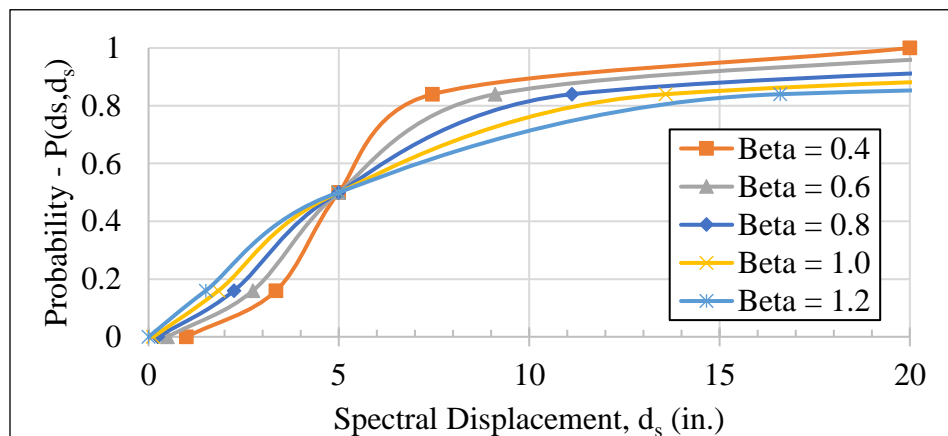
Figure 5. Example Fragility Curve with Various β values

The effect of the beta value is shown in Figure 5 (Figure 6.2 AEBM Manual) and reflected in Equation 2. Equation 2 calculates the vertical axis of a fragility curve, which is the probability of a damage state given a spectral displacement:

where φ is the standard normal cumulative distribution function (cdf), d_s is the spectral displacement, and $\bar{d}_{s,ds}$ is the median spectral displacement where the building reaches a particular damage state.

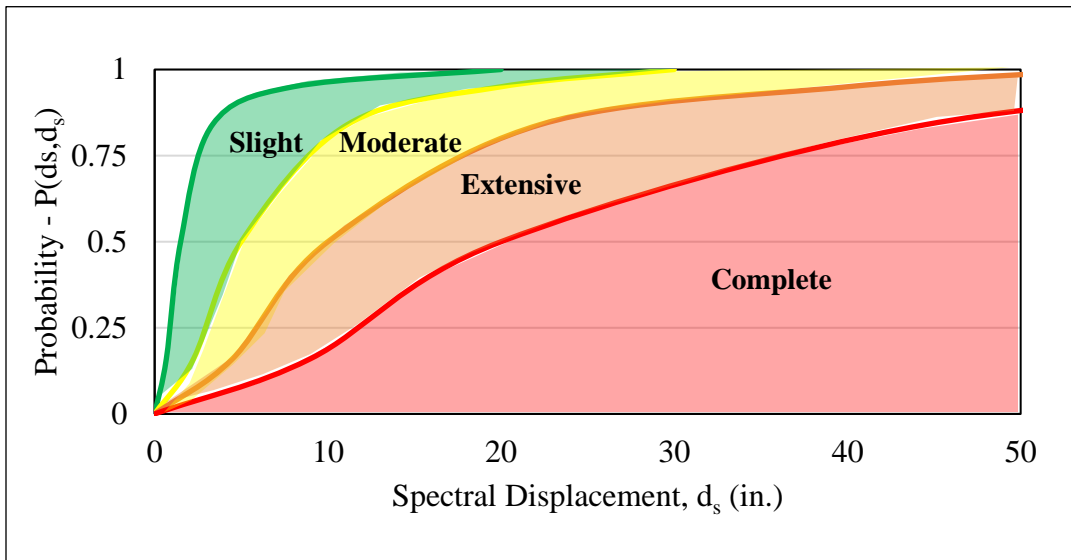
Figure 6. Example Fragility Curve

The process above is completed four times for each building type and earthquake design level combination to yield the slight, moderate, extensive, and complete thresholds. Then, the fragility curve for the component type, building type, and earthquake design level is developed, and together it looks like Figure 6.

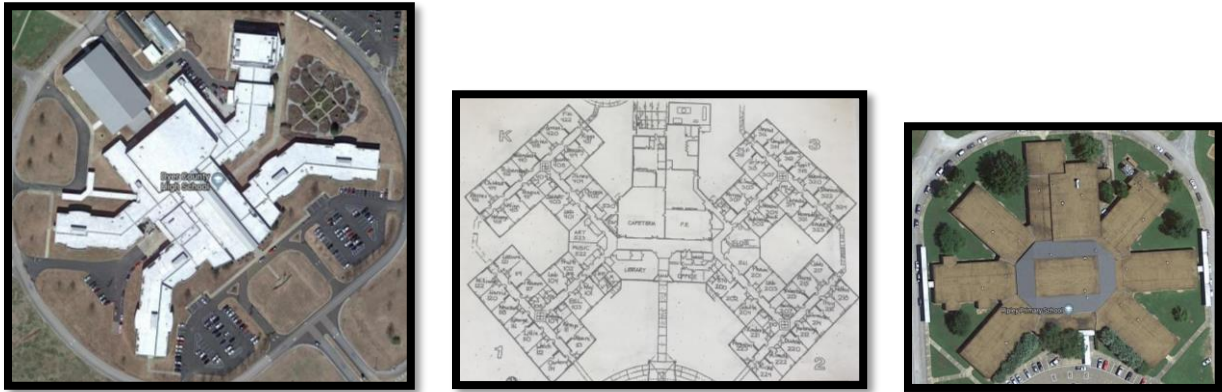
Figure 9. Examples of Buildings with a Reentrant Corner

The most common plan irregularity observed was a reentrant corner. A building with a reentrant corner is common even among modern buildings, so although strides have been made in earthquake engineering, buildings are still being designed with awkward plan dimensions. The most popular plan irregularity is a specific example of a reentrant corner, observed in the school buildings and some hospitals, it resembles a spider-like plan view of four or more separate hallways. Although this formation, shown in Figure 9, is convenient for hallway congestion, it is not safe seismically as it causes buildings to be subject to torsion.

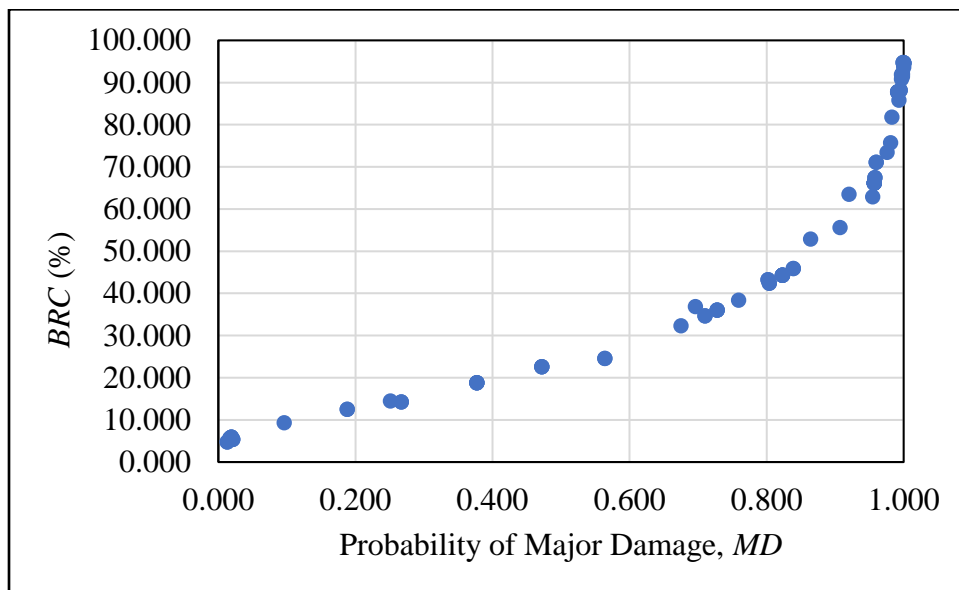
Figure 10. Case 1: *BRC* vs. *MD*

From Figure 10, as the probability of major damage increases, the estimated cost to repair the structure also increases. The strong correlation between BRC and MD is clearly visible in Figure 10. Intuitively, a BRC and IO should be inversely correlated.

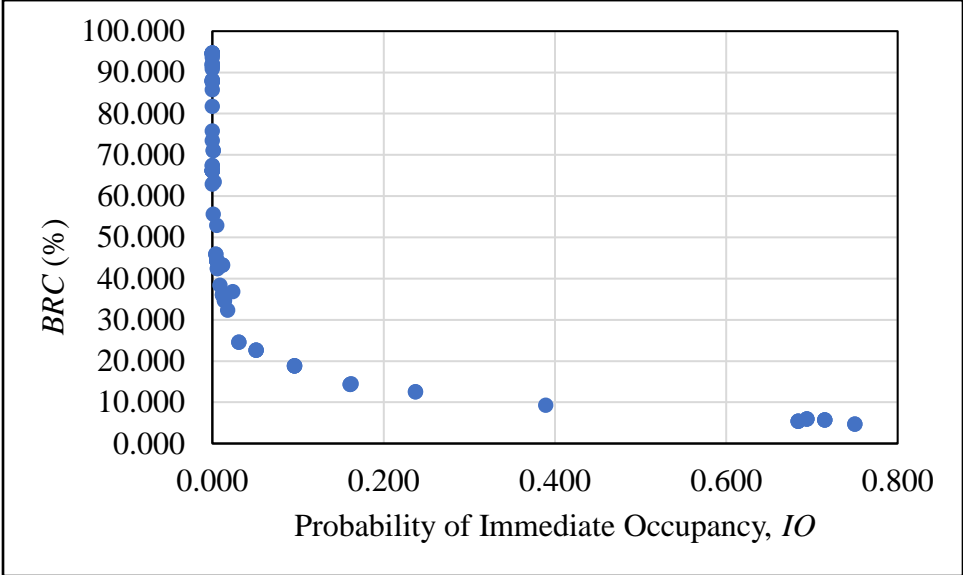
Figure 11. Case 1: *BRC* vs. *IO*

From Figure 11, as the probability of immediate occupancy increases, the cost to repair the building decreases. Though the graph above shows a seemingly strong inverse correlation exists, the correlational coefficient, r , is -0.673 , indicating a moderate inverse correlation. The primary reason for this is the large variation in *BRC* when *IO* is zero. For an $IO = 0$, *BRC* ranges anywhere from 55%-95%.

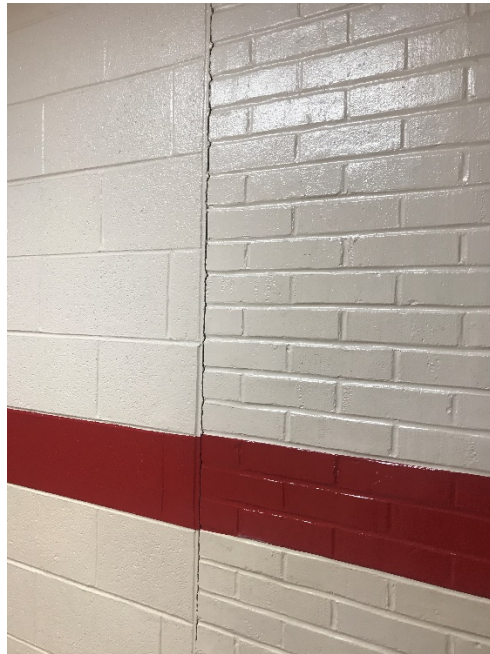
Connection Between this Portion (Left) and Older Portion, Visible Cracking

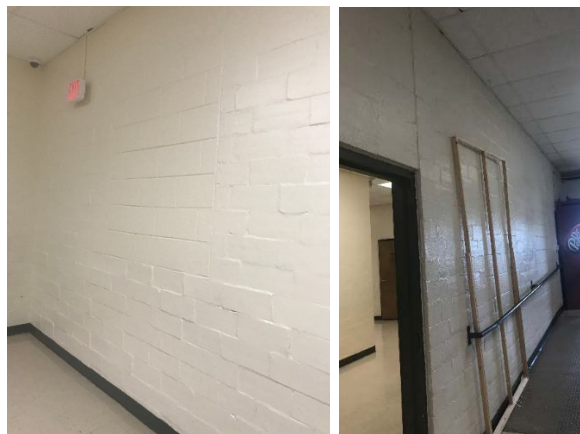
Interior, Damage to Masonry

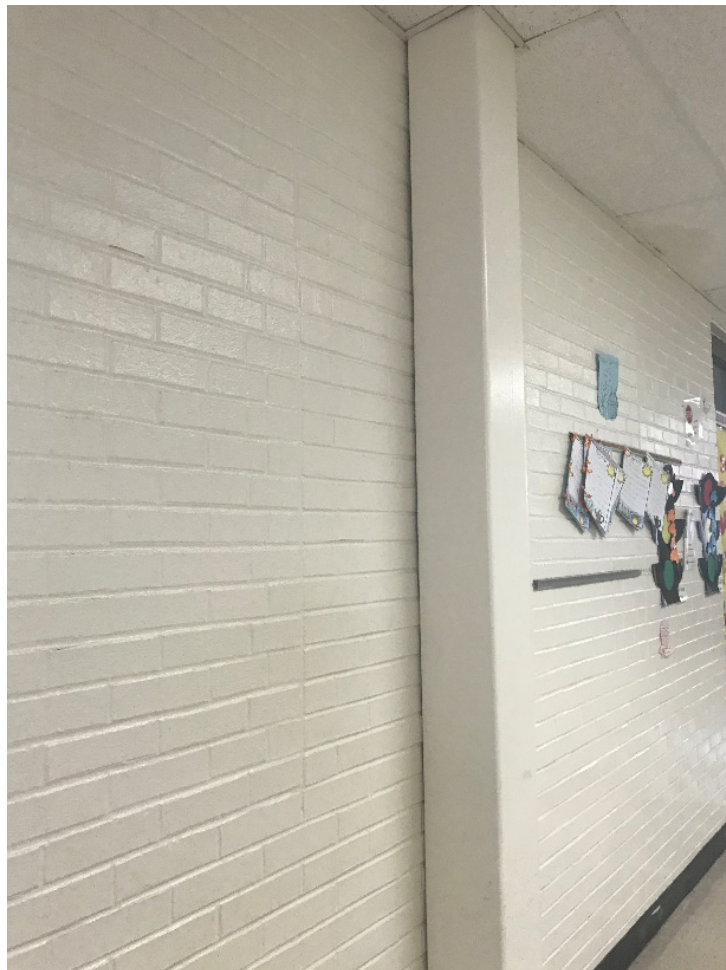
Previous Exterior of Structure 31, Column Added to Support Addition of Structure 32

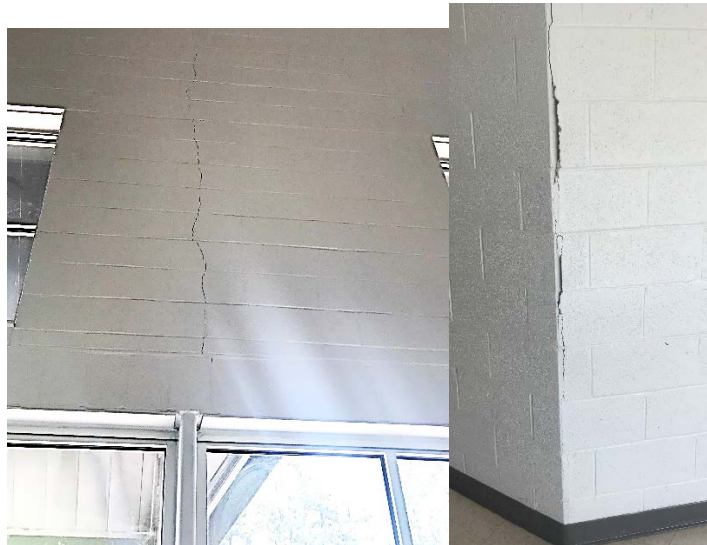
Cracks in Structure, Evidence of Pounding and Deterioration/Settling

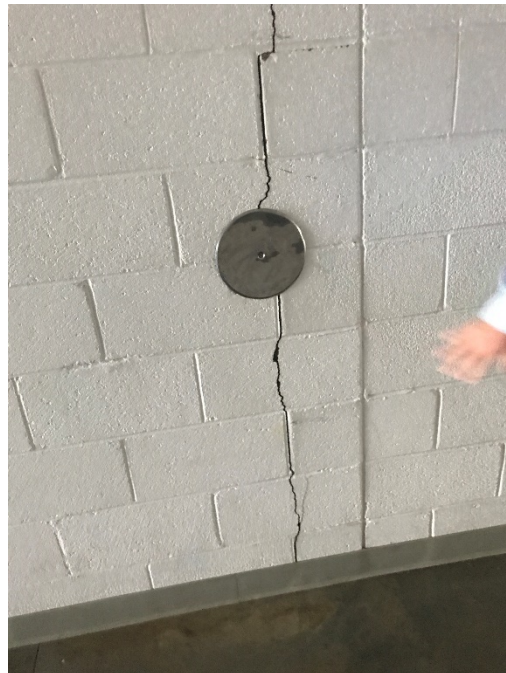
Interior, Cracks
