## Identifying the Vulnerability of Earthen Levees to Slump Slides using Geotechnical and Geomorphological Parameters

A Thesis  
Submitted to the Faculty of  
Mississippi State University  
in Partial Fulfillment of the Requirements  
for the Degree of Master of Science  
in Civil Engineering  
in the Department of Civil and Environmental Engineering

December 2014

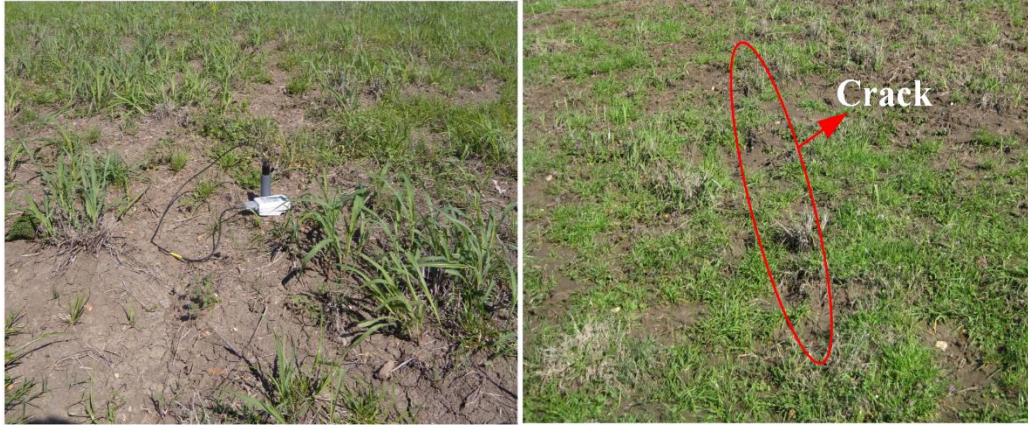
Figure 13 Sparse grass (left) and cracks (right) in FP2 observed after the UAVSAR image acquired for this study.

The overall trend observed from the two methods leads to the conclusion that in the surface layer, the false positives and the slide area were following similar trends in the distribution of different relevant soil measurements. In contrast to the surface layer, in the subsurface layer the false positives and the healthy areas were following similar trends, and sometimes the three areas had similar soil distribution. As UAVSAR is capable of penetrating soil to a few centimeters depth, the most accurate results for classification were derived at the surface layer. Therefore distinct trends of soil measurement distribution were mostly found in the surface layer, while no specific trends were seen in the deep subsurface layer. As mentioned in the previous sections, the UAVSAR image acquired from January 25, 2010 was used in this study. It should be noted that a slide had occurred at the location of FP2 in October of 2009 which was repaired in November of the same year. However, during our field visits in 2011 linear cracks perpendicular to the levee slope were discovered in that area. As shown in Fig. 13, grass growing in this location was also stressed and sparse compared to the surrounding areas. It was identified as an area of weakness based on these evidences. One possible hypothesis to explain the occurrence of cracks could be that it is an early sign of reactivation of the repaired slide.

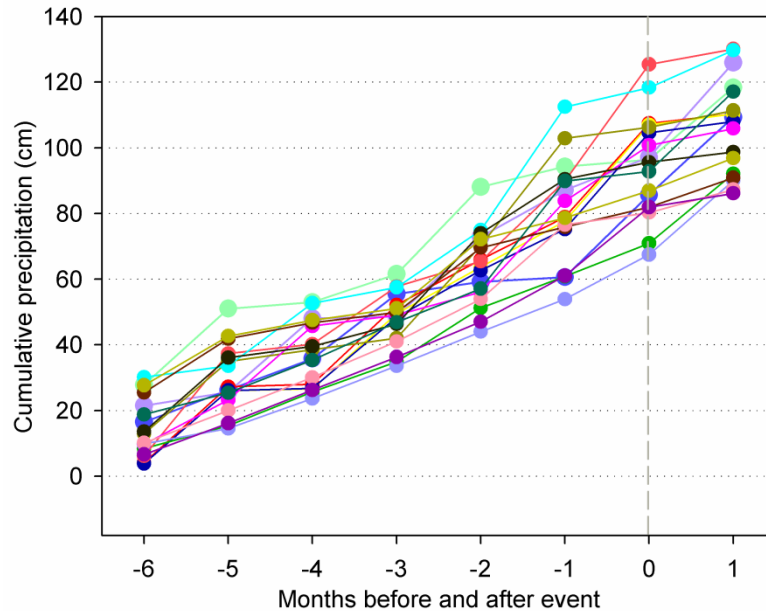
Figure 17 Six month cumulative rainfall for 23 slump slides in the study area

The cumulative monthly rainfall curves are qualitatively tested for the 23 slump slides (Figure 17). These curves indicate the importance of rainfall gradient in the ultimate slump slide failure. The curves show an average gradient of 10 cm/month for the first 3-month time step, and a much steeper mean gradient of approximately 16 cm/month in the second 3-month time step before the slump slide event. Overall, it indicates an

intense rainfall in the 3 months prior to the slump slide event. Similar investigation has been implemented by Ibsen and Brunsten (2004) to study the relations between rainfall and landslides, and found that an approximate six month rainfall period is enough for landslide analysis in a homogeneous clay shales.

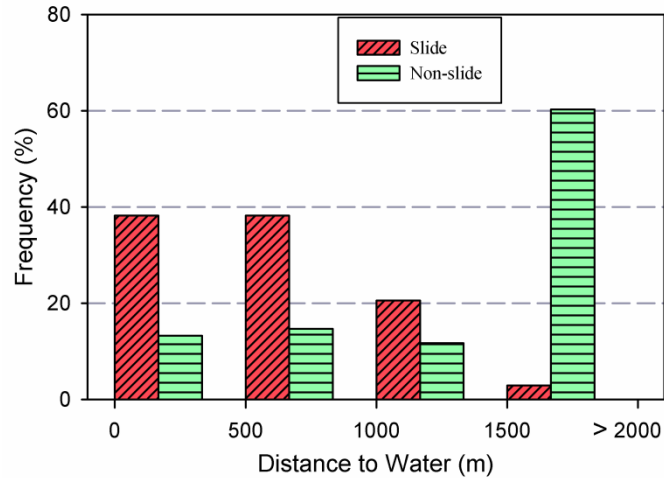
Figure 19 Data distribution for the numerical variable “Distance to water”

Figure 19 shows the data distribution for the numerical variable distance to water. More than 70% of non-slide locations are located more than 1000 m away from the water, while approximately 80% of slide areas are located in less than 1000 m from the water.
