Causes of Damage to Fruits and Vegetables During Shipment

By J. W. LLOYD and H. M. NEWELL

UNIVERSITY OF ILLINOIS
AGRICULTURAL EXPERIMENT STATION
BULLETIN 379

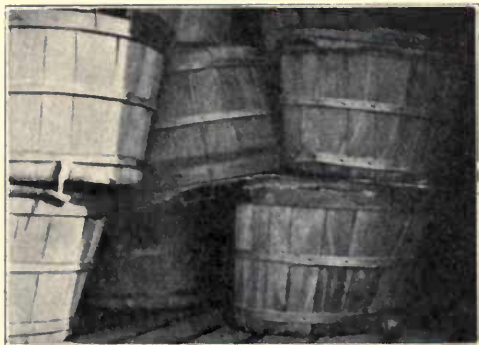
FIG. 2.—SLACK SPACE, WRENCHED BASKETS, AND SPILLED CONTENTS ATTEST THE BAD RESULTS OF LOOSE LOADING

These baskets of apples were loaded 21 packages long instead of 22. Picture was taken after unloading had commenced. (Car 8)

Car 8, loaded with Transparent apples in bushel containers, showed a 12- to 18-inch shift in the two top layers at both ends of the car. This car had been loaded only 21 baskets long instead of 22, and there was slack space at the center. A view in the doorway after unloading had commenced is shown in Fig. 2.

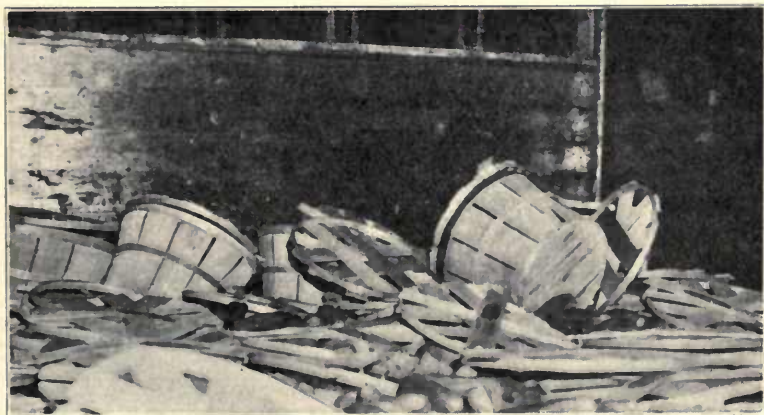
FIG. 3.—CUCUMBERS IN TUB BUSHELS LOADED WITH NO OFFSET

Loaded 5 wide with no offset, many covers were off and contents spilling. (Car 10)

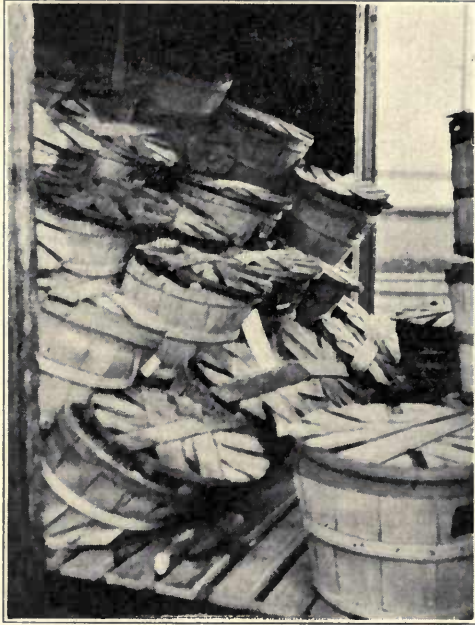
FIG. 4.—A VIEW IN THE DOORWAY OF CAR 10

In the lower layer many packages were wrenched and crushed. Picture was taken after one end of the car had been unloaded.

This was supposedly an end-to-end load 5 wide, but it had no offset. Loose loading was apparently the primary cause of the trouble. There were gaps several inches wide between baskets.

Car 10, loaded with cucumbers in tub bushels, showed a 5-foot shift in the top layer at one end and a 6-inch to 5-foot shift in the top layer at the other end. Several packages had the covers off (Fig. 3). Many baskets in the bottom layers near the doorway were wrenched and crushed (Fig. 4). In salvaging this load 42 new containers were used.

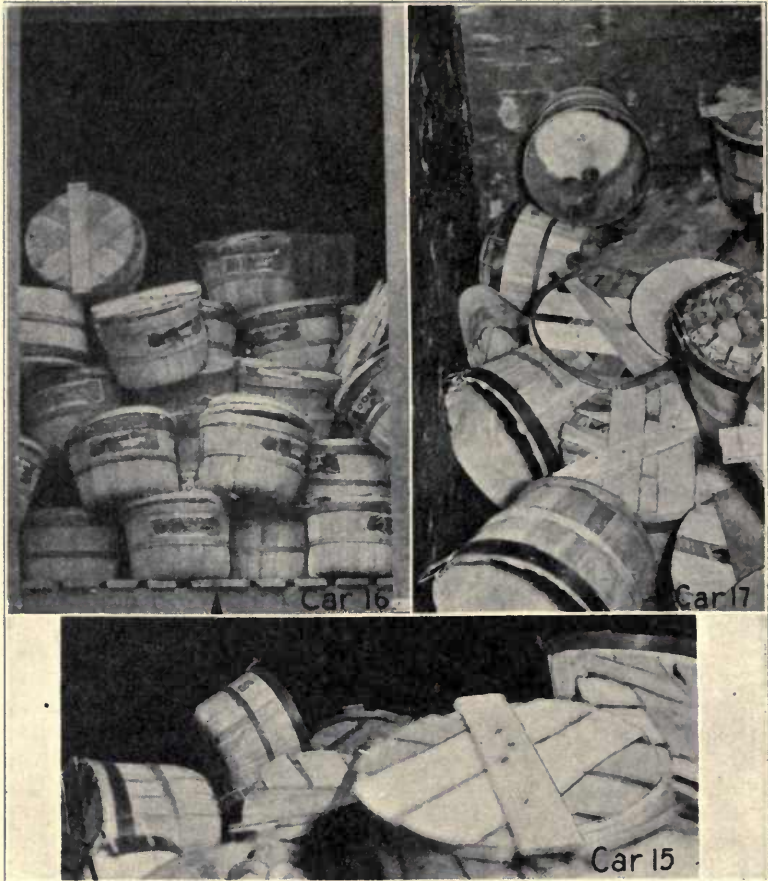
FIG. 5.—THE RESULTS OF LOOSE LOADING OF HALF-BUSHEL CONTAINERS OF PEACHES

A 4-foot shift occurred from the end of Car 15, which was loaded cross-wise. Several baskets were crushed and the contents spilling; many more were disarranged and tilted.

The first six rows in Car 16 had been loaded by the end-to-end offset method; the last two rows along one side of the car had been loaded loosely, with break joints. Baskets along this side of the car were badly disarranged.

Car 15 showed a 4-foot shift from the east end toward the center (Fig. 5). Several baskets were crushed and the contents spilling; many more were disarranged and tilted. The final report on this car showed "50 baskets wrenched—15 percent of same with broken faces; 9 new baskets used to replace broken ones." This also was a cross load 6 and 7 wide.

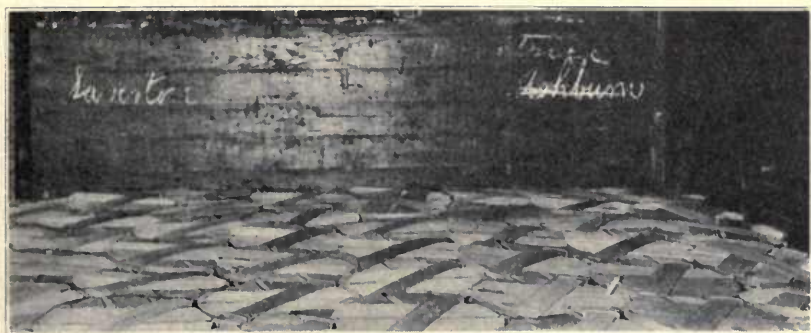
FIG. 6.—A PERFECT LOAD OF PEACHES IN HALF-BUSHEL TUBS

Wider than most cars, this car gave sufficient space for a solid end-to-end offset load 8 rows wide. (Car 18)

the same, would make it possible to build a compact load by the end-to-end offset method, 8 baskets wide. Such a change would overcome the chief disadvantage of this type of package as a shipping container for peaches. The present package does not lend itself readily to secure loading. One load of these half-bushel packages was in an extra wide car (No. 18, 8 feet $4\frac{5}{8}$ inches wide) and rode in perfect condition (Fig. 6). It was an end-to-end offset load, 8 baskets wide.

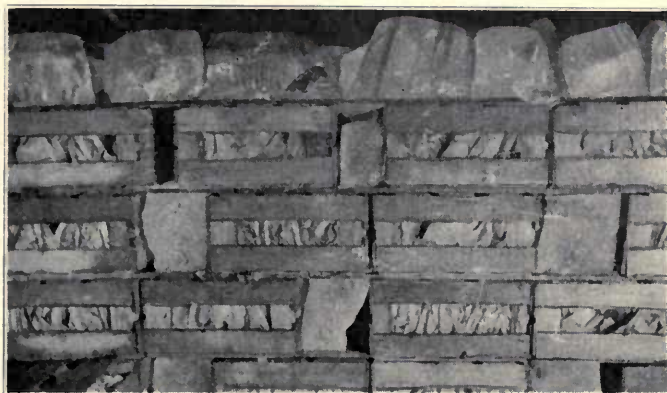
FIG. 8.—CAULIFLOWER IN CRATES, WITH TOP-ICING AND "PIGEON-HOLE" ICING

The usual method of loading western cauliflower and western lettuce includes top-icing; "pigeon-hole" icing is less common. (Car 23)

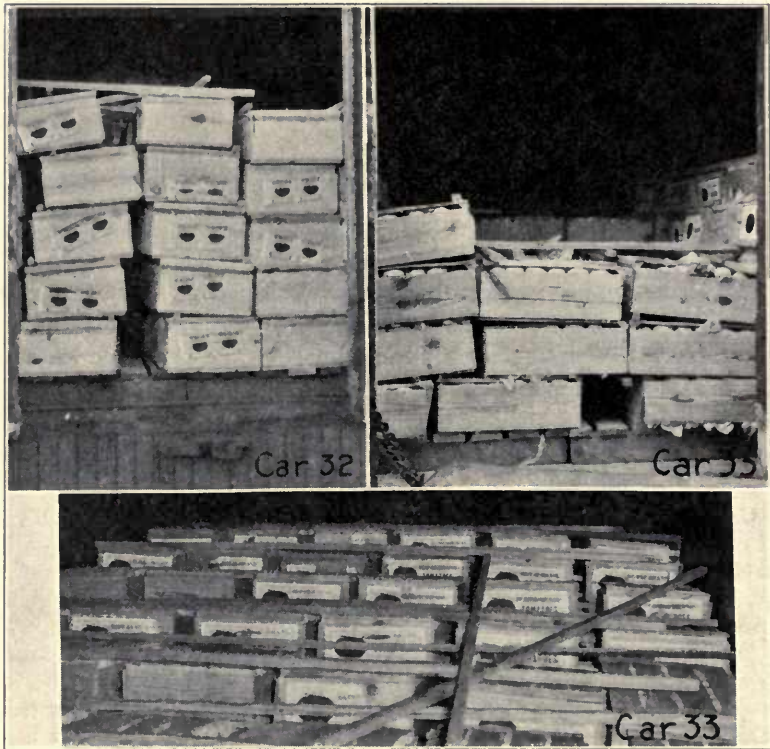
FIG. 10.—IMPROPERLY BRACED TOMATO LOADS

The shift in Car 32 was due to inadequate stripping and lack of center bracing. In Car 33 inadequate bracing permitted the load to shift from both ends toward the center. Practically all the boxes were off the strips, giving a "saw-tooth" effect to the load. Several lugs were crushed and leaking.

broken, however, and the two stacks of lugs at the center of the car had shifted together (Fig. 10). There was also considerable side shift in the car owing to lack of proper stripping.

Car 33 had no pretense at center bracing except 6 little strips nailed to the top lugs. These had failed to hold. The load had shifted from both ends toward the center of the car, resulting in the crushing of several lugs (Fig. 10). Practically all lugs had shifted off the strips, giving a "saw-tooth" effect to the load (Fig. 10). Several lugs were leaking.

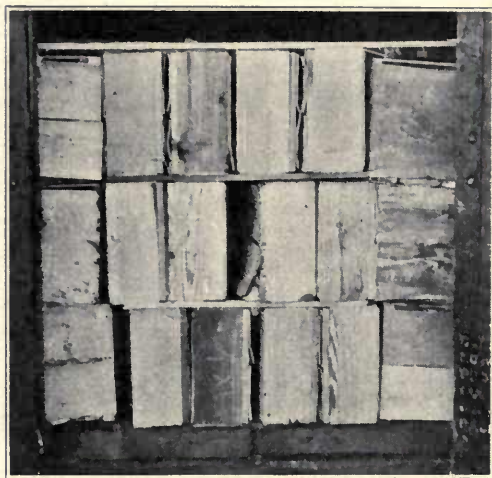
FIG. 11.—UNUSUAL METHOD OF LOADING TOMATOES

Loaded edgewise instead of flat, the pack seemed slack, the tomatoes having settled to the lower side of each lug. Many lugs had to be recoopered and renailed. (Car 35)

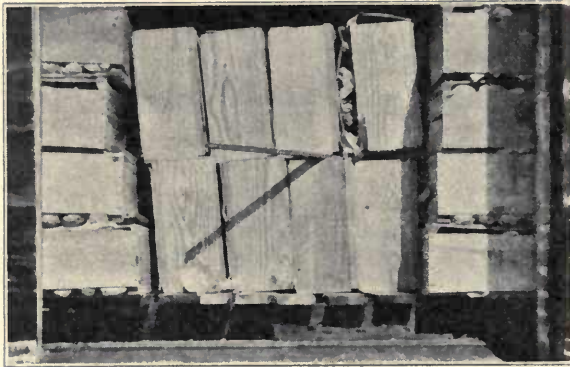
FIG. 12.—FAULTY LOADING AT DOORWAY

These lugs of tomatoes were loaded flat except at the doorway. There was no adequate bracing, however, and a slight end shift in the load resulted in several lugs dropping off the strips. (Car 36)

Car 36 had no center bracing except 12 little strips nailed on the top layer of lugs across the doorway. There was a slight end shift on both sides of the doorway that let several lugs drop off the strips. There were two broken crates in the doorway (Fig. 12). This car had been loaded lengthwise 4 high and 7 wide, except at the doorway, where the lugs were placed on edge.

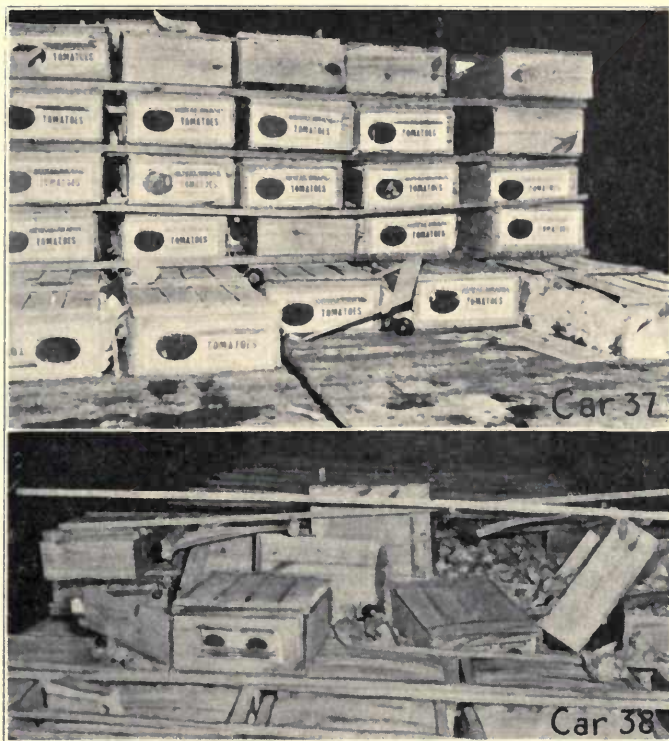
FIG. 13.—FURTHER EXAMPLES OF IMPROPER CENTER BRACING

This picture of Car 37, loaded with tomatoes, was taken after the car was partially unloaded. At both ends of this car the lugs had shifted entirely off the strips. In the bottom layer the lugs were crushed and jammed, with contents mashed and leaking. Many packages in Car 38 were disarranged and broken.

Car 37 had merely strips for center bracing extending across two stacks in the top layer. There was a 10-inch shift of the load from the east bunker toward the door. At both ends of the car the lugs had shifted entirely off the strips. Apparently all lugs in the bottom layer were crushed and jammed, with contents mashed and leaking (Fig. 13). All other layers except the top showed bruising of the tomatoes in nearly every lug.

Car 38 was loaded 5 high and 5 wide crosswise instead of lengthwise of the car. Strips $\frac{3}{4}$ -by- $\frac{3}{4}$ -inch nailed lengthwise on top of the two middle stacks of the top layer constituted the only center bracing. Strips of the same dimensions were nailed crosswise on the top layer thruout the load. There were no strips on any of the other layers except on the two middle stacks. The east end of the car showed a shift of 8 to 12 inches from the bunker toward the doorway. The packages were much disarranged and had fallen down in at least three layers and three stacks. The west end of the load was slightly jammed. At the center of the car 12 lugs were disarranged and broken and the contents of most

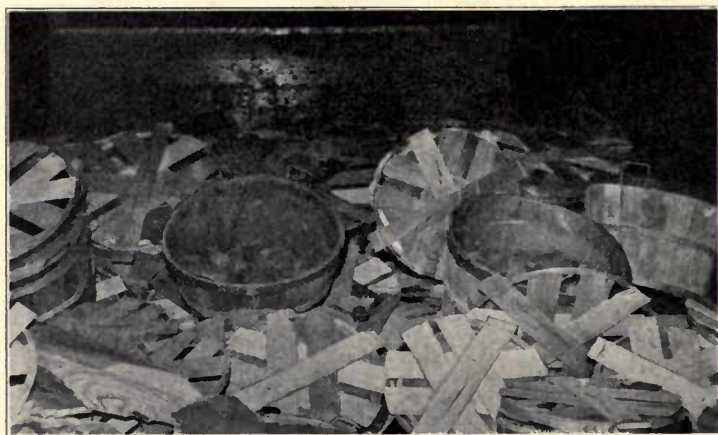
FIG. 14.—PARTIAL FOURTH LAYER IN CARLOAD OF PEACHES

Tho this partial layer had been braced by a 4-by-4-inch cross member nailed to cleats at the sides of the car, the brace had broken, permitting the baskets in this layer to shift out of place. (Car 40)

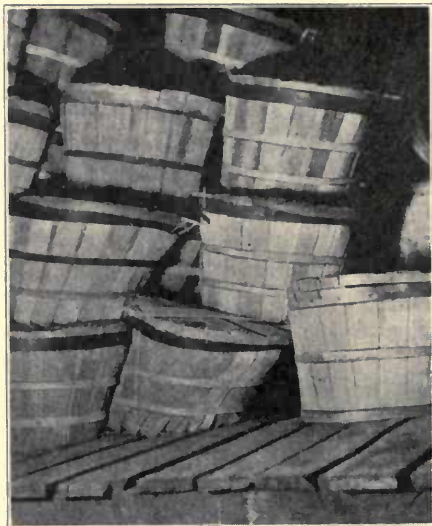
FIG. 16.—SHIFT DUE TO MIXED LOADING OF BASKETS AND HAMPERS

In this load of cucumbers several covers had come off and a few baskets were crushed. (Car 49)

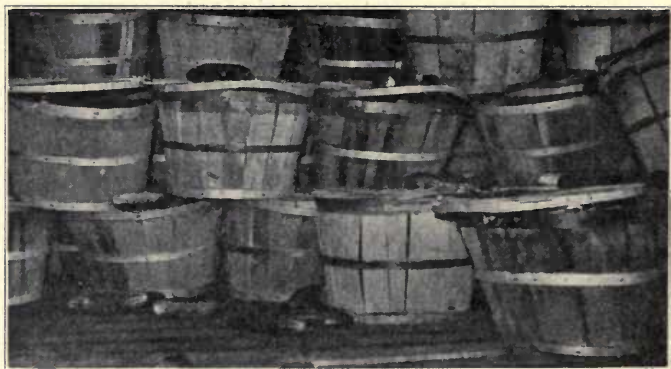
FIG. 17.—A MIXED LOAD OF TUBS AND HAMPERS

The load was badly shifted from both ends of the car. The packages of cucumbers were wrenched and their contents spilling. (Car 50)

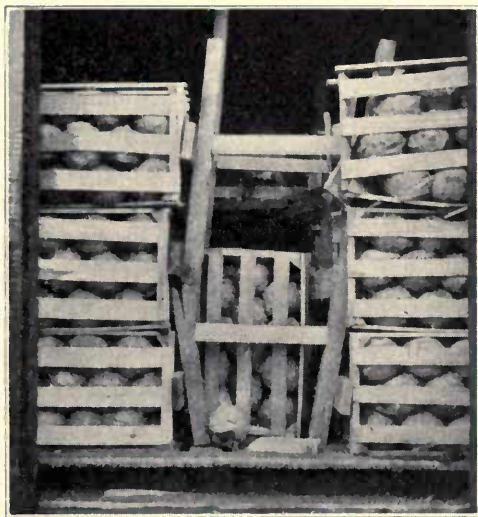
FIG. 19.—THE RESULT OF A SEVERE JOLT

The center bracing in this car of cantaloupes was broken, and one crate displaced from the top layer had dropped to the floor. Five crates in the top layer were broken and the contents partly spilled. (Car 60)

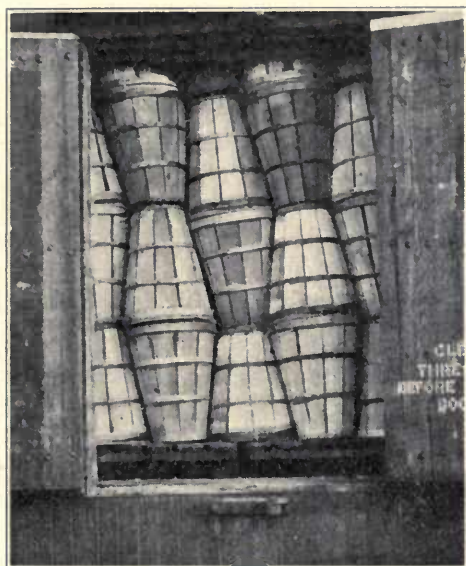
FIG. 21.—A COMPACT LOAD OF PEPPERS IN BUSHEL HAMPERS

With the hampers properly stowed 7 wide and 4 high this load arrived in ideal condition even tho the packages were slightly tilted. The top layer extends considerably above the top of the door. (Car 64)
