Effects on Fatigue of Applying Titanium Nitride Coating to 17-4 PH Stainless Steel

Jade Welsh, Scott Zinn, Steven Stagon, and Jutima Simsiriwong

School of Engineering, College of Computing, Engineering & Construction, University of North Florida, Jacksonville, FL 32224

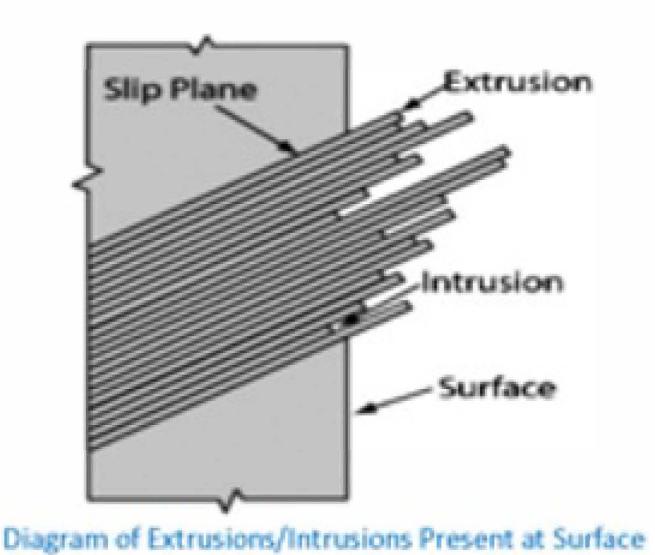
Progressive movement of grains under cyclic loading can lead to extrusions or intrusions appearing at the surface.

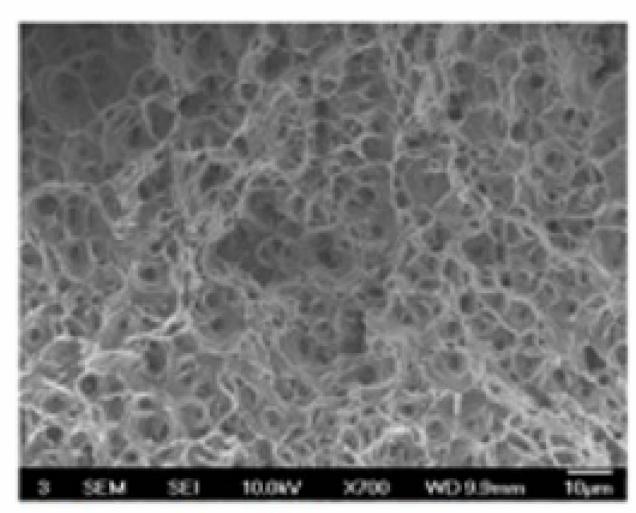
A collection of microscopic voids may cause crack initiation to occur internally within the material.

A Representation of Microvoid Coalescence

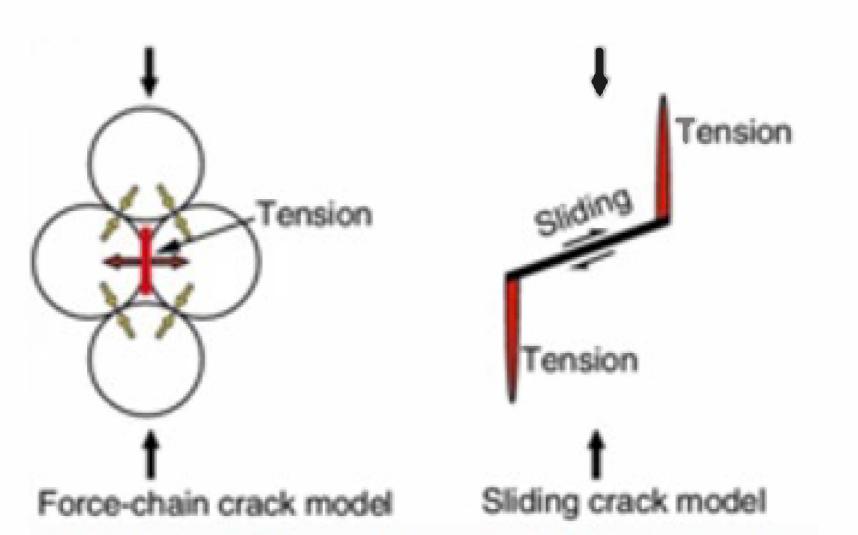
Different directions of slip that grains can be subjected to will give varying modes of crack growth and initiation.

An Image of Microscopic Movements That Cause Internal Cracks to Form

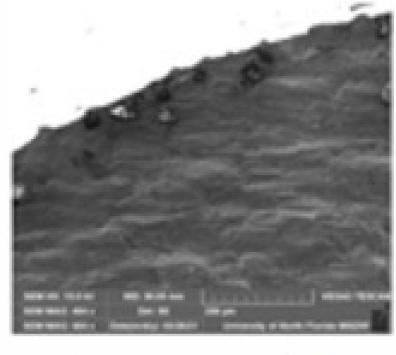
Fracture Surface of TiN Coated Specimen Tested at 650 MPa

- Specimens exhibited better fatigue strength under PVD coating for a duration of 2 hours.
- More than half an order of magnitude at higher stress amplitudes.
- Increase in fatigue resistance in not significant.
- The specimens subjected to a PVD coat of 1 hour showed no substantial improvement to fatigue resistance.
- ⇒ A longer duration of the PVD coating process does show to have an effect on prolonging the life of the specimens.
- This is most likely due to the fact that <u>cracks initiate at the surface</u> in both wrought and PVD coated specimens.

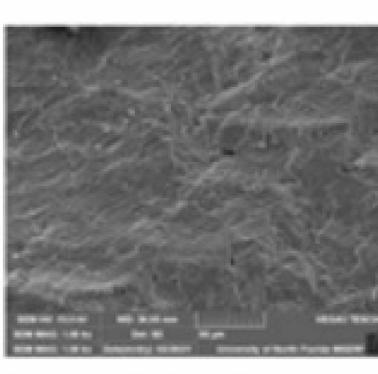
Crack Initiation Site of TiN

Coated Specimen Tested at 650 MPa

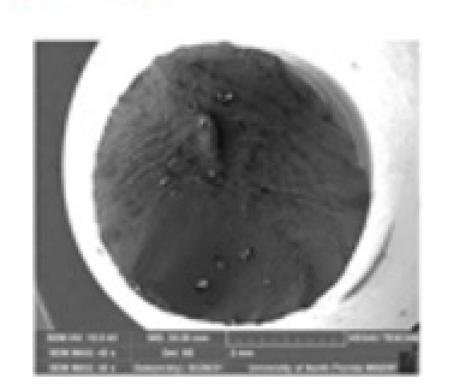
Striae on TiN Coated

Specimen Tested at 650 MPa

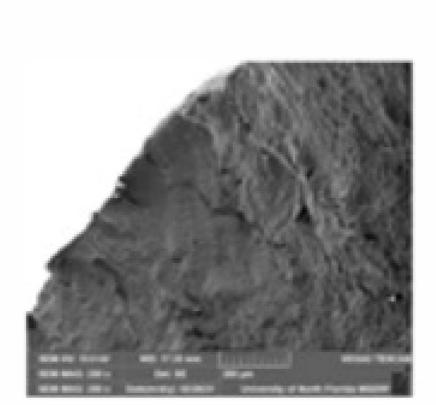
Fracture Surface of Wrought Specimen
Tested at 650 MPa
