Negative Findings Phase I Survey Report Justin Hurst Wildlife Management Area Brazoria County, Texas

**A CULTURAL RESOURCE SURVEY OF
TWO DIRECTIONAL DRILL LOCATIONS
ON THE AIR LIQUIDE SOUTH TEXAS
SYNGAS PIPELINE WITHIN TPWD'S
JUSTIN HURST WILDLIFE
MANAGEMENT AREA**

Technical Report 276

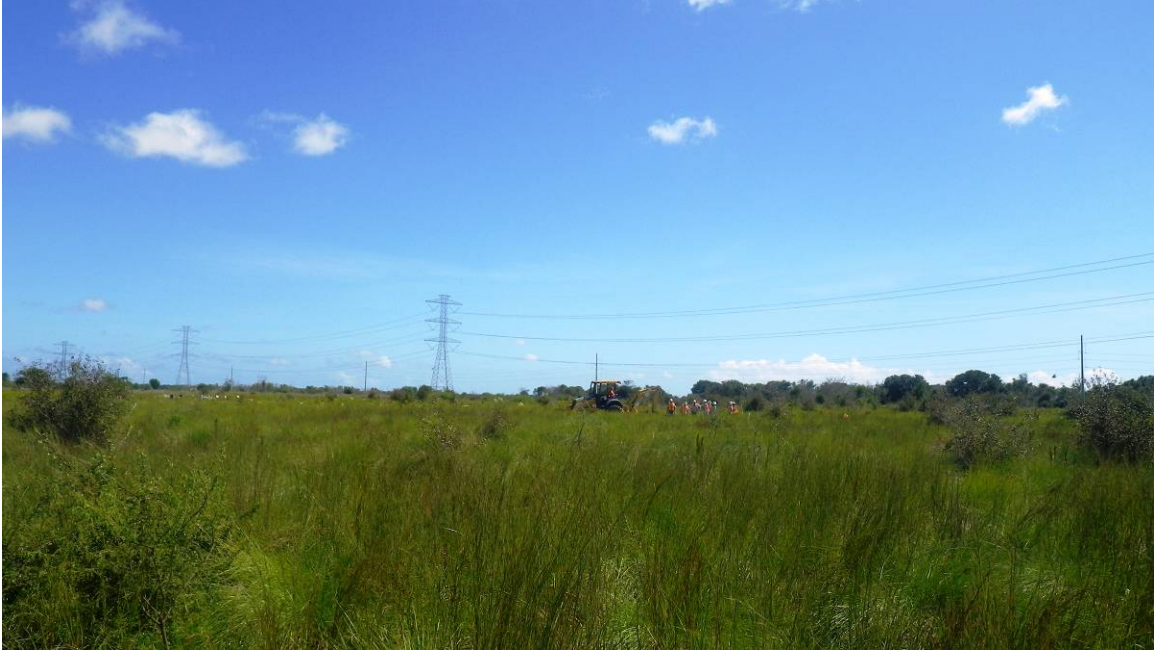
Figure 6. General environment near Trenches 4 & 5, looking SE.

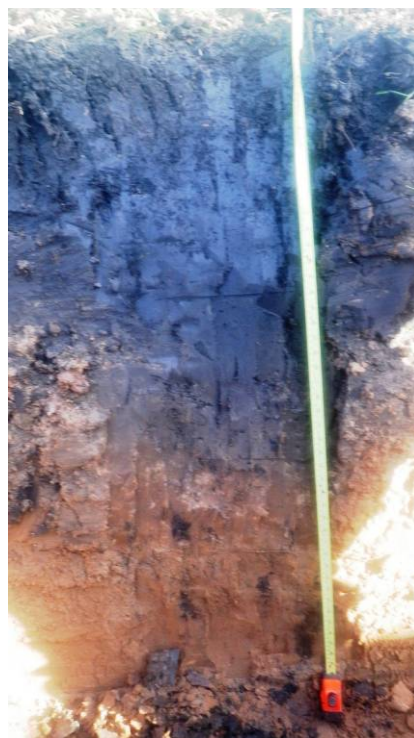
Figure 9. Trench 1 north wall soil profile.

Trench 1 is the southern of the two and is the proposed location of the bore entry/exit hole, 8 m northeast of the southwest corner of the temporary work space (see Figure 3, 8). The trench was 5 m long by 2 m wide by 1.25 m deep. The trench showed Munsell 10YR 2/1 black clay loam from 0-94 centimeters below surface (cmbs) over 10YR 5/8 strong brown clay from 94-125+ cmbs (Figure 9). Both walls were examined for archeological material, with the entire north wall hand-cleared. No artifacts or features were exposed in either of the two 6.25 square meter walls or in the back dirt.

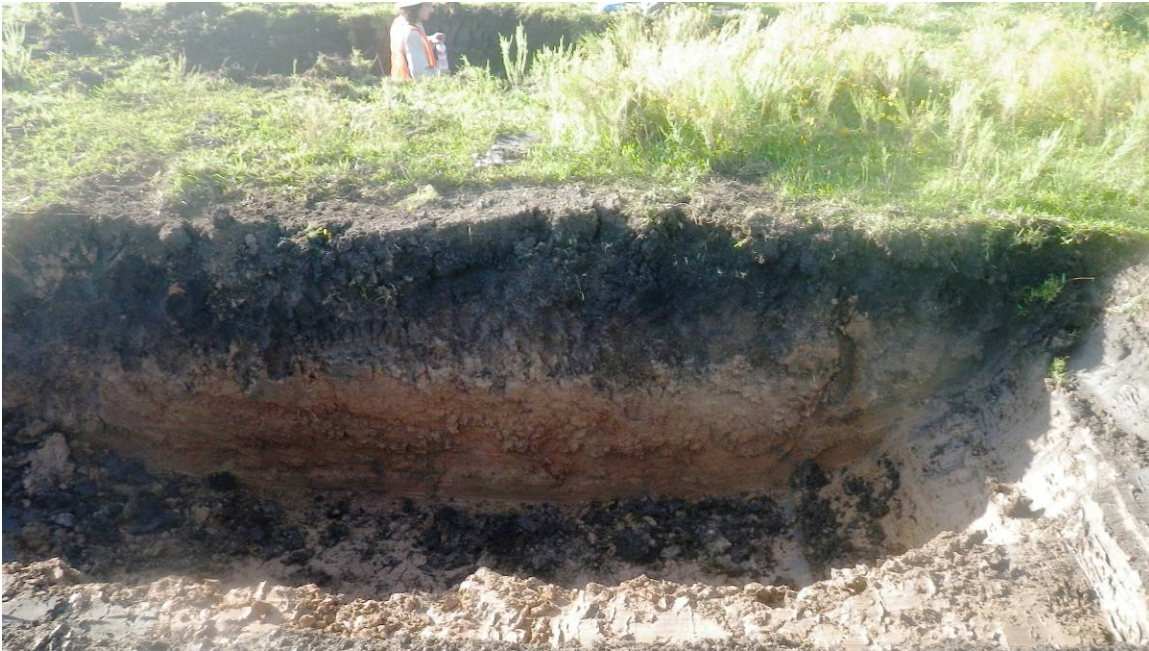
Figure 10. Trench 2 south wall profile - note trench 1 in the background.

Trench 2 is located approximately 2 m north of Trench 1, and is the proposed location of the mud pit which will be used in conjunction with the drill hole at Trench 1. The trench was 6 m long by 2 m wide by 1.25 m deep. The soil was similar to Trench 1, with 10YR 2/1 black clay over 10YR 5/8 strong brown clay (Figure 10). The south wall, covering 7.5 square meters, was hand cleared and examined for cultural remains. The remaining wall and the back dirt were also examined. No artifacts or features were noted.

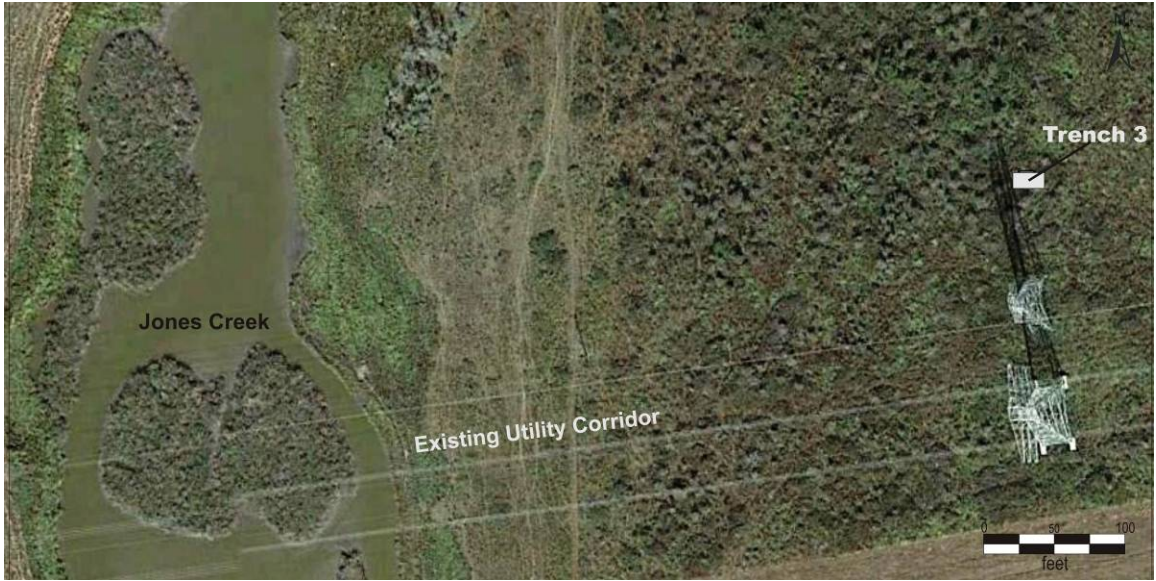
Trench 3 was dug 130 m east of Jones Creek, in an area that had the highest potential for containing cultural remains. No construction activity will occur at this location. The trench was placed along the northern edge of the existing utility corridor, oriented in an east-west direction at 160 degrees magnetic (Figure 11). The trench was 6 m long by 2 m wide by 1.30 m deep. The soil was slightly different than that at Trenches 1 and 2 and showed 10YR 3/1 very dark gray clay from 0-63 cmbs over 10YR 6/6 reddish yellow clay from 63-104 cmbs covering 10YR 5/8 strong brown clay from 104-130+ cmbs (Figure 12). Examination of the 7.8 square meters of the hand-cleared north wall as well as the south wall and back dirt produced no cultural material.

Figure 11. 2012 aerial showing Trench 3 location (source: Google Earth).
