Cultural Resources Survey for the Proposed Dam No. 101 Project within the Upper Brushy Creek WCID, Williamson County, Texas

Submitted to
UBCWCID
460 Texas Avenue
Round Rock, Texas 78664

Submitted by
AECOM
9400 Amberglen Blvd.
Austin, TX 78729

January 2021

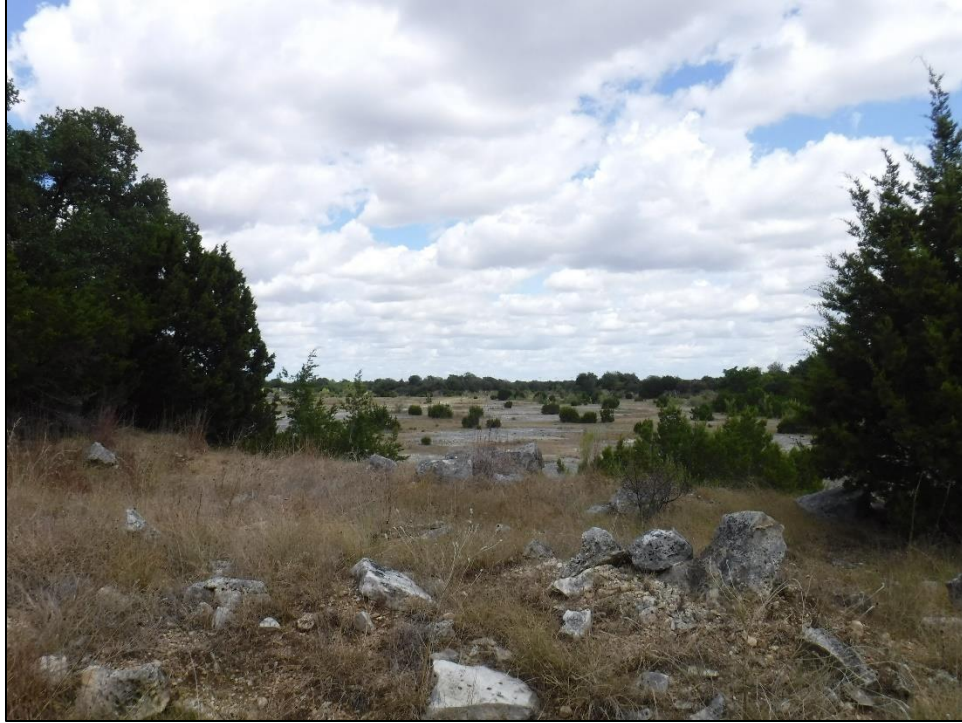
Figure 6. Overview of northern portion of APE, facing north

The APE consists of a relatively open and undulating grassland and oak mosaic centered on Lake Creek (**Figures 6 and 7**). Prior impacts to the APE appear to be minimal and surficial, and include two-track and paved access roads, as well as natural soil erosion. More significant impacts have resulted from the construction and maintenance of the earthen dam and auxiliary spillway for Dam No. 9, which is partially within the southern part of the APE (**Figure 8**). Previous impacts have also resulted from the construction of O'Connor Drive, which is intersected by the APE. Pedestrian survey and shovel testing revealed the APE is within dissected uplands exhibiting shallow and cobbly soils that formed in residuum weathered from the underlying Cretaceous limestone. Overall ground surface visibility was greater than 30 percent, with increased visibility in highly eroded areas.

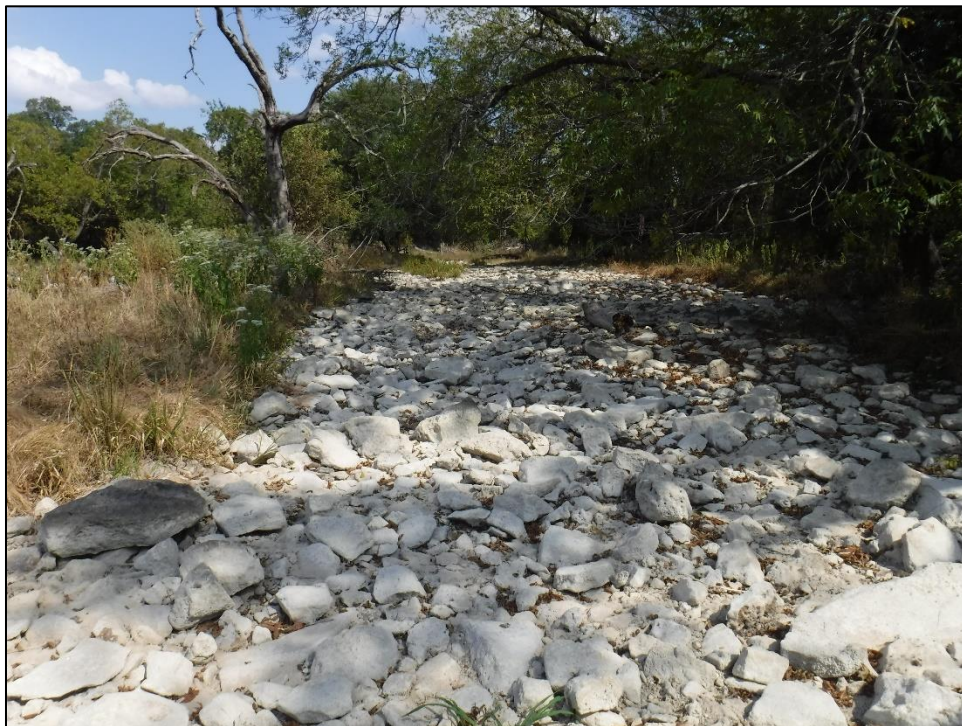
Figure 7. Overview of Lake Creek channel within APE, facing north

Gravelly and cobbly soils were more common within shovel tests around Lake Creek. Inspection of cutbank profiles revealed lenses of poorly sorted and angular gravels (2-10 cm diameter), which are indicative of high-energy flood regime discharges following storm events. This is further evidenced by large bedload cobbles and gravels at the base of the stream channel (see **Figure 7**). Within the APE, Lake Creek has incised between 30 and 50 cm into the surrounding soils, which lie directly upon Cretaceous limestone bedrock (**Figure 9**).

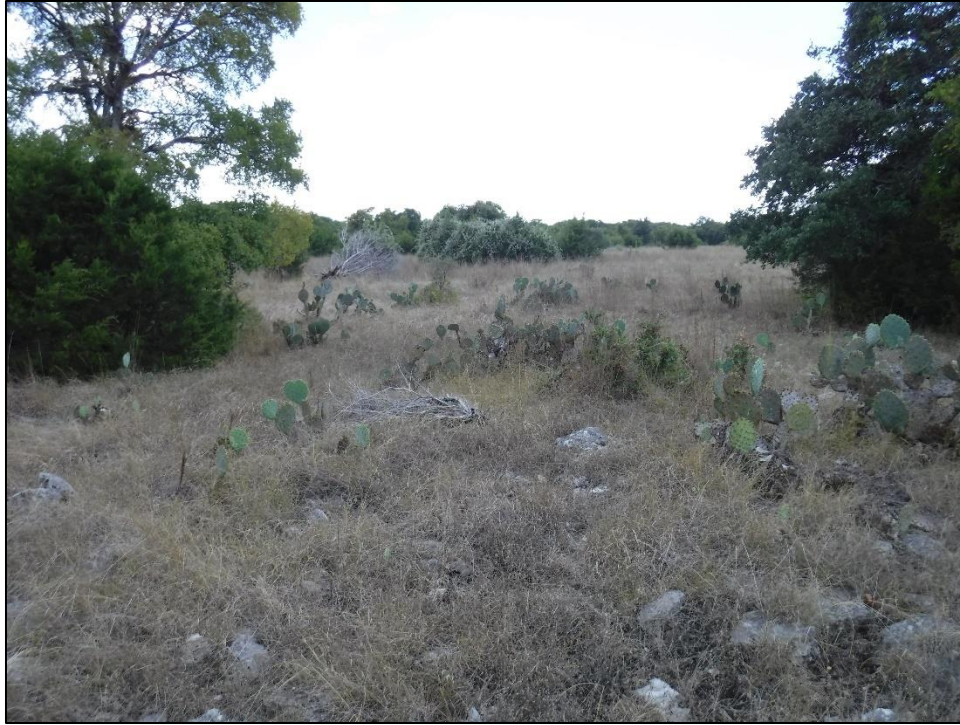
Figure 11. Overview of 41WM748, facing south

AECOM revisited and reevaluated the portion of site 41WM748 within the APE in September 2019. Numerous limestone outcrops were observed across the site area, along with a general paucity of overstory vegetation (**Figure 11**). Short grasses are common across the entire site area, which exhibited approximately 50 percent ground surface visibility. Soils at the site consist of Georgetown stony clay loam, 1 to 3 percent slopes (NRCS 2020); they are very shallow to eroded. The shallow depth of the potential artifact-bearing soils was confirmed by the excavation of 11 shovel tests within the site, which averaged 31 cm in depth before encountering either bedrock or a restrictive argillic horizon.

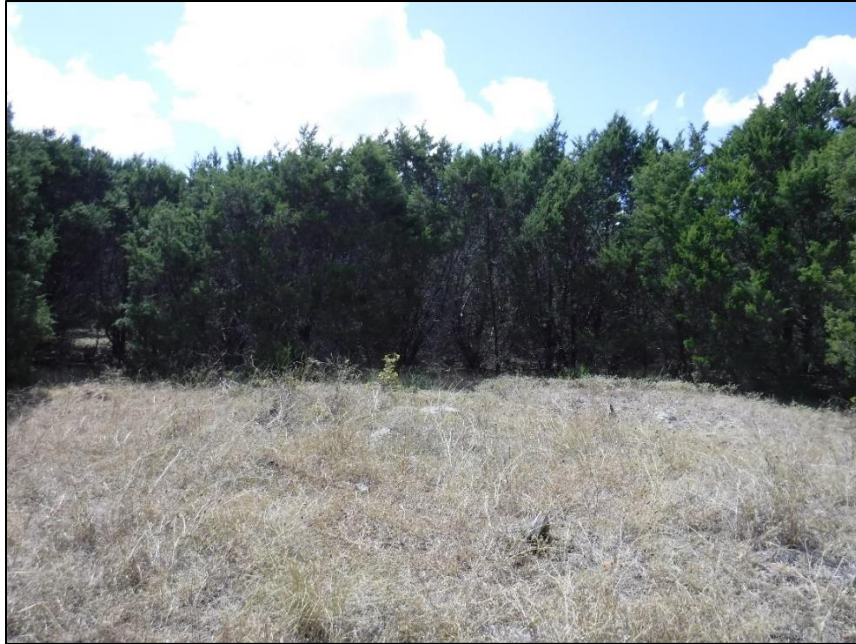
Figure 13. Overview of 41WM750, facing south

AECOM revisited and reevaluated the portion of site 41WM750 within the APE in September 2019, which extends approximately 480 m north-south by 240 m east-west along the east bank of Lake Creek. Numerous limestone outcrops extend across the site area, which is moderately well-wooded with short grasses (**Figure 13**). Ground surface visibility is approximately 50 percent. Soils at the site are mapped as Georgetown stony clay loam, 1 to 3 percent slopes (NRCS 2020), and in most areas, these soils are very shallow or eroded. The shallow soils were confirmed by the excavation of 12 shovel tests within the site, which averaged 28 cm deep before encountering either bedrock or a restrictive argillic horizon.

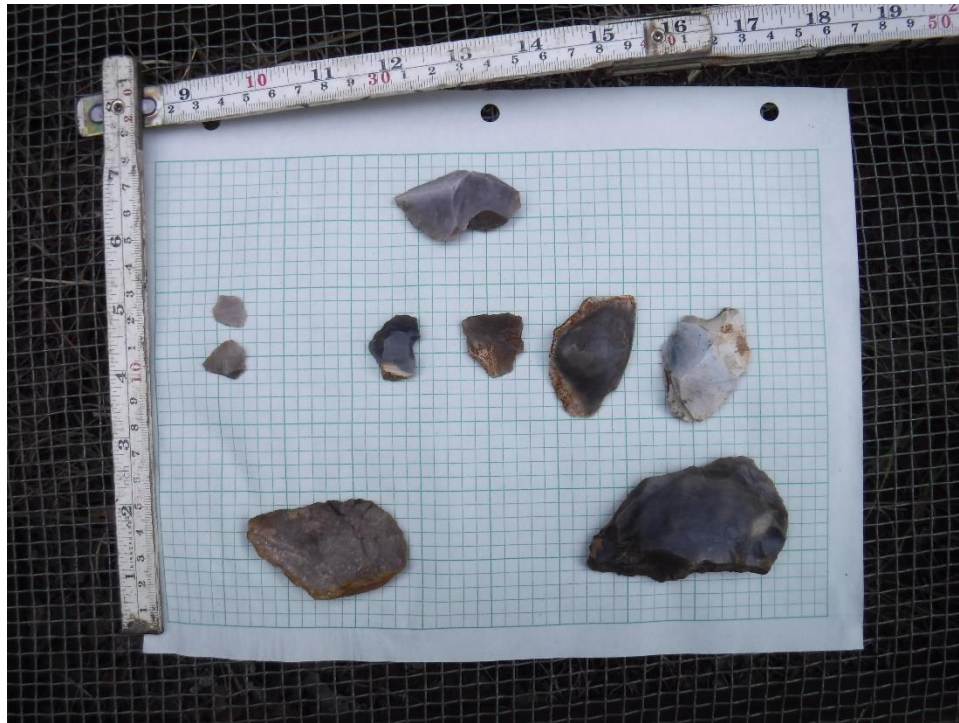
Figure 16. Selected chert flakes observed at 41WM750.

Three of the 12 shovel tests were positive for cultural materials (**Table 5; Figure 14**). These shovel tests yielded a total of six lithic flakes and one piece of animal bone. In addition, 40 chert flakes, one biface, and one partial utilized flake were observed on the surface of the site, at the northern end and slightly north of the current site boundary (**Figures 15 and 16**). No temporally diagnostic artifacts or features were found. Based on the current survey results revealed by surface finds and shovel tests, the site boundaries for site 41WM750 should be extended approximately 140 m to the north.

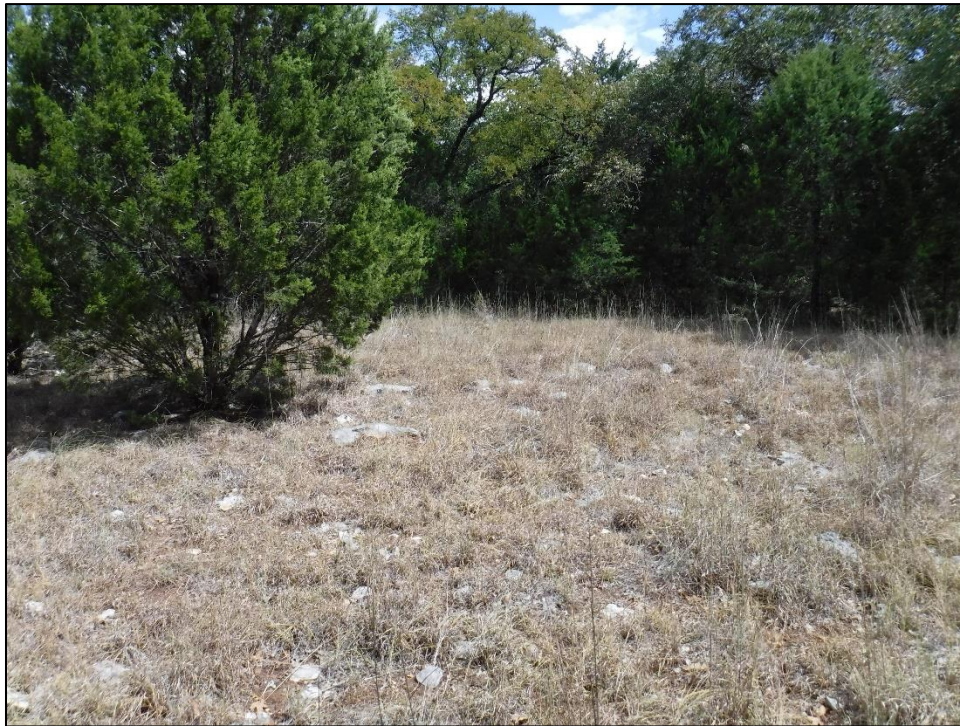
Figure 17. Overview of site 41WM1058, facing southeast

AECOM attempted to relocate site 41WM1058 in September 2019 during the survey. Despite intensive ground surface inspection and the excavation of shovel tests, no artifactual evidence of the site could be found. Numerous limestone outcrops are present across the site area; the site is moderately well-wooded and contains short grasses and exhibits greater than 50 percent ground surface visibility (**Figure 17**). Soils are mapped as Georgetown stony clay loam, 1 to 3 percent slopes (NRCS 2020), and in most areas, are very shallow or non-existent. The shallow depth of the potential artifact-bearing soils was confirmed by the excavation of two shovel tests in the recorded boundaries of the site, which terminated at bedrock at 10 and 22 cmbs (**Figure 18**). None were positive for cultural materials; no temporally diagnostic artifacts or features were found.

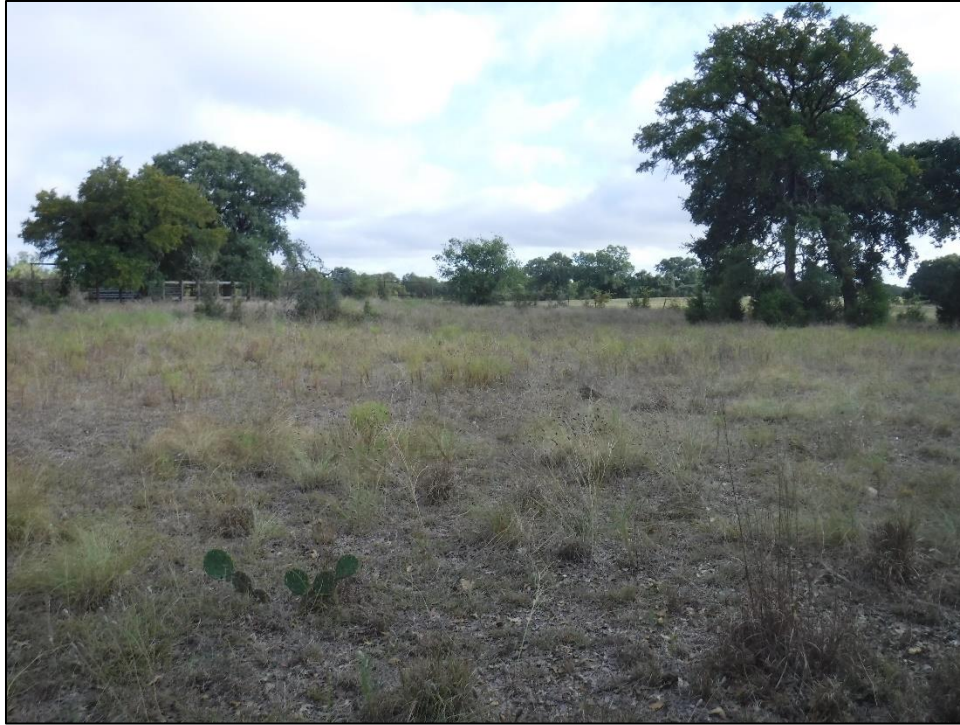
Figure 19. Overview of 41WM1248, facing north

Site 41WM1248 is open and contains short grasses across the site area. Bare ground areas are extensive, and the area exhibits approximately 50 percent ground surface visibility (**Figure 19**). Soils at the site are mapped as Georgetown stony clay loam, 1 to 3 percent slopes (NRCS 2020), and in most areas, are very shallow or non-existent. The shallow depth of the potential artifact-bearing soils was confirmed by the excavation of nine shovel tests within or immediately adjacent to the site. These shovel tests averaged 27 cm in depth before encountering either bedrock or a restrictive argillic horizon. Two of the nine shovel tests were excavated to the east of the corral and were both positive for cultural materials and yielded a total of three chert flakes/debitage (**Table 6; Figure 20**). Because these materials were recovered from two shovel tests that were excavated within the disturbed/graded auxiliary spillway, it is questionable whether the flaked chert materials are prehistoric in origin (**Figure 21**). Given their provenance it is quite possible that they are pieces of chert that were mechanically fractured during construction of the Dam No. 9 spillway. None of the other shovel tests were positive for cultural materials. Furthermore, no additional surface finds were observed at this site.

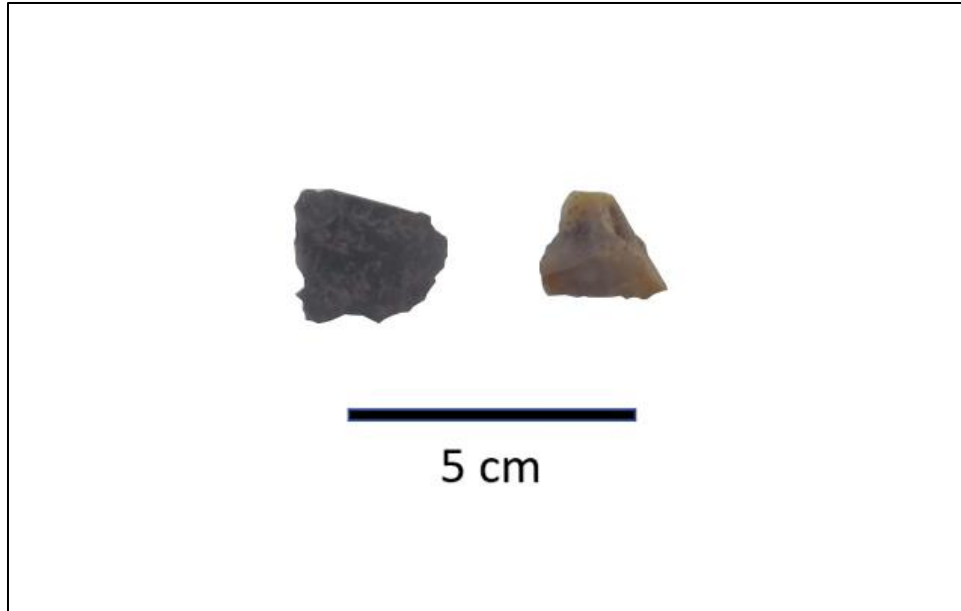
Figure 21. Potential debitage observed in shovel tests within Dam 9 spillway east of 41WM1248.

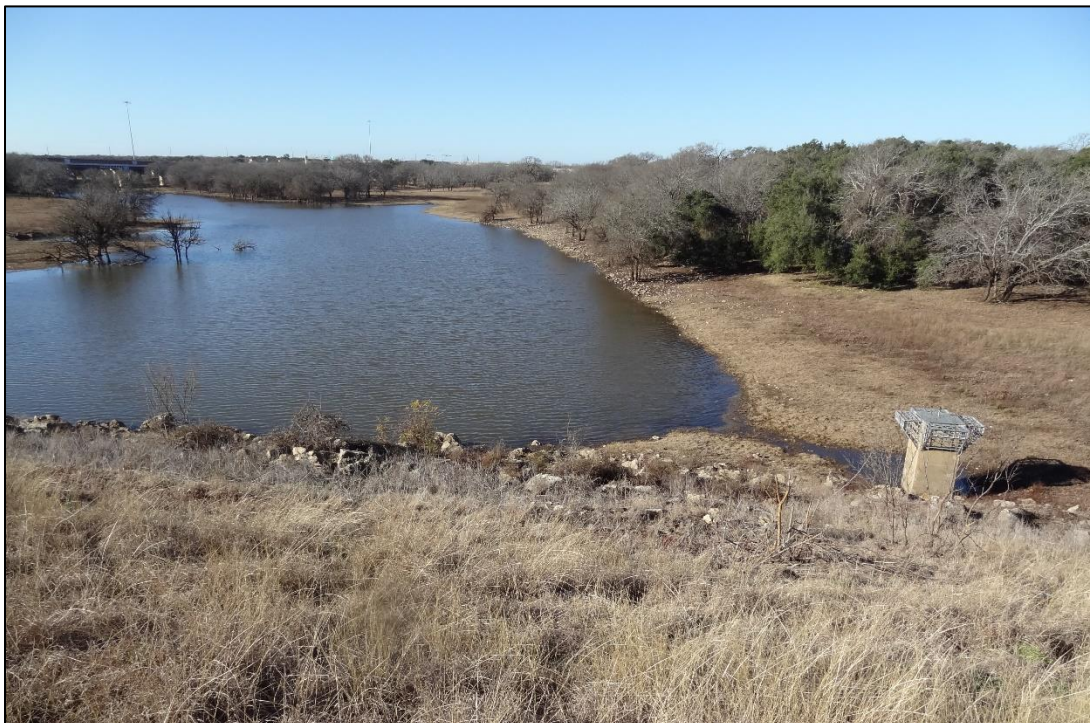
Figure 24. View from top of Dam No. 9, facing west

Dam No. 9 does not appear to have been altered, and the surrounding landscape has remained undeveloped. Therefore, this resource has retained integrity of location, design, setting, materials, workmanship, feeling, and association. Although the resource retains integrity, its association with flood control development in the Brushy Creek Watershed is not sufficient for NRHP-listing as there are many examples of this type of resource in Williamson County that have a similar historical context. The resource is not associated with a pattern of development in Williamson County as there was not a significant growth in population until the 1980s. As such, the resource fails to illustrate any known association with significant historical events or a significant pattern of development in Williamson County, and does not qualify for NRHP eligibility under Criterion A. The resource is also not associated with significant persons in history and lacks engineering design merit to qualify for NRHP eligibility under Criteria B or C. Furthermore, the resource is not likely to yield information important to history or prehistory, and does not qualify for NRHP eligibility under Criterion D. Therefore, Resource 001 (Dam No. 9) is recommended as not eligible for listing in the NRHP.

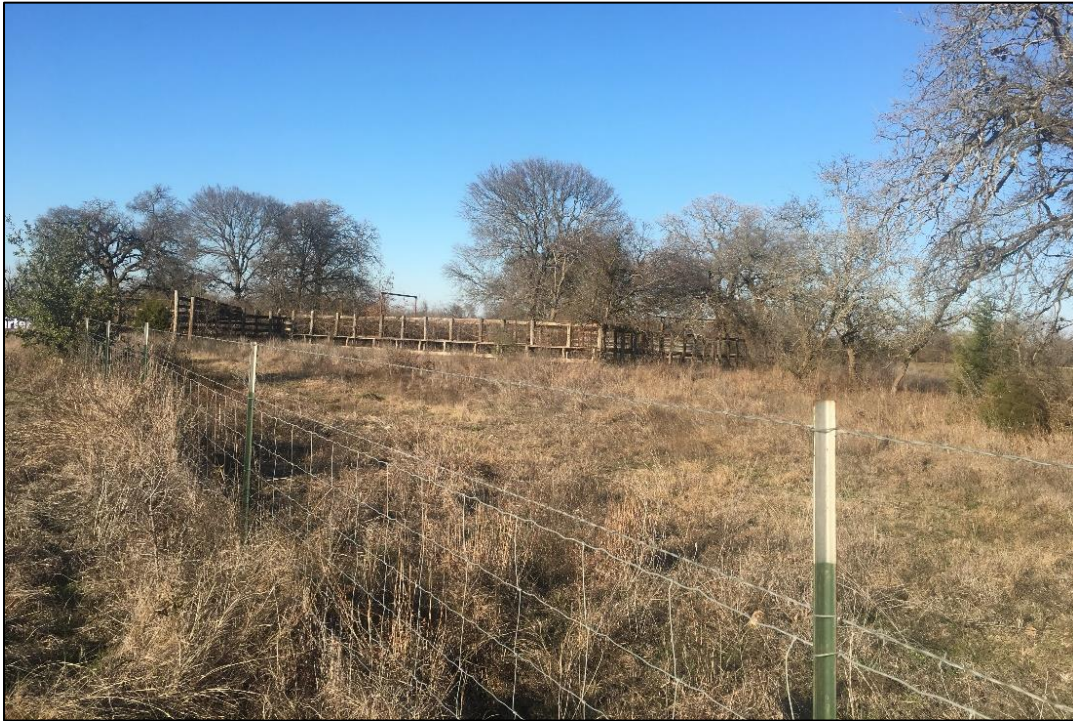
Figure 26. View of Resource 002, facing north

The corral first appears on the 1964 aerial photograph as consisting of two compartments. The structure was divided into four compartments between 1981 and 1985. The physical condition of the corral is poor and some of the materials used in the construction of the corral appear to be non-historic age. The corral is overgrown with vegetation; no livestock was observed in the area during the field visit. Due to the use of modern replacement materials, the resource lacks integrity of design, materials, and workmanship, but retains integrity of location, setting, feeling and association.

Although the resource retains some integrity, its association with ranching is not sufficient for NRHP-listing as there are many examples of this type of resource in Williamson County with similar historical context. As such, the resource fails to illustrate any known association with significant historical events or a significant pattern of development in Williamson County, and does not qualify for NRHP eligibility under Criterion A. The resource is also not associated with significant persons in history and lacks engineering design merit to qualify for NRHP eligibility under Criteria B or C. Furthermore, the resource is not likely to yield information important to history or prehistory, and does not qualify for NRHP eligibility under Criterion D. Therefore, Resource 002 is recommended not eligible for listing in the NRHP.
