INTENSIVE ARCHEOLOGICAL SURVEY OF FORT RICHARDSON STATE PARK AND HISTORIC SITE

Jack County, Texas

Final Report
September 2018

**FORT RICHARDSON STATE PARK
WATER AND WASTEWATER
SYSTEM REPLACEMENT**

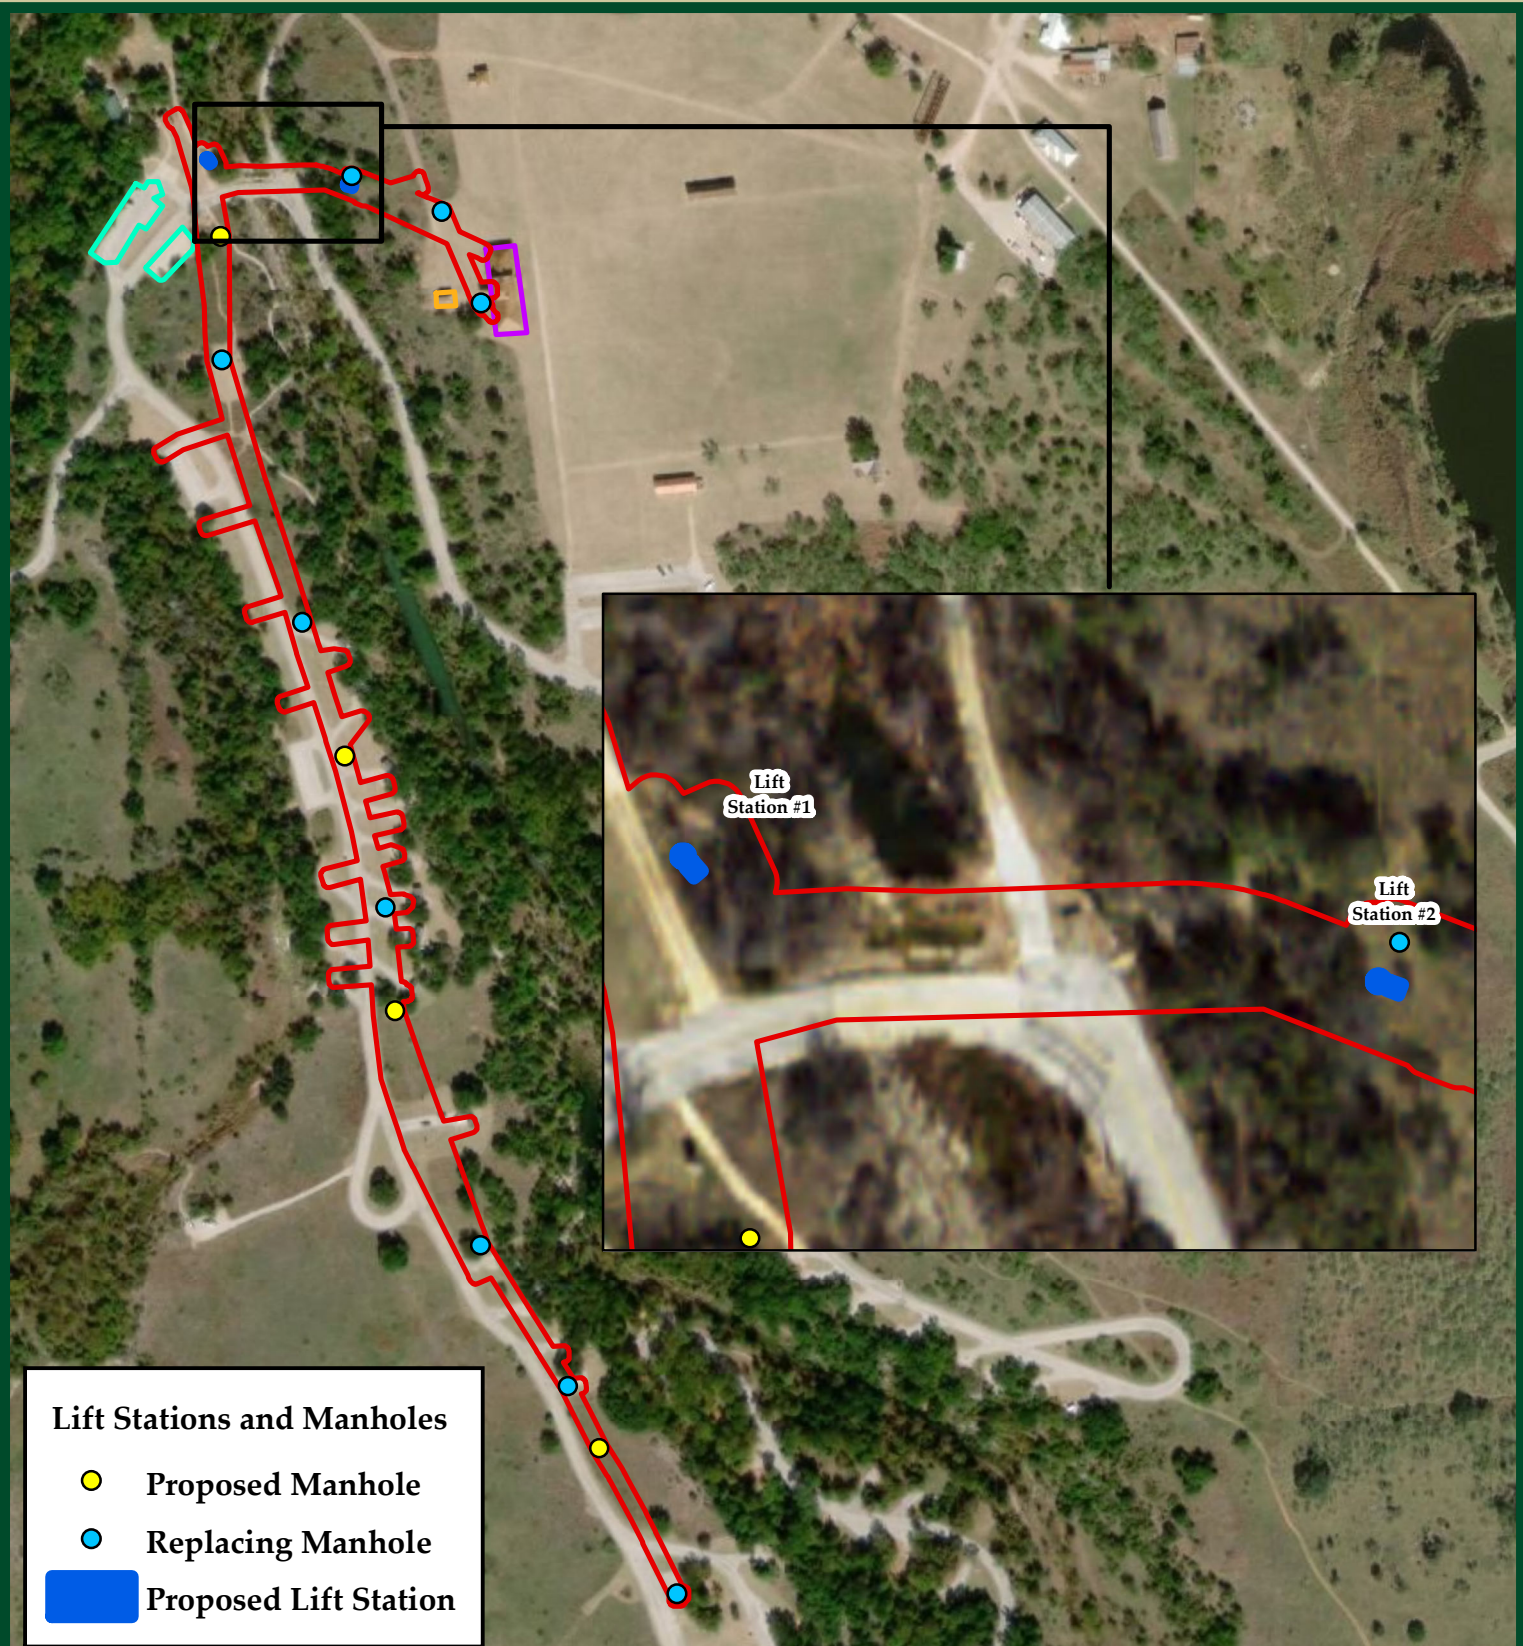
Lift Stations and Manholes

- Proposed Manhole
- Replacing Manhole
- Proposed Lift Station

Two manholes will be replaced in the vicinity of the historic hospital and morgue, and two new lift stations are proposed near Lost Creek. NRHP testing was established necessary for these areas. However, in the field it was determined that the locations near the manholes were significantly impacted during their original construction (see Figure 3).

The proposed areas for NRHP testing included any deep disturbances within 15 feet of the fort hospital and morgue, and at Lift Stations 1 and 2 (see Figure 3). The manholes that are within 15 feet of the hospital are being replaced, and thus the soil was already disturbed during original construction. Lift Station 1 was on a bedrock creek bank with no soil, thus subsurface investigations were not necessary or suitable. Lift Station 2 also had some bedrock at surface, but was adjacent to the yard of the fort hospital, within view of the hospital. We had recovered numerous artifacts from the surface and within 10 centimeters of the surface near the hospital, thus some level of subsurface investigation was determined necessary at the nearby proposed lift station, albeit not as an intensive investigation as NRHP testing.

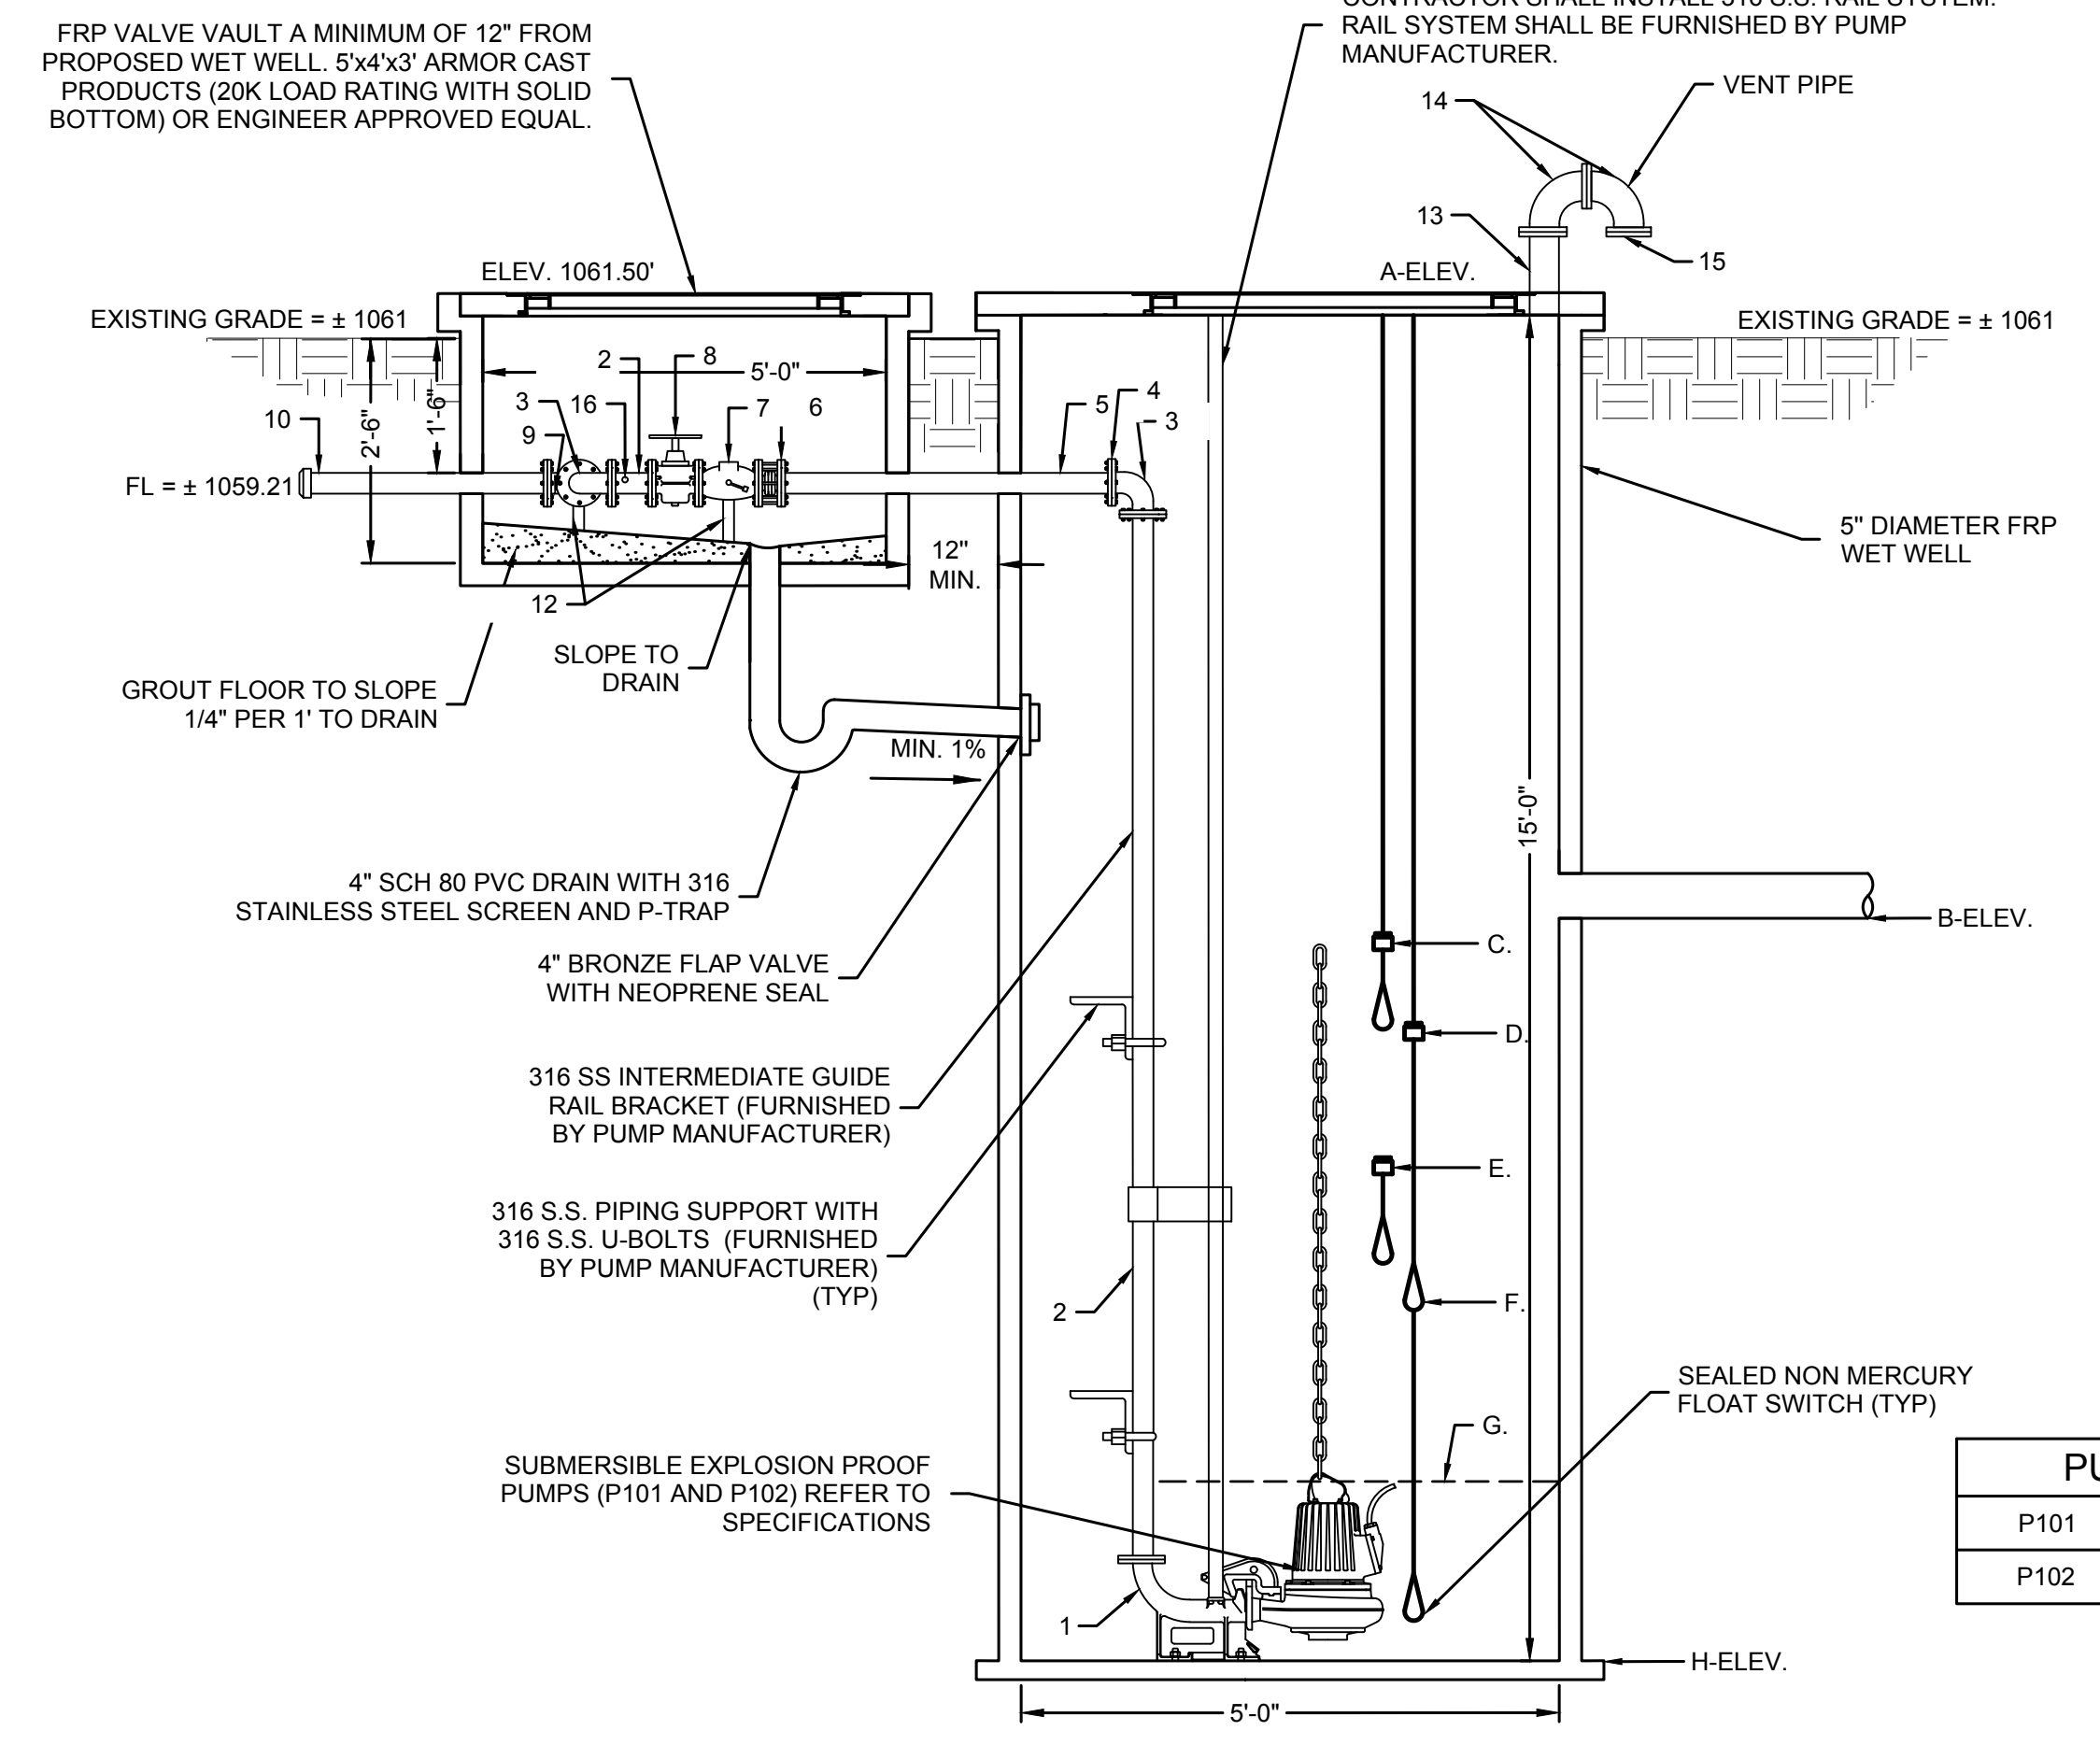
LIFT STATION NO.2 SECTION

LIFT STATION NO.2 DETAIL
NTS

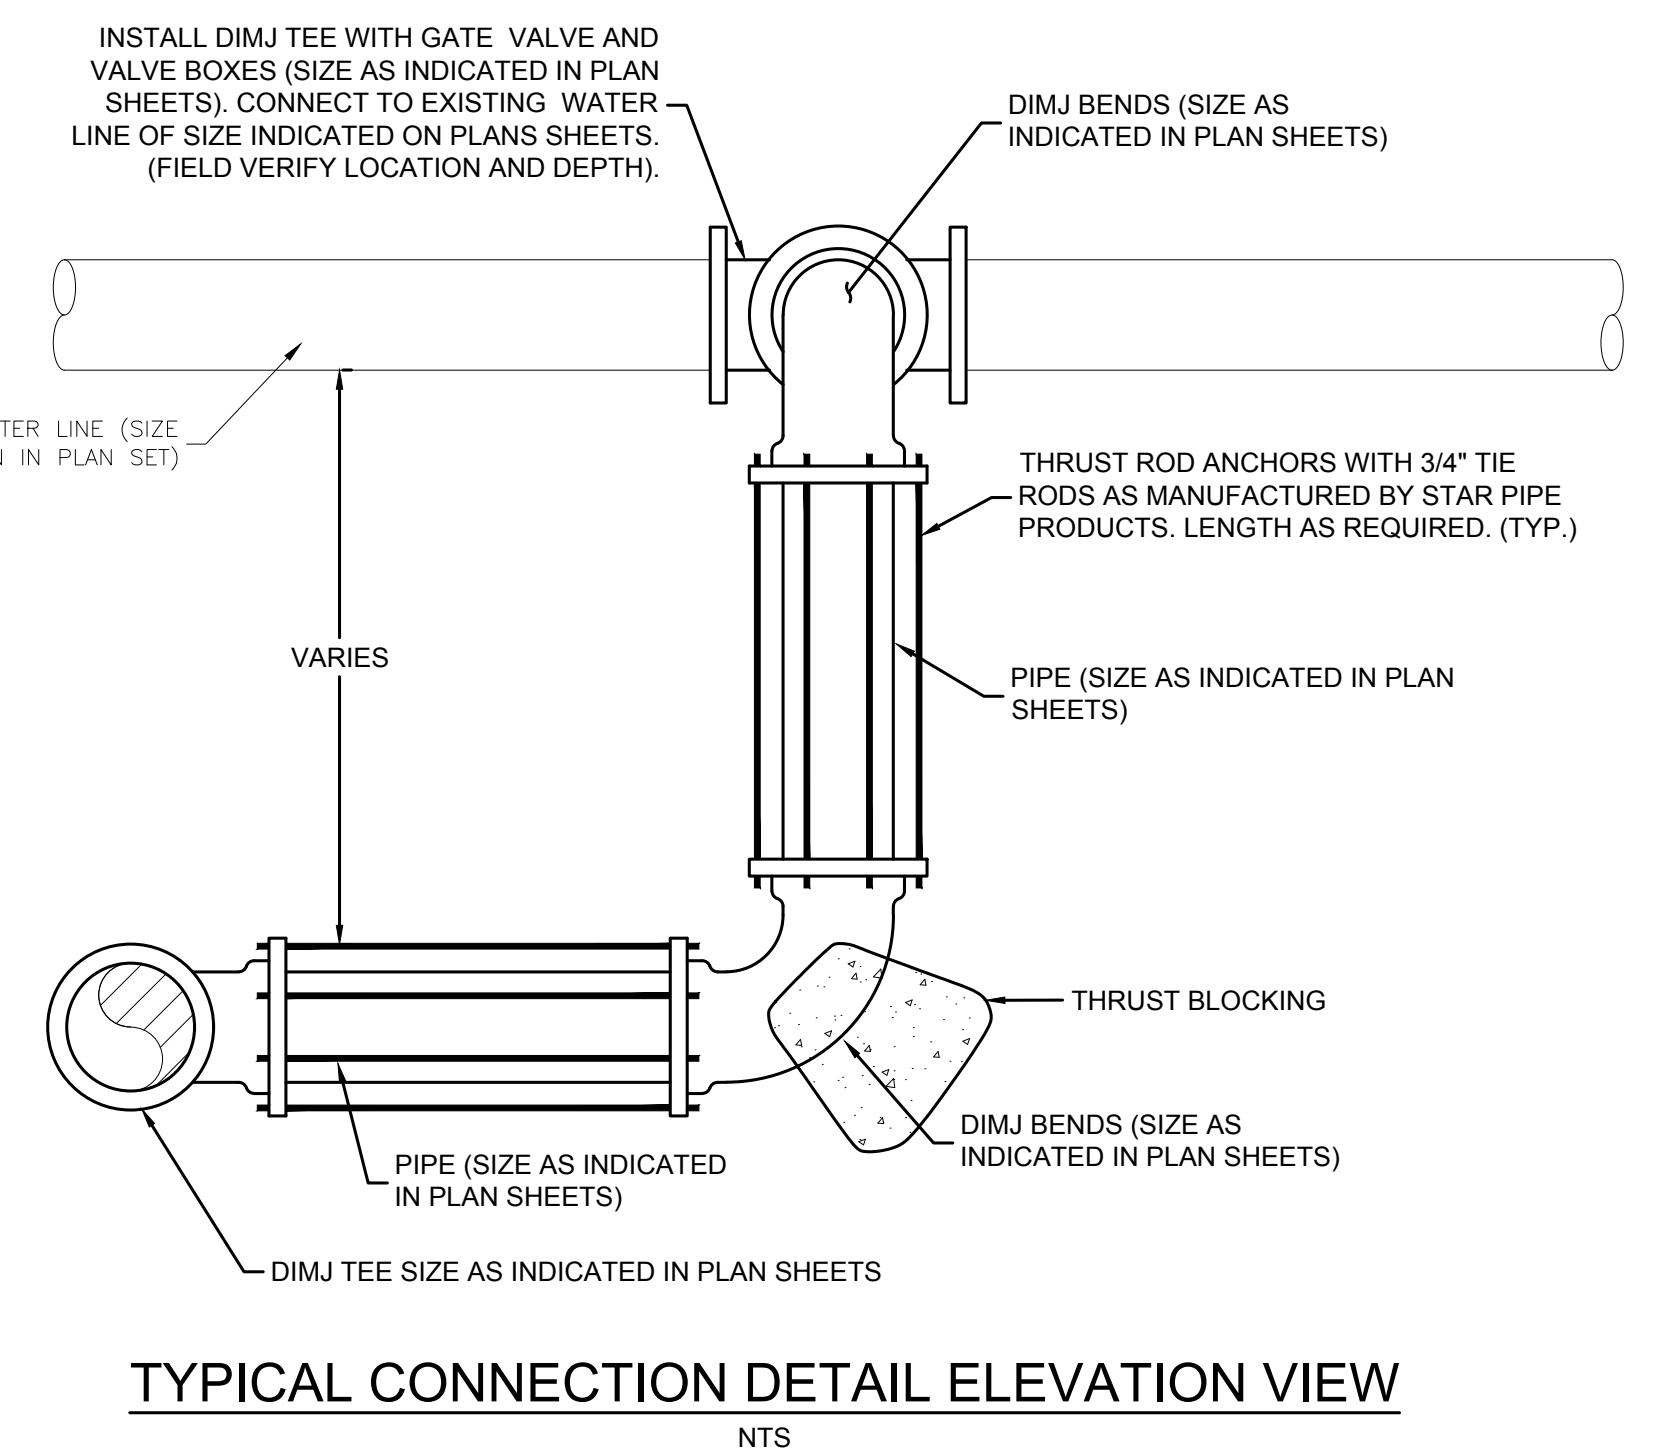
TYPICAL CONNECTION DETAIL ELEVATION VIEW
NTS

NOTE:
THRUST BLOCKING REQUIRED AT ALL FITTINGS. THRUST BLOCKING IS NOT SHOWN IN DETAILS FOR CLARITY.

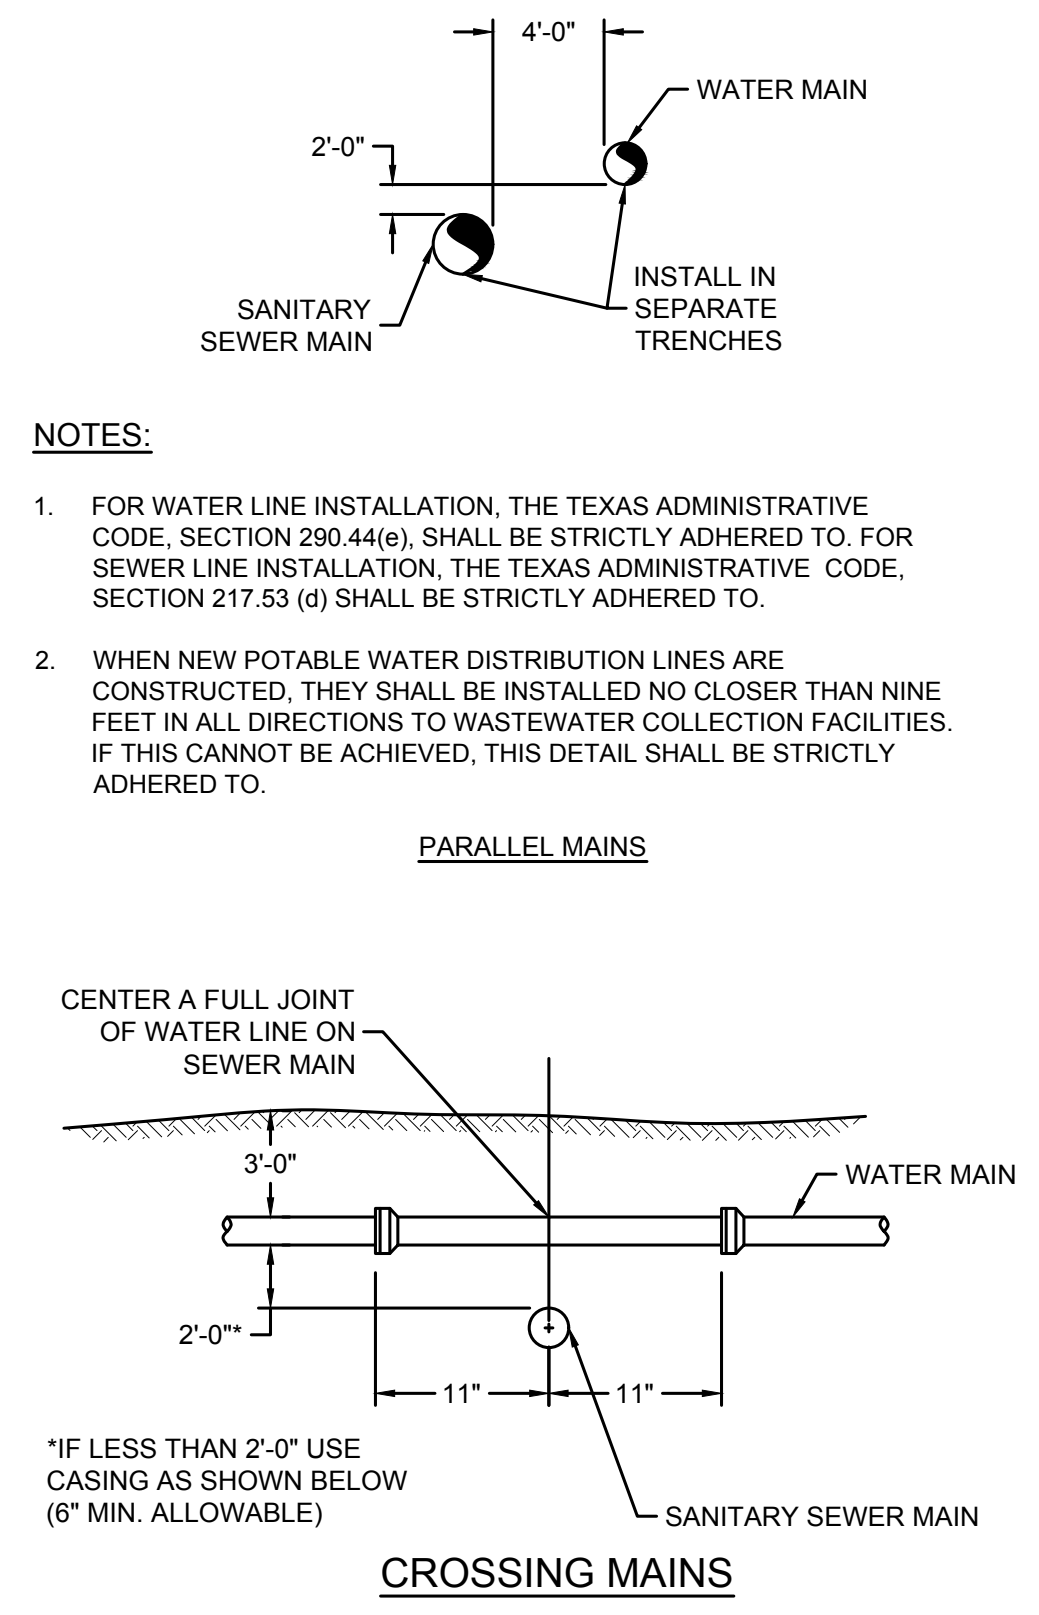
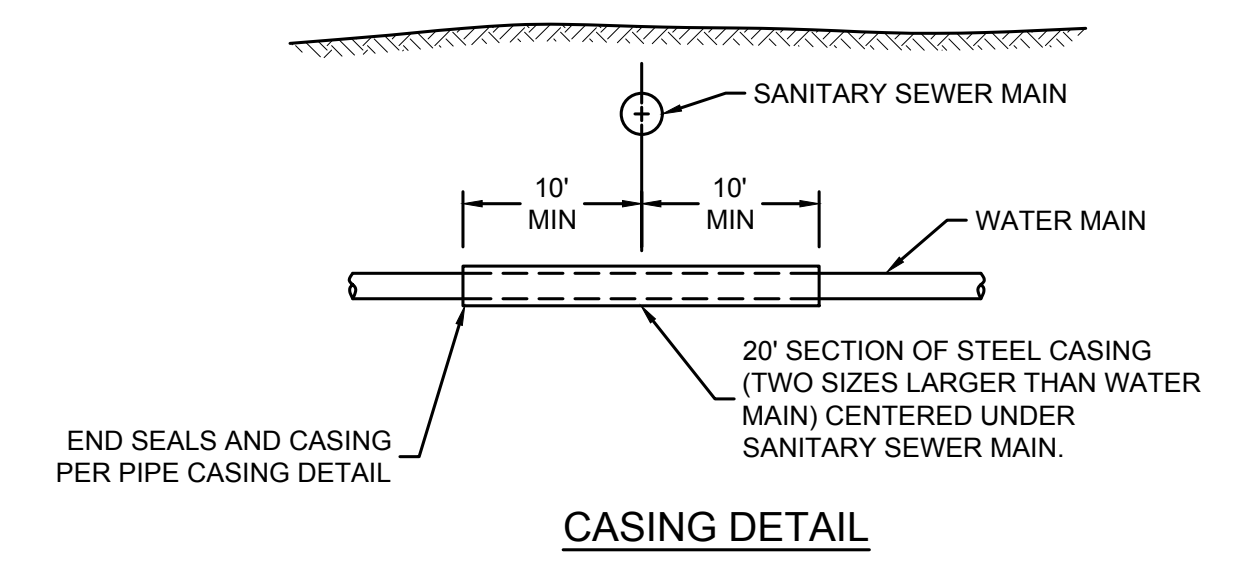
UTILITY CROSSINGS DETAIL
NTS

- NOTES:**
- REQUIRED FOR WATER MAINS CROSSING BELOW, OR WITHIN 2 FEET ABOVE, SANITARY SEWER MAINS.
 - IN LIEU OF THIS PROCEDURE THIS 20' SECTION OF WATER LINE CASING PIPE CAN BE DELETED AND THE SEWER LINE REPLACED WITH DUCTILE IRON PIPE WITH WATERTIGHT JOINTS TO MAINTAIN 10.0 FT. CLEARANCE EITHER SIDE OF WATERLINE.
 - CEMENT STABILIZER SAND BACKFILL INITIAL BACKFILL ZONE OF SEWER FOR 10.0 FT. EACH SIDE OF CROSSING. CENTER ONE JOINT OF WATER MAIN ON SEWER PIPE.

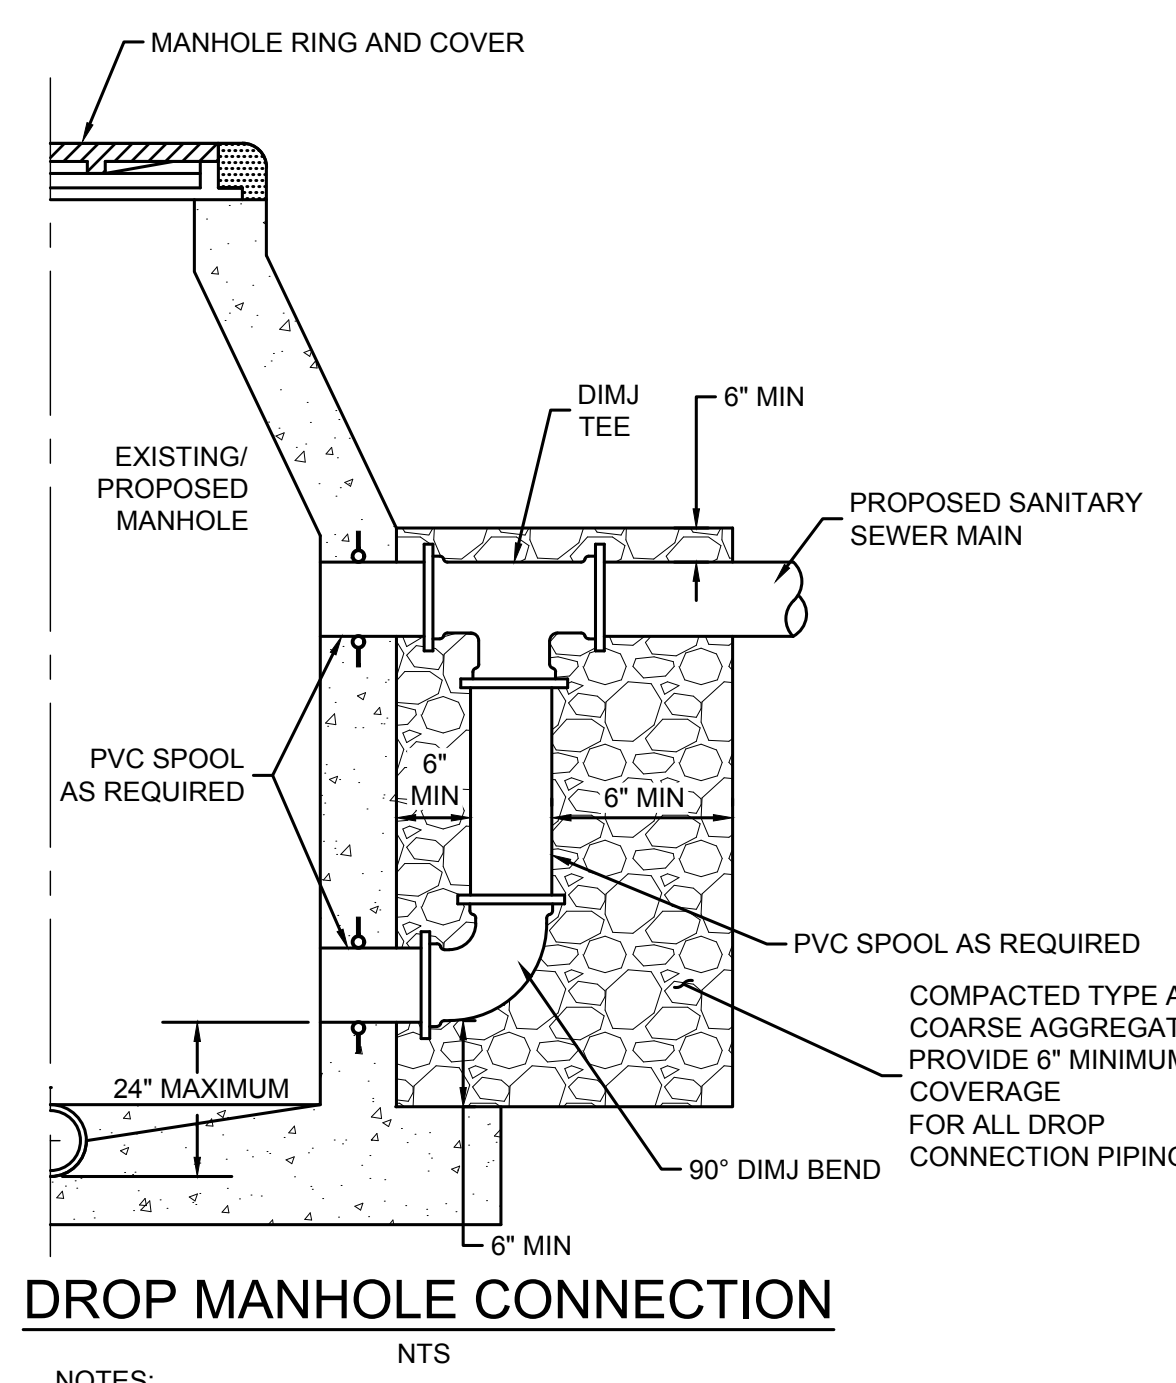
DROP MANHOLE CONNECTION
NTS

NOTES:
DROP MANHOLE CONNECTIONS SHALL BE CONSTRUCTED WHERE A CONNECTION PIPE ENTERS A MANHOLE MORE THAN 24\"/>

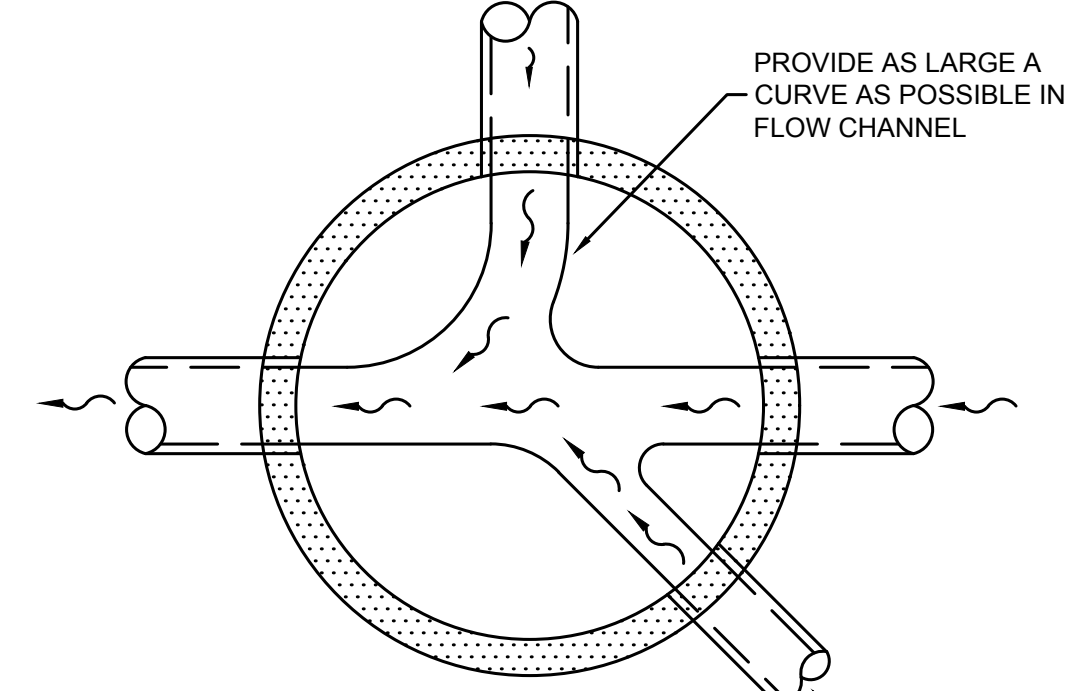
MANHOLE BOTTOM DETAIL
NTS

- NOTES:**
1. CENTERLINE OF ALL PIPES ENTERING AND LEAVING MANHOLE SHALL PASS THROUGH CENTER OF MANHOLE.
 2. CONSTRUCT FLOW CHANNEL FOR ALL PIPES ENTERING MANHOLE, INCLUDING SERVICES MAINTAIN A CONSTANT GRADE THROUGHOUT EACH INVERT.
 3. GROUT FILLET MANHOLE INVERTS FOR PIPES ENTERING MANHOLE WITHOUT DROP CONNECTION.

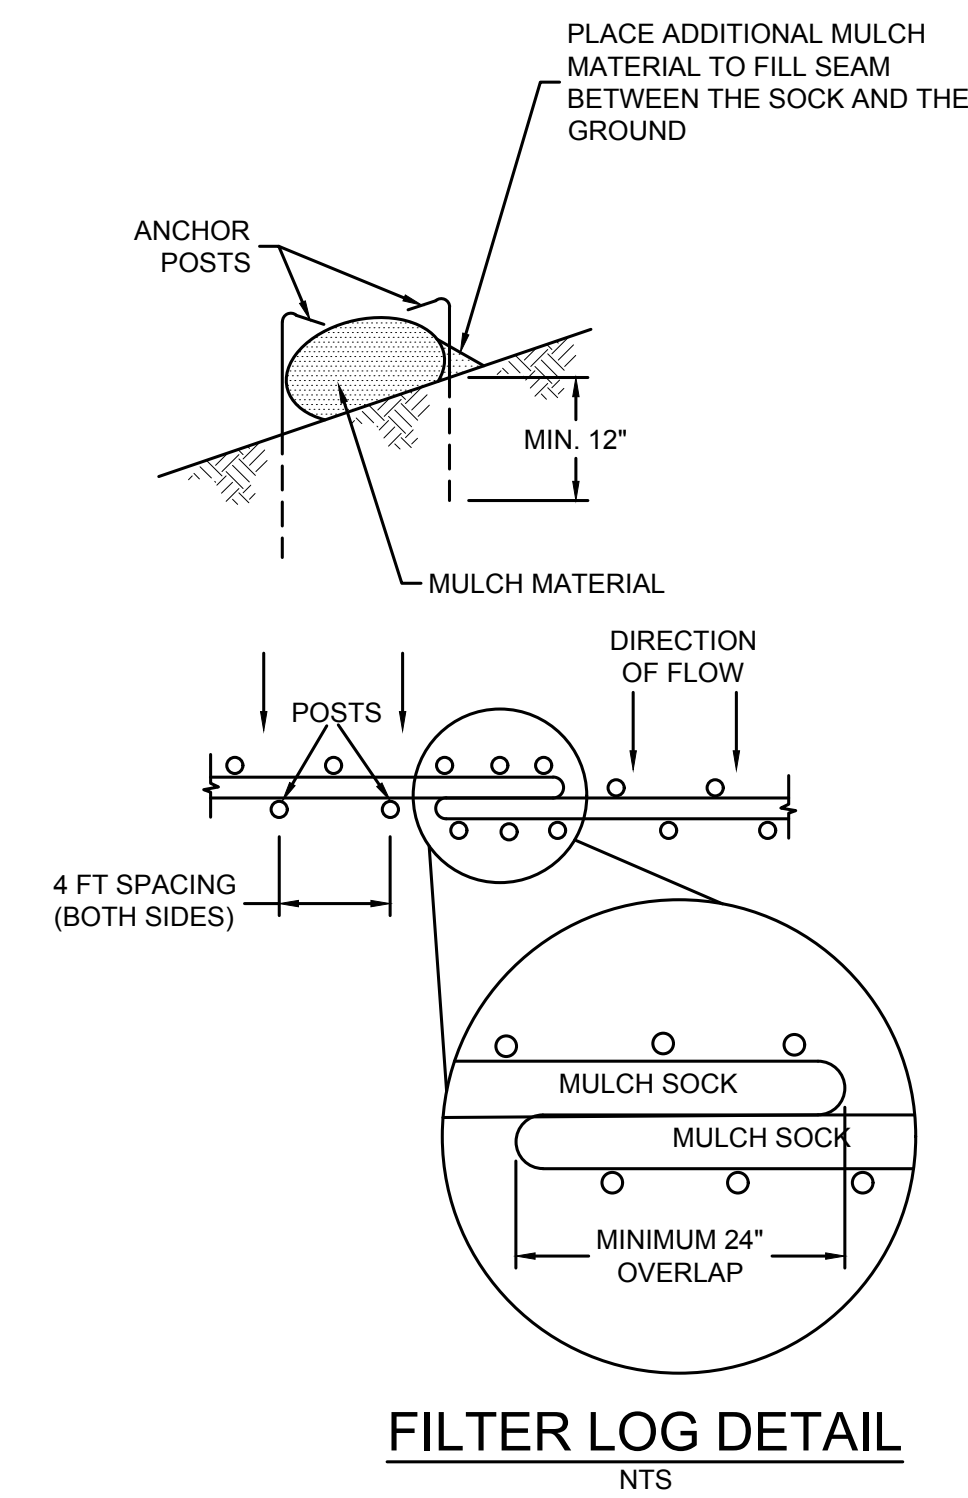
FILTER LOG DETAIL
NTS

- NOTES:**
- MULCH SOCKS SHALL BE 12" DIAMETER AND MADE OUT OF BIO-DEGRADABLE OR RECYCLABLE MATERIAL SUCH AS BURLAP, TWINE AND SOME DEGRADABLE PLASTICS. IT IS PREFERRED THAT ON-SITE MULCH PRODUCED FROM TREE TRIMMING REQUIRED FOR THIS PROJECT IS USED TO FILL THE SOCKS. OTHER MATERIAL MAY BE ACCEPTABLE AT THE ENGINEER'S DISCRETION.

- ACCUMULATED SILT SHALL BE REMOVED WHEN IT REACHES A DEPTH OF 6 INCHES. THE SILT SHALL BE DISPOSED OF ON AN APPROVED SITE AND IN SUCH A MANNER THAT WILL NOT CONTRIBUTE TO ADDITIONAL SILTATION.

- AT THE CONCLUSION OF CONSTRUCTION, SOCKS MAY BE CUT OPEN AND MULCH SPREAD ON-SITE. ALL OTHER DEBRIS TO BE REMOVED FROM SITE.

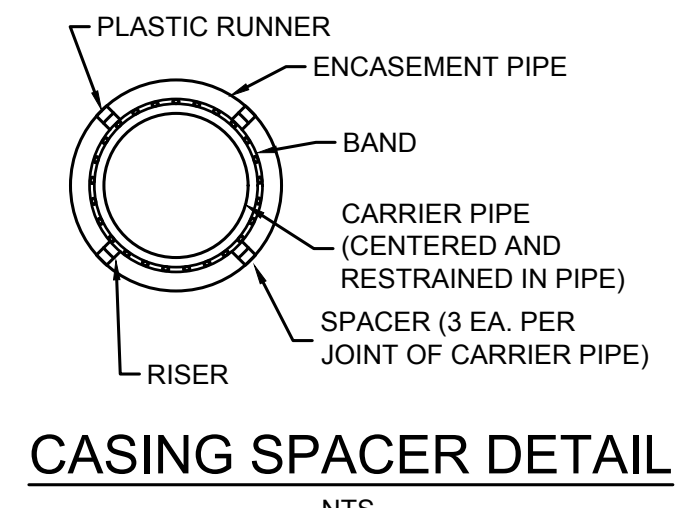
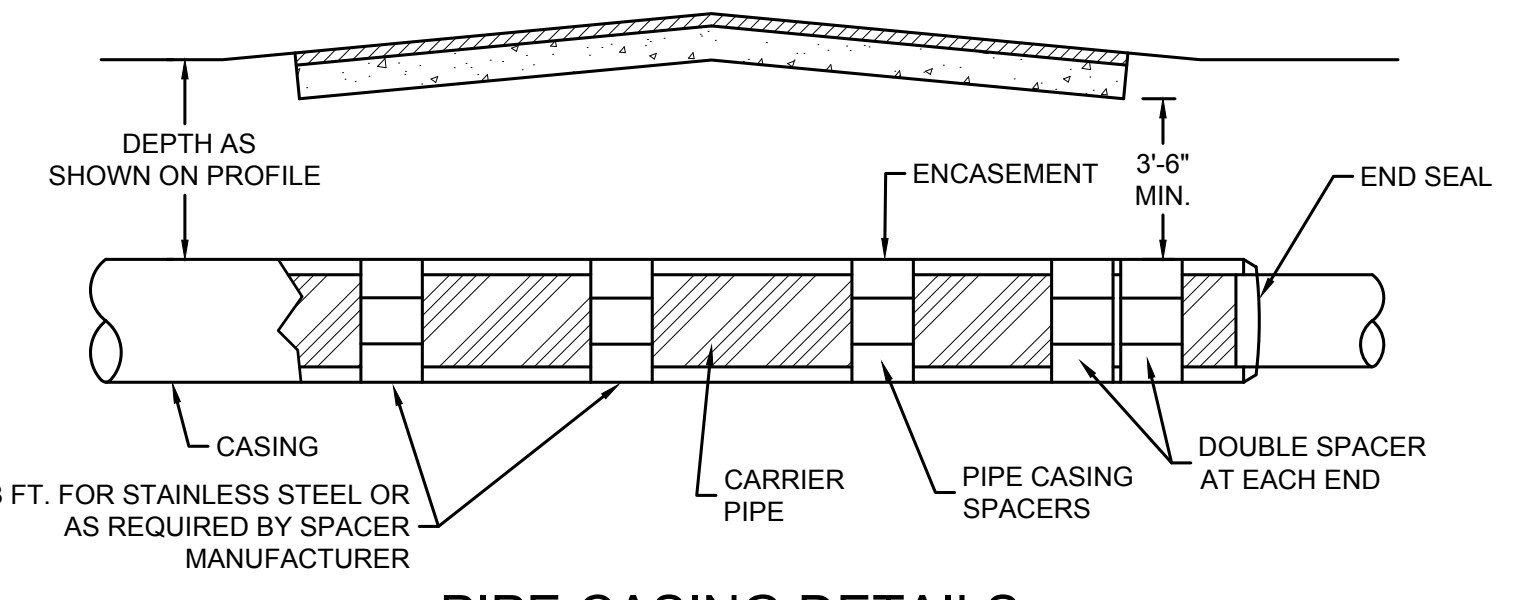
PIPE CASING DETAILS
NTS

- NOTES:**
- CASING SPACERS SHALL BE STAINLESS STEEL.
 - ENCASEMENT PIPE SHALL BE OF SIZE AND THICKNESS SPECIFIED IN THE TECHNICAL SPECIFICATIONS.
 - CASING SPACERS SHALL CENTER AND RESTRAIN CARRIER PIPE IN CASING.
 - CASING END SEALS SHALL BE "PULLON" TYPE. "WRAP AROUND" END SEALS ARE PROHIBITED.

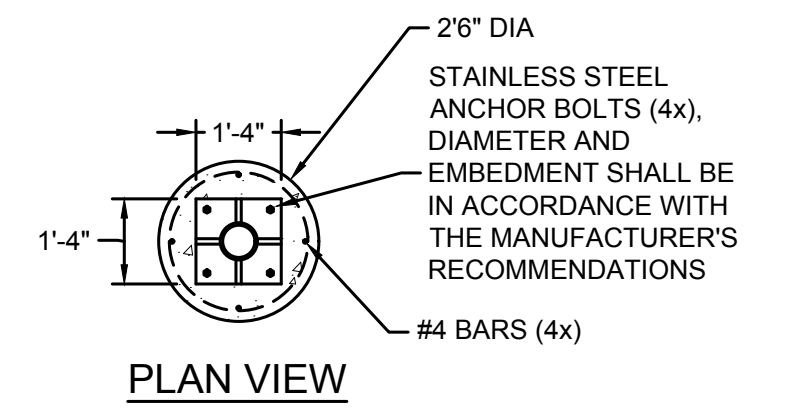
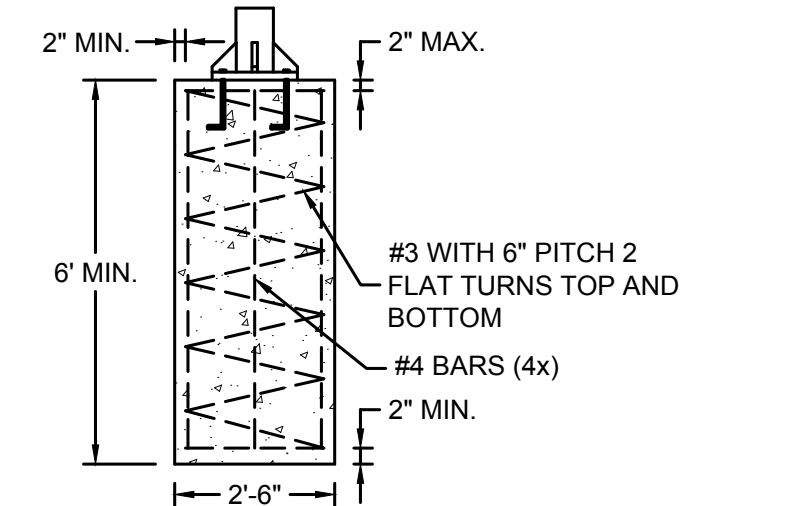
HOIST SOCKET FOUNDATION DETAILS
NTS

- NOTE:**
CONCRETE SHALL BE CLASS A.

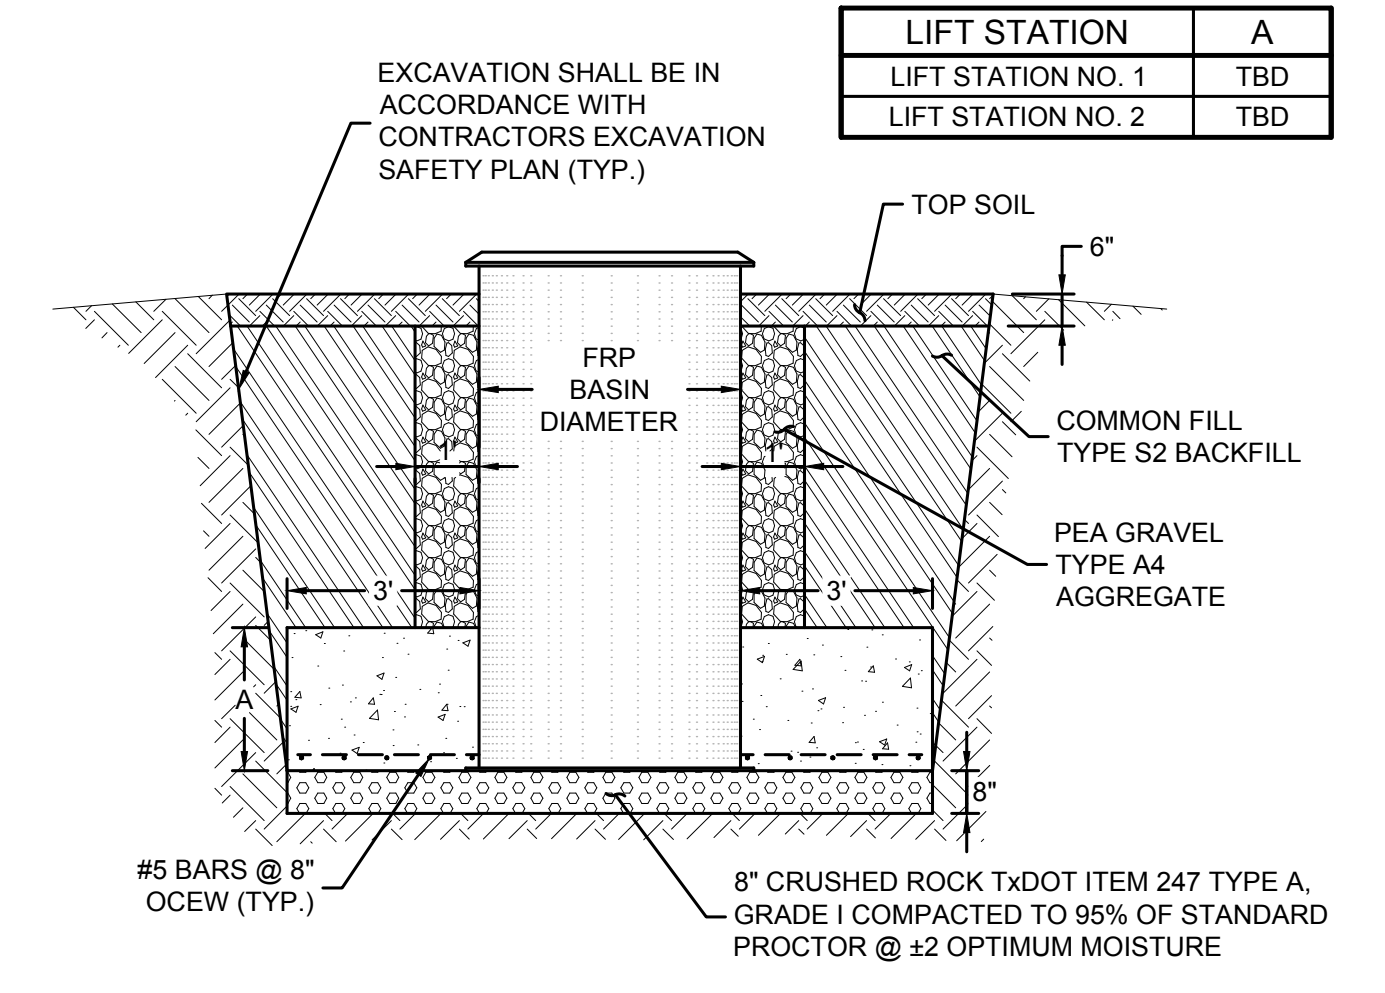
FPR LIFT STATION TYPICAL INSTALLATION
NTS

- NOTES:**
- CONCRETE SHALL BE CLASS A.
 - FRP LIFT STATION SHALL BE INSTALLED PER MANUFACTURERS RECOMMENDATIONS.
