Negative Findings Report Cultural Resource Survey Comanche Trail Pipeline, LLC. San Elizario Crossing FERC Regulated Area El Paso County, Texas

Negative Findings Report Cultural Resource Survey

Comanche Trail Pipeline, LLC.

Technical Report 298
July 2015

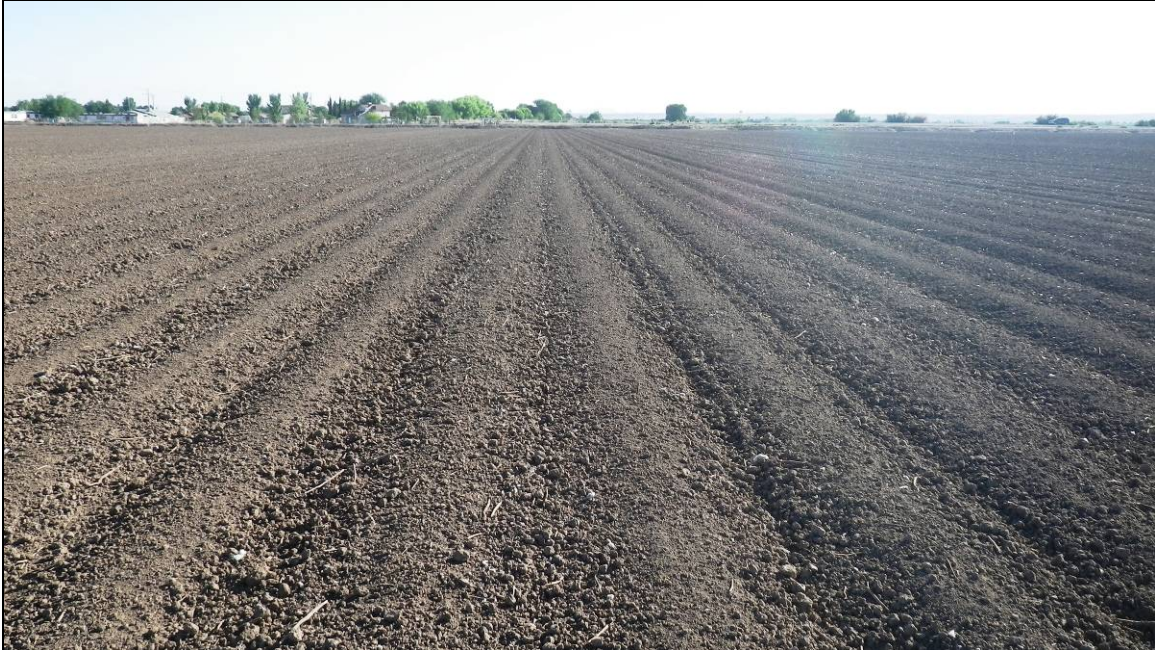
Figure 6. General environment of the project area looking north.

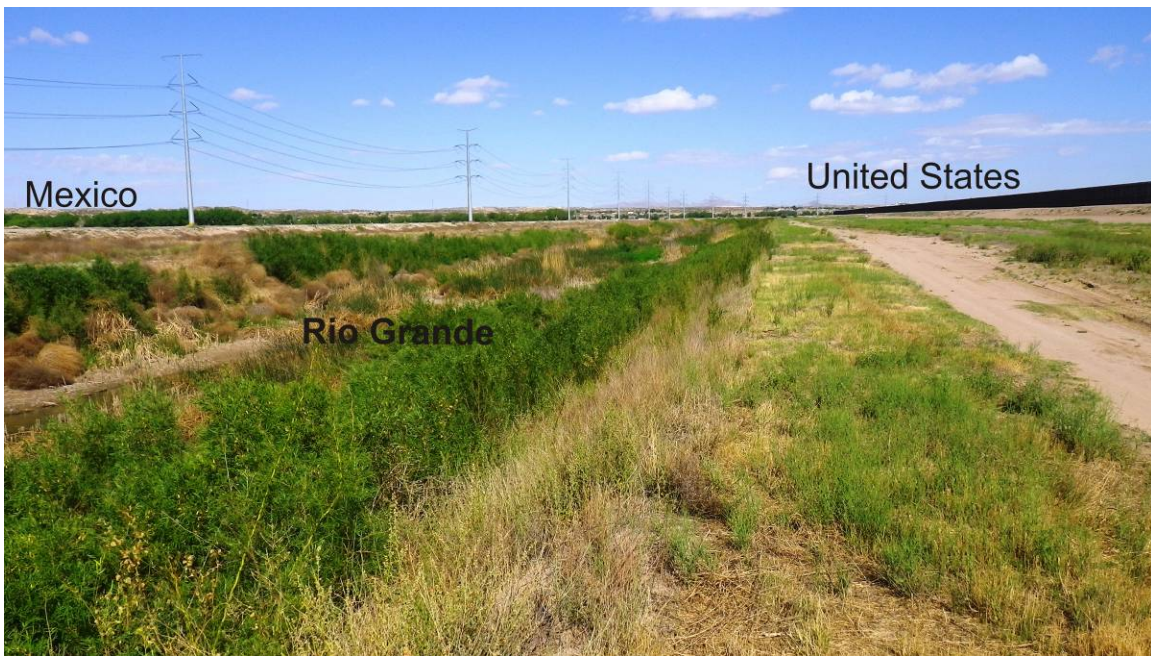
proposed crossing, the Rio Grande is little more than a channelized drainage ditch. The river was dry and easily crossable (Figure 7).

Figure 7. Photo of Rio Grande from pipeline crossing looking northwest.

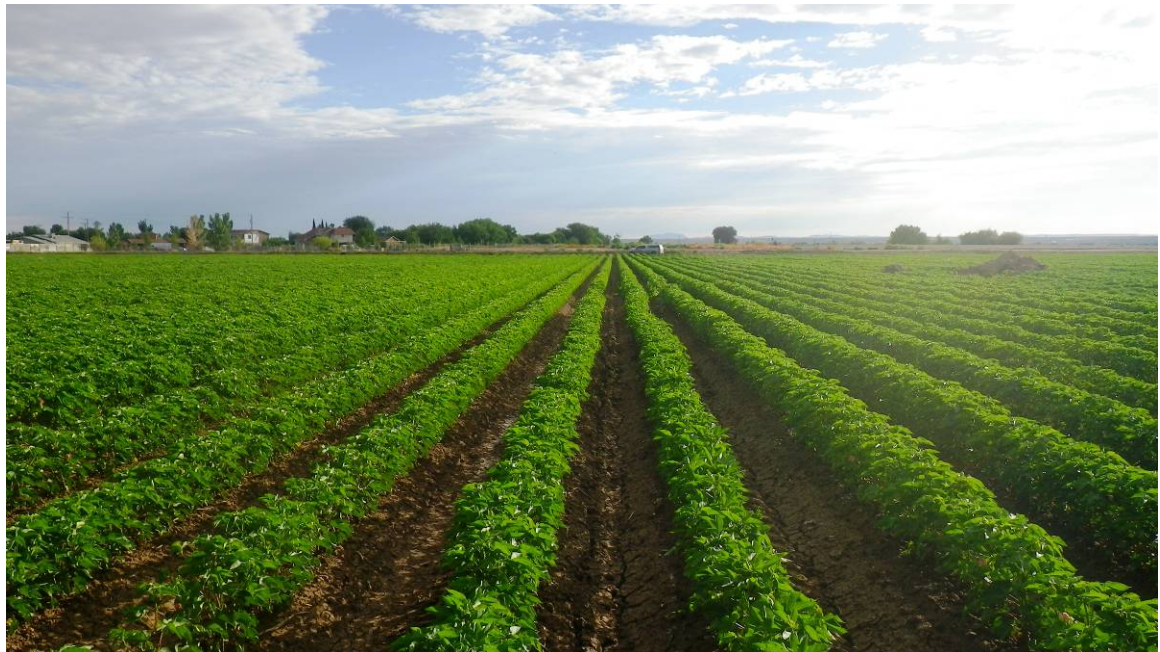
The trenches were dug in an agricultural field that has been row planted for decades, mixing the upper 30 cmbs of soil into homogenous brown clay devoid of stratification (Fig. A-3). Current trenching found silty clay over fine sand indicating that the Ap horizon has been removed or altered in the last 45 years, leaving only the C1 and C2 horizons relatively intact.

Figure A-6. Overview of planted cotton field where trenches were dug, looking north from Trench 2. Note Trench 1 in the distance to the right.

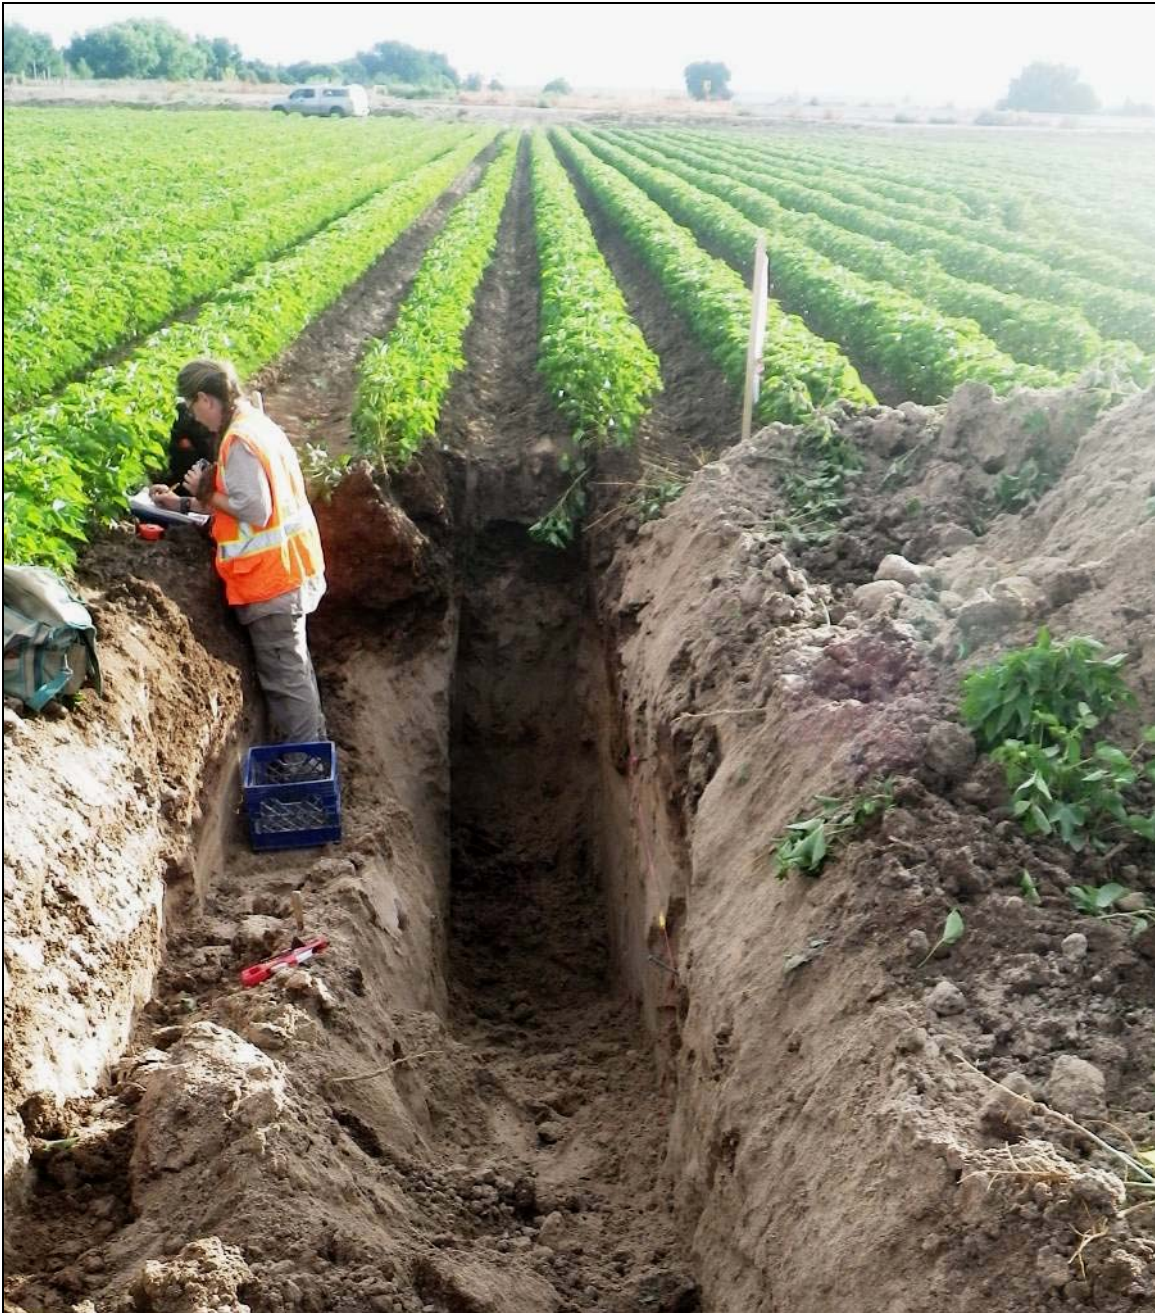
Figure A-7. Trench 1 looking north.

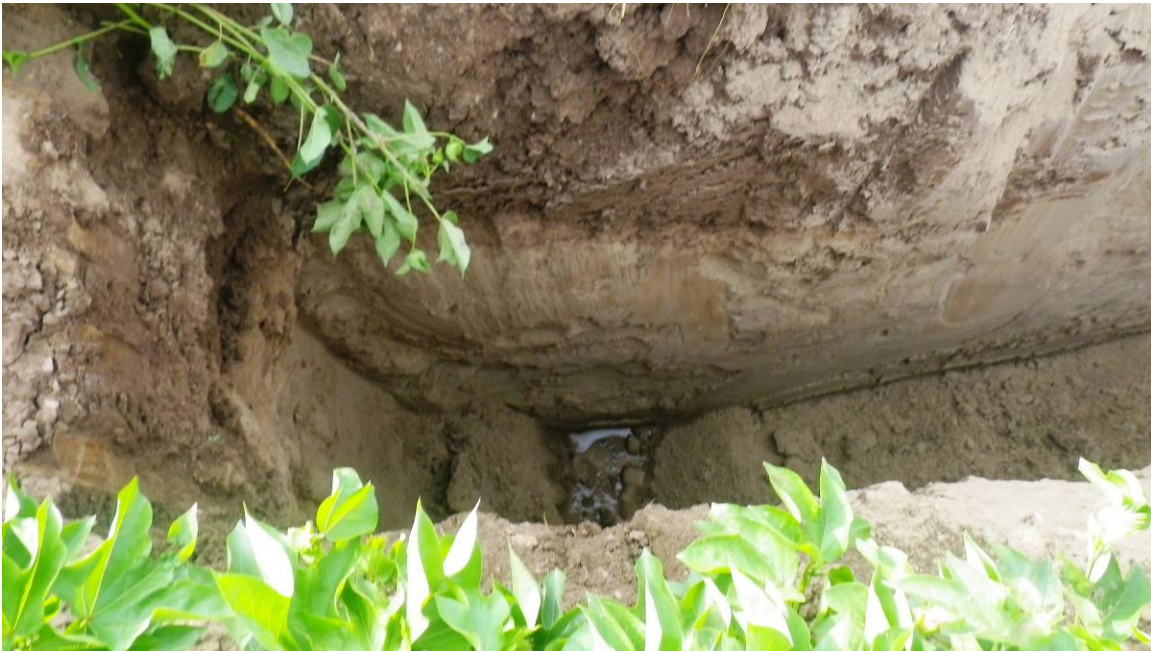
Figure A-9. Water table at the bottom of Trench 1.

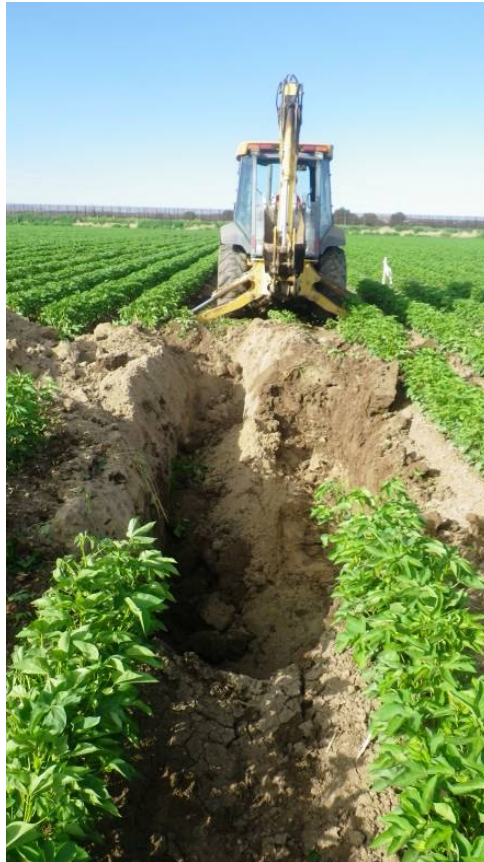
Figure A-10. Overview of Trench 2 looking south.

Trench 2 was also dug along a 200 degree (magnetic) trajectory following the planted cotton rows. The trench was 14 m in length by 2.1 m in depth by 70 cm wide with a safety step along the west side (Fig. A-7).

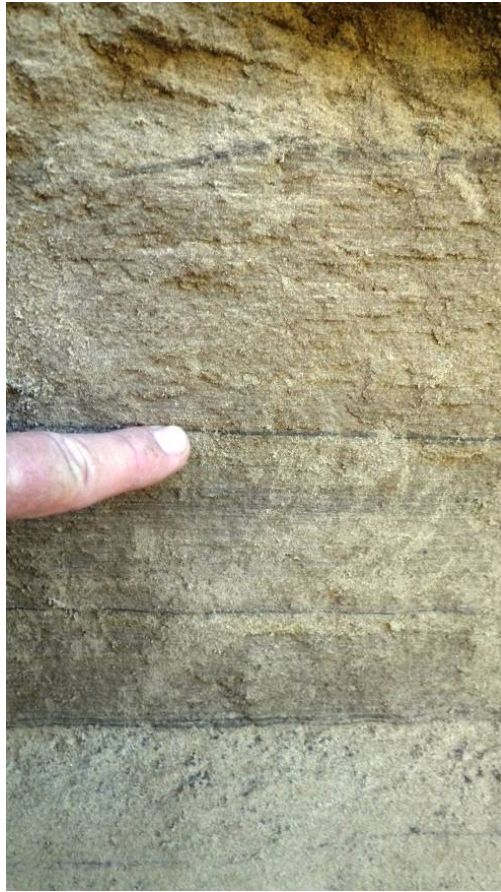
Figure A-12. Lamellae in Zone II of Trench 2, approximately 100 cmbs.

A consistent profile was encountered within both trenches, revealing 10YR 3/3 dark brown clay over 10YR 6/3 pale brown silty sand with layers of lamellae. Clay lamellae are stratified clay features in sands. These thin, relatively clay-rich zones within a sandy parent material are thought to originate through pedogenesis, or soil development (Holliday and Rawling 2004). The pedogenic origin of lamellae involves clay movement (argilluviation), with clays bridging and coating sand grains, and the eventual formation of micro-laminae in response to varying wetting fronts or flood events. The deepest lamellae are commonly very

thin and parallel to each other, formed from sedimentary strata or bedding planes (Brockheim and Hartemink 2013). These thin, parallel deposits were observed in the lower zone of Trench I and II, suggesting the soil at depth is relatively old.
