Report for Archeological Survey CSJ 0923-06-056, CR 225 at Clear Creek Brown County, Brownwood District

Report for Archeological Survey

CSJ 0923-06-056, CR 225 at Clear Creek
Brown County, Brownwood District

Jon Budd - Principal Investigator, Antiquities Permit No. 7536

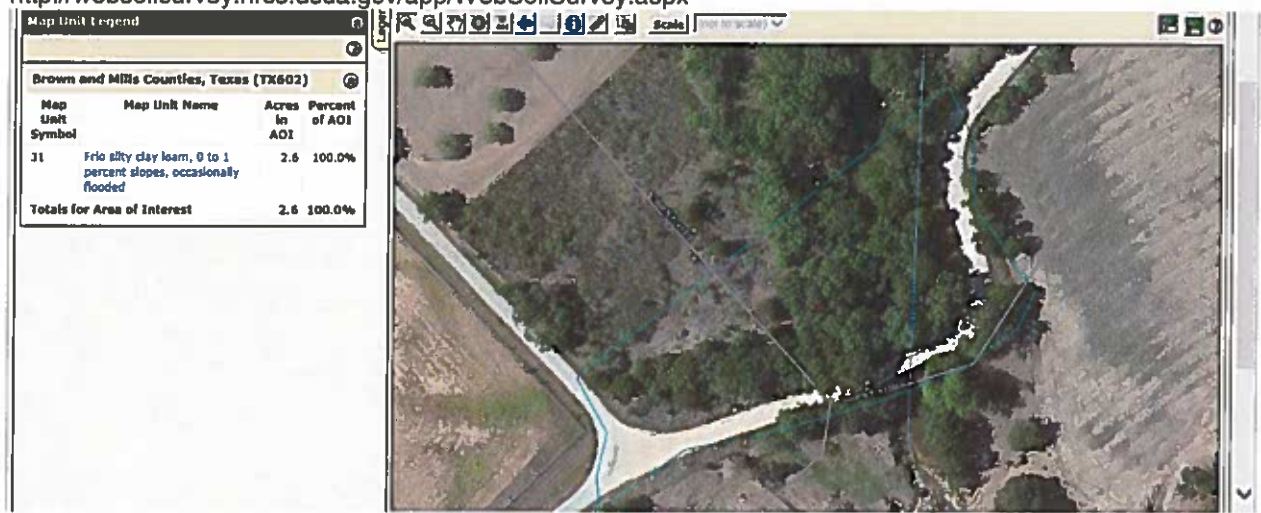
USDA/SCS Soil Survey of Brown County
<http://websoilsurvey.nrcs.usda.gov/app/WebSoilSurvey.aspx>

Frio silty clay loam, 0 to 1% slopes, occasionally flooded: Potential to harbor buried intact archeological deposits.

- **Soils:** According to the attached illustration of the USDA/SCS Soil Survey of Brown County, 100% of the sediments underlying the APE are comprised of Frio silty clay loam, 0 to 1% slopes, occasionally flooded (31). This sediment has historically demonstrated potential to harbour buried intact archeological deposits.

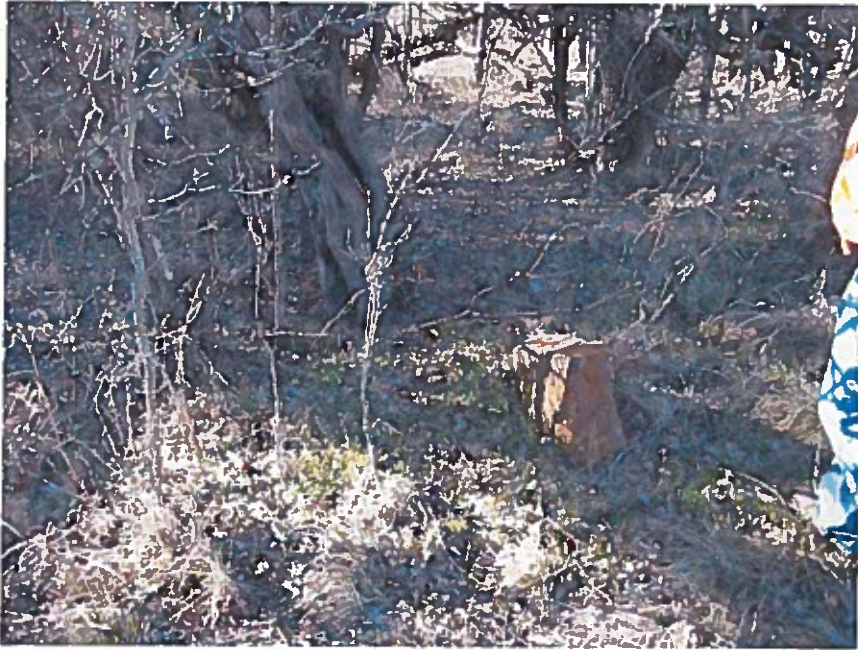
Photo 1: Facing west toward upright limestone slab. Gradall Trench (GAT) #1 was placed here under the slab to confirm that it was not a grave stone marker.

- **Archeological Materials Identified:** No archeological remains were observed. One large upright limestone slab (see attached photo #1) along with a diffuse scatter of limestone cobbles was observed. In order to confirm that these stones did not delineate an historic grave, Gradall Trench (GAT) #1 was excavated. No archeological remains including human remains, coffin hardware, etc. was observed. It was determined that the limestone scatter did not warrant designation as an archeological site.
- **APE Integrity:** The APE located outside of the existing CR225 ROW was relatively intact. However, despite a total of four Gradall Trenches, no archeological remains were observed.

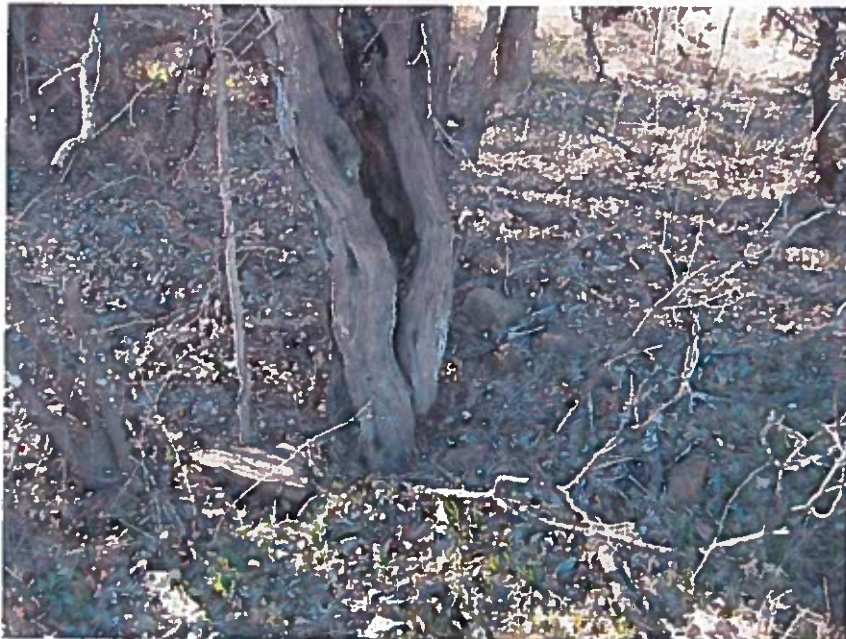
Photo 2: Facing west just beyond the limestone slab noted above. Note the old oak tree and smaller limestone cobbles. GAT #1 was placed here to investigate whether these marked a gravesite.

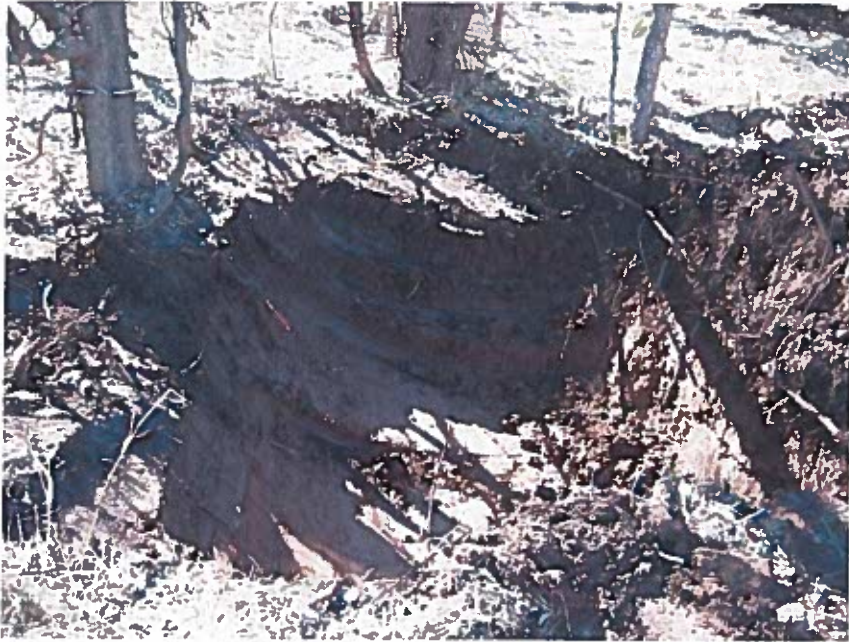
Photo 3: Facing west toward GAT #1 in process. It was negative for archeological remains including human remains, coffin hardware, etc.

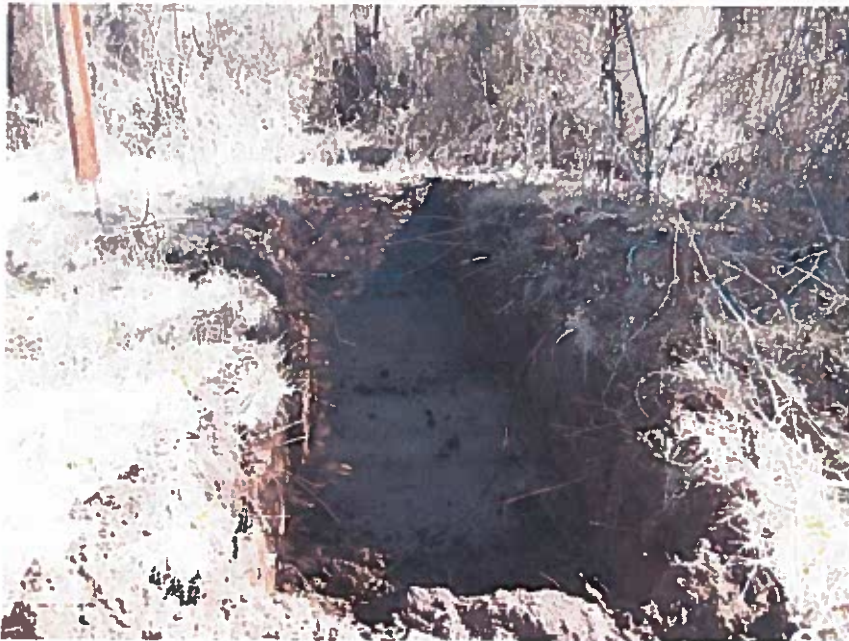
Photo 4: Facing east toward GAT #2. It was negative for archeological remains.

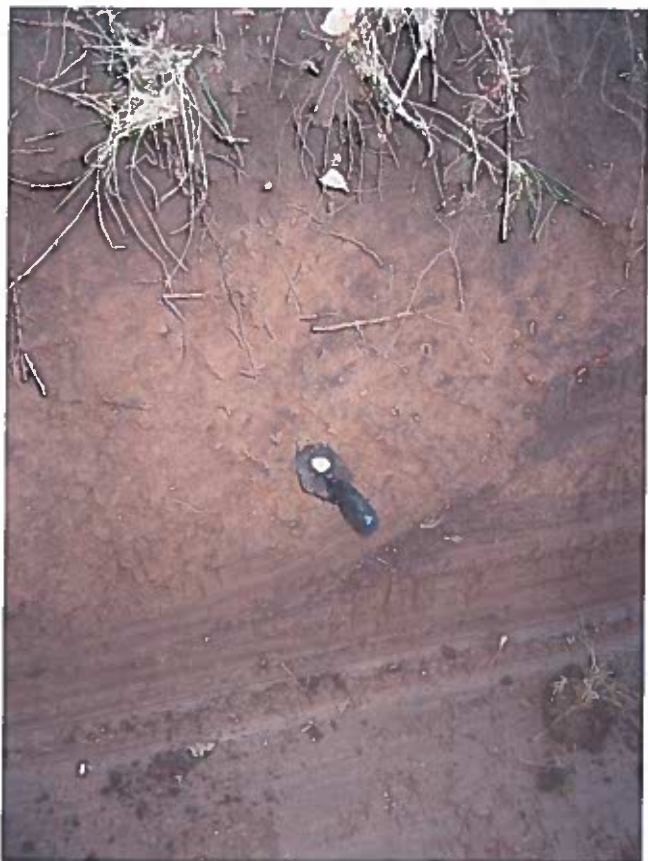
Photo 5: Facing southwest toward sidewall of GAT #2 illustrating stratigraphy.

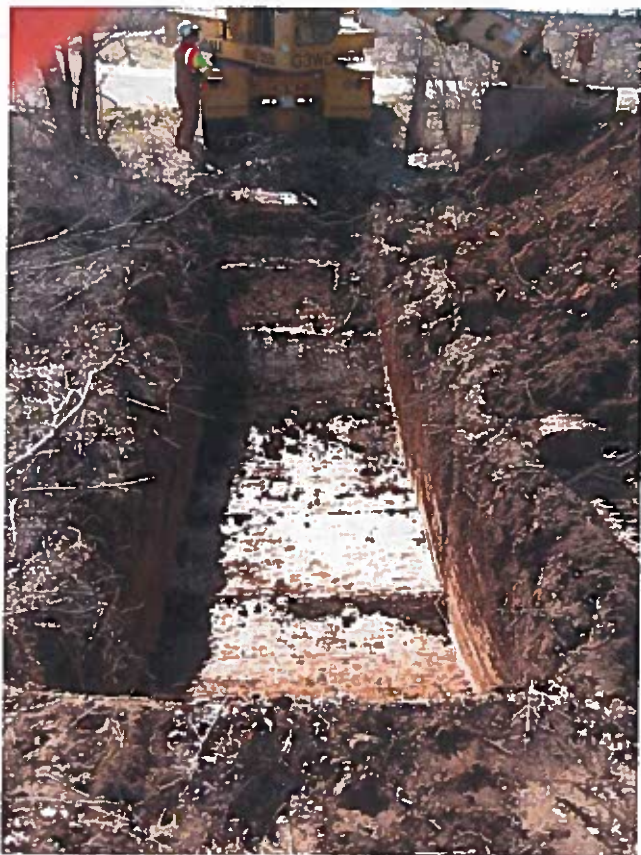
Photo 6: Facing west towards GAT #3 in process. It was also negative for archeological remains.

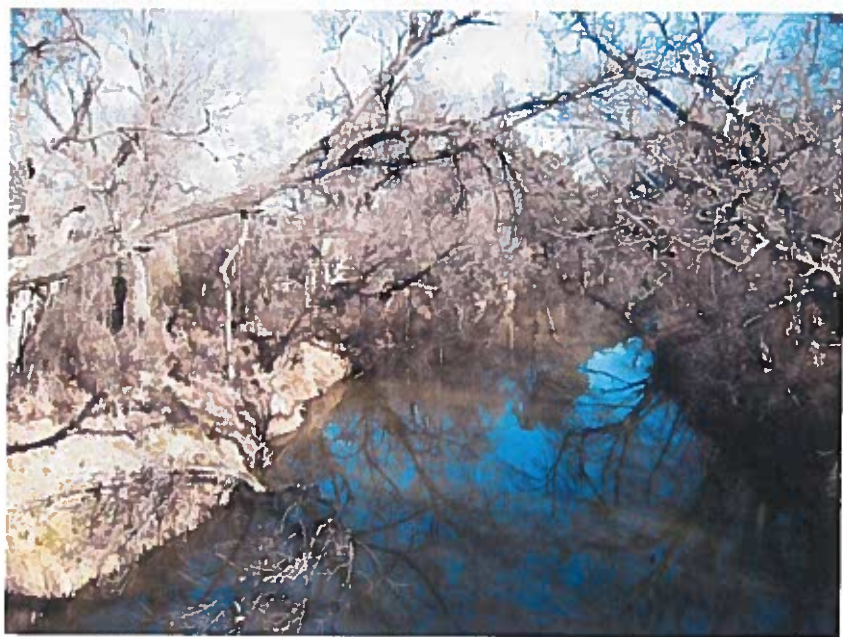
Photo 8: Facing north toward Clear Creek from existing bridge. The proposed new bridge would be place in the foreground.

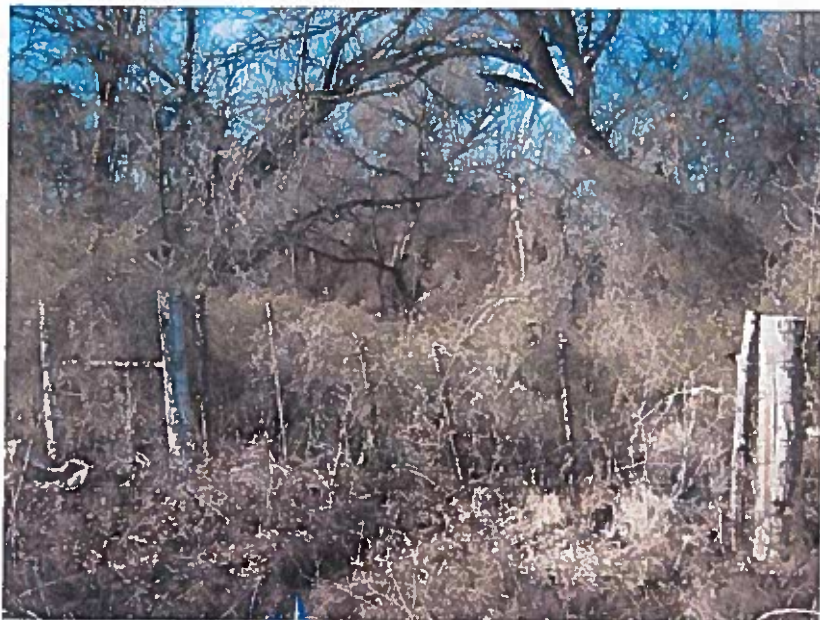
Photo 9: Facing west toward dense brush and gate on the east side of Clear Creek. GAT #4 was placed just on the other side of this fence gate.

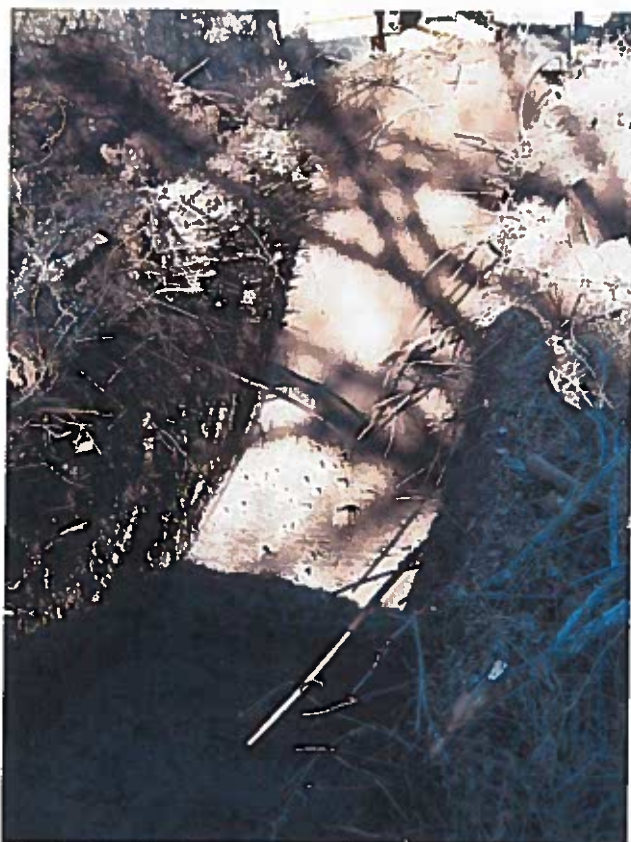
Photo 10: Facing east toward GAT #4. This trench was excavated into the east side of the creek. It was negative for archeological remains.
