## Archeological Survey for the Lubbock Canyon Lakes Sanitary Sewer Interceptor Rehabilitation Project, City of Lubbock, Lubbock County, Texas

Archeological Survey  
for the Lubbock Canyon Lakes Sanitary Sewer Interceptor Rehabilitation Project,  
City of Lubbock, Lubbock County, Texas

By:  
Jennifer Hatchett Kimbell  
and Julie Shipp

Texas Historical Commission  
TAC Permit #7105

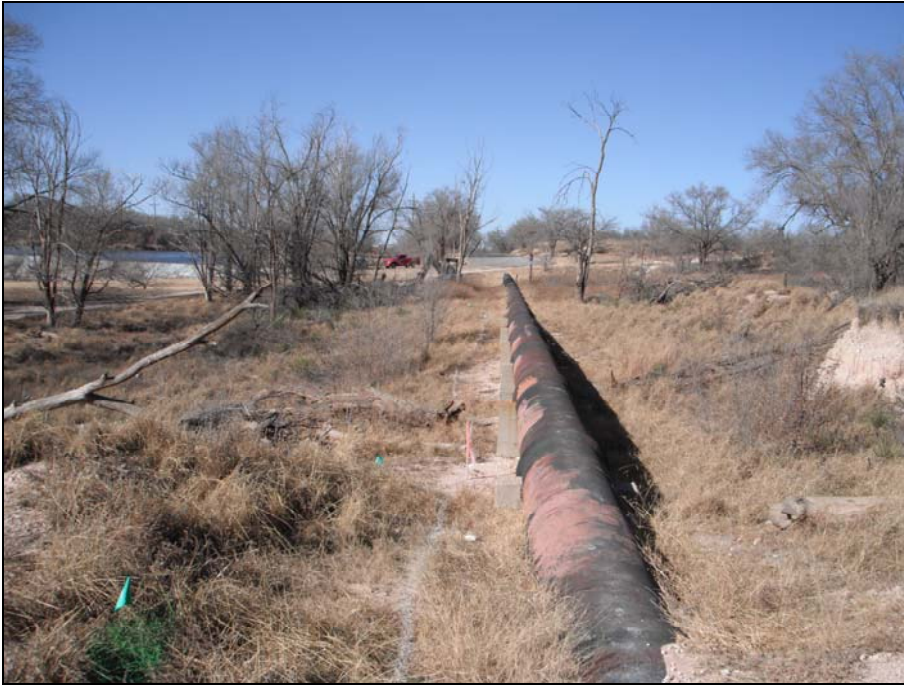
**Photo 2. Setting for Trench 1 and Trench 3, at proposed location of Segment 1 (parallel to existing line), facing north.**

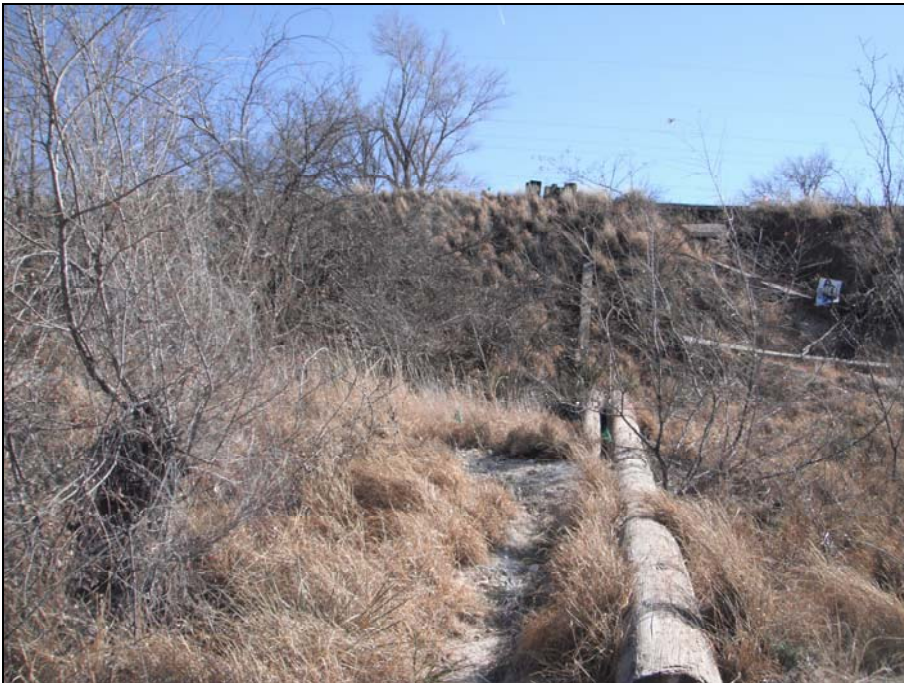
**Photo 3. Proposed location of Segment 1 (parallel to existing line), facing south toward railroad tracks from Trench 3.**

approximately 10 gallons of fill from each stratigraphic unit yielded no artifacts. Trench 3 reached 250 cm (just over 8 ft) below the surface and also yielded no artifacts. The southern portion of the proposed alignment was not investigated due to evidence of massive landscape alteration and other disturbance. Raised railroad tracks, a flattened area where numerous sewer and water lines converge and where manholes provide access, and an area of bike and walking paths all indicate significant disturbance to the ground (Photos 3 and 4).

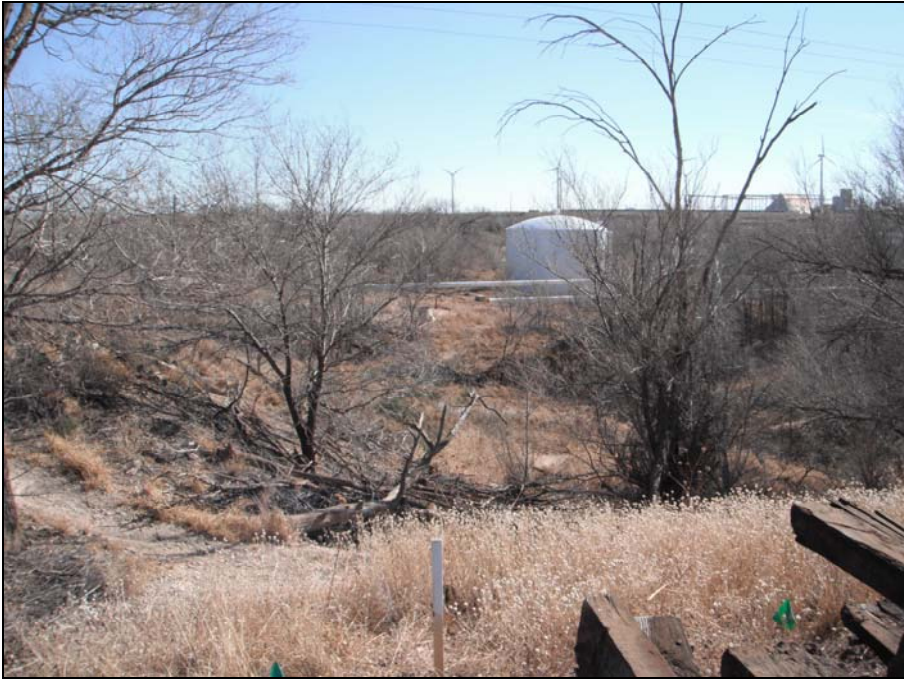
**Photo 4. Proposed location of Segment 1, facing south from railroad tracks.**

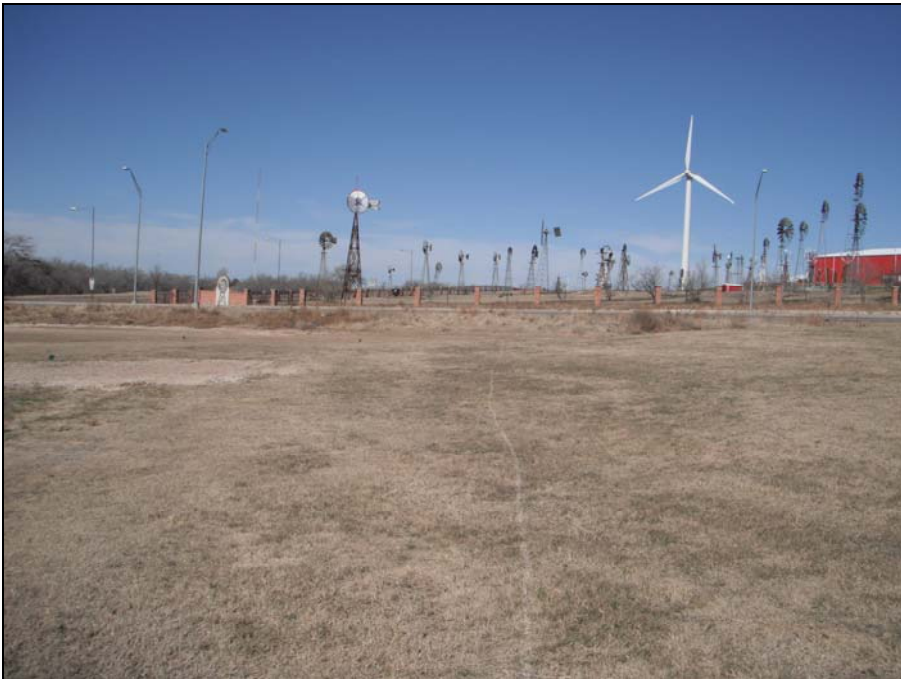
**Photo 5. Proposed location of Segment 3, facing north.**

Due to the evidence that the area north of SH114 is heavily disturbed, no investigation was conducted in that area. The portion of the segment south of SH114 was investigated through backhoe trenching (Photo 5). Trench 2 reached 270 cm (almost 9 ft) below the surface (Table 5). Approximately 12 gallons of matrix (2 gallons from each of 6 stratigraphic units) were screened through 1/4-in hardware cloth, but no cultural material was recovered.

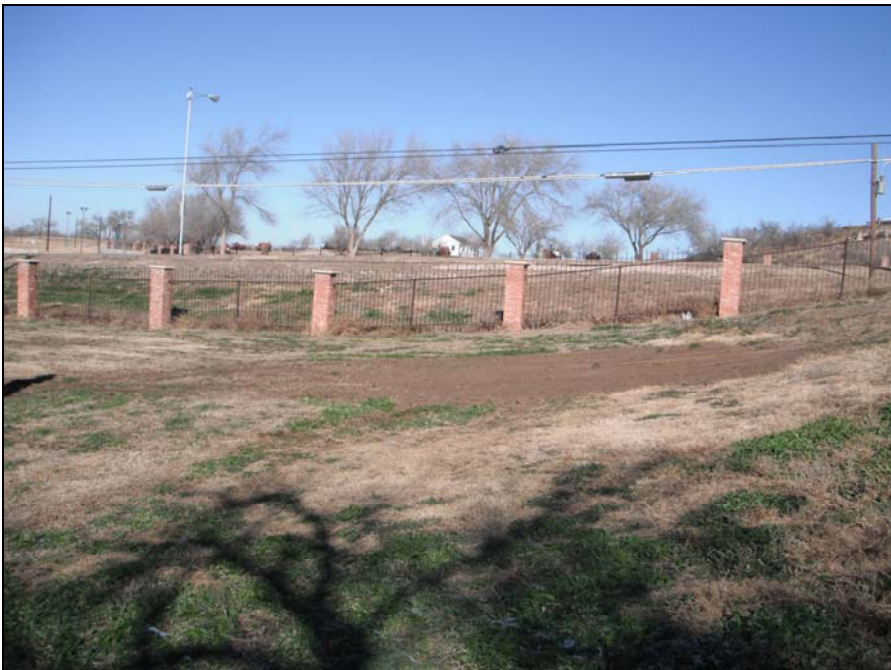
**Photo 6. Setting for Trench 17 at south end of proposed location of Segment 4, facing northwest.**

Backhoe trenches were excavated at both the south and north ends of proposed Segment 4. The portion of the proposed alignment south of East Broadway runs across the edge of site 41LU137, and along that portion of the proposed alignment, samples of deposits from each stratigraphic unit were collected and screened through 1/8-in hardware cloth. This proposed impact area is within the boundaries of the American Wind Power Center. Trench 17, excavated in this area, reached 310 cm (10 ft) below the surface (Photo 6). Up to 125 cm (4 ft) below the surface, fill was mixed with modern debris. Below that depth, sediments appeared to be relatively intact, although no evidence of soil development was encountered (Table 6). No artifacts were recovered from the approximately 10 gallons of matrix that were screened through 1/8-in hardware cloth. North of East Broadway, the alignment crosses into the property of the Bayer Museum of Agriculture, the grounds of which have undergone considerable landscape modification. Trench 18 (Photo 7), excavated in this area, yielded fill and modern debris to about 60 cm (2 ft) below the surface (see Table 6).

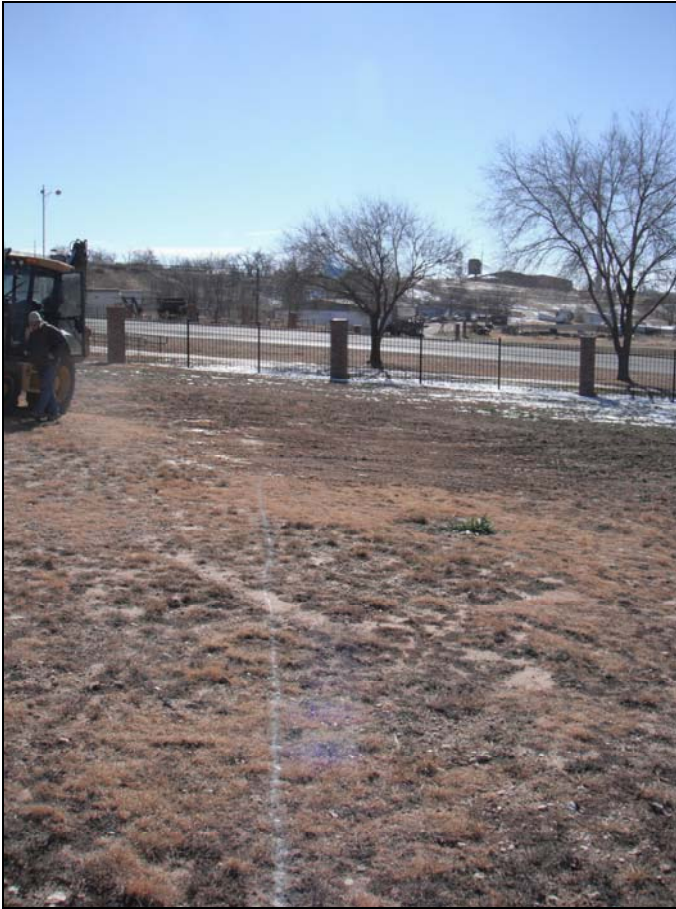
**Photo 7. Setting for Trench 18 at north end of proposed location of Segment 4, facing southeast.**

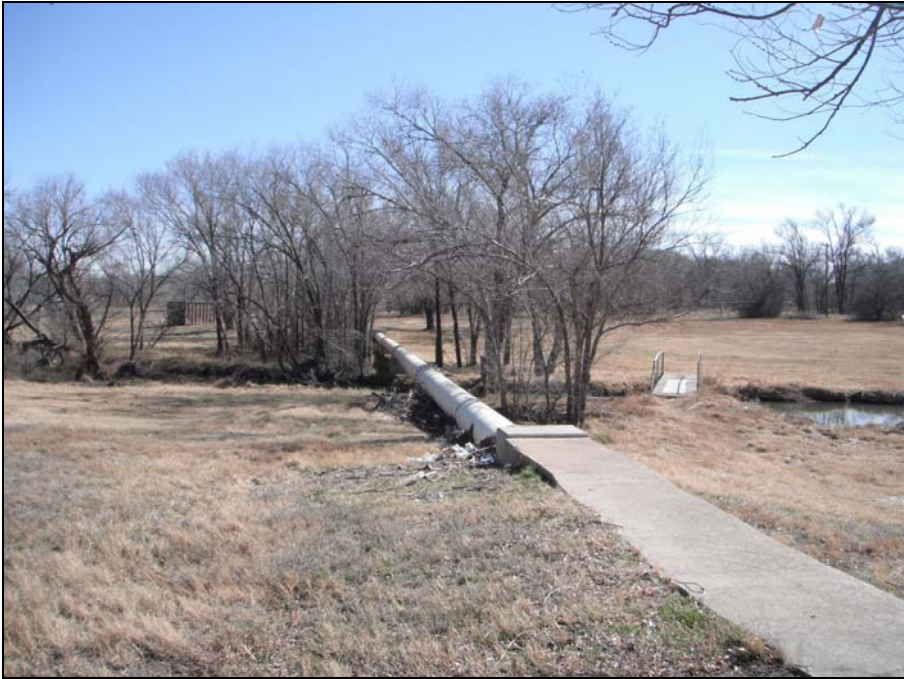
**Photo 9. Segment 5, aerial portion, facing south from north side of tributary.**

Segment 5, a 152-m- (500-ft-) long section of 24-in sewer line will be replaced in place, within the existing easement (Appendix A, Figure 6-7). A portion of the segment crosses the North Fork of the Double Mountain Fork of the Brazos River and is supported on concrete piers. Since the segment lies within the boundary of site 41LU77, backhoe scraping of the surface above the existing pipe was proposed in order to determine the width of the existing trench. However, the line is only very shallowly buried where it is buried at all, and conditions in the field indicated that the entire area surrounding the alignment was heavily disturbed; therefore no subsurface investigations were conducted (Photos 8-10).

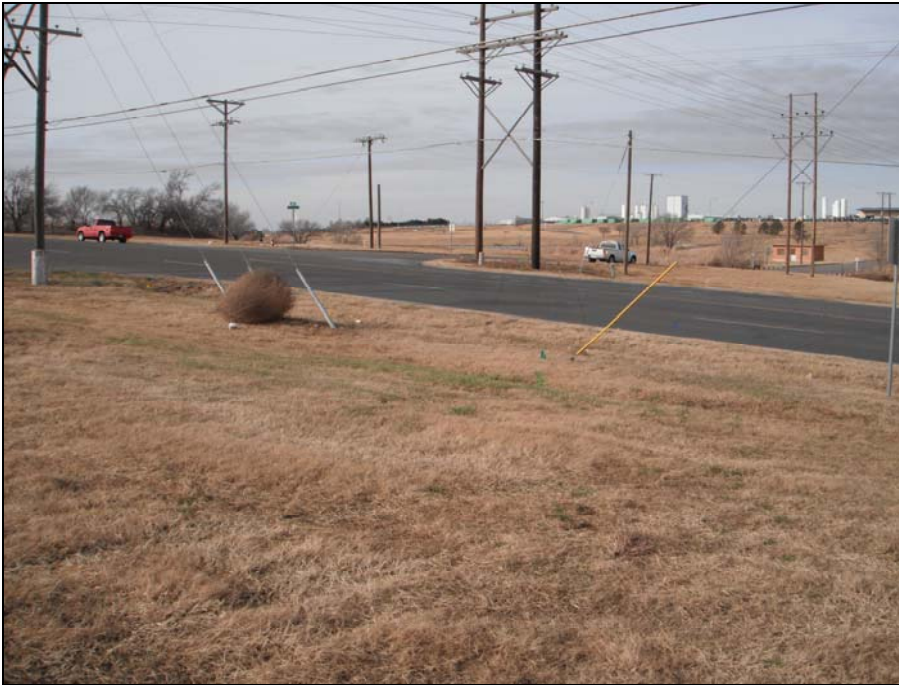
**Photo 16. Proposed location for southern portion of Segment 15, facing northwest. Note utility easement in foreground.**

Proposed Segment 15 will cross the intersection of Erskine and Avenue U (Appendix A, Figure 6-12). This segment will consist of 87.5 m (287 ft) of 24-in sewer line and will be 3 m (10 ft) deep at its deepest point. It will connect to the existing line via two new manholes, one at each end of the proposed new section. A proposed 36.6-m- (120-ft-) long section of 4-in sewer line will extend north from the southern manhole. At the time the fieldwork was conducted, the proposed approach to installation of this segment was open-cut trenching. Since that time the City of Lubbock has requested both the 24-in and the 4-in sections be bored underneath the road intersection, and the engineering plans have been revised accordingly. Most of this segment is within the boundary of the Canyon Lakes Archeological District. Investigations included trenching at the north end, outside the roadway. Trenching of the southern portion of the alignment had also been proposed, but the presence of a heavily disturbed utility easement across the entire southern portion of the alignment precluded this effort (Photo 16).

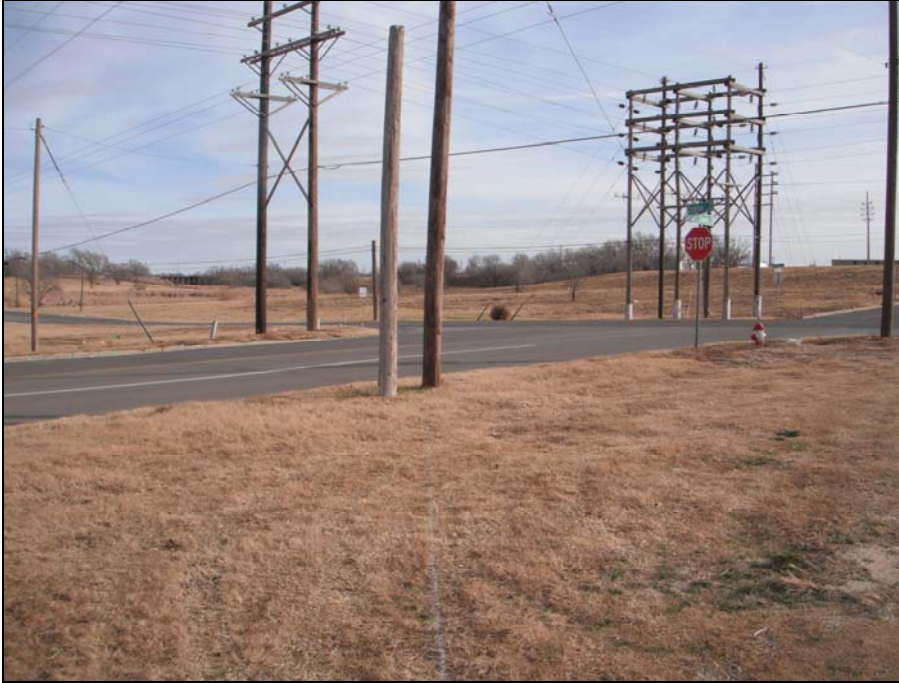
**Photo 17. Setting for Trench 4, at proposed location of Segment 15. View is from northwest end of alignment facing southeast.**

modern debris on one end and a heavily used utility easement on the other indicate a low likelihood that the road overlies intact archeological deposits. In addition, the revised proposal, which includes boring under the road intersection, makes monitoring unnecessary.

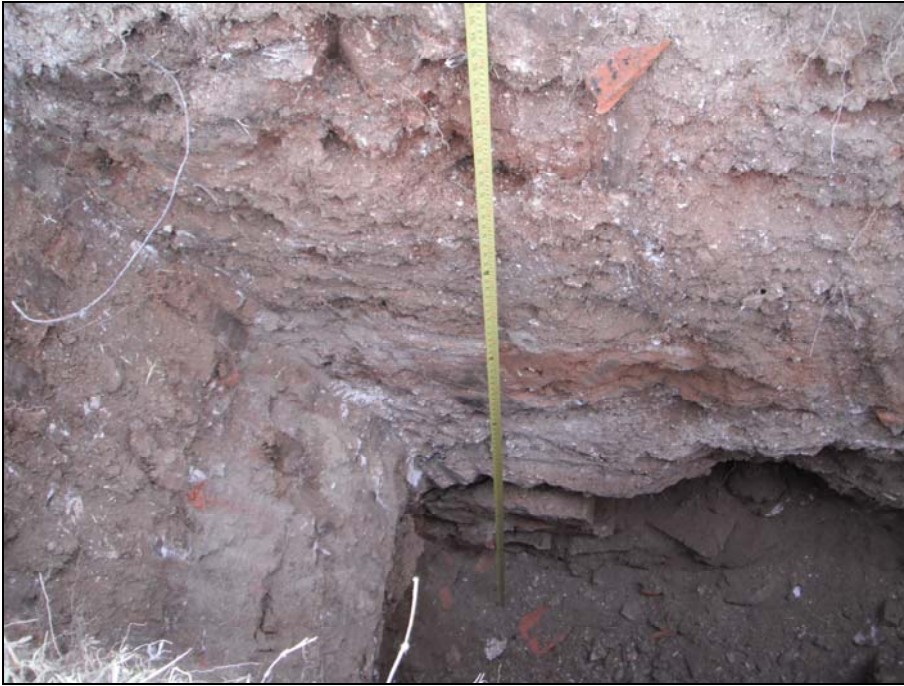
**Photo 18. Trench 4. Note bricks and other building debris at bottom of trench.**

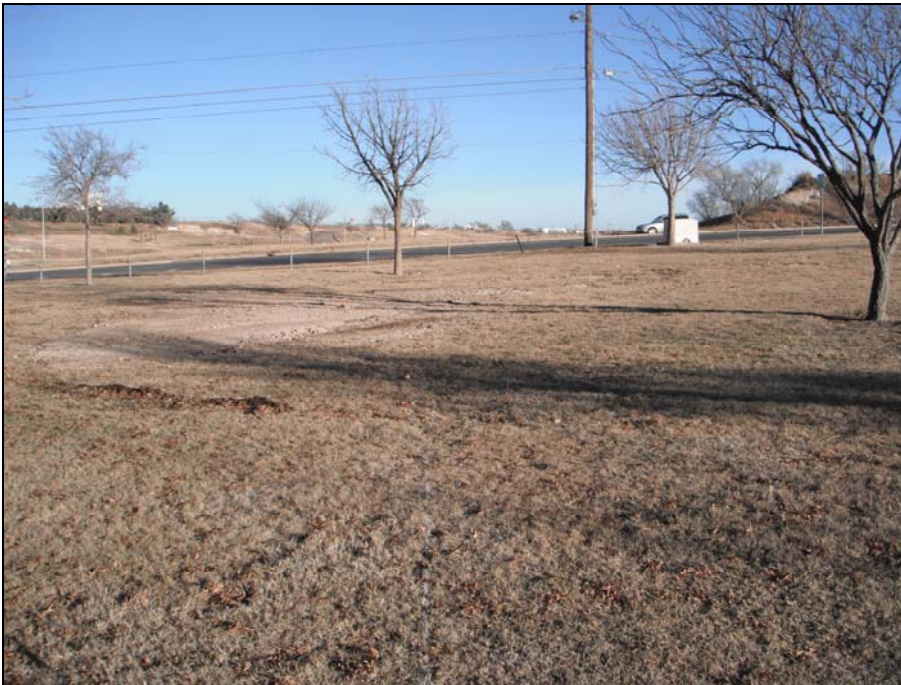
**Photo 19. Setting for Trench 5, at proposed location of Segment 16, west of University Avenue facing east.**

Two backhoe trenches, Trench 5 and Trench 6, were excavated along the proposed alignment. Trench 5 (Photo 19) revealed modern debris overlying multiple layers of asphalt between 100 and 140 cm (39 and 54 in) below the surface (Photo 20). Underlying this debris was unconsolidated bedrock (Table 9). Trench 6 reached 200 cm (79 in) below the surface, and modern debris was recovered from all depths (see Table 9; Photo 21).

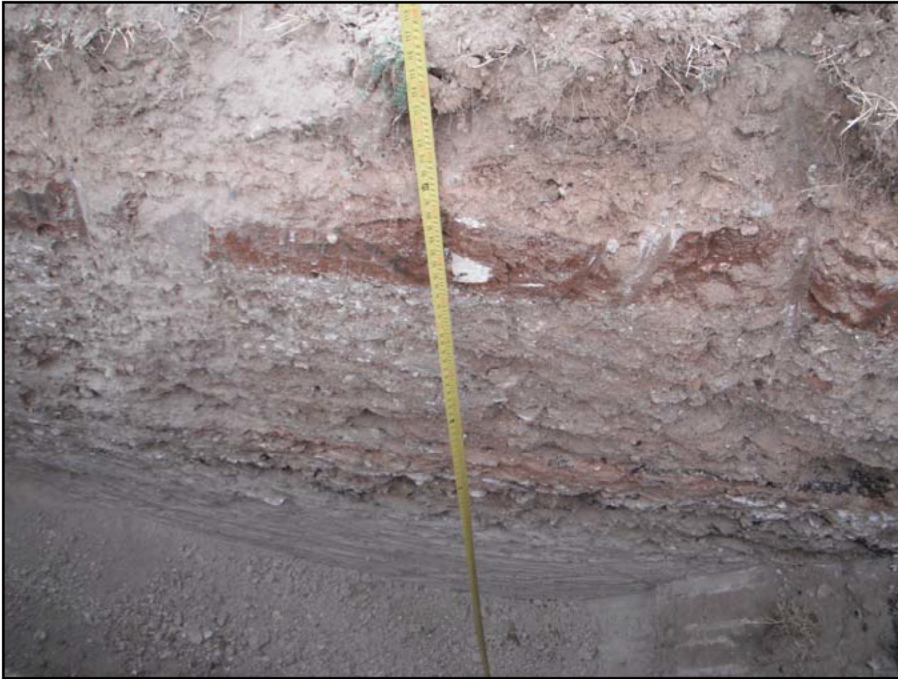
Photo 20. Trench 5, south wall profile.

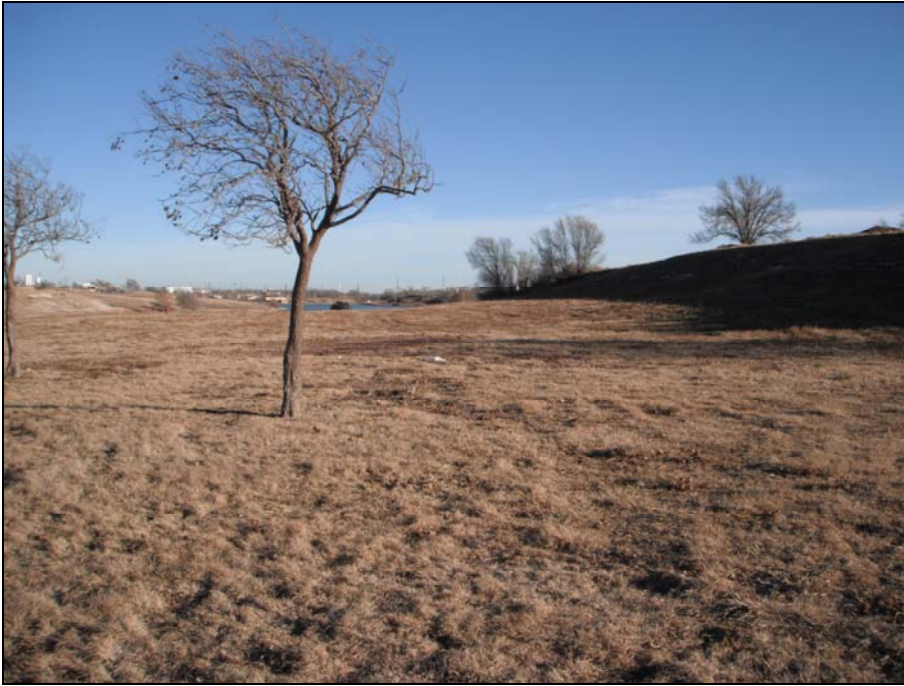
**Photo 21. Setting for Trench 6 at proposed location of Segment 16, eastern portion of alignment, facing east.**

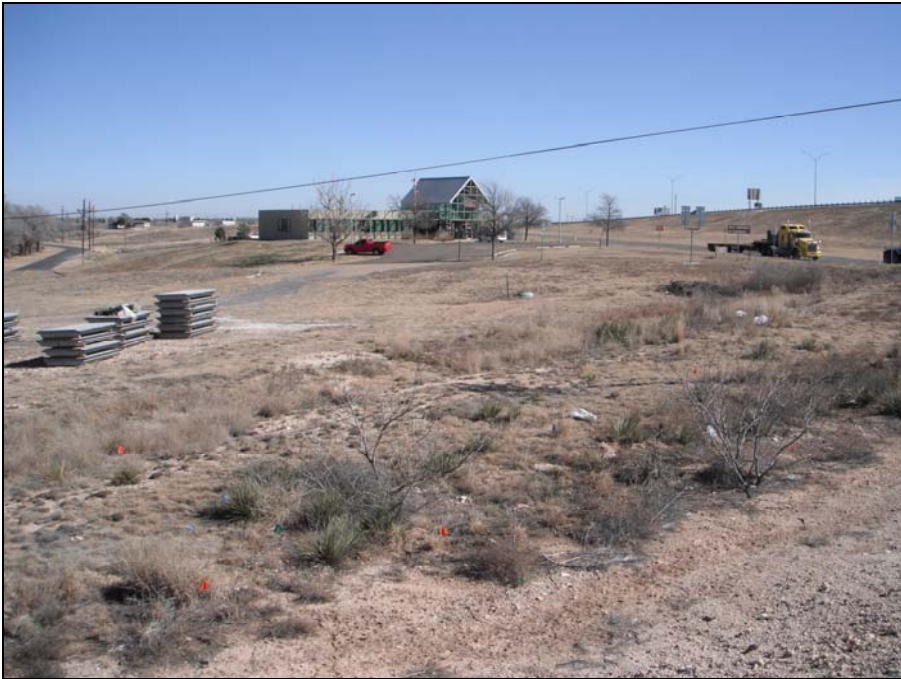
**Photo 23. Proposed location for eastern portion of Segment 18. View is from railroad tracks, facing east. Eastern end of alignment coincides with manhole visible in middle distance.**

Proposed Segment 18 begins south of US 84 and north of the Loop 289 access road and crosses the edge of a field, the Loop 289 access road, another small field, US 84, and the edge of another field before terminating just west of Landmark Lane (Appendix A, Figure 6-16). The proposed segment comprises four sections that will be connected to the existing lines via existing manholes and will be connected to one another via two proposed new manholes. The southernmost section of Segment 18 consists of approximately 129 m (423 ft) of proposed 8-in sewer line. The other sections, all of 30-in sewer line, measure 83.2 m (273 ft), 75.3 m (247 ft) of which 69.5 m (228 ft) will be bored under US 84, and 41.8 m (137 ft). The maximum depth of impacts is 7.6 m (23 ft). One backhoe trench was placed within the southeasternmost portion of the proposed location of Segment 18 (Photo 23). The proposed locations of the other portions of the segment are in areas that have clearly been heavily disturbed in modern times (Photo 24). Backhoe Trench 7 revealed very shallow, very disturbed deposits (Table 10).

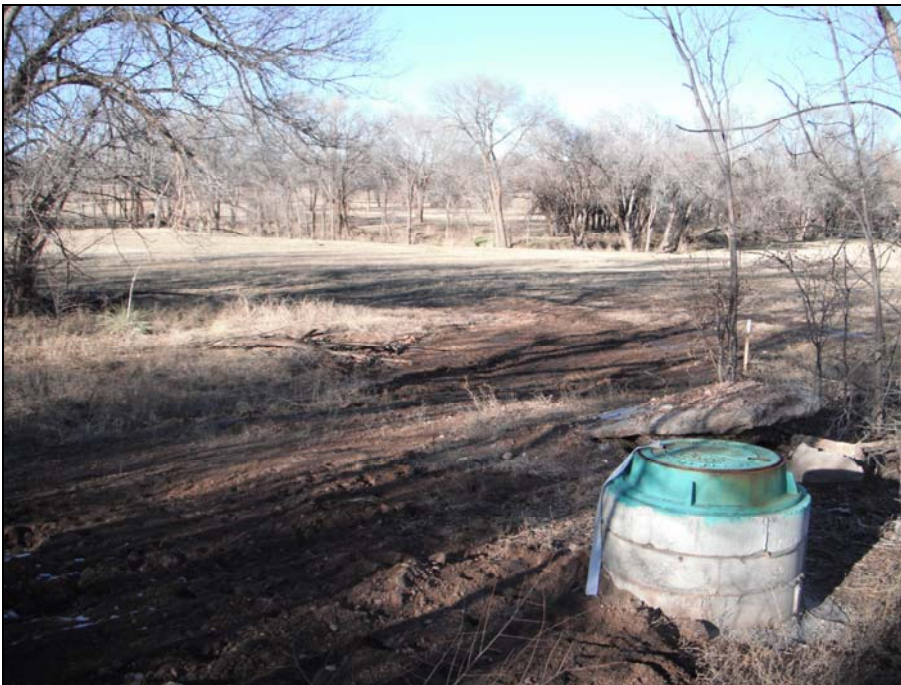
**Photo 25. Setting for Trench 8 at proposed location of Segment 28, facing north.**

Because proposed Segment 28 is within the boundary of site 41LU77, which has been demonstrated to retain intact archeological deposits, the proposed location of the segment was investigated through backhoe trenching and screening of samples through 1/8-in hardware cloth. To avoid impacts to potentially undisturbed portions of the site, LAN proposed to place the new segment as near to the existing sewer line as was possible. Trench 8 (Photo 25), placed immediately adjacent to the proposed alignment, revealed heavily disturbed deposits as deep as 220 cm (7 ft) below the surface (Photo 26). Modern trash, including snack wrappers, elastic bands from clothing, and plastic bags were recovered (Table 11). Had the deposits appeared to be undisturbed, hand excavation of a 1-x-1-m (39-x-39-in) test unit was planned. However, the disturbed nature of the sediments indicated that the proposed alignment in this area will not impact an intact portion of site 41LU77, and no hand excavation was conducted.

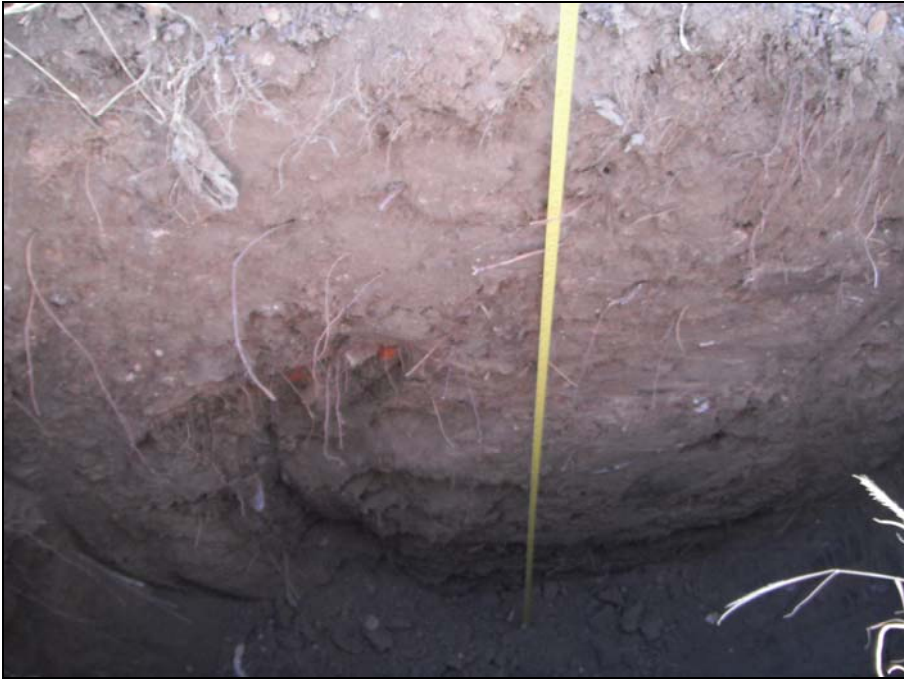
Photo 26. Trench 8, west wall profile.

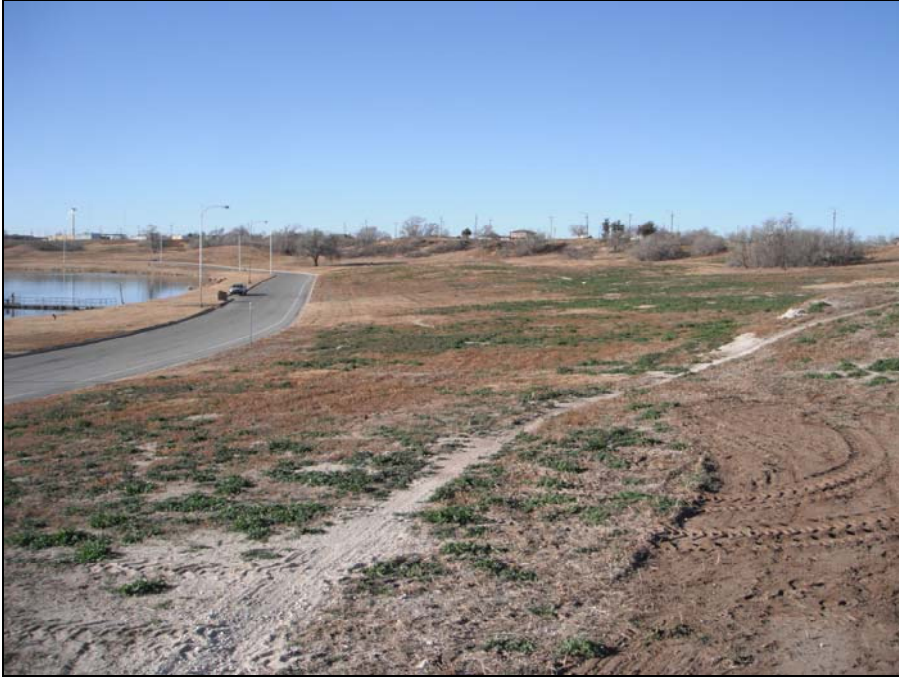
Photo 29. Setting of Trench 16 at proposed location of NWL-008A, facing north.

This proposed new manhole location is just north of Canyon Lake Drive in an area covered with mountain bike trails (Appendix A, Figure 6-3). One backhoe trench, Trench 16, was excavated near the existing alignment (Photo 29). The trench reached 130 cm (51 in) in depth and yielded no cultural material (Table 12).

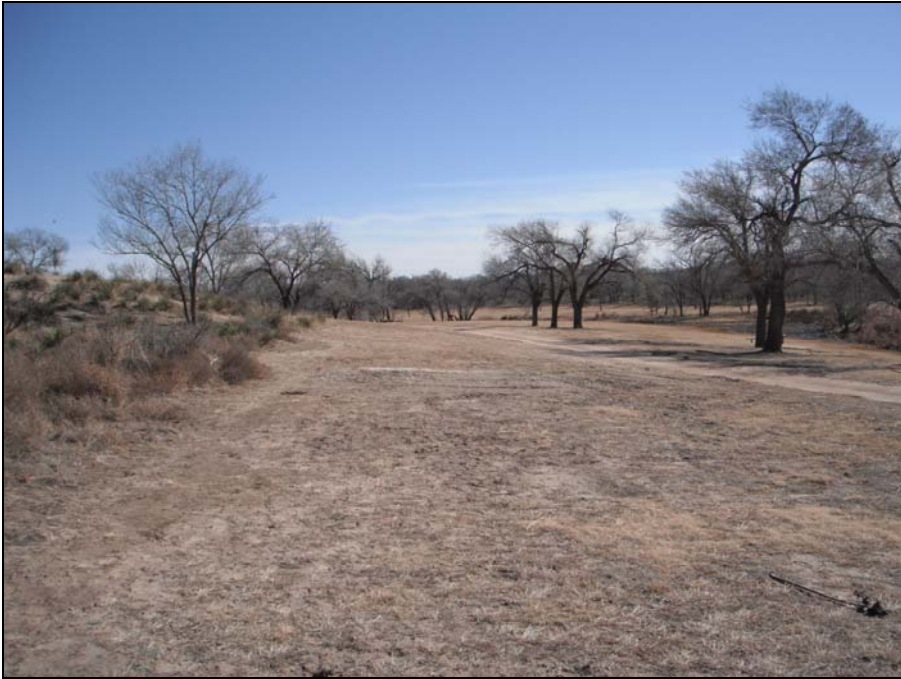
Photo 31. Proposed location for NWL-023A, facing east from west end.

The proposed location for manhole NWL-023A is on land currently in use as a disk golf course (see Appendix A, Figure 6-7). The backhoe trench, Trench 15 (Photo 31), reached 100 cm (39 in) below the surface and yielded one possible lithic flake from the upper 70 cm, but there was no evidence of intact archeological deposits (Table 13).

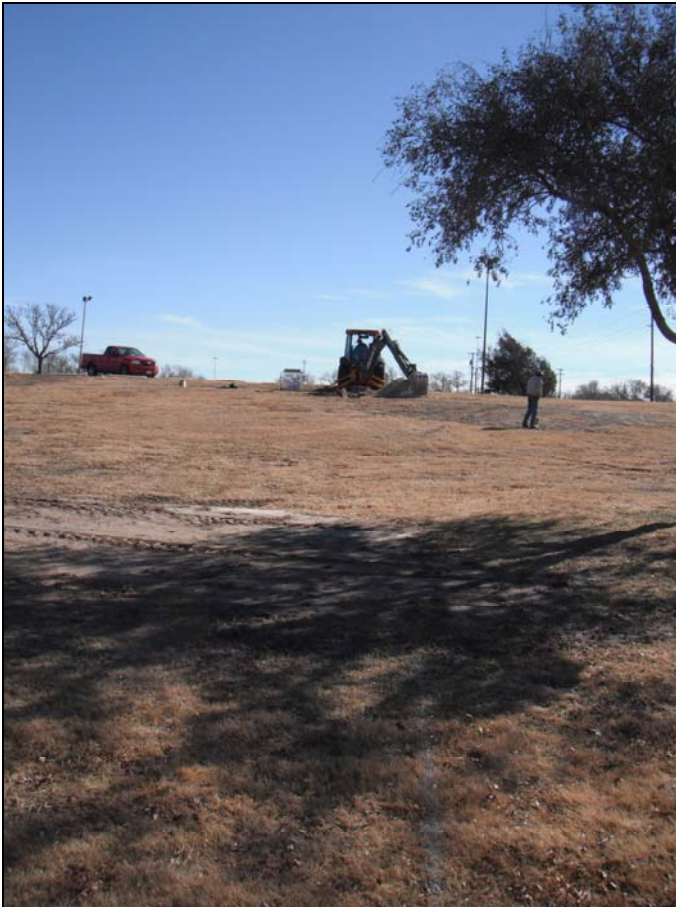
**Photo 34. Locations of Trench 13 (foreground, see cleared area in shade of tree) and Trench 14 (background, where backhoe is stationed), facing southwest.**

The proposed location of this manhole is within a 160-m (525-ft) range just east of I 27 (Appendix A, Figure 6-9). Approximately half of the range of potential locations is underneath a parking lot. Two backhoe trenches were placed northwest of the parking lot along the northern half of the proposed range (Photo 34). Trench 13 was placed at the bottom of the slight slope that rises to the south. This trench reached 300 cm (almost 10 ft) below the surface and yielded no cultural material (Table 14). Trench 14 was placed on the slope and reached only 30 cm (12 in) below the ground surface before hitting unconsolidated bedrock. Excavation continued to 80 cm (32 in) in increasingly dense bedrock before being terminated (see Table 14).

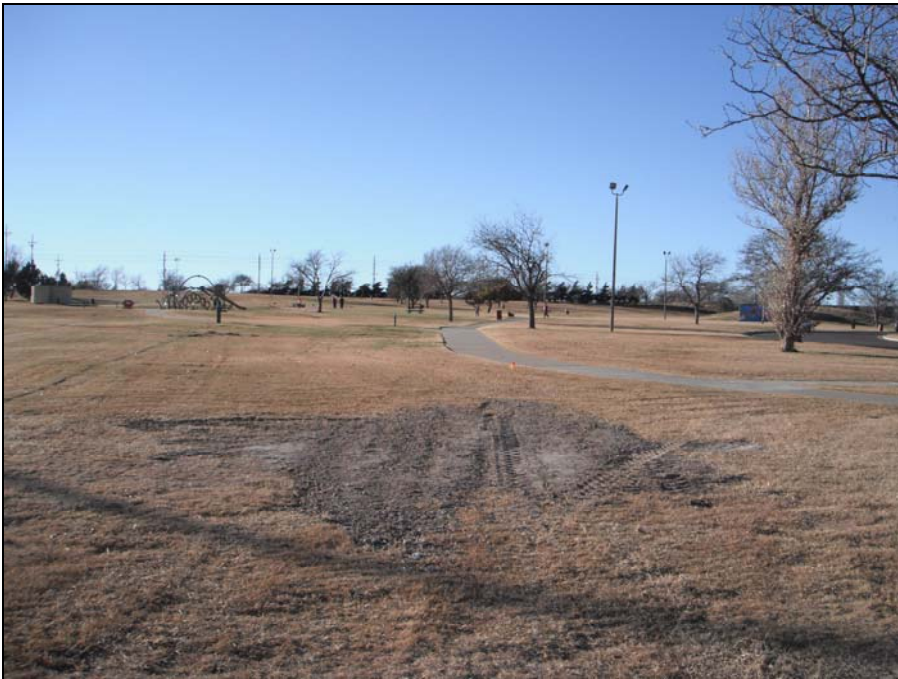
Photo 35. Setting of Backhoe Trench 12 at proposed location of NWL-034, facing west.

The proposed location for this manhole is within Aztlan Park, within a 156-m (512-ft) range (Appendix A, Figure 6-10). Backhoe Trench 12 was placed near the eastern end of this alignment, outside the main portion of the park and east of the walking path (Photo 35). This location was chosen with the aim of not disturbing the irrigation system that underlies most of the park but does not extend as far east as the backhoe trench location. The trench reached 65 cm (26 in) before hitting unconsolidated bedrock. Excavation was continued, through increasingly consolidated stone, to 170 cm (approximately 5.5 ft) below the surface. Although there was modern debris in the trench, no intact cultural features were observed (Table 15; Photo 36).

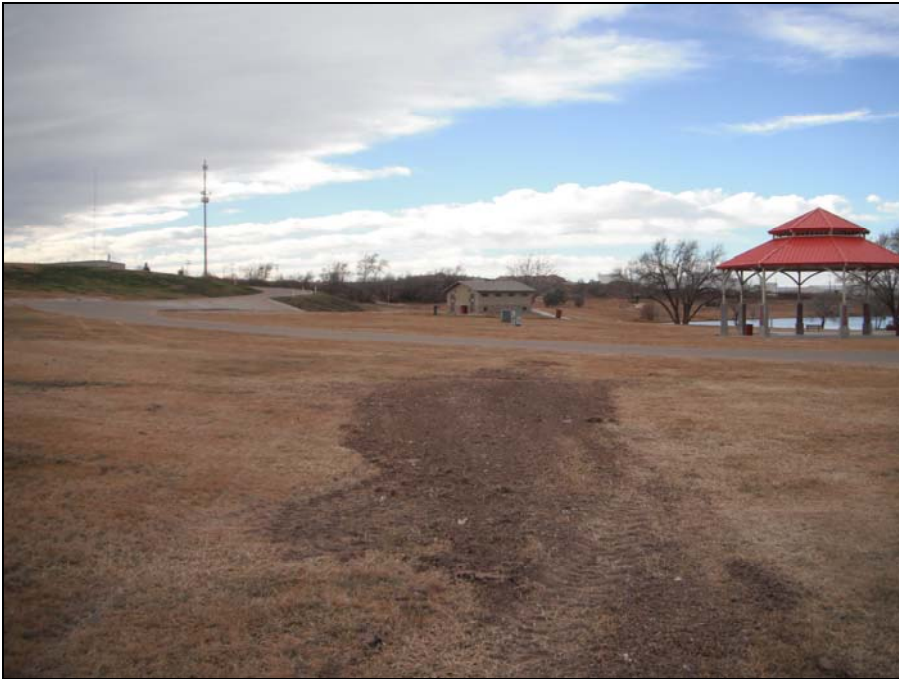
Photo 37. Setting for Trench 9 at proposed location of NWL-057A, facing west.

Backhoe Trench 9 was excavated adjacent to the proposed location for NWL-057A, within Helen Hodges Park, west of University Avenue (see Appendix A, Figure 6-13). The proposed location for the new manhole is within a 155-m (509-ft) range. Backhoe Trench 9 was placed near the middle of the location range (Photo 37). The trench was excavated to 190 cm (about 6.25 ft) below the ground surface. It yielded chunks of asphalt from around 55 cm (22 in) below the surface along with a section of chain, fragments of painted stucco, brick fragments, and other modern debris (Table 16; Photo 38). The modern materials found in this trench are consistent with debris from the 1970 tornado.

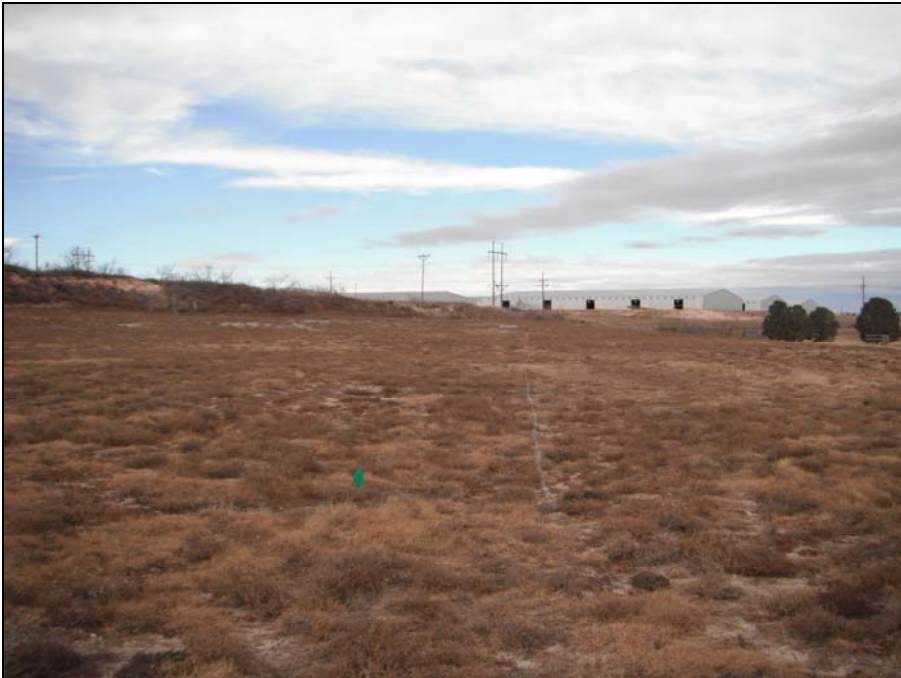
**Photo 39. Setting for Trench 10 and Trench 11, at proposed location of NWL-059A, facing northwest.**

The range of proposed locations for NWL-059A stretches across 210 m (689 ft) along the west side of one of the Canyon Lakes on the west side of Helen Hodges Park (Appendix A, Figure 6-14). The alignment runs east of a small bluff that appears to be at least partially artificial. The bluff rises to the west and is topped by an industrial complex with warehouses and spoil piles of dirt, gravels, and asphalt. Backhoe Trenches 10 and 11 were excavated along this range of locations, adjacent to the existing sewer line (Photo 39). Trench 10 reached unconsolidated bedrock at about 55 cm (22 in) but was continued to 80 cm (32 in) below the surface through increasingly dense limestone (Table 17; Photo 40). Trench 11 reached unconsolidated bedrock at 85 cm (33 in) below the surface but was continued to 120 cm (4 ft) (see Table 17; Photo 41).

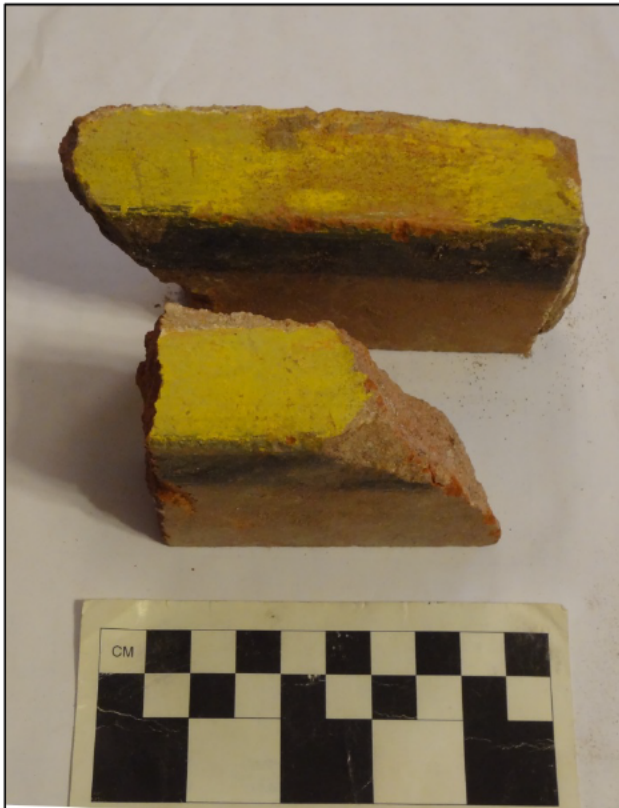
**Figure 2. Lot 2 bricks (sample).**

<b>Lot #</b>	<b>Trench</b>	<b>Depth</b>	<b>Description</b>
1	2	0-10 cmbs	1 white stoneware edge sherd with brown pattern
2	4	0-300 cmbs	6 fragments brick (apparently from wall), three painted yellow along narrow edge, none stamped , 2 3/8" wide, 1 1/8" tall (painted on edge measuring 1 1/8")
3	6	90-120 cmbs	1 ceramic horse head (broken off body)
4	9	20-55 cmbs	1 fragment bubbly green glass with wire reinforcement; 1 fragment clear rounded glass (bottle glass); 1 fragment green bottle glass
5	11	30-45 cmbs	3 small tertiary flakes (less than 1.5 cm in any dimension); 5 small fragments possible fire-cracked rock (less than 1.5 cm in any dimension)
6	11	45-105 cmbs	1 Falstaff beer bottle cap (screw on); 1 small fragment amber bottle glass
7	12	0-20 cmbs	1 fragment red terra cotta (floor tile?); 1 fragment thick glazed brick
8	12	50-70 cmbs	1 small fragment brick (no stamp visible); 2 fragments flat clear glass; 2 fragments translucent clear glass; 1 fragment ferrous metal unidentified artifact

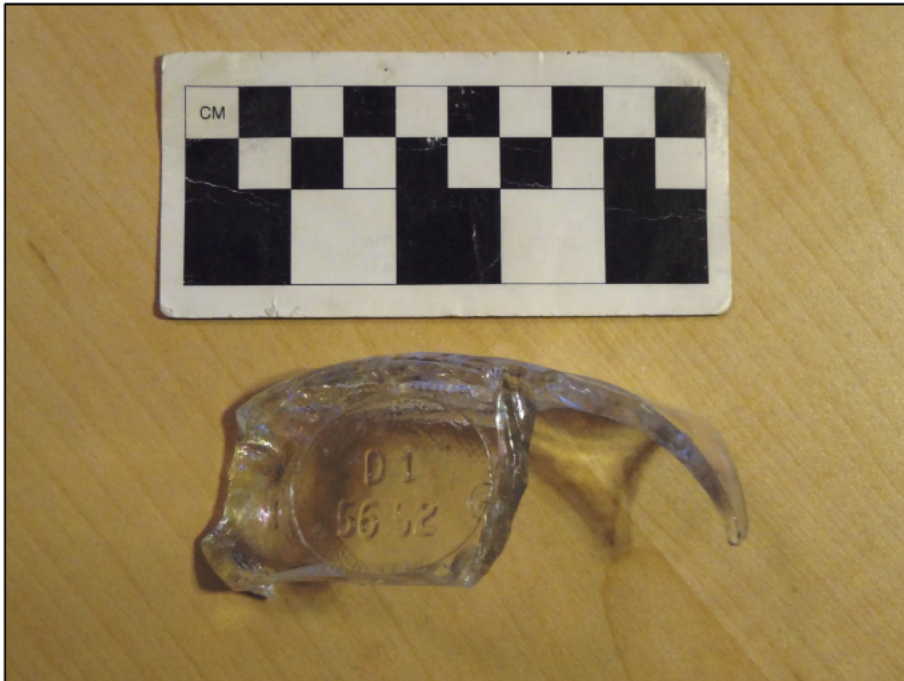
**Figure 6. Lot 9 glass fragment.**

9	18	0-60 cmbs	1 fragment clear glass (from 1 pint liquor bottle); base has Owens-Illinois stamp design; D1 and 56 52 (Manufactured 1952)
