Report for Archeological Survey

Hooks Road at Tributary of Bear
Creek, Polk County, Texas

Lufkin District

CSJ: 0911-04-062

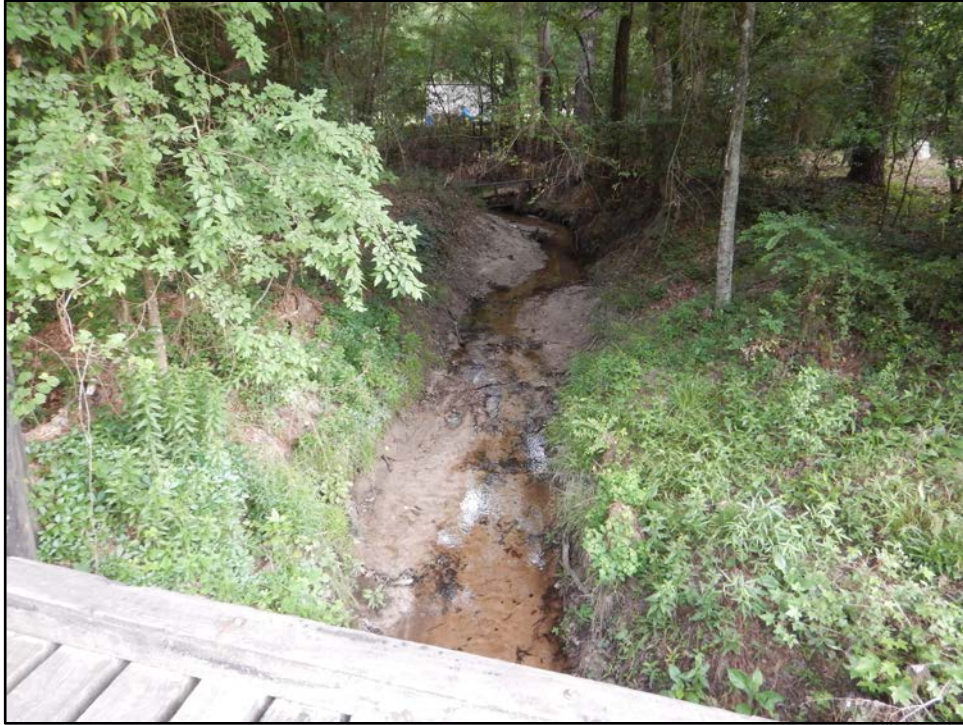
Figure 2. Photo of unnamed tributary and erosional cutbanks, facing north.

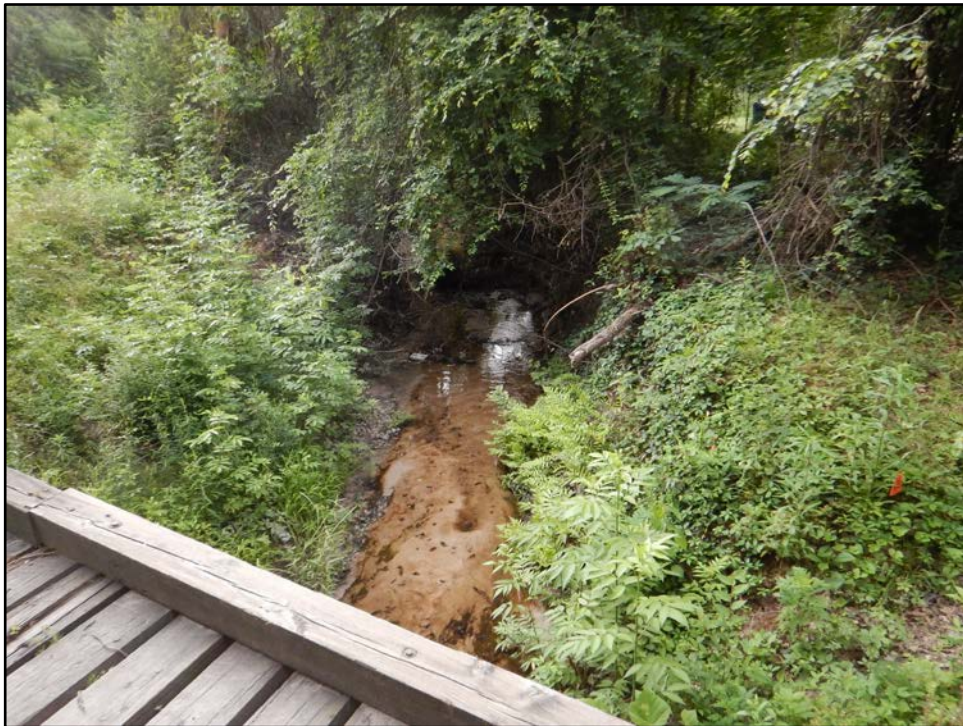
Figure 3. Photo of unnamed tributary and erosional cutbanks, facing southeast.

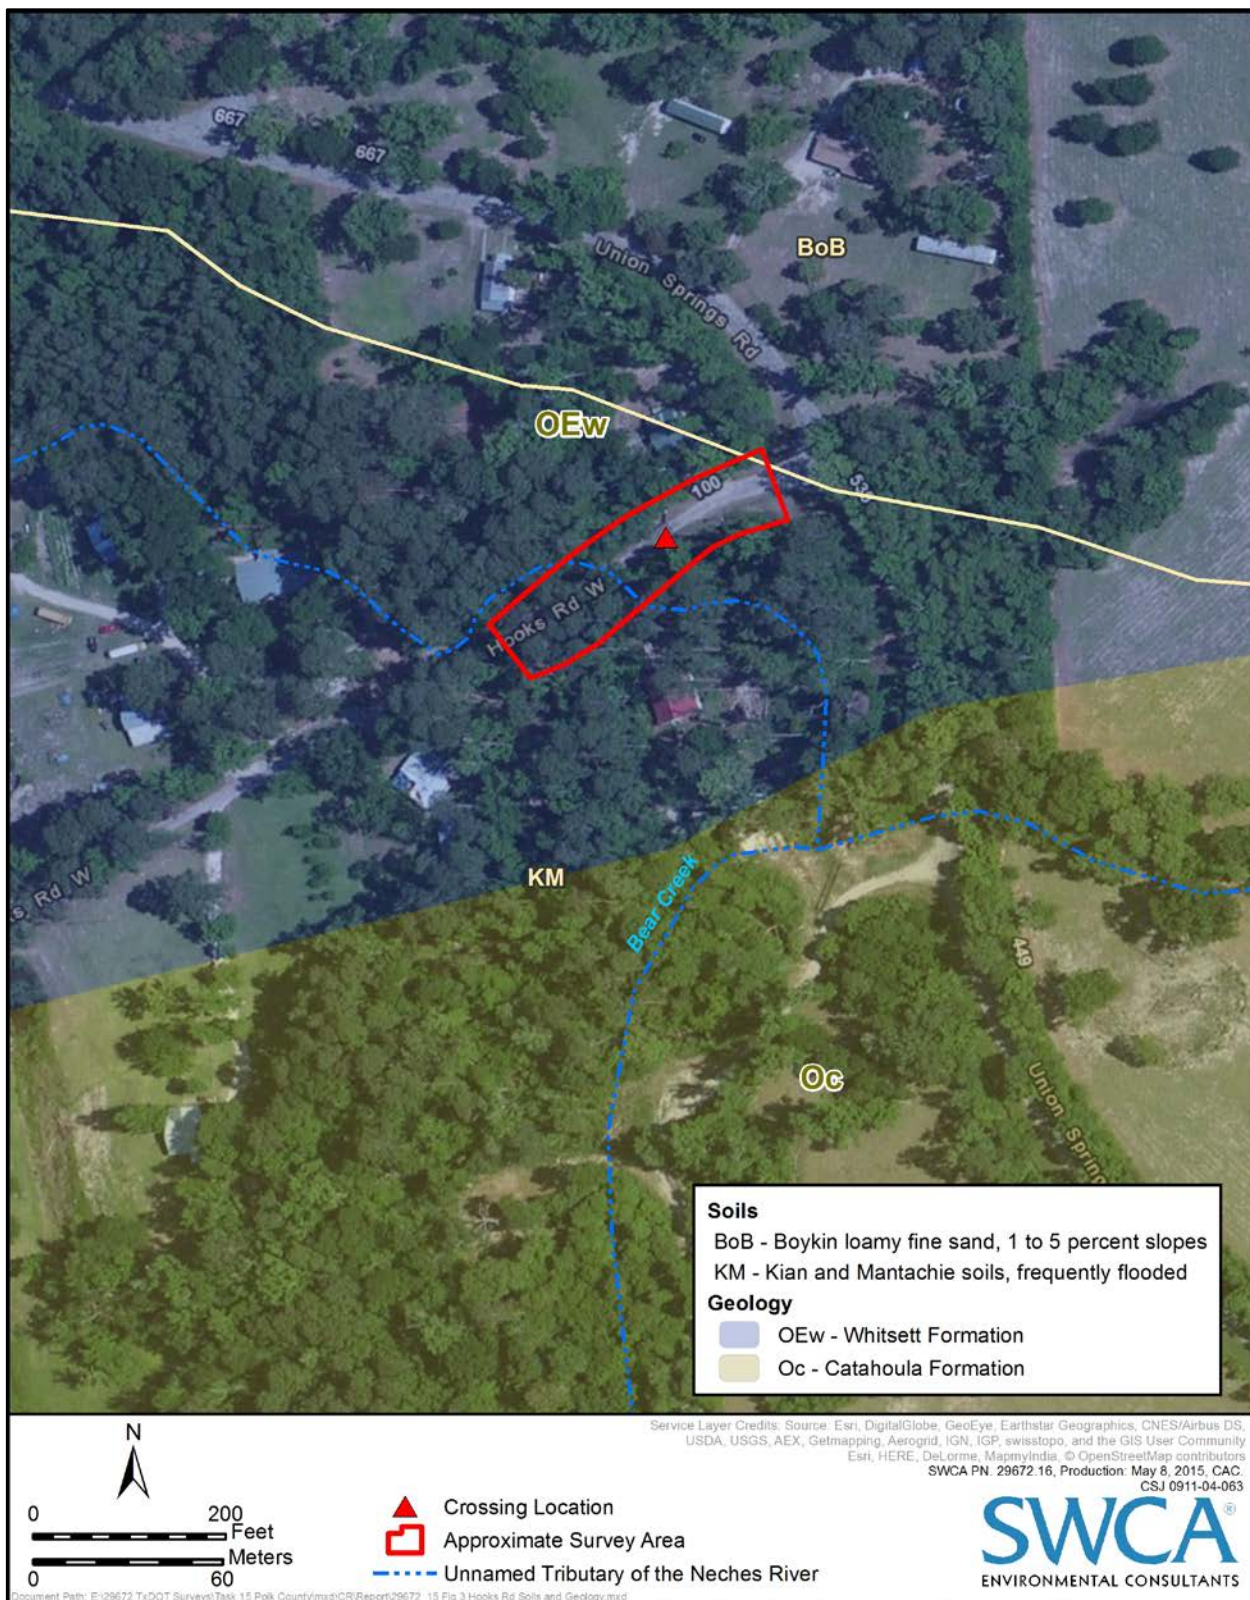
Figure 4. Soils and geology of the survey area.

- **Geology:** The surface geology for the project area is mapped as Eocene or Oligocene-aged deposits of the Whitsett Formation (Figure 4; Barnes 1992). The Whitsett Formation is described as fine- to medium-grained quartz sand that is tuffaceous, lignitic, argillaceous, and locally silica cemented. The deposits are light gray weathering to a dark gray with abundant fossilized wood (Barnes 1992).

- **Soils:** The soils for the project area are mapped as the Hatliff-Pluck-Kian Complex (0–1 percent slopes), frequently flooded (see Figure 4) (Natural Resources Conservation Service [NRCS] 2015). This soil mapping unit comprises 38 percent Hatliff soils, 35 percent Pluck soils, 24 percent Kian soils, and 3 percent soils of minor extent (NRCS 2015). All three of the major soils in this complex are characterized as very deep soils that formed in loamy alluvium of Holocene age. The Hatliff soils are located on natural levees and point bars, and the Pluck and Kian series soils are on meandering channels of creeks and streams.

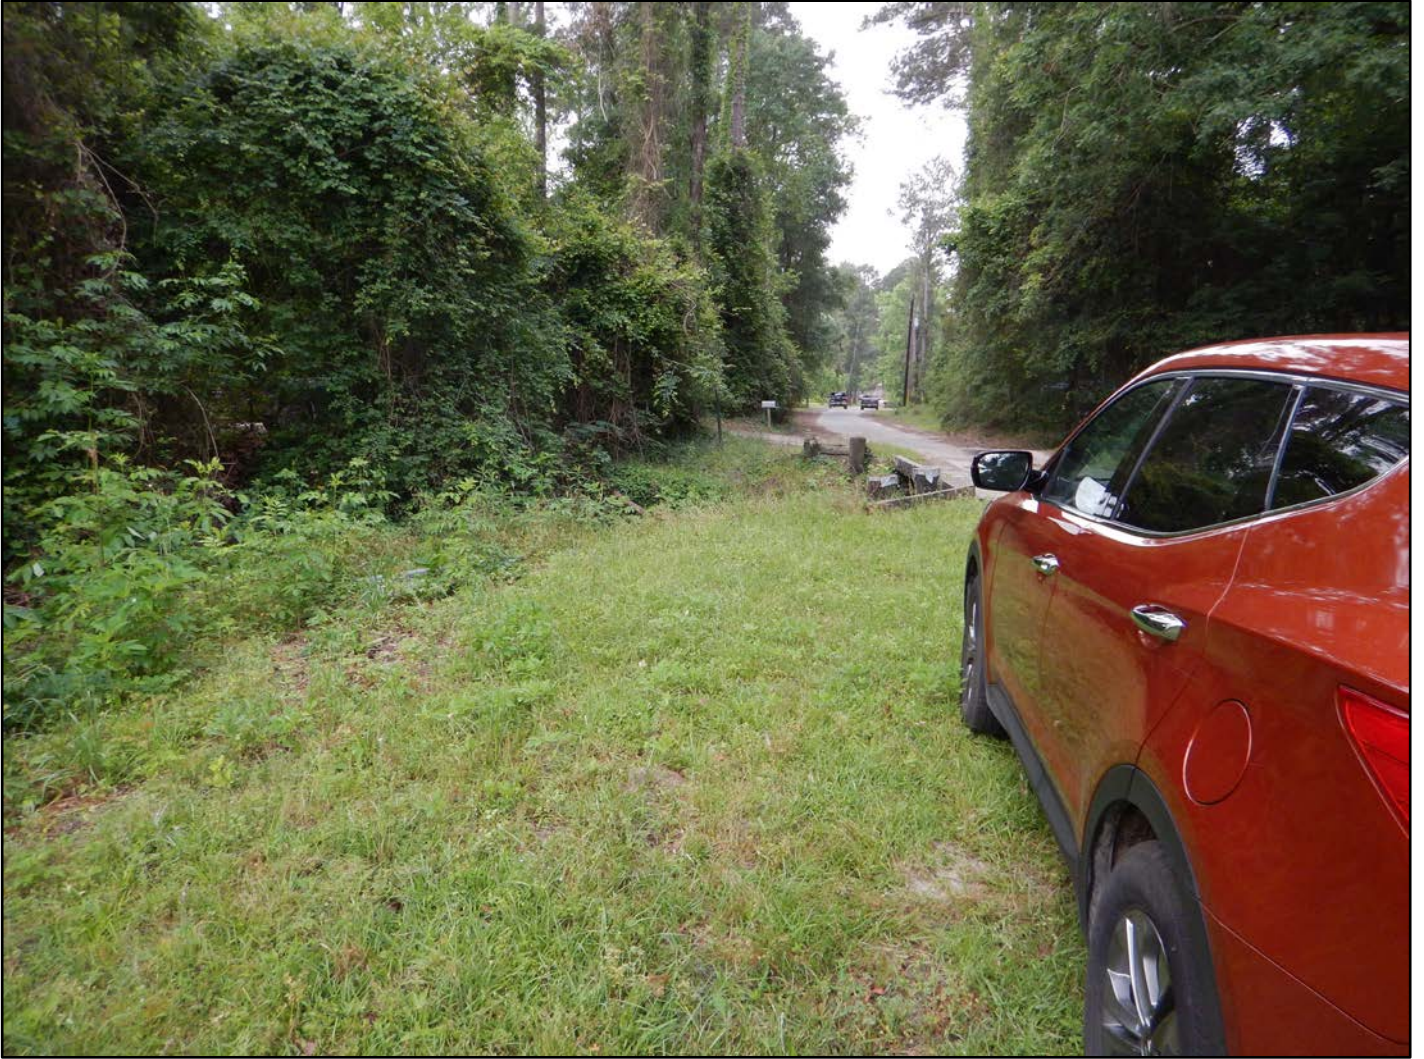
- **Vegetation:** The crossing contained mixed grasses (60 percent) along the roadway in all quadrants. The drainage in all quadrants is bracketed by a 10-m-wide (33-foot-wide) swath containing mature, mixed hardwoods (15 percent), and an abundance of vines and shrubs (25 percent) (Figure 5).

Figure 5. Overview of bridge replacement area, facing west.

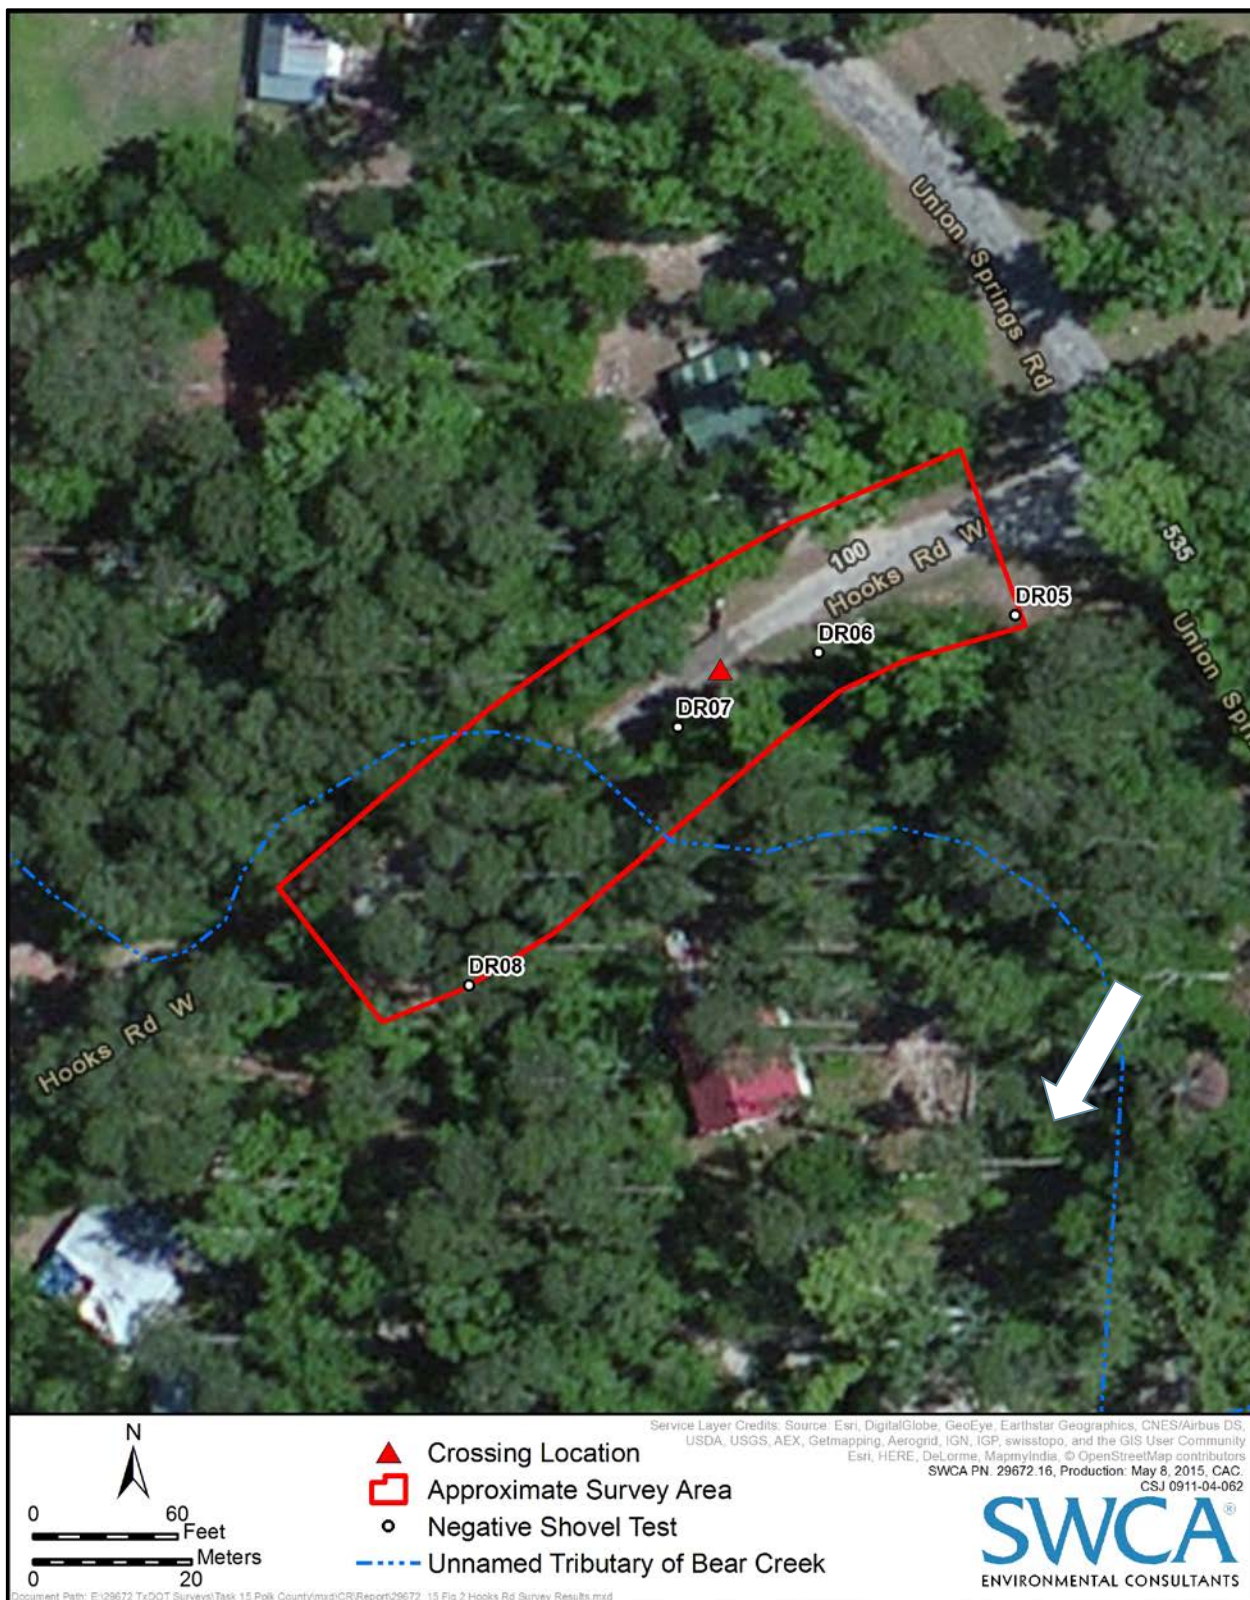
Figure 6. Map of investigations within APE.

- **Other Methods:** With regards to TxDOT ROW, parcel access, and disturbances, two shovel tests were placed on each side of the bridge crossing, for a total of four (see Figure 2). These excavations exceed the recommended Texas Historical Commission (THC) / Council of Texas Archeologists (CTA) survey standards for a project of this size (i.e., three shovel tests per 1 acre).
- **Collection and Curation:** NO YES If yes, specify facility. No artifacts were recovered, but the files will be curated at the center for Archeological Studies at the Texas State University.

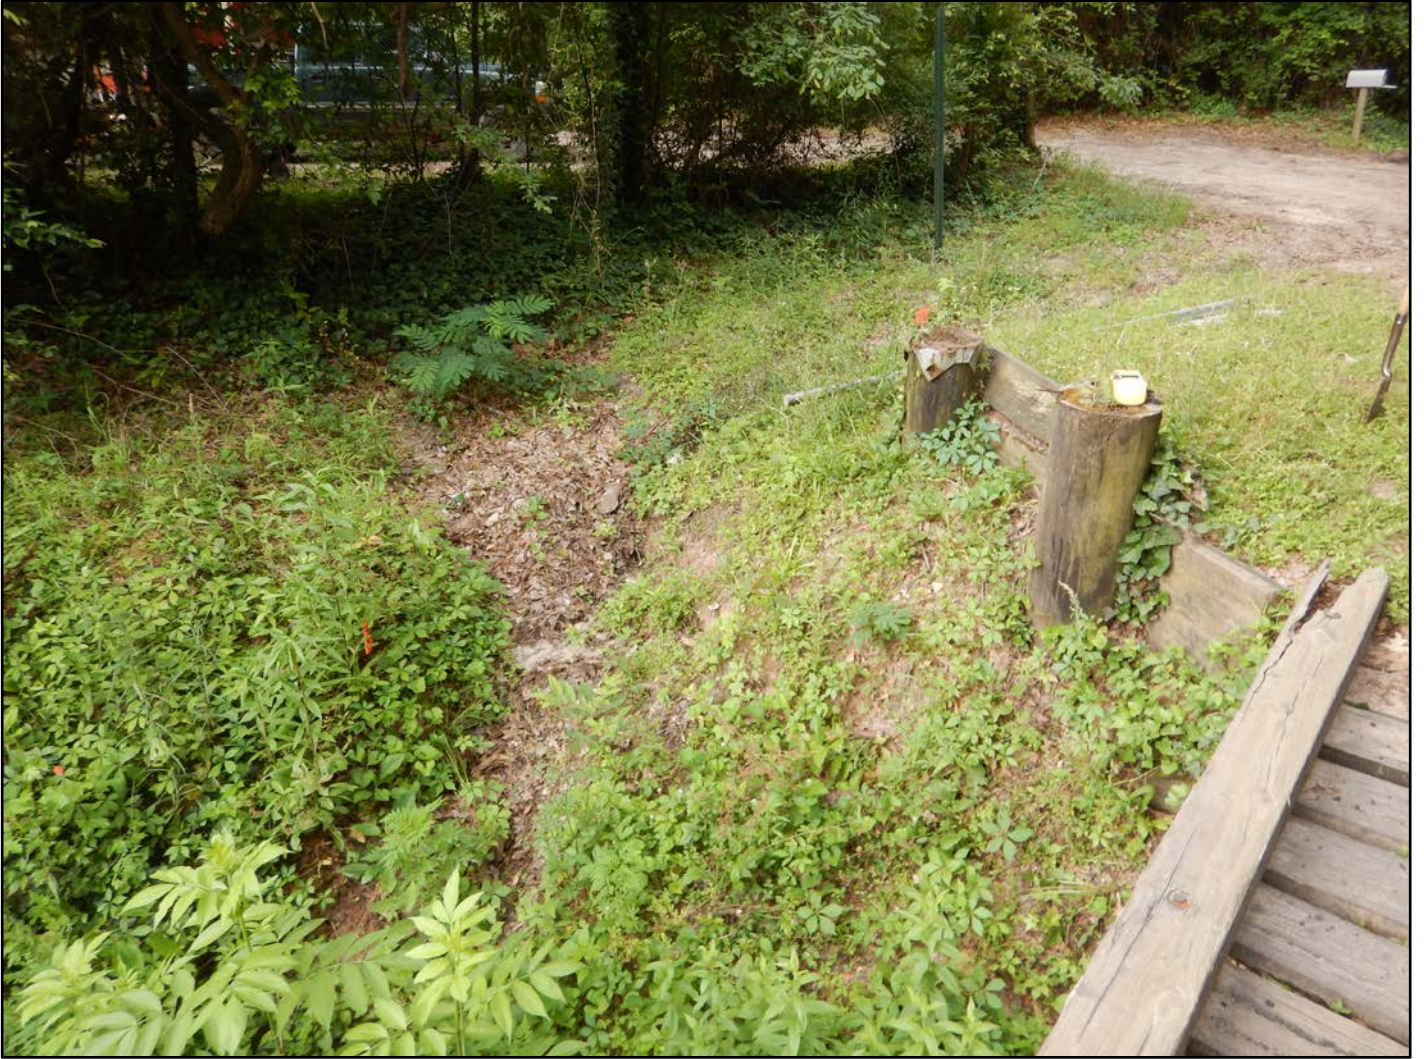
Project Area Description: At the survey area, the tributary of Bear Creek is a small drainage with an approximately 3-m-wide (10-foot-wide) base that had slow-moving water at the time of investigation. At the crossing, the tributary has been highly modified by residential and road construction in all quadrants (Figure 6). Push piles, buried and raised utilities, and driveways are all found within the proposed project area. Two shovel tests were excavated in the southeastern and southwestern quadrants of the crossing, for a total of four (Table 1). These shovel tests were placed within the existing TxDOT ROW, near the southern boundary, and avoiding the buried utility line (Figure 7).

- **Archeological Materials Identified:** No cultural materials were observed during the investigations.
- **APE Integrity:** The survey area within the new and existing ROW has low integrity and appears to have been highly modified to a depth of generally 40 cm (15 inches) below surface. These disturbances at the surface are attributed to previous road and bridge construction, residential construction, and buried utilities. The southern quadrants of the crossing, the proposed project area, appear to be the most heavily modified, including large gravel driveways and raised utilities.

Figure 7. Photo of disturbances and fill in southwestern quadrant of APE.
