Report for Archeological Survey

Howell Road at Paces Creek,
Polk County, Texas
Lufkin District

CSJ: 0911-04-063

On May 5, 2015, SWCA Environmental Consultants conducted an intensive cultural resources survey at Howell Road and Paces Creek crossing in Polk County, Texas. On behalf of Texas Department of Transportation (TxDOT), the investigations were conducted for the proposed replacement of an existing bridge. The work was conducted in compliance with Section 106 of the National Historic Preservation Act (16 USC 470) and the Antiquities Code of Texas (9 NRC 191). Eric Oksanen served as Principal Investigator under Texas Antiquities Code Permit No. 7267.

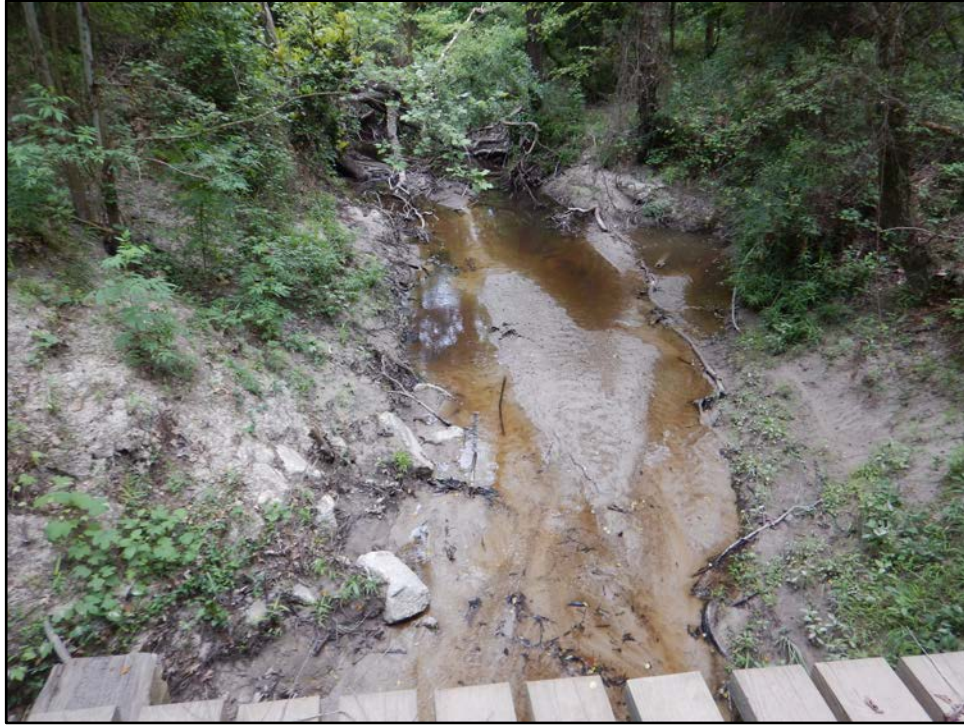
Project Area Description: At the survey area, Paces Creek is a small drainage with an approximately 7-m-wide (23-foot-wide) base that had slow-moving water at the time of investigation (Figures 3 and 4). At the crossing, the tributary has been moderately modified by bridge construction in the northwest quadrant. Push piles, concrete rubble, and buried utilities are all found within the proposed project area. The buried telephone line parallels the existing gravel road on the west side, in the proposed ROW. Two shovel tests were excavated in the southeastern and southwestern quadrants of the crossing, for a total of four (Figure 5; Table 1). These shovel tests were placed within the existing TxDOT ROW near the southern boundary to avoid a buried utility line (Figure 6).

Figure 3. Photo of Paces Creek, facing west.

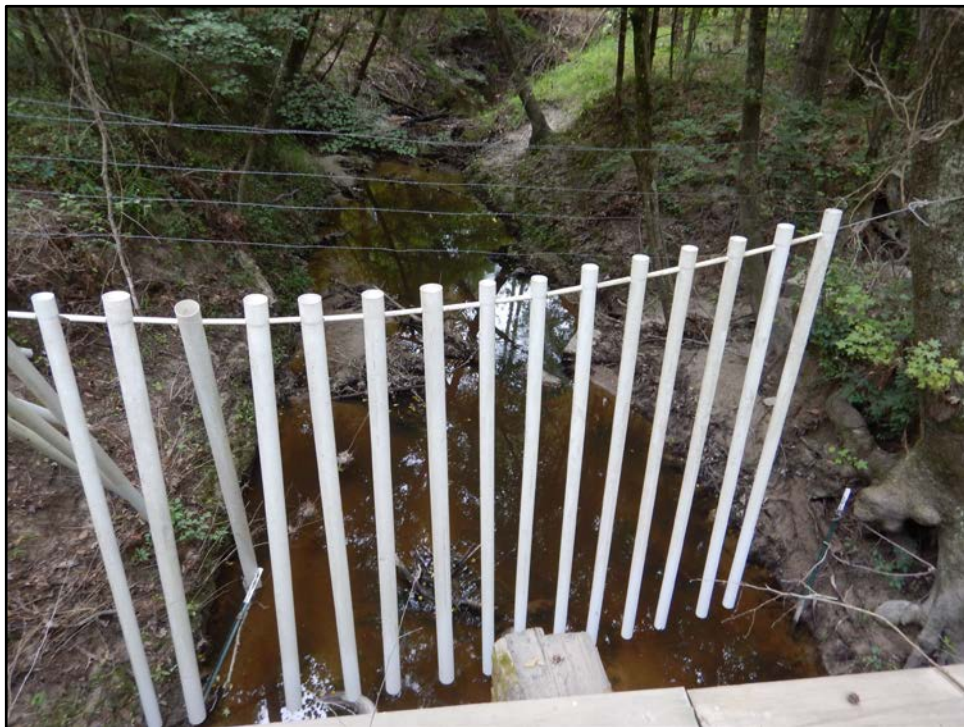
Figure 4, Photo of Paces Creek, facing east.

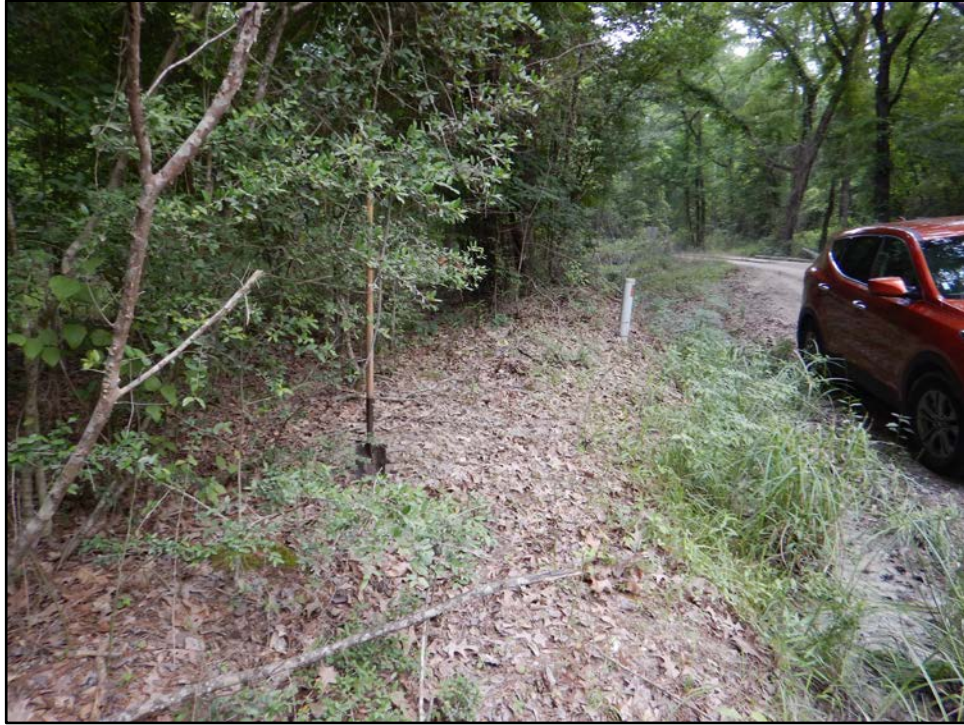
Figure 6. Photo of buried utility marker and location of shovel test on the southwestern quadrant, facing southwest.

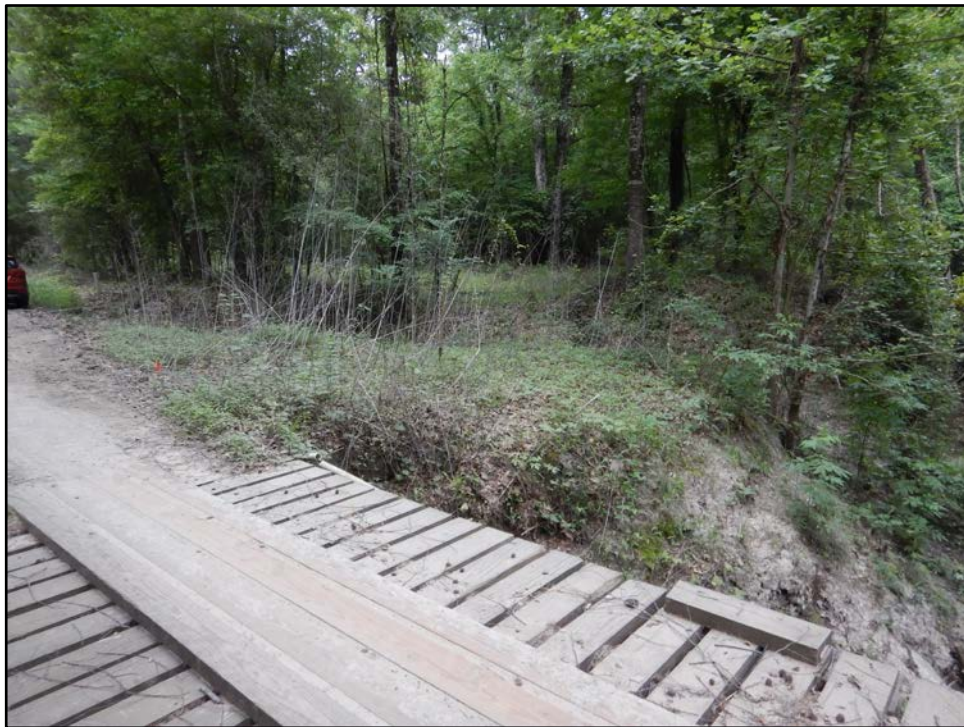
At the crossing, the tributary is a slightly modified paired terrace system consisting of terraces containing deep alluvial deposits that bracket the drainage. Both banks of the crossing have one landform, the T₀ terrace that is the current floodplain (see Figure 1). The riser of the T₀ terrace at the drainage is sloping and covered with vegetation, concrete rubble, and fallen trees, which prevented

a clear profile inspection (Figure 7). The typical tread of the T₀ landform is level about 1.5 m (5 feet) above the channel, and extends beyond the limits of the project area (Figure 8).

Figure 7. Photo of northwestern quadrant, facing northwest, showing profile that contains rubble and fill.

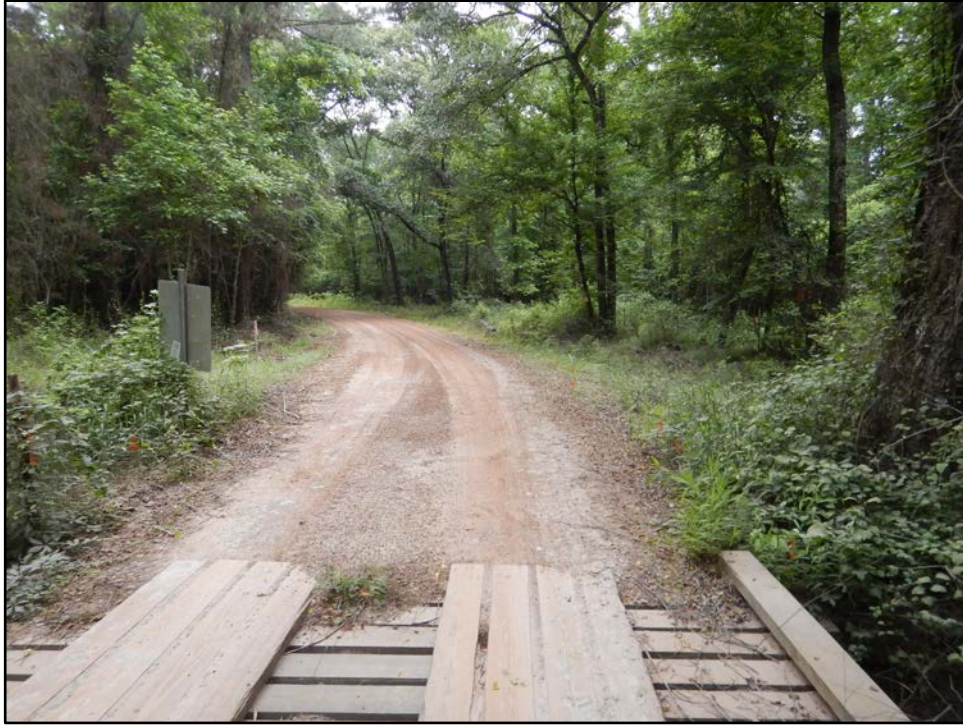
Figure 8. North side of project area, facing west.
