## **Intensive Pedestrian Archaeological Survey of the Lower Segment of San Pedro Creek, South Alamo Street to the Apache-Alazán Creek Confluence, San Antonio, Bexar County, Texas**

**RABA KISTNER ENVIRONMENTAL, INC.  
San Antonio, Texas**

Texas Antiquities Committee Permit Number: 6913

**April 2015**

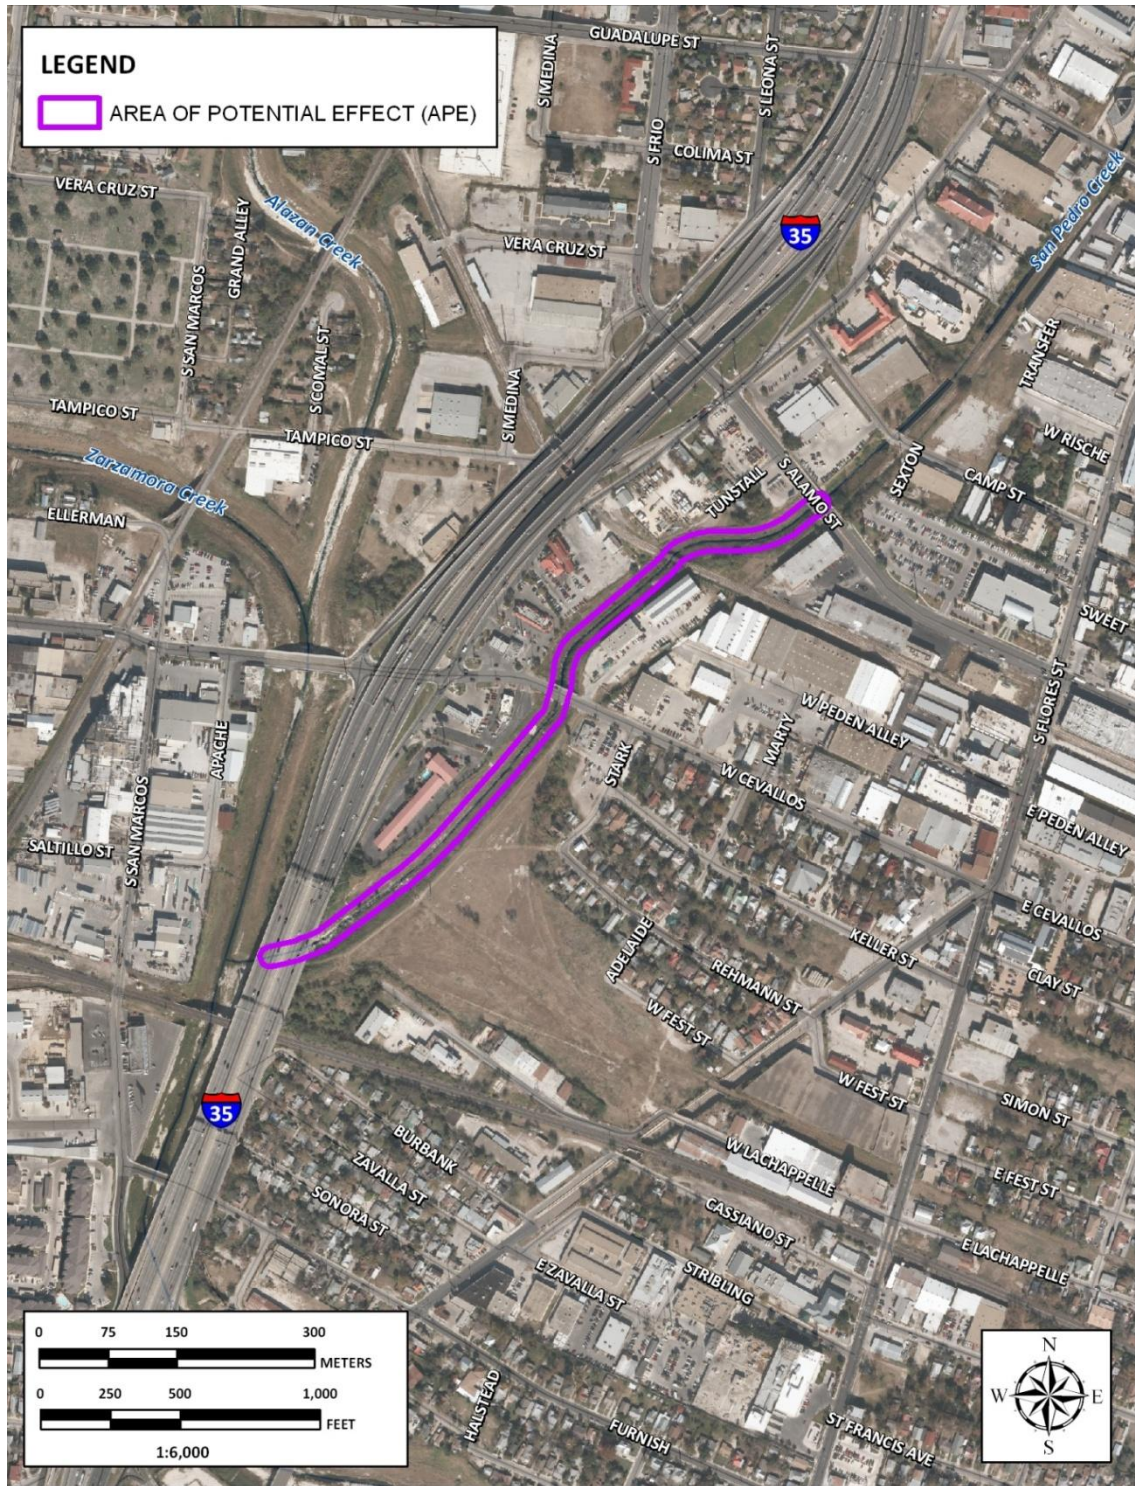
Figure 1-2. A current aerial with the project corridor outlined.

The project area is bound by Alamo Street and the Apache-Alazán creeks confluence. The segment is approximately 1,850 linear feet measured along the channel centerline (**Figure 1-2**). From the centerline of the creek, the project limits for the archaeological survey extends to 35 feet on either side, for a combined total of 70 feet. The project area has been the subject of extensive modifications going

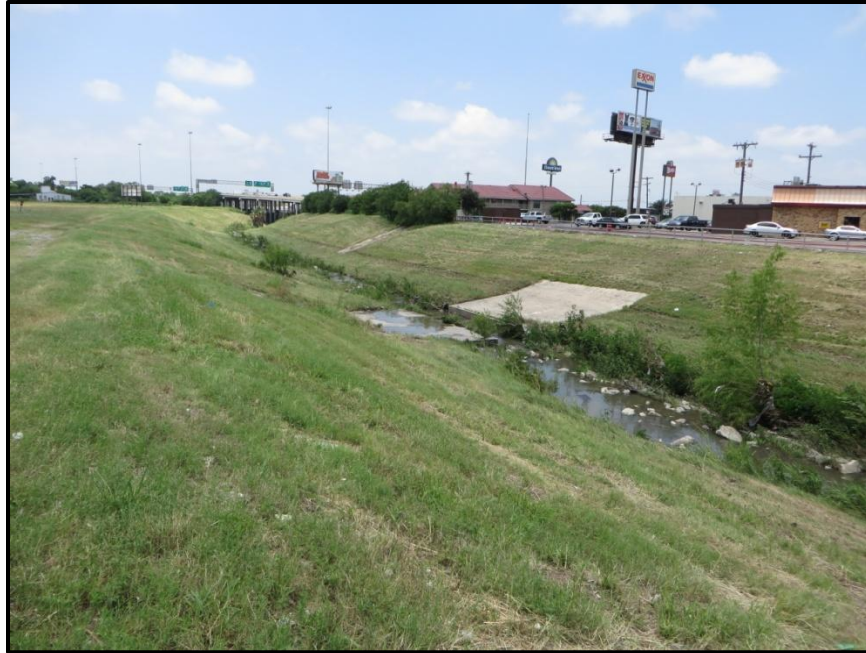
**Figure 1-3.** Graded San Pedro Creek banks south of FM 536 (South Alamo Street).

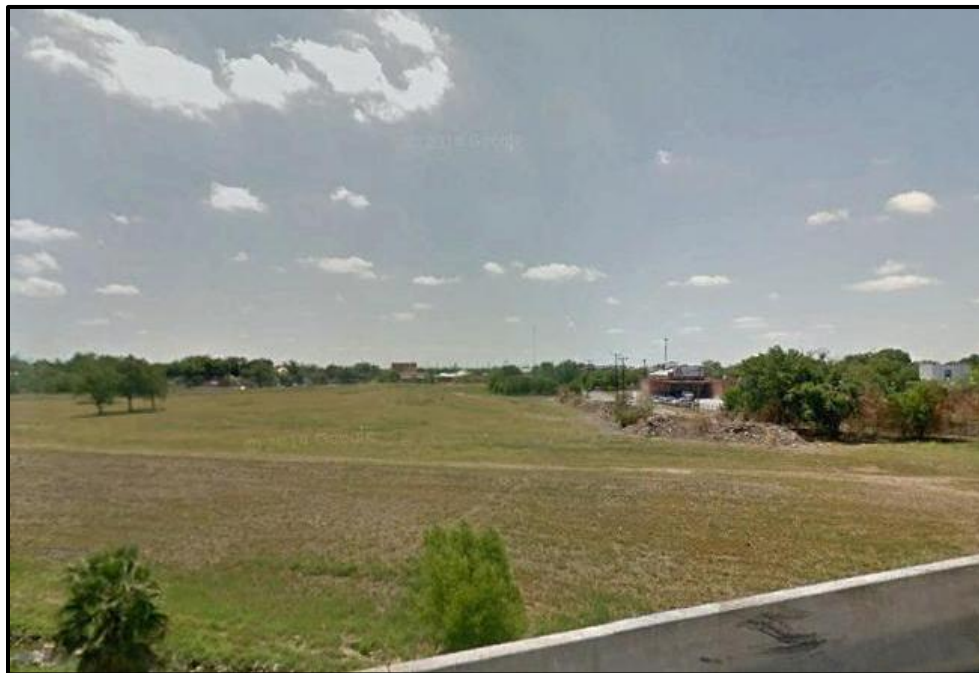
**Figure 1-4.** Terrace of San Pedro Creek in the vicinity of U.S. Interstate Highway 10, near the south terminus of project area.

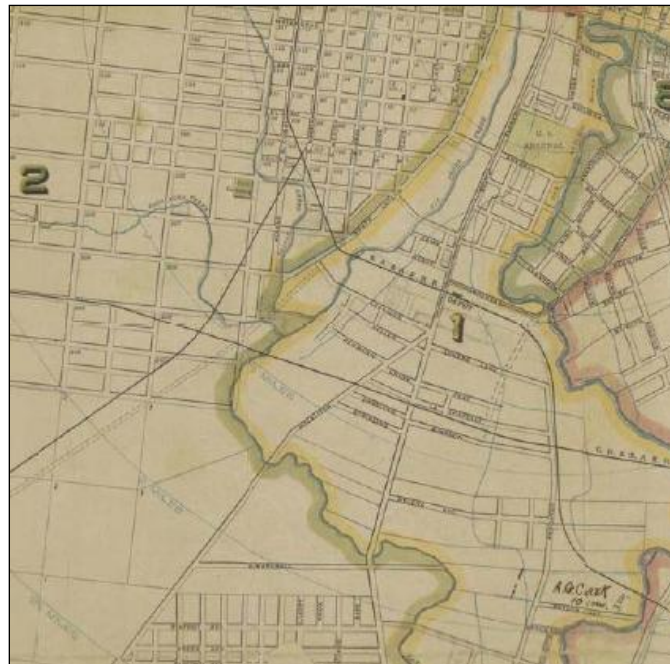
**Figure 4-2.** Portion of JJ Olson Map showing vicinity of the San Pedro Creek, Alazán Creek, and Apache Creek confluences as they were depicted in 1889.

A review of historic maps associated with the project area reveal how the route of the creek as well as the use of the surrounding land has changed throughout the years. The J. J. Olson map of 1889 shows Alazán and Apache Creeks entering San Pedro Creek at distinct places along the channel of the creek (**Figure 4-2**). Alazán Creek enters San Pedro Creek some 750 feet north of the confluence of Apache Creek and San Pedro Creek. The confluence of the two creeks is depicted on the west bank of San Pedro Creek immediately west of Rehmann Street, which in 1889 terminated in Stark Street which paralleled the channel of San Pedro Creek. In addition, the 1889 J.J. Olson map of the area shows a very

pronounced bend in the creek immediately where the San Antonio and Aransas Pass Rail Road crosses the channel. An island appears to be depicted in the channel of the creek.

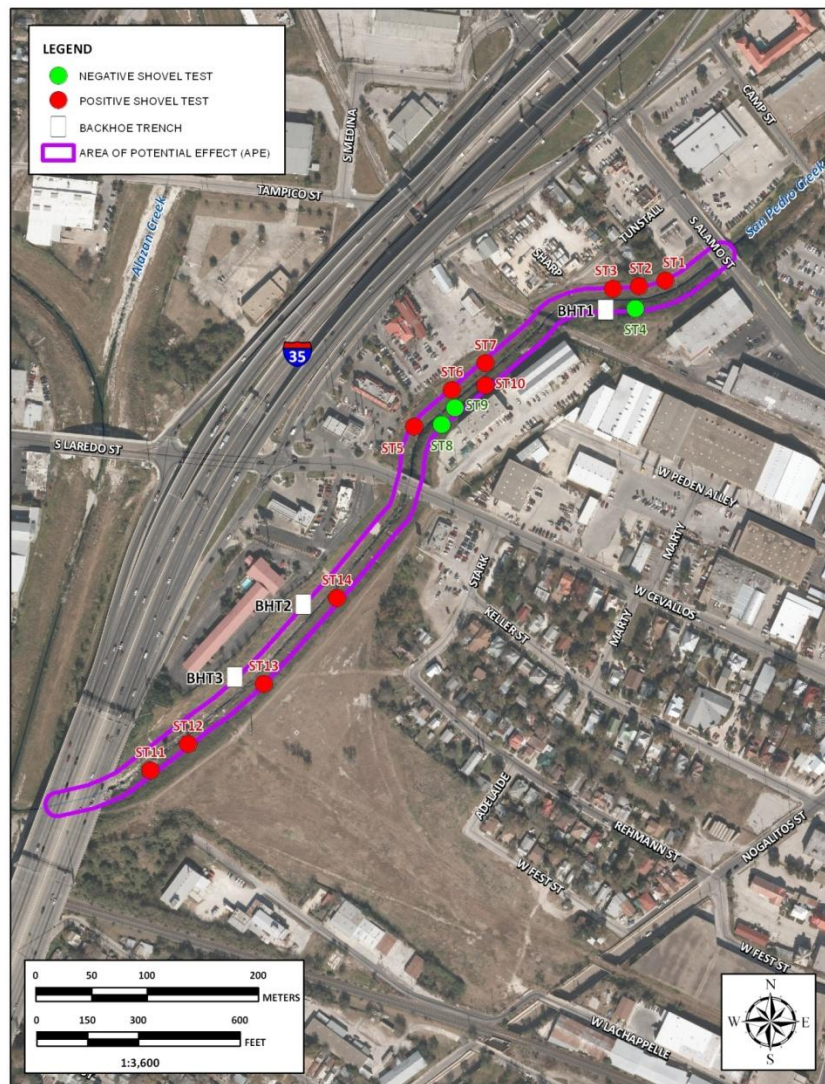
**Figure 5-1.** Location of the shovel tests and backhoe trenches excavated during the project.

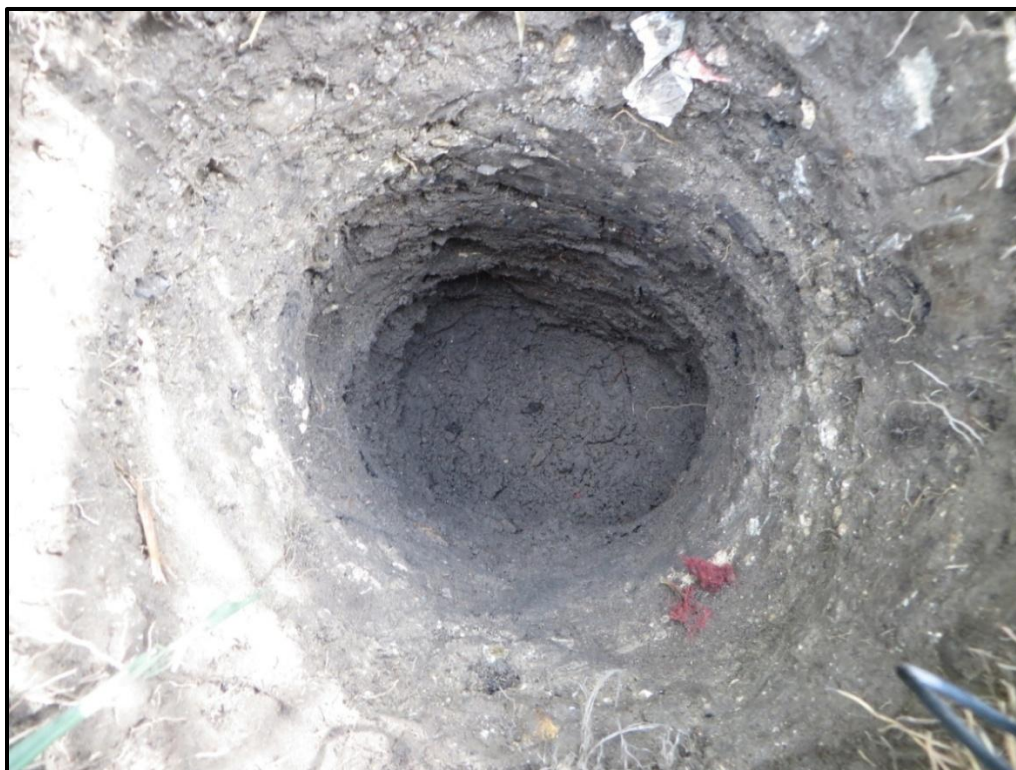
The soil of each of the shovel tests in this section of the APE differed greatly. Shovel Test 1 exhibited brown silty clay in the upper 20 cmbs. Level 3 (20-30 cmbs) was a transition zone, with yellowish brown silty clay. The remainder of the shovel test exhibited yellowish brown clay with varying percentages of gravels (10-35 percent). Shovel Test 2, which had the highest density of artifacts, exhibited dark brown silty clay in the upper 50 cm. The soil changed to dark gray silty clay which continued to a depth of 80 cmbs (**Figure 5-2**). Shovel Test 3 also exhibited dark brown silty clay in the upper 30 cm below surface. Level 4 (30-40 cmbs) transitioned to a dark brown silty clay that was moister than the upper levels. At Level 5 (40-50 cmbs) the matrix became brown silty clay with higher clay content than silt. Gravels increased at this level as well. The last two levels (60-76 cmbs) changed to pale brown caliche-like clay with very few gravels. Shovel Test 4 exhibited dark brown silty clay loam in the upper 10 cm. This layer capped yellow mottled clay (**Figure 5-3**).

**Figure 5-2.** Photograph of Shovel Test 2.

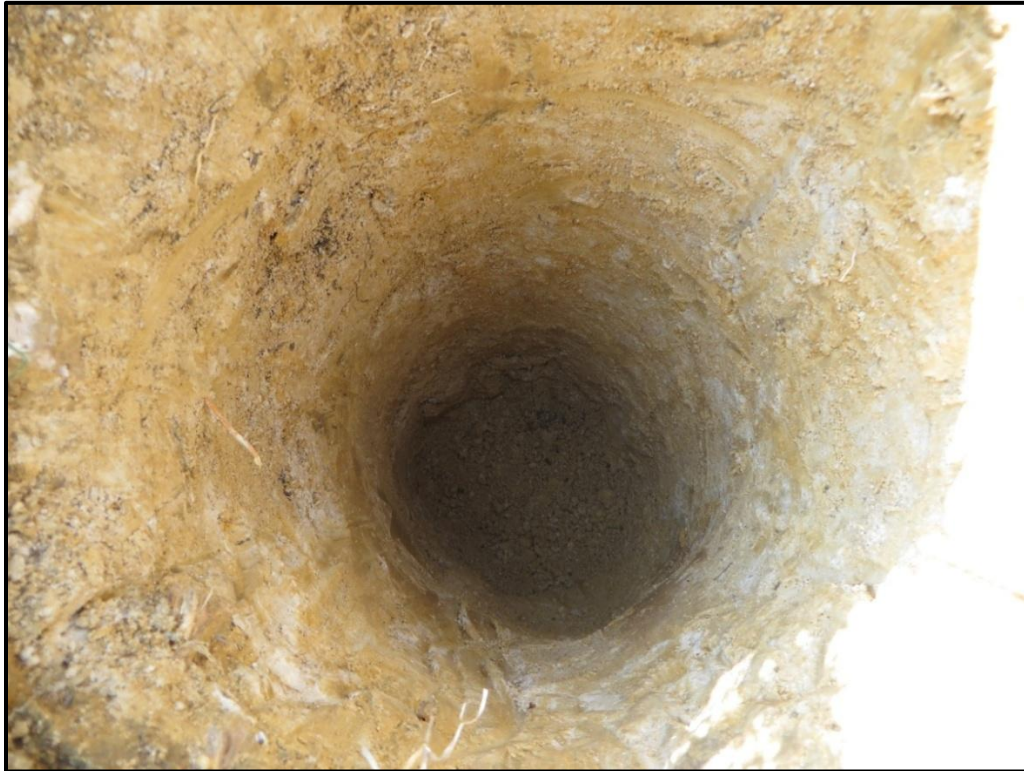
**Figure 5-3.** Photograph of Shovel Test 4.

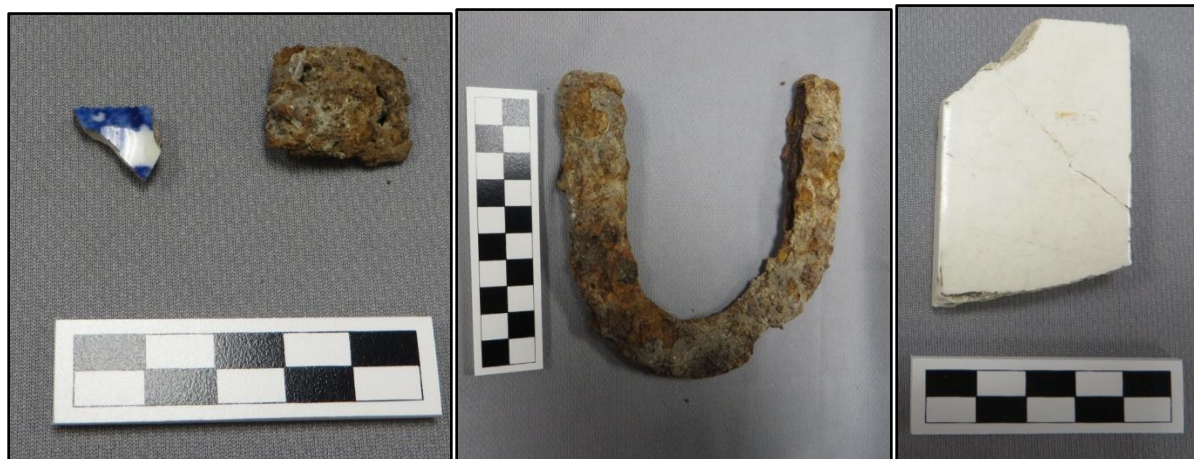
The majority of the artifacts consisted of glass, metal, and plastic. Shovel Test 2 produced the highest density of artifacts with 111 items collected. Plastic fragments comprised the largest number of the items (n=39) in the “Other” category and were recovered to a depth of 60 cm below surface (cmbs). Between 60 cmbs and 80 cmbs the “Other” category consisted of fragments of slag. Brick, concrete, and a fragment of granite were classified as “Construction Material.” Of the seven fragments of ceramic, six were classified as undecorated white earthenware. One was a fragment of transferware. These ceramics have been manufactured over a long period of time, throughout the mid-century and into the 20<sup>th</sup> century (**Figure 5-4**). Glass fragments were recovered throughout Shovel Test 2. Ten of the twelve fragments were clear container glass. One fragment was clear flat glass and another was a fragment of brown container glass. These glass colors are typically associated with later dates. The personal items consisted of a metal belt buckle, a scarf fragment, and a button. The unidentified metal fragments comprised the largest portion of the metal category (n=16). In Shovel Test 2, one cut nail was recovered in Level 4 (30-40 cmbs). One horseshoe was recovered in Level 7 (60-70 cmbs).

**Figure 5-4.** Examples of potentially historic artifacts recovered during the survey (l-r: Transferware, buckle, horseshoe, undecorated white earthenware).

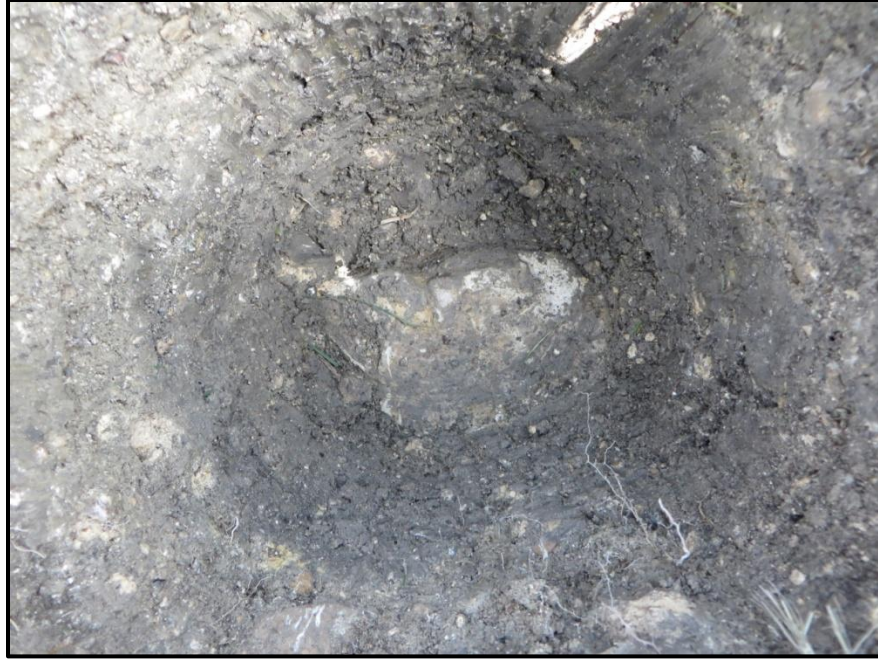
Six shovel tests were excavated between the wooden trestle railroad bridge and the W. Cevallos Street Bridge. Three were excavated on each side of the creek bank. Shovel Tests 5 through 7 were excavated on the west side of the creek bank. Shovel Tests 8 through 10 were placed on the east bank. Shovel Test 5 exposed dark grayish brown mottled silty clay with a high clay content throughout the entire test. The soil became wetter towards the base of the shovel test. Shovel Test 6 exhibited dark gray silt in the upper 10 cm. Beneath this layer, the soil changed to dark grayish brown silty clay for approximately 20 cm before changing to dark silty clay extending the base of the shovel test. The test was terminated at 46 cmbs due to the presence of large limestone cobbles (**Figure 5-8**). The shovel test produced a mixed context assortment of artifacts, including construction material (concrete), plastic a wire nails, and glass fragments. The limestone encountered at the base of the test appears to be the common cobbles found along the creek bank. This would indicate that the deposits located above the cobbles are likely related to the flooding of the creek and possess no cultural significance. Shovel Test 7 exhibited dark grayish brown sandy clay in the upper 10 cm. The soil changed to dark grayish brown clay for the next 10 cm, before becoming yellowish brown clay with a few fist-sized chert cobbles. Between 30 cm and 66 cm below surface, the color of the soil changed to brown. The matrix continued to be a clay, but became moister and more sticky the greater the depth. Shovel Test 8, located on the east bank of San Pedro Creek, exhibited light brownish gray silty clay with heavy gravels throughout the extent of the test. Shovel Test 9 was characterized by gray silty clay with large gravels (approximately 5-20 cm in diameter) in the upper 30 cm. Between 30 and 40 cm below surface, the soil became light brownish gray mottled clay with heavy gravels. The transition zone was located in Level 5 (40-50 cmbs) with brownish yellow compact clay. The remainder of the shovel test exhibited light gray mottled clay with gravels (**Figure 5-9**). Shovel Test 10 exhibited different soils with a dark brown silty clay in the first 40 cm below surface. The matrix contained gravels that ranged in sizes of 2-4 cm in diameter. By the end of Level 4 (30-40 cmbs) the gravel content increased to approximately 50 to 60 percent with some mottled clay. In Level 5 (40-46 cmbs) the matrix became highly mottled, dark yellowish brown clay. Large chert cobbles made digging a shovel test near impossible. The shovel test excavation was terminated at 46 cm below surface due to the cobbles.

**Figure 5-8.** Photograph of Shovel Test 6.

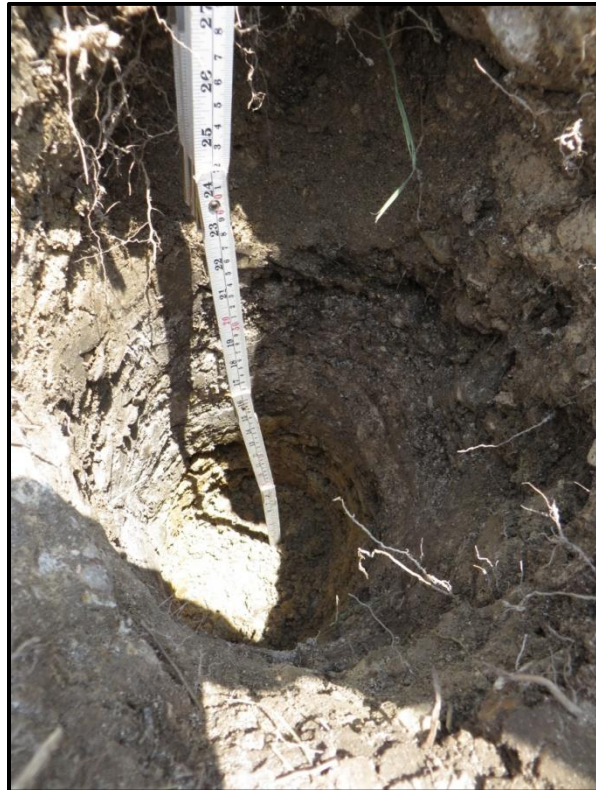
**Figure 5-9.** Photograph of Shovel Test 9.

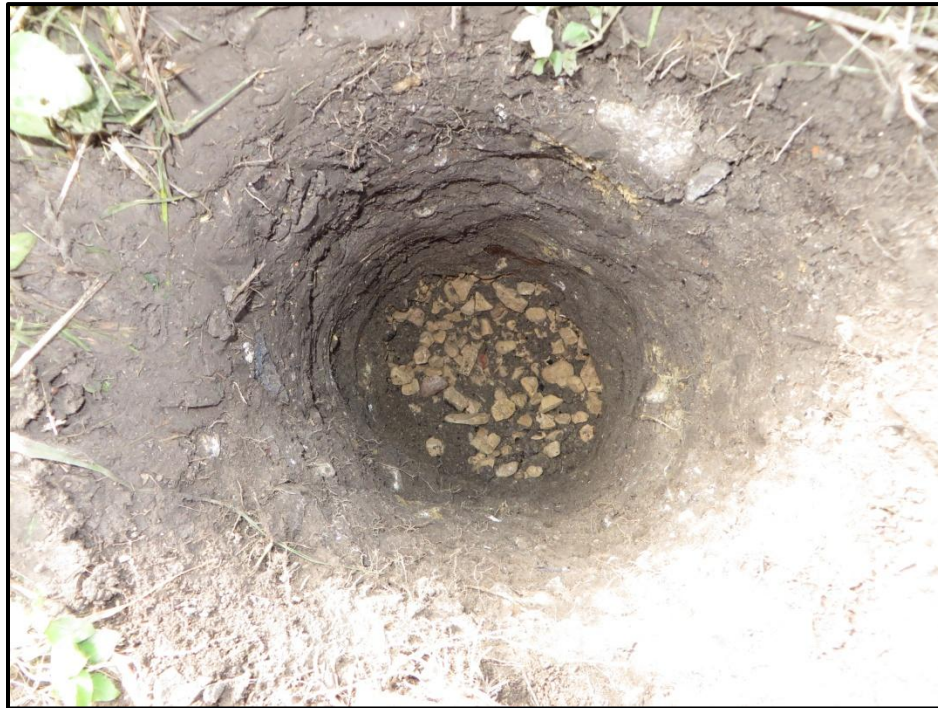
Four shovel tests were excavated between the W. Cevallos Street Bridge and the bridge for IH-35. These four shovel tests were located on the east bank of San Pedro Creek. The shovel tests in this segment appeared to exhibit similar soils. The shovel tests had dark gray to very dark gray silty clay throughout most of the levels. Due to rain the night before these shovel tests were excavated, the soils were moist and the clay was plastic. Shovel Test 12 was the only one that appeared to have a dramatic difference. Shovel Test 12 became mottled in Level 7 (60-70 cmbs) and began to pick up some gravel at

approximately 65 cmbs. In Level 8 (70-80 cmbs), the matrix consisted of 100 percent gravels (**Figure 5-10**). This gravel layer was not encountered in the other shovel tests.

**Figure 5-10.** Shovel Test 12 exhibiting the gravels encountered.

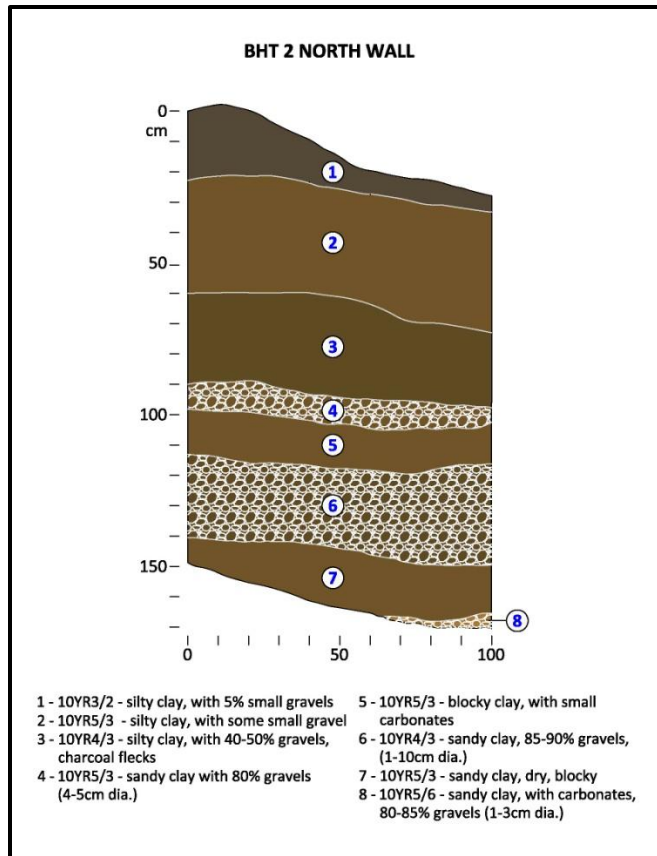
Backhoe Trench 2 (BHT 2) was located along the west bank of San Pedro Creek south of the W. Cevallos Bridge. The trench was excavated perpendicular to the creek. The maximum depth was 1.5 meters, although due to the slope of the bank, the eastern portion of the trench was approximately 1.4 meters below the surface (**Figure 5-13**). The strata noted in BHT 2 were very different from that in BHT 1. The upper 5 to 20 cm consisted of dark grayish brown silty clay with small gravels and grass roots. The materials noted in this stratum consisted of modern trash such as plastic, wrappers, and glass fragments. The second stratum consisted of brown silty clay, although the soil had higher clay content. Very few gravels were noted. Stratum 3 was a slightly different brown silty clay soil with approximately 40 to 50 percent gravels. Charcoal flecks were noted in the matrix. Below the clay of Stratum 3, Stratum 4 was a gravel lens with little soil. The layer consisted of approximately 80 percent gravels that were 4 to 5 cm in diameter. Beneath the gravel lens was blocky, brown clay that exhibited some carbonate streaking. A thicker gravel lens was observed below the clay. This lens was approximately 25 cm in thickness. The layer consisted of approximately 85 to 90 percent gravels that ranged in size from 1 to 10 cm in diameter. Another clay layer was present below the gravels. This layer consisted of blocky, brown sandy clay. This layer was approximately 10 to 20 cm in thickness. The eastern portion of the trench picked up the top of another gravel lens at the base of the trench. No cultural material was noted within the backdirt or the trench walls below the upper 5 to 20 cm below surface.

**Figure 5-13.** North wall profile of BHT 2.

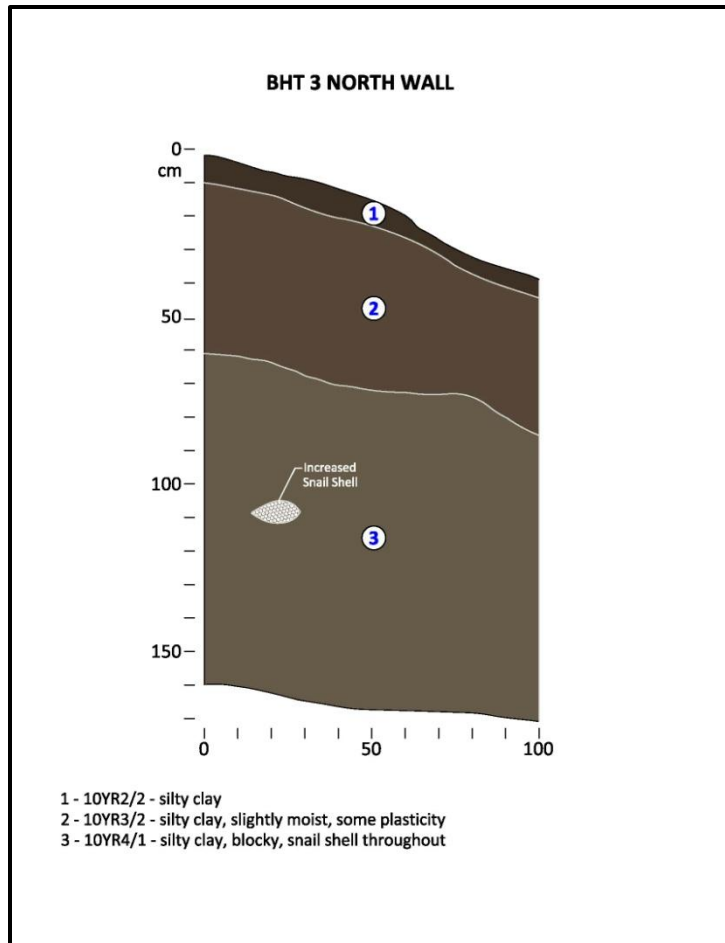
Backhoe Trench 3 (BHT 3) was located along the western bank of San Pedro Creek, north of the IH-35 bridge. The stratigraphy of BHT 3 was very different from that noted in BHT 1 or BHT 2 below the upper silty clay that contained grass roots and modern trash (**Figure 5-14**). Below the upper sediment, the soil becomes dark grayish brown silty clay. Within in the upper portion of this stratum clear glass fragments and an aqua bottle base were noted. These items were not collected as they appeared to be modern, machine made glass fragments. The layer was approximately 50 cm thick. Below Stratum 2 and extending to the base of the trench at 1.5 meters below the surface, the soil was gray blocky silty clay. The matrix contained snail shell fragments throughout the stratum. Pockets of increased concentrations of snail shell were noted. The trench walls appeared to have calcium carbonate streaks due to the amount of snail shell. No cultural material was noted in this layer.

**Figure 5-14.** North wall profile of BHT 3.
