RESULTS OF METAL DETECTOR SURVEY,
TESTING OPERATIONS, AND ARCHIVAL STUDIES
THE WOOTEN-SEALE PLANTATION, SITE 41RT362

ROBERTSON COUNTY, TEXAS

State Department of Highways and Public Transportation

November 1988

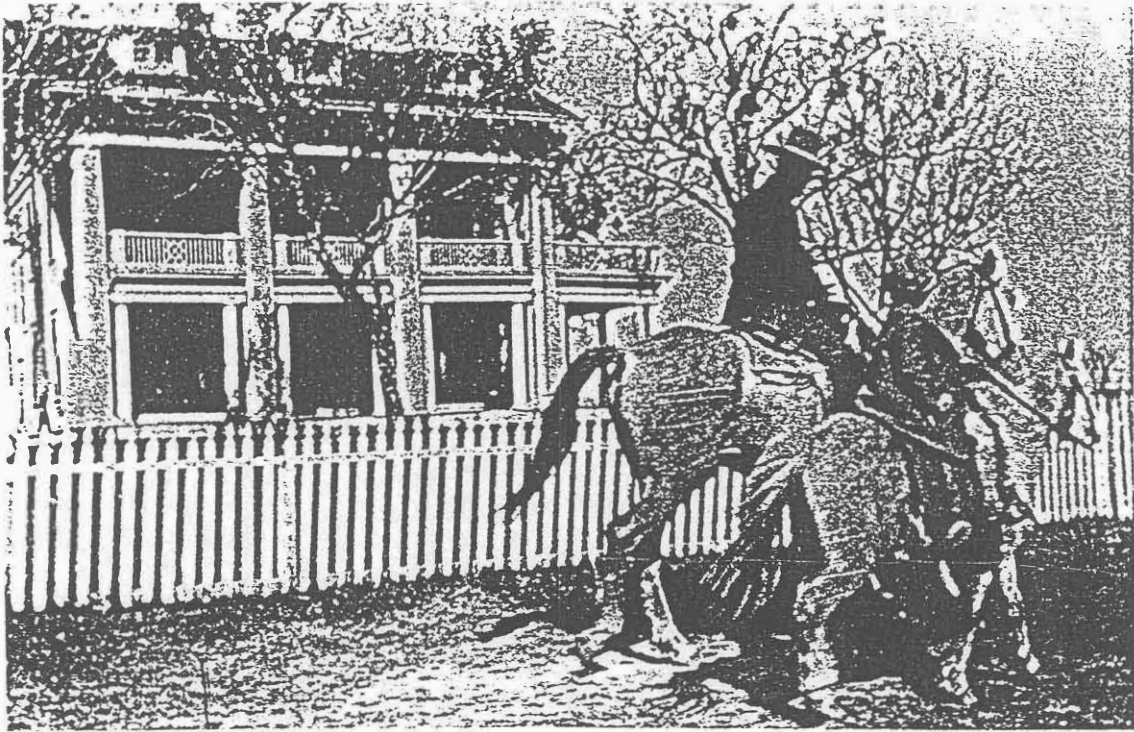
FIGURE 2. Two historic residences of Annie Lee and Robert Henry Seale. A, the two-story house built around 1910 and B, the earlier single-story house built in the late 1880's.

The Highway Design Division of the SDHPT requested that the Bryan District contact descendants of the original property owners to provide historic photographs and historical data. In February of 1988 descendants of the original owners were contacted by the author. The first to be contacted was Edward Burkhart, the husband of one of Robert H. Seale's daughters and keeper of the family history. Burkhart said that the historic house represented by the foundation remains was built in 1909 or 1910 - at a time when Robert H. Seale became a partner with Dr. Giesecke in the First Bank and Trust Co. in Bryan. Burkhart knows of no houses previous to the 1910 two-story structure on the property containing the foundation remains. Information provided by the Bryan District showed that this house was razed in the early 1970s. No early artifacts were found in the original on-site survey. A photograph of the two-story house is shown in Figure 2A.

An examination of the photograph of the earlier Seale house indicates--&bat it was built on brick piers and was of frame construction. Examination of the photograph of the later house indicates that it too was of frame construction, was two stories high, and had a brick chimney. It is not clear in the photograph what was used in the construction of the foundation. Both structures were quite substantial.

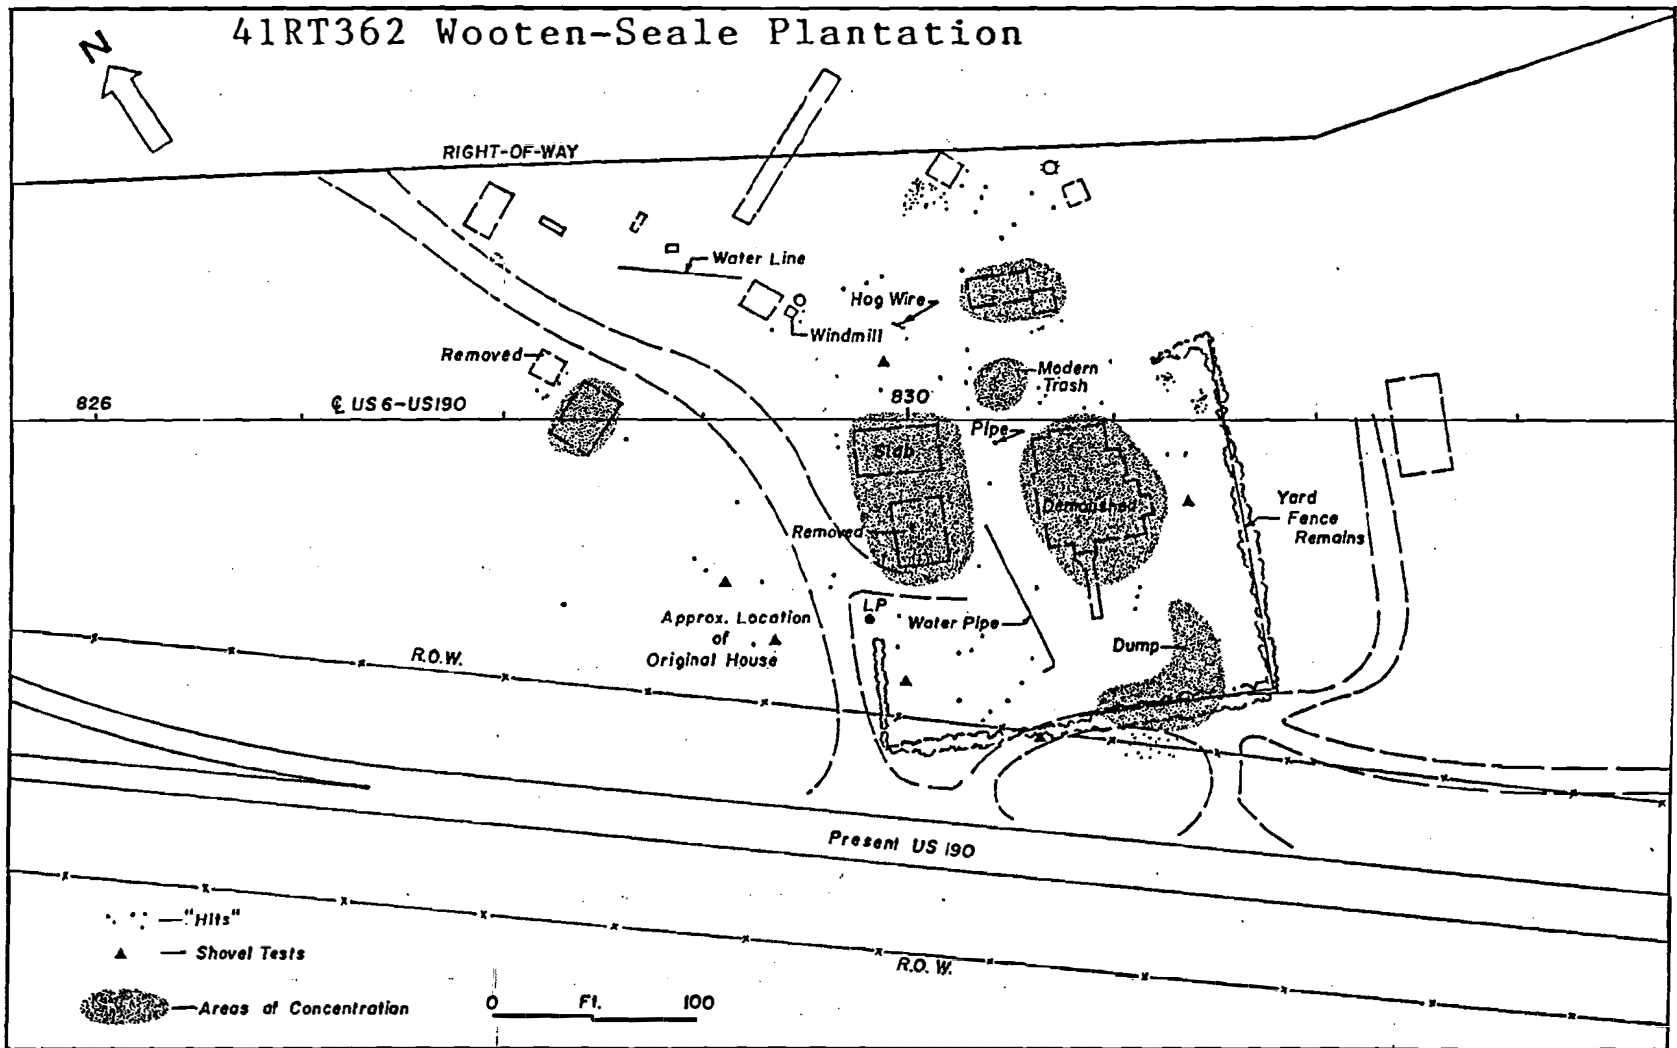
A site map including results of the metal detector survey is shown in Figure 3. Metal concentrations are found around the standing outbuildings and the foundation ruin of the two-story 1920s house. Another area of concentration was encountered in the southeast corner of the yard where piles of debris had been left by bulldozer activity (labeled dump in the figure). Few metal items were located in areas between structures and in the area thought to have been the location of the earlier house. The purported location of the earlier house was remarkably clear of metal and showed exposed sterile subsoil in most areas examined.

FIGURE 3. Site map of Site 41RT352, the Wooten-Seale Plantation.

Six shovel tests were made, each in an area where magnetic encounters were noted. Two were situated in the area reported by informants as the site of the earlier house. Four shovel tests were placed in areas around the later two-story house which were felt to be somewhat less disturbed by bulldozer activity. Two of these shovel tests were placed in the yard southwest of the later house, one was placed east of the house, and one was placed northwest of the house. In each of these units recovery was limited to a single wire nail. In each case, these single wire nails were responsible for the magnetic anomaly recorded by the metal detector. In addition, the southernmost test in the area of the earlier house produced a few very small brick fragments and a small amount of ash which perhaps represented the base of a pit. All tests showed shallow soil over basal clay. Soil had been removed from the first house locality so that clay was at the surface of the shovel tests in that area. The deepest soil encountered east of the second house was about 5 cm thick.
