## Archaeological Monitoring Of The Henry B. Gonzales Convention Center Expansion Project, San Antonio, Bexar County, Texas

**Prepared for:**

**PROJECT CONTROL OF TEXAS, INC.**  
San Antonio, TX 78232

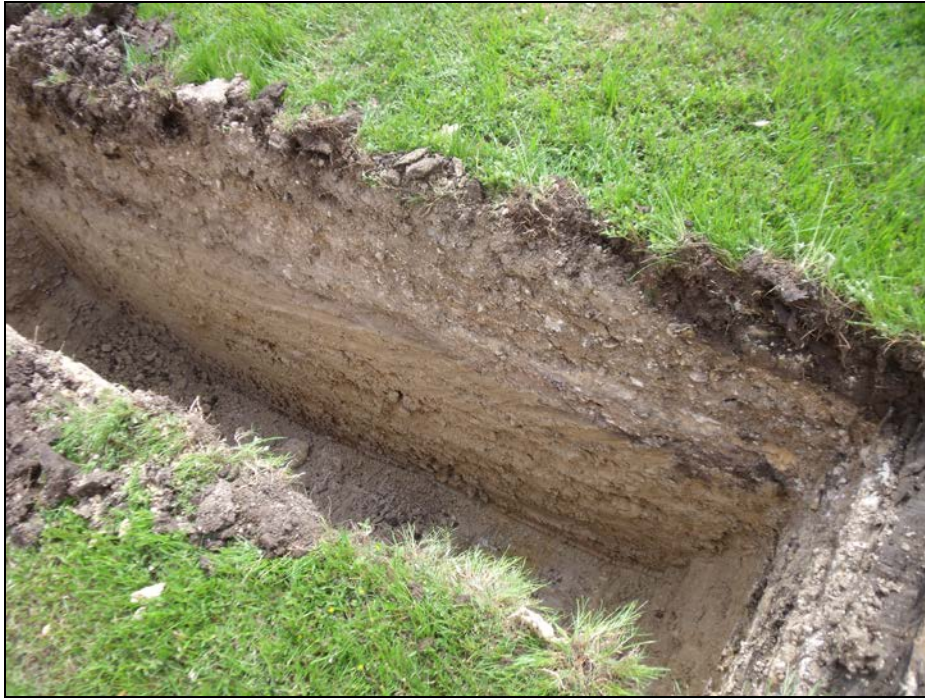
south to continue the trench excavation to the desired depth. Modern fill material covers the entire APE, (Figure 5-2). Below the fill is either sterile caliche or sterile dark gray clay (Figure 5-3)

Figure 5-2. Thick zone of fill on top of sterile caliche in BHT 4.

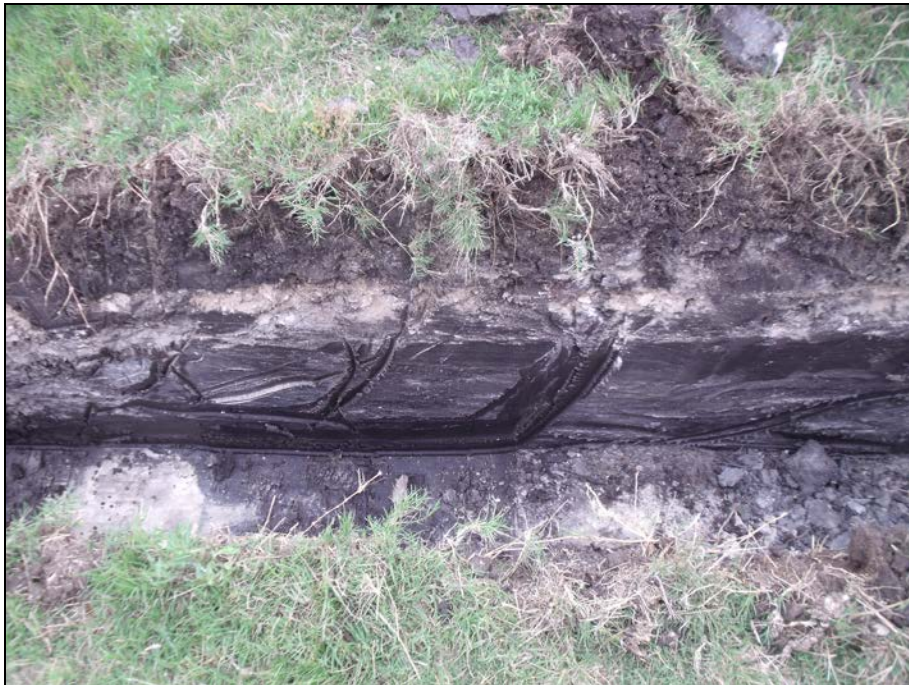
Figure 5-3. Modern top soil and road base on top of sterile dark gray clay, BHT 1.

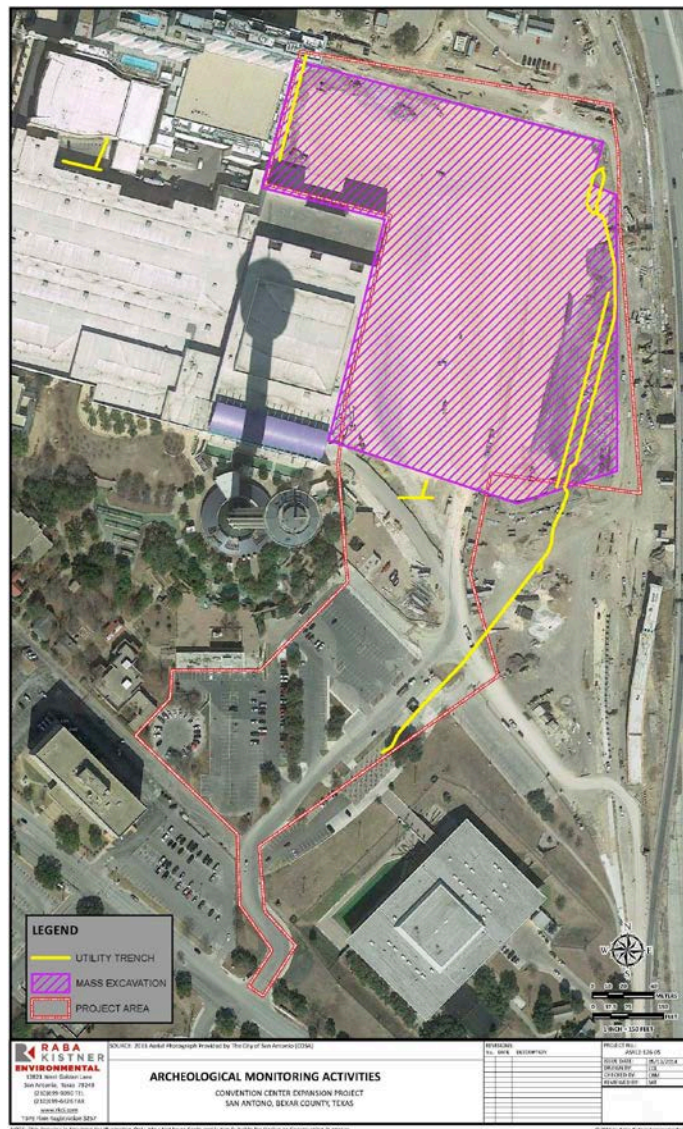
Before considering in detail the findings of the monitoring, below we summarize the types of construction activities and their sequencing. Construction activities associated with the expansion of the Henry B. Gonzales Convention Center can be grouped into four categories: demolition of selected existing modern amenities, pad site excavation, drilling of piers, and utility trenching. The general location of the principal impacts within the project area is shown in **Figure 6-1**.

Figure 6-1. Locations of principal construction impacts and archaeological monitoring.

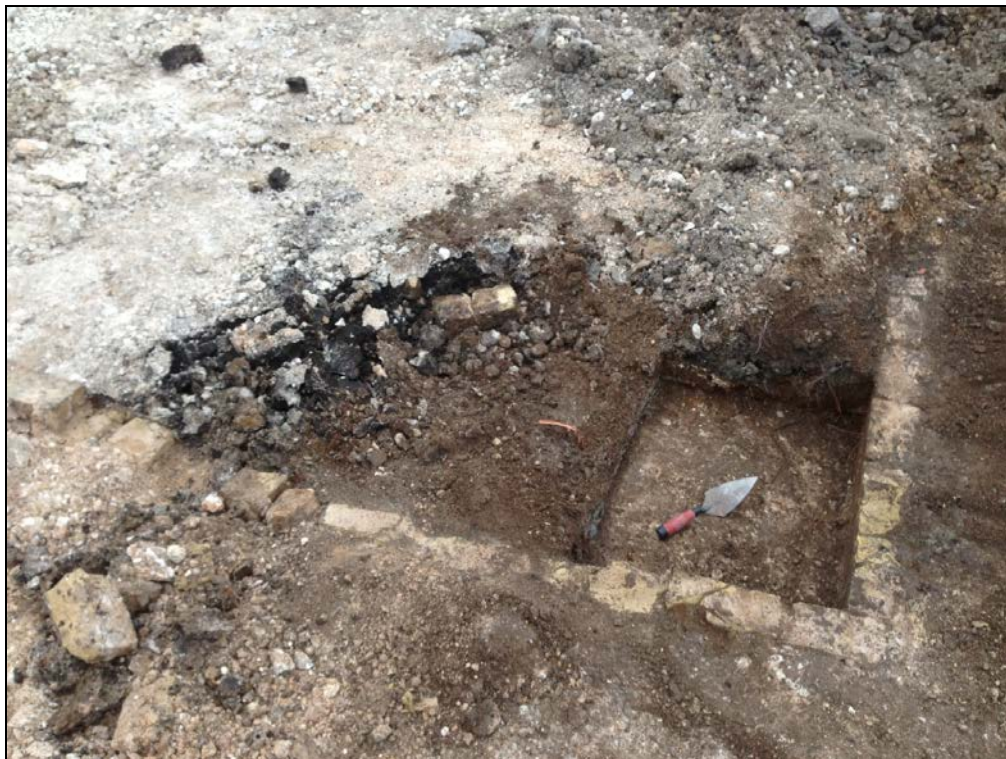
**Feature 1** was found on 12/7/2013. It is a yellow brick lined rectangular feature with burned refuse on the inside of the feature (**Figure 6-4**). The feature had already been cut down to grade or a little below when it was discovered. No more of the feature was exposed since the terminal grading depth had been reached. The entire area was covered by a minimum of five feet of fill.

Figure 6-4. Photograph of Feature 1, facing northwest.

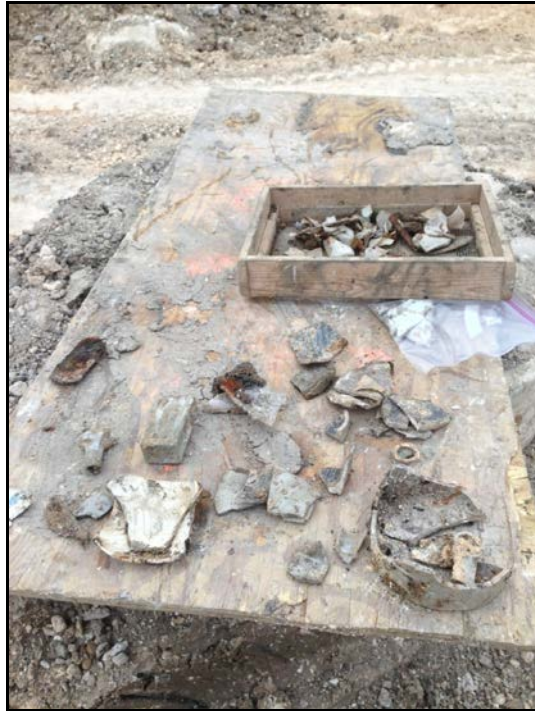
Figure 6-5. Artifacts found in Feature 1.

The feature was oriented NW/SE with two brick walls exposed. The northeast wall had 1.34 meters of exposed brick and the southwest wall had 1.98 meters of exposed brick. Both walls consisted of three-courses of bricks while the southwest wall was at least five-courses tall before the feature was exposed. The top two or more tiers of bricks were removed during excavation activities. The bricks were yellow but retained no maker's marks. Each brick measured 21x10x6 cm (Length x Width x Height). The top of the brick was approximately 1.2 meters below pre-excavation/original starting surface level. At the base of the feature was a white caliche floor or layer covered by a 20 cm-thick lens of burned material and a mixture of ash and charcoal. A 70x50 cm (Length x Width) excavation unit was positioned in the corner of the feature and excavated to a depth of 20 cmbs. All soil was screened and the artifacts recovered are listed in **Table 6-1** and a sample is shown in **Figures 6-5 and 6-6**.

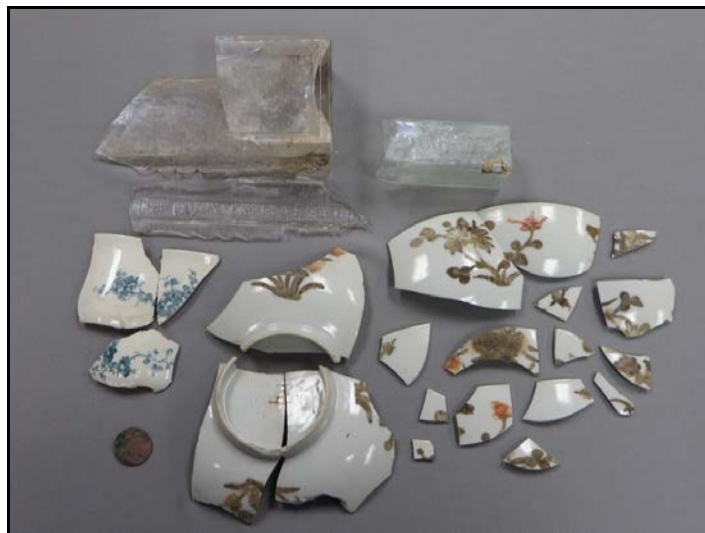
Figure 6-6. Diagnostic artifacts collected from Feature 1.

- broken cork stopper bottles from 1880's to 1900's
  - McLean's Volcanic Liniment Oil
  - The Dunkley Celery Co.
- 1899 "V" Nickel
- 26 Porcelain Chinese Imari fragments
- 3 White Earthenware transfer pattern fragments

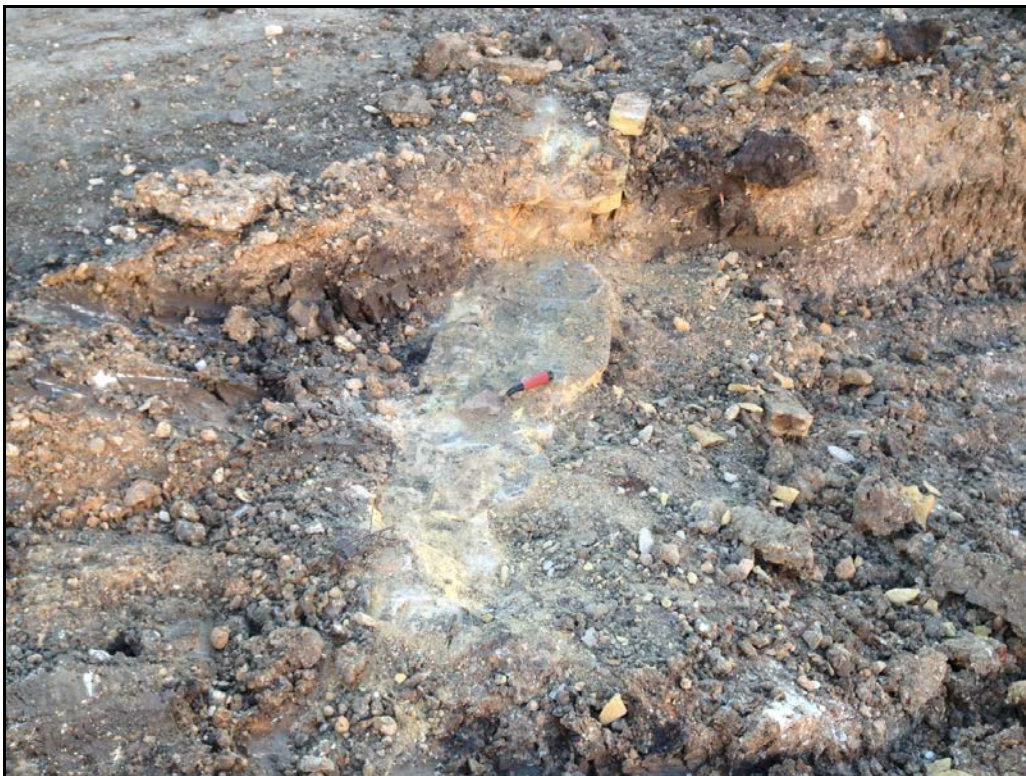
**Feature 7** was found on 12/10/13 and is continuous footing/foundation constructed of yellow bricks laid on a concrete foundation (**Figure 6-7**). The feature is 4-bricks-wide and the bricks are mortared together. At the time of discovery, the feature was 204 cm long, 45 cm wide, and 5-bricks tall. It was oriented at 130 degrees. The feature continued into the unexcavated overburden.

Figure 6-7. Photograph of Feature 7, facing east.

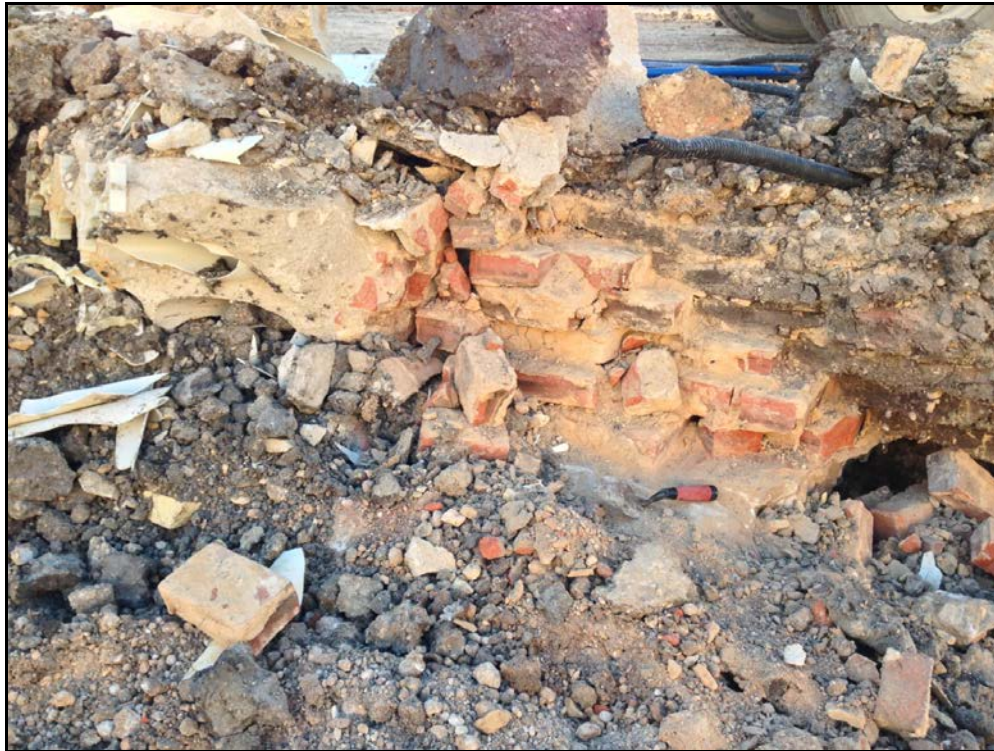
the top. The feature consists of 6-courses of mortared bricks. At the time of discovery, the feature extended into the trench wall. A portion of the feature was bisected by a modern utility duct of nine 4-inch PVC conduits suspended in a concrete/flow able fill mix. The second cut into the feature (15 foot cuts) did not expose any remnants of the brick feature suggesting that the brick alignment represented as short footing or foundation.

Figure 6-8. Photograph of Figure 8, facing east.

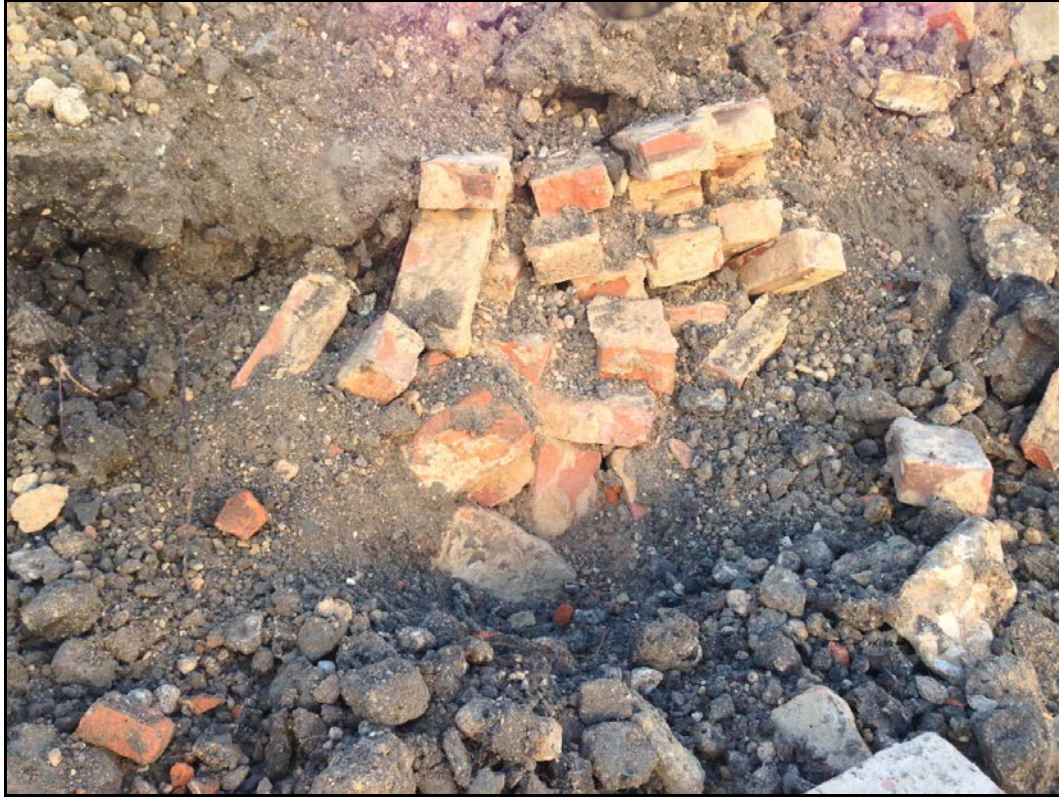
**Feature 9** was found on 12/10/13 and is a continuous footing/foundation constructed of dry-stacked red bricks (**Figure 6-9**). No concrete foundation was apparent at the time of the monitoring. The feature consisted of nine courses of bricks and was 4-bricks wide. The feature continued into the trench wall and none of the bricks had maker's marks.

Figure 6-9. Photograph of Feature 9, facing east.

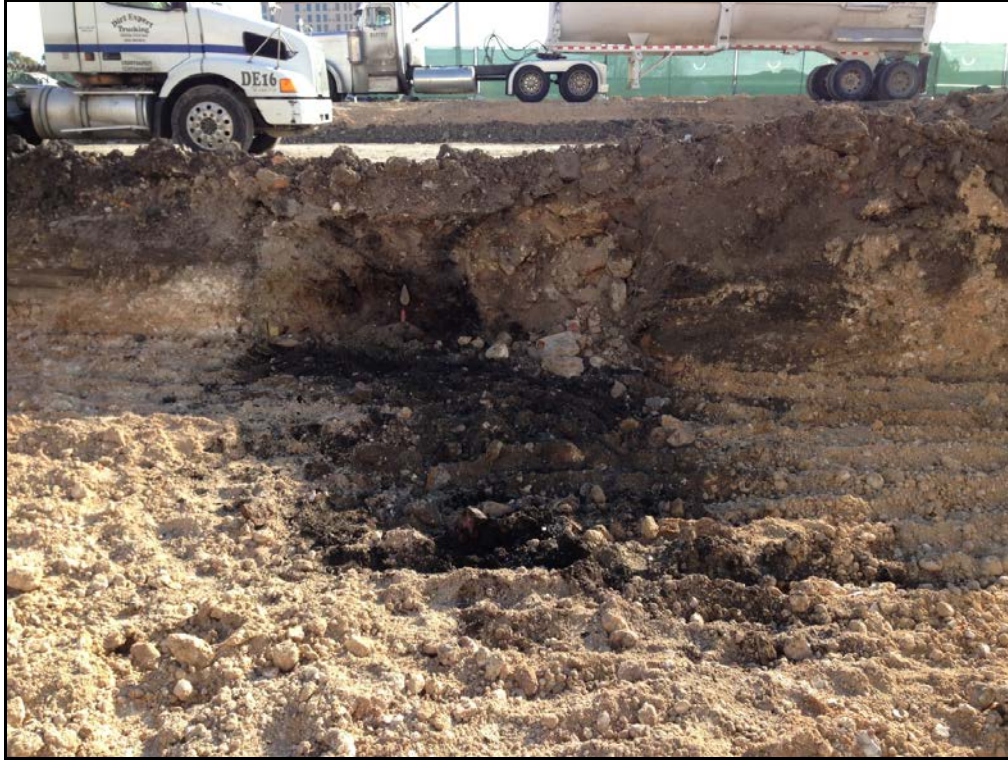
**Feature 10** was found on 12/10/13 and was a trench filled with burned construction materials (**Figure 6-10**). The feature was approximately 3 meters long, 27 cm wide and 90 cm deep. Dimensions are based on soil staining on floor of excavation and cut wall. The feature contained lumber, brick, and glass fragments. All contents were burnt. No diagnostic items or complete artifacts were identified. The feature was oriented 110 degrees. At the time of discovery, it appeared that there was a jumble of red bricks up against the burned feature (south side) and they were part of the jumbled burned feature. Further trenching indicated that the burned feature continued and the jumbled bricks were part of a continuous footing/foundation. Total length of feature was approximately 6 meters.

Figure 6-10. Feature 10, facing east.

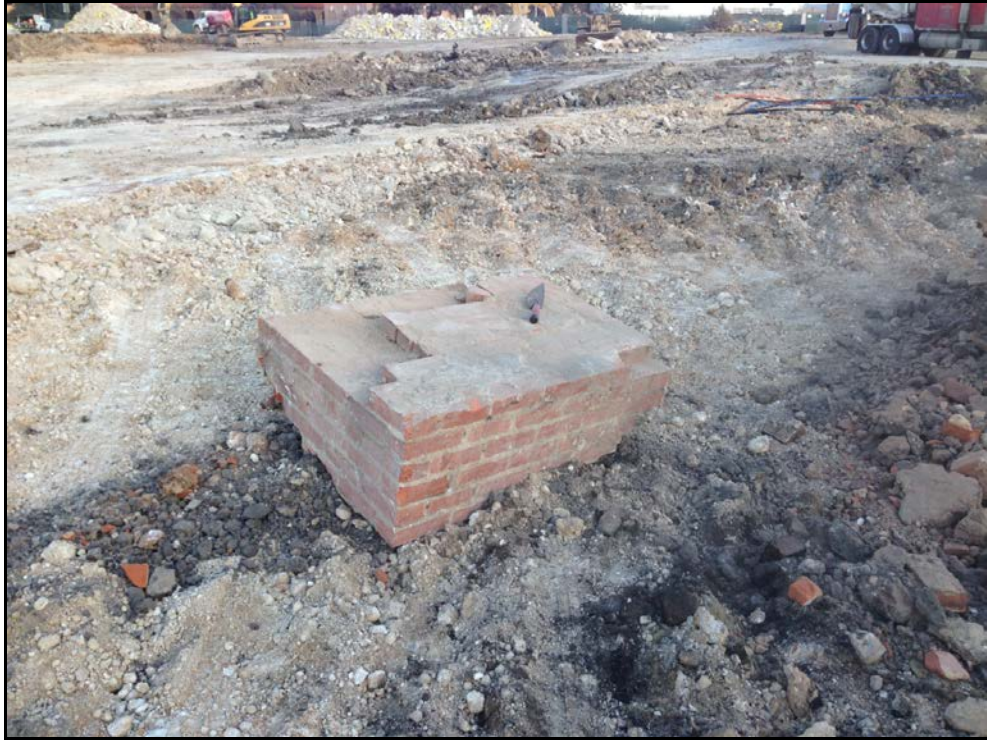
**Feature 12** was found on 12/11/13 and represented the remains of a red brick column or corner (**Figure 6-11**). It was found between Feature 9 and 10 and was made up of “ALAMO” bricks. The feature was 113 cm by 86 cm by 48 cm tall and it was on a 22 cm-thick slab of concrete.

Figure 6-11. Feature 12, facing north.

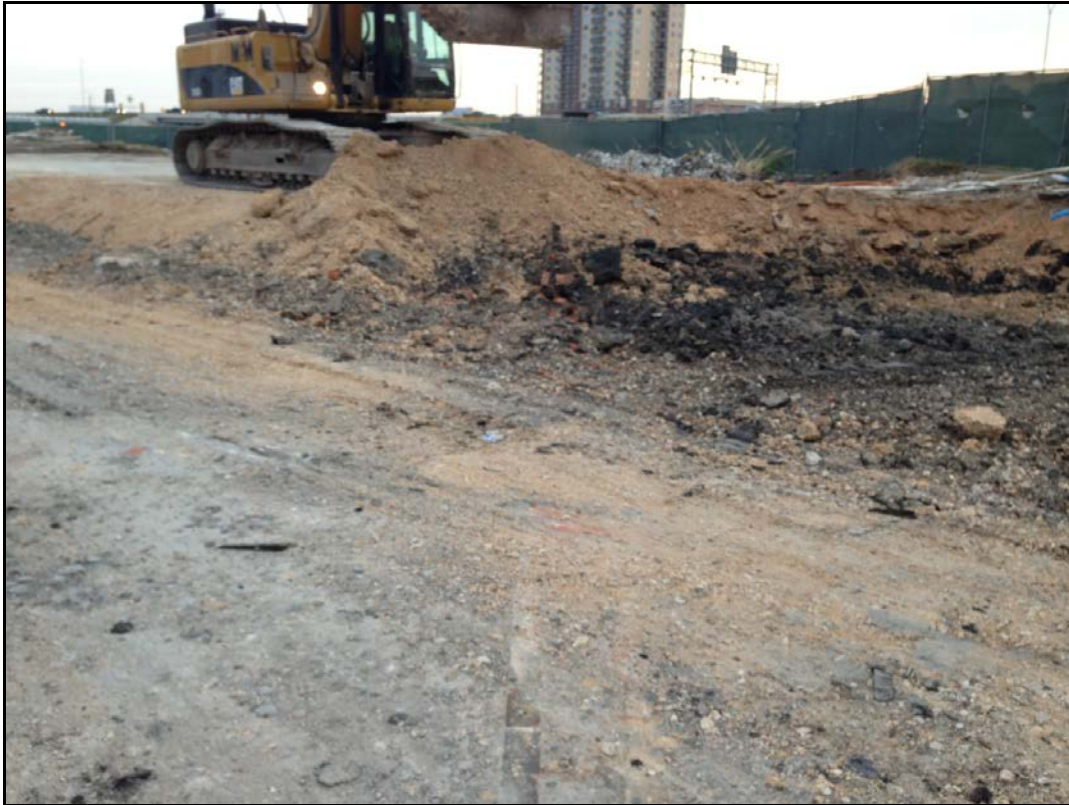
**Feature 15** was found on 12/12/2013 and was the eastern corner of a continuous footing/foundation with the two foundation walls at a right angle from the corner (**Figure 6-12**). One foundation wall was oriented 130 degrees and the feature was approximately 22 meters in length. The other foundation was oriented approximately 70 degrees and was approximately 10 meters in length.

Figure 6-12. Feature 15, facing northeast.

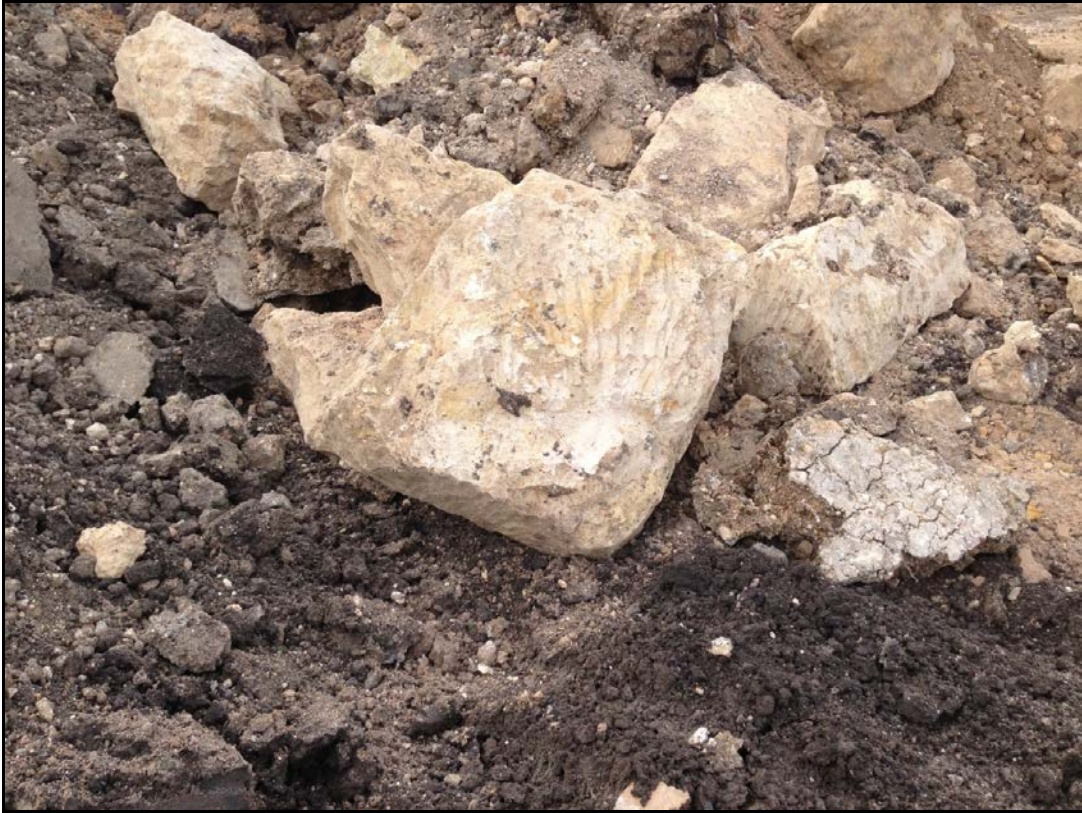
**Feature 16** was found on 12-12-2013 and was a hand-quarried limestone continuous footing/foundation (**Figure 6-13**). The feature was approximately 80 cm tall, 70 cm wide and 3 meters long. The foundation had three tiers of limestone and it was oriented 220 degrees. The east end was removed during previous water and electrical utilities installations. The limestone blocks averaged 70x60x20 cm.

Figure 6-13. Feature 16, facing west. Note chisel marks in stone.

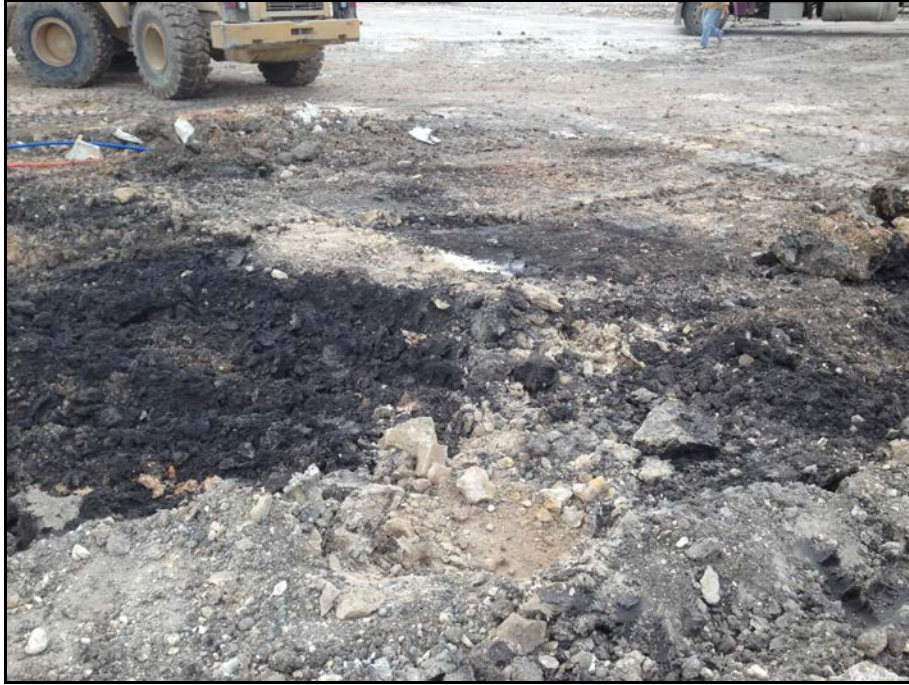
**Feature 17** was found on 12/12/2013 and was a corner wall or footing made of limestone blocks. The two foundation walls formed an approximate 45 degree angle (**Figure 6-14**). One foundation wall was oriented 220 degrees and the other was oriented at 270 degrees. The footings were 70 cm wide. The excavator had removed the top row of blocks before more data or photos could be gathered on the footing remnant. The bottom blocks were left in place since they were at grade.

Figure 6-14. Feature 17, facing northwest.

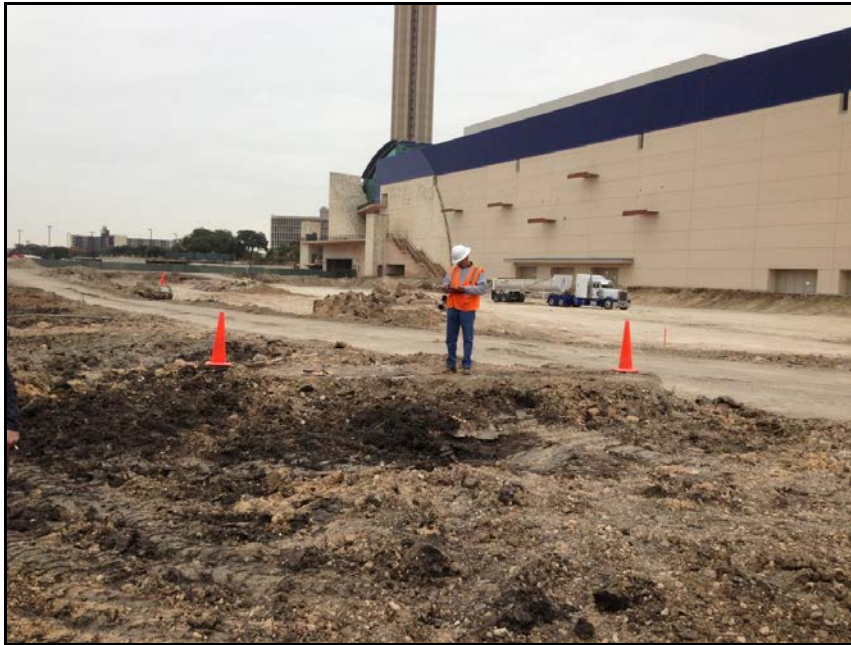
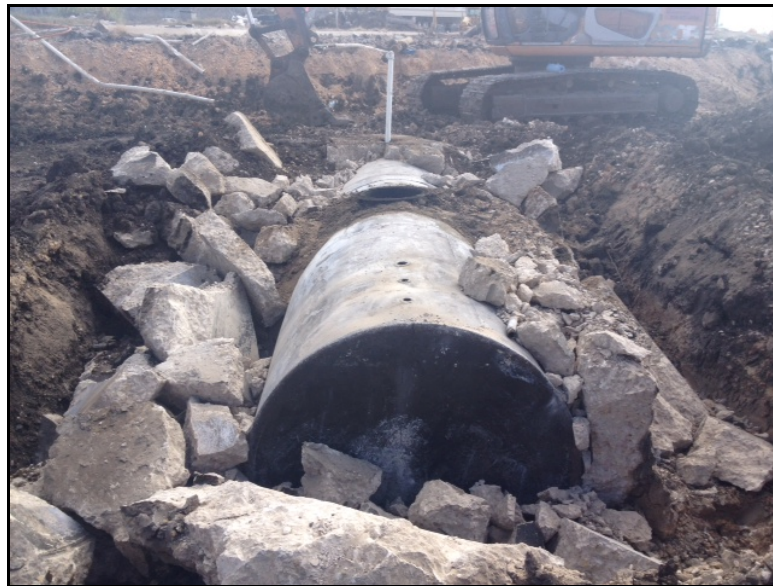
2-inch delivery port at other end, and was completely filled with water with a residual oily sheen prior to cleaning and removal activities.

Figure 6-15. Feature 20, facing southwest. Orange cones mark ends of feature.

Figure 6-16. Feature 20, after excavation, facing east.

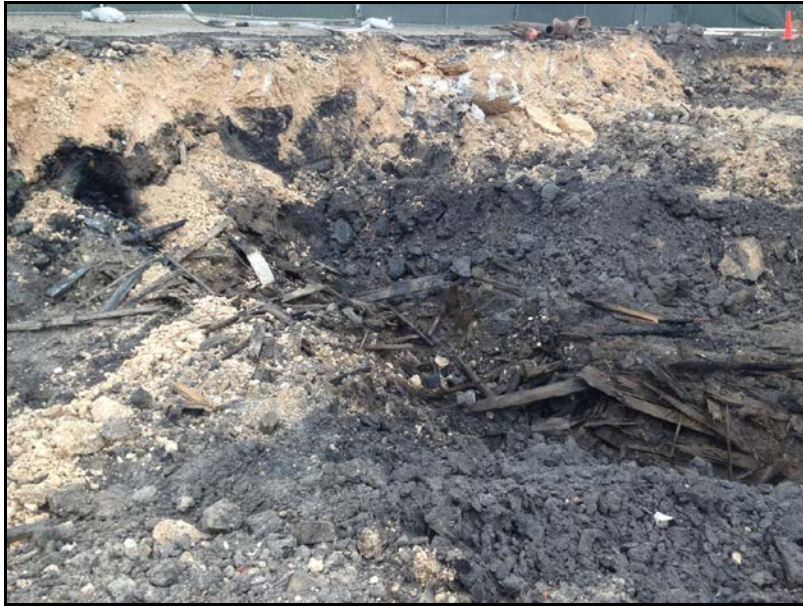
such as bottles or other personal items, were found in the feature. Some of the lumber was tongue and groove floor boards. The feature was oriented at 240 degrees.

Figure 6-17. Feature 34, facing southeast.

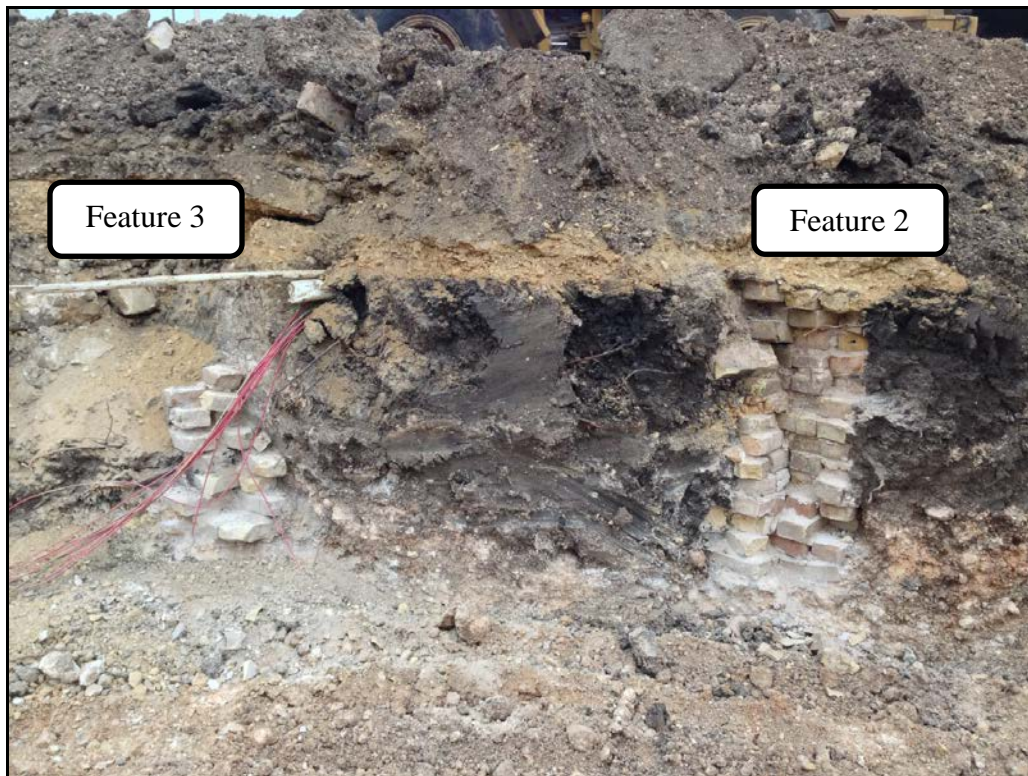
Two modern concrete poured piers with rebar were also encountered just west of Features 2 and 3.

Figure 6-19. Features 2 and 3, facing east.

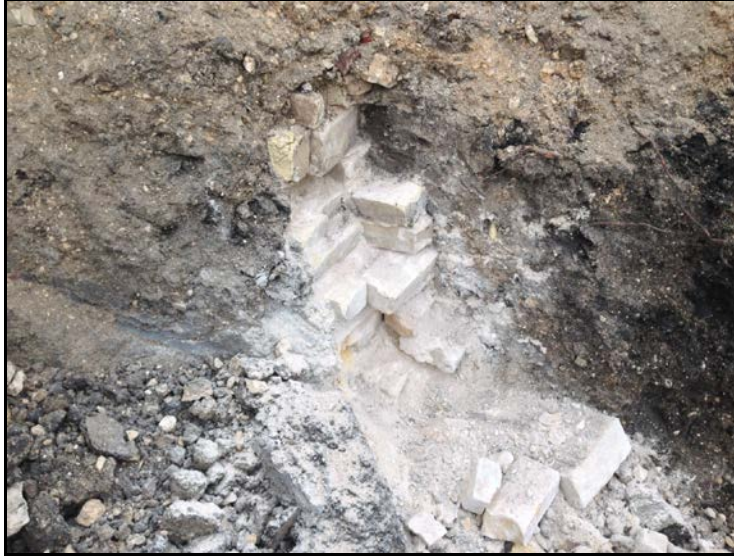
The pier was 3-bricks-wide and 10-bricks-tall. The bricks measure 20x10x6 cm and were held together with mortar. It was approximately 7 meters east of Feature 3.

Figure 6-20. Feature 5, facing northeast.

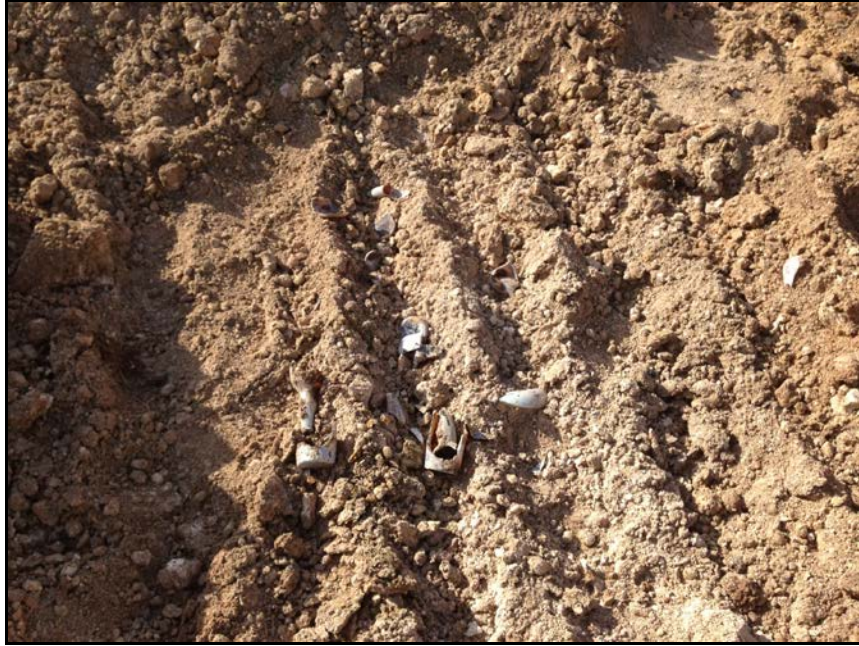
**Feature 14** was found on 12/11/13 and was a small trash pit containing a cluster of artifacts (**Figure 6-22**). There was no soil discoloration within the area. Artifacts encountered included one partial wine glass, a few butchered animal bones, 2 unmarked prescription bottles, 1 marked prescription bottle, and multiple brown wine bottle fragments with three different maker's marks.

Figure 6-22. Feature 14, facing southeast.

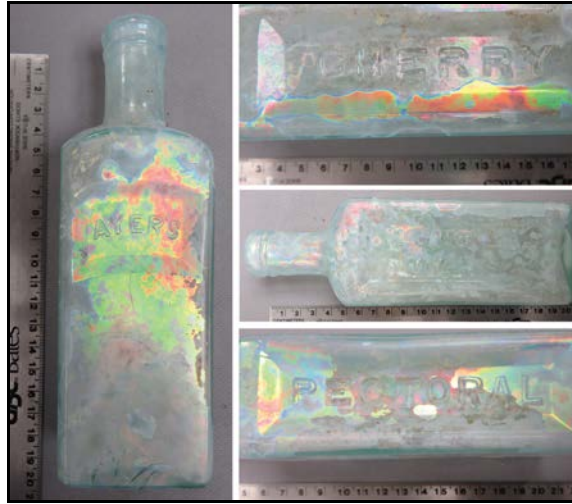
Figure 6-23. Four faces of bottle collected from Feature 14.

Only artifact collected from Feature 14 was an "Ayer's Cherry Pectoral", "Lowell, Mass" prescription bottle that was manufactured between the 1840's and 1870's (**Figure 6-23**).

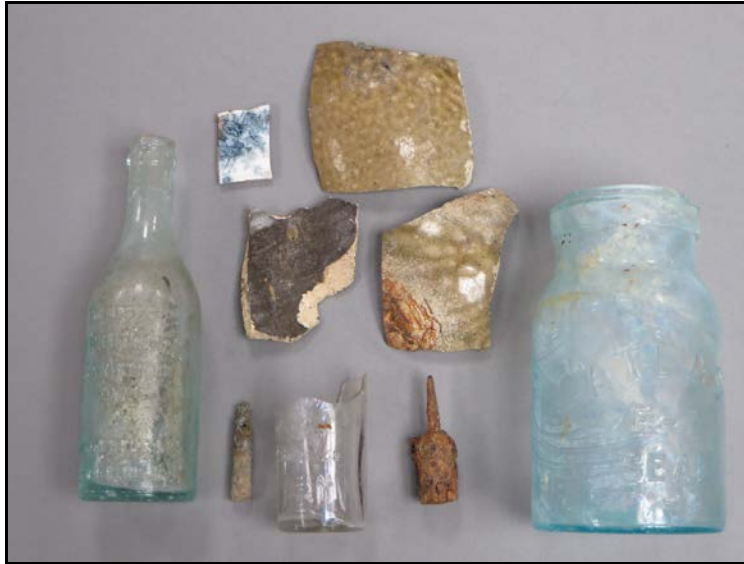
Figure 6-25. Diagnostic artifacts collected from Feature 6.

Upon arrival to the site, the monitor was directed to the location where the excavated soils had been piled adjacent to the trash pit. The artifacts were found in the piled soils adjacent to the excavation. The materials observed and counted are listed in **Table 6-3** and a sample of the materials is shown in **Figure 6-25**).

- "G.A. Duerler MFG. Co." bottle dating to the late-19th to early-20th century
- "Atlas E-Z Seal" Mason Jar dating to the late 19th century.
- "Olive Growers Assn Los Angeles, CA" bottle base fragment.
- Rifle bullet casing
- Unidentified metal finial or spike.
- three stoneware fragments with an unusual light green outer glaze.
- White Earthenware transferware fragment

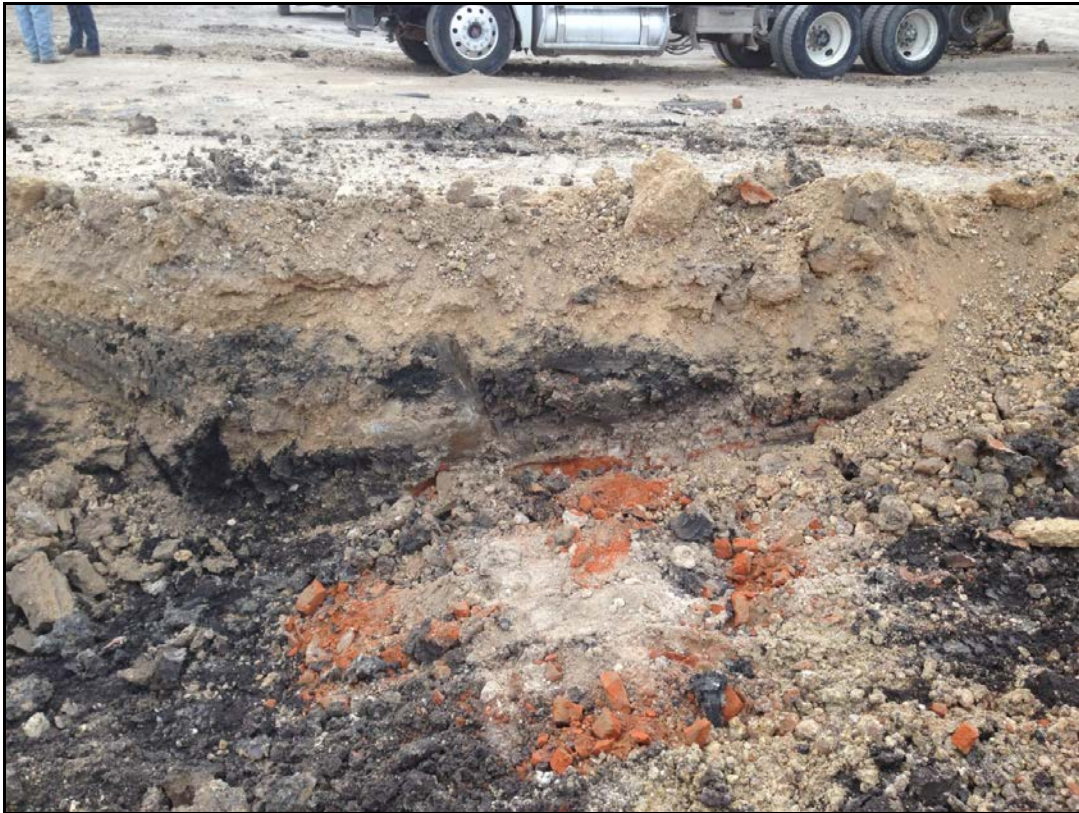
**Feature 19** was found on 12/12/2013 and it was a continuous footing/foundation constructed of red brick laid on a limestone foundation (**Figure 6-27**). The southern end of the structure was destroyed by the installation of the chill water lines. Remains of the feature were approximately 2-meters-long.

Figure 6-27. Feature 19, facing south.

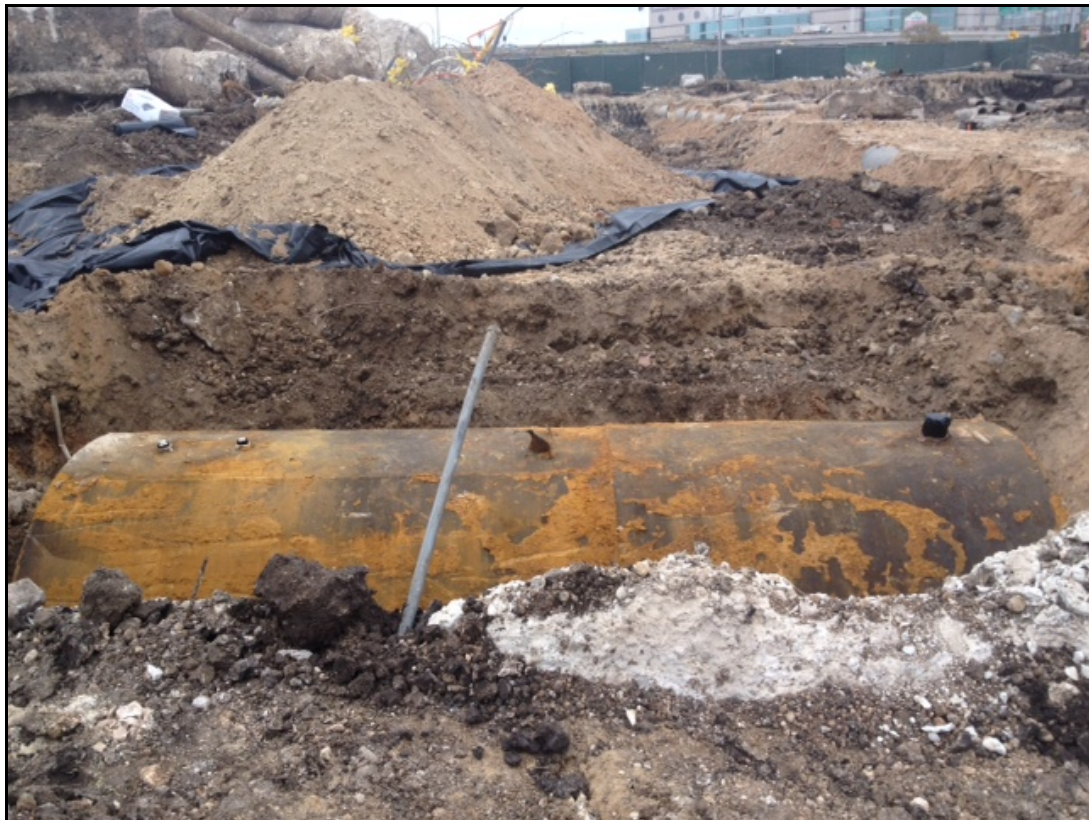
exploratory trenching conducted by H-Z in the immediately surrounding area did not reveal the presence of additional USTs or any underground product piping associated with UST-2. It is possible that other tanks associated with the former filling station, if existing, were removed in conjunction with a previous phase (or phases) of SITE development (i.e., installation of roads, utility trenches, etc.). As further discussed in the following section, upon exposure the steel UST was observed to be completely empty of fluids but contained approximately 3 inches of residual sediment. UST-2 measured 14 feet in length and 7 feet in diameter, with a calculated capacity of 4,030 gallons, situated within a 11-foot x 18-foot tank hold backfilled with dry, fine-grained orange sand.

Figure 6-28. Feature 21 in 41BX2027, facing east.

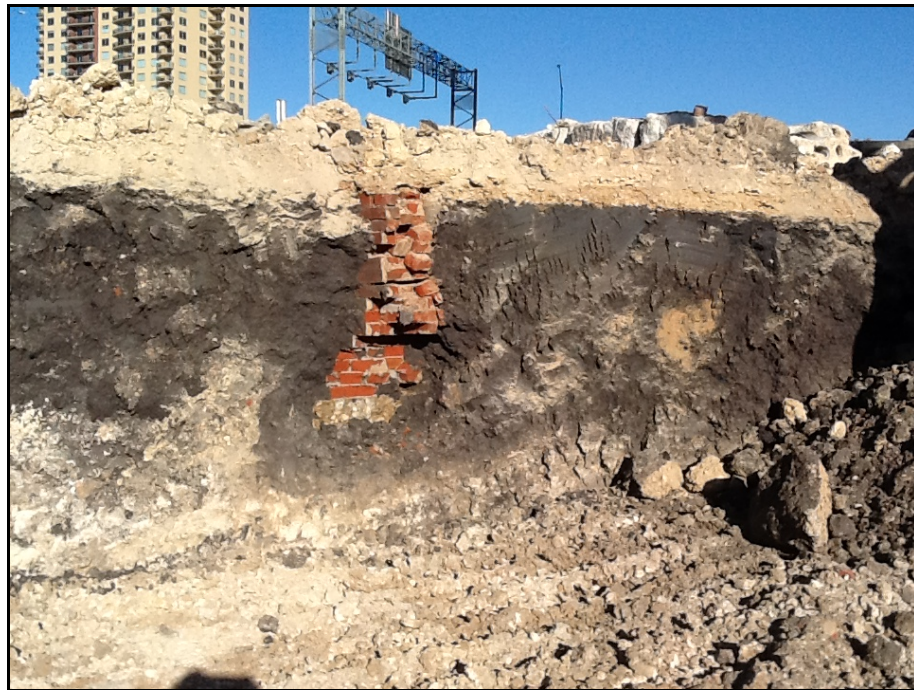
Extending northward from the northwest corner, the foundation made a 90 degree turn towards the east. The north-bound wall was 2.5-meters long and the east-bound wall was 4-meters long.

Figure 6-30. "L"-shaped brick footing of Feature 22, facing northeast.

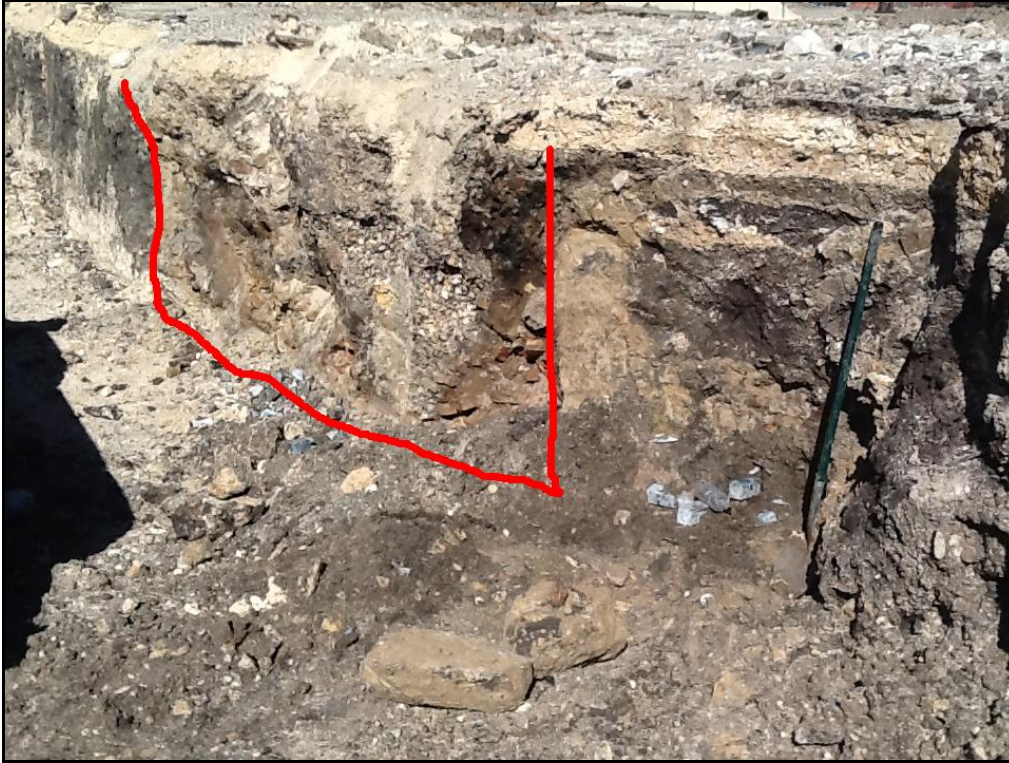
**Feature 24** was found on 1/14/2014 and was a trash pit containing burned construction materials (**Figure 6-31**). East of Feature 22, and exposed in the same cut bank, was a mixed deposit of burned lumber, metal, white porcelain light bulb socket (2 seen), a metal round door knob with skeleton key lock, and Blumberg bricks. Only construction-related items were noticed in the feature. The feature was 4 meters wide (N/S) and 6 meters long (E/W). No artifacts were collected.

Figure 6-31. Feature 24, outlined in red, facing northwest. Feature 25 to the right.

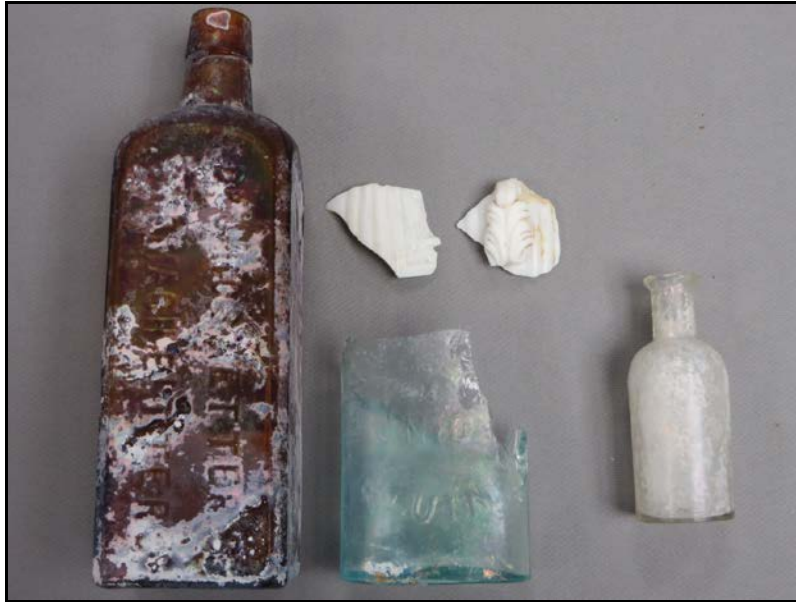
Figure 6-32. Diagnostic artifacts collected from Feature 25.

At the base of the footing, as seen in **Figure 6-31**, there was a cache of “Dr. J. Hostetter’s Stomach Bitters” bottles. Sixteen complete, or nearly complete, bottles and 19 bottle bases were uncovered. The artifacts encountered are listed in **Table 6-4** and a sample is shown in **Figure 6-32**.

- 1 “Dr. J. Hostetter’s Stomach Bitters” Bottle
- “Union Bluing” Bottle fragment
- Clear cork stop bottle
- 2 decorated milk glass fragments.

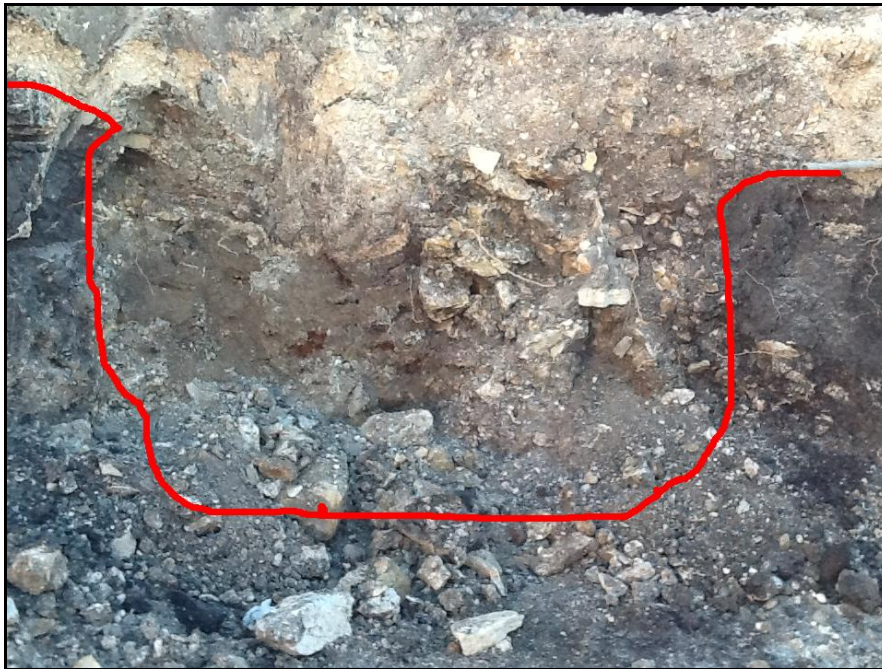
**Feature 23** was found on 1/13/2014, and was a trash pit situated immediately next to a kitchen at the site (**Figure 6-34**). Broken bottles, 1 button, and a few complete bottles were encountered. No artifacts were found within the portion of the feature still in the wall of the cut. All artifacts were encountered in the loose soils at the base of the cut. The feature measured 183 cm in height and 198cm in width.

Figure 6-34. Feature 23, outlined in red, facing east

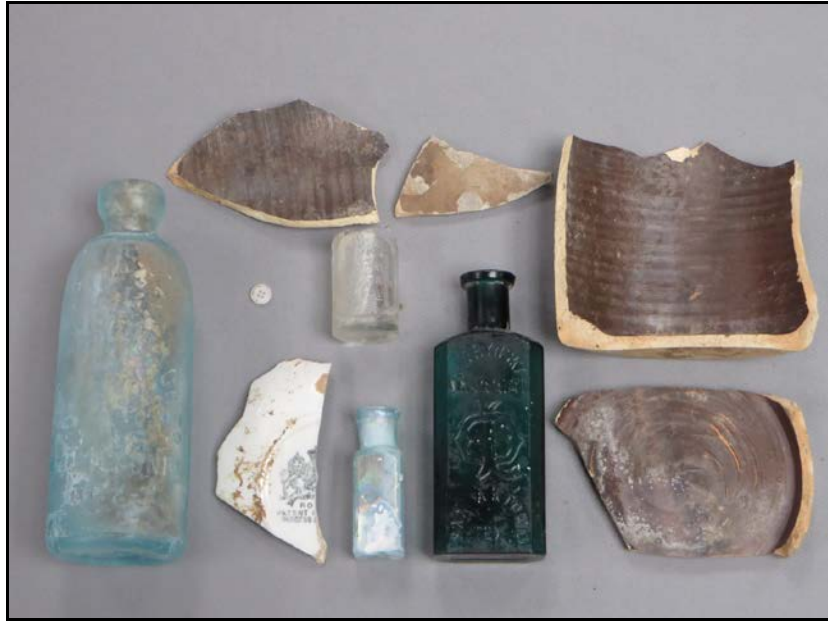
Figure 6-35. Diagnostic artifacts collected from Feature 23.

A list of the artifacts encountered is provided in **Table 6-5** and a sample is shown in **Figure 6-35**.

- "OCHS & ASCHBACHER", "San Antonio TEX", Hutchinson bottle
- "L. Orynski Druggist", "San Antonio TEX", Prescription bottle
- 7cm tall unmarked prescription bottle
- "Hoyt's German Cologne E.W. Hoyt & CO", "Lowell Mass" bottle base fragment
- Porcelain glass 4-hole button
- White Earthenware fragment with "Ro", "Patent", and "Burgess" partial transferware type makers mark with a lion
- Stoneware fragments that refit

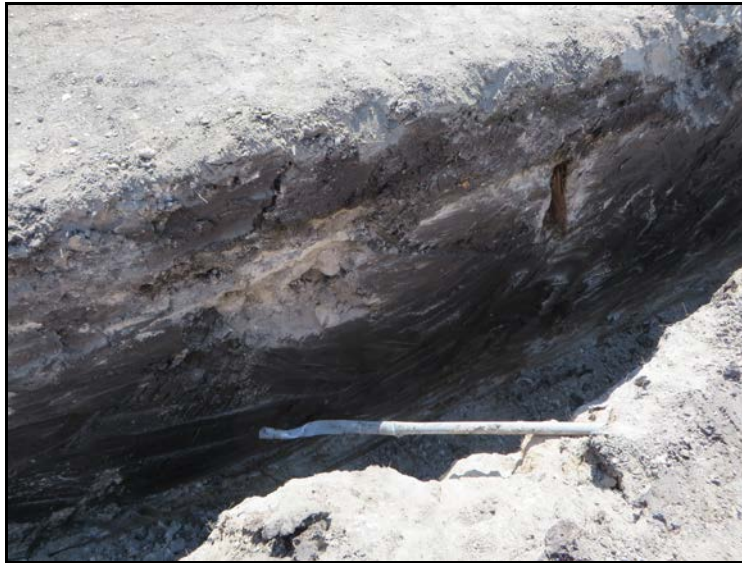
Figure 6-38. Photograph of Feature 35, facing east.

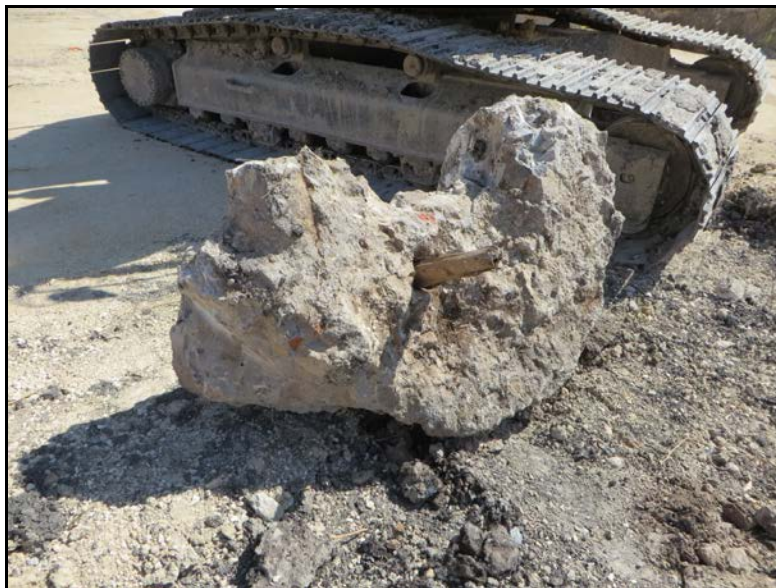
Figure 6-39. Concrete slab found at Feature 35.
