## Archaeological Monitoring Of The Henry B. Gonzales Convention Center Expansion Project, San Antonio, Bexar County, Texas

**Prepared for:**

**PROJECT CONTROL OF TEXAS, INC.**  
San Antonio, TX 78232

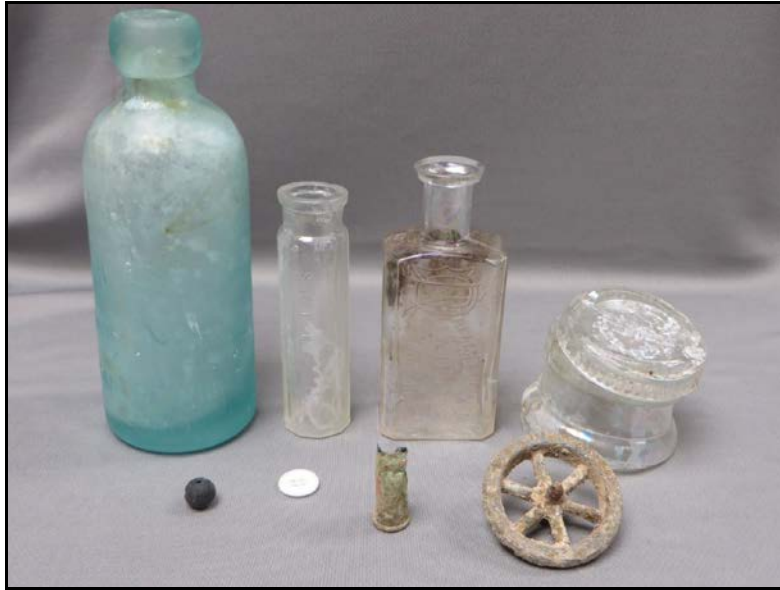
Figure 6-41. Diagnostic artifacts collected from Feature 27.

**Feature 27 (Figure 6-40)** was found on 1/22/2014 and represents a small trash pit (not shown). The feature was mostly removed during the mechanical excavation. The base of the feature was buried approximately 155cmbs. The feature measured 77cm (N/S) by 70cm (E/W) and only a 7-15 cm thick lens of debris remained in the bottom of the trench, when excavation was halted. The feature consisted of fine grey ash with some charcoal, broken glass, and three bottles. The artifacts encountered are listed on **Table 6-6** and a sample is shown in **Figure 6-41**.

- "W.R.A co, 40-70 SS", Winchester Repeating Arms, Co. 40-70 Sharps Rifle Round made in the late 1880's to early 1900's.
- "Wm. Esser Trade Mark San Antonio TX" Hutchinson style bottle
- "Santal de Midy Paris", late 19th century syphilis cure all imported from Midy Pharmacy in Paris France.
- jar neck w/glass lid, on lid is "Columbia patented DEC 29th 1896"
- "Alamo Drug Store A. Dreiss San Antonio TX" Pharmacy bottle
- Metal wheel or flywheel that has a gear on one side. Possibly a toy wheel.
- Porcelain 4 hole button
- A possible black glass bead or a possible head to a hat pin

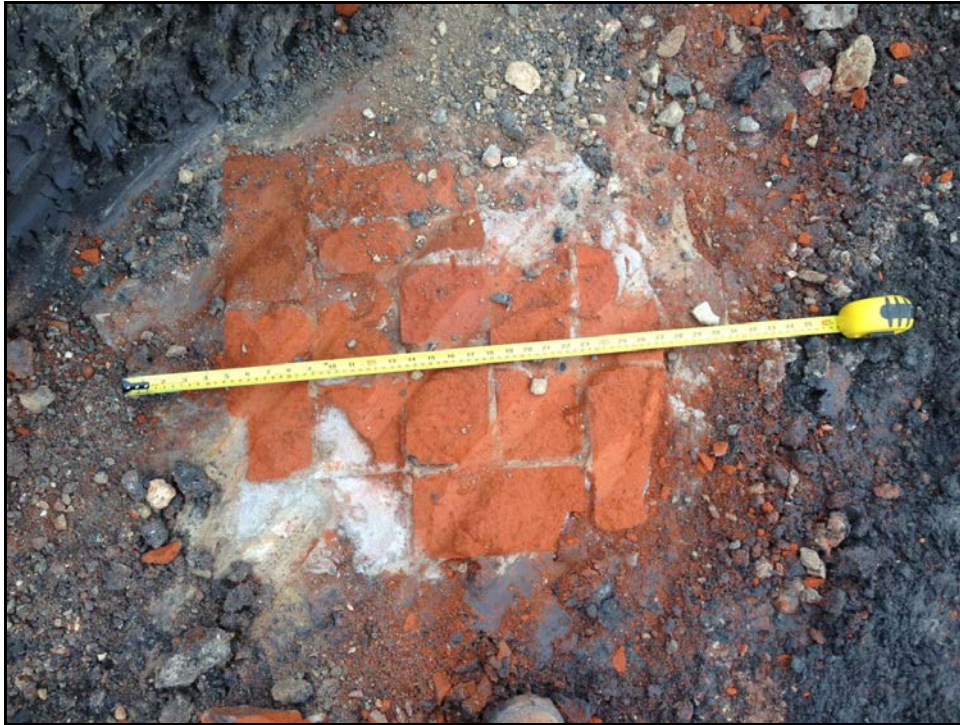
Figure 6-43. Feature 28, facing west.

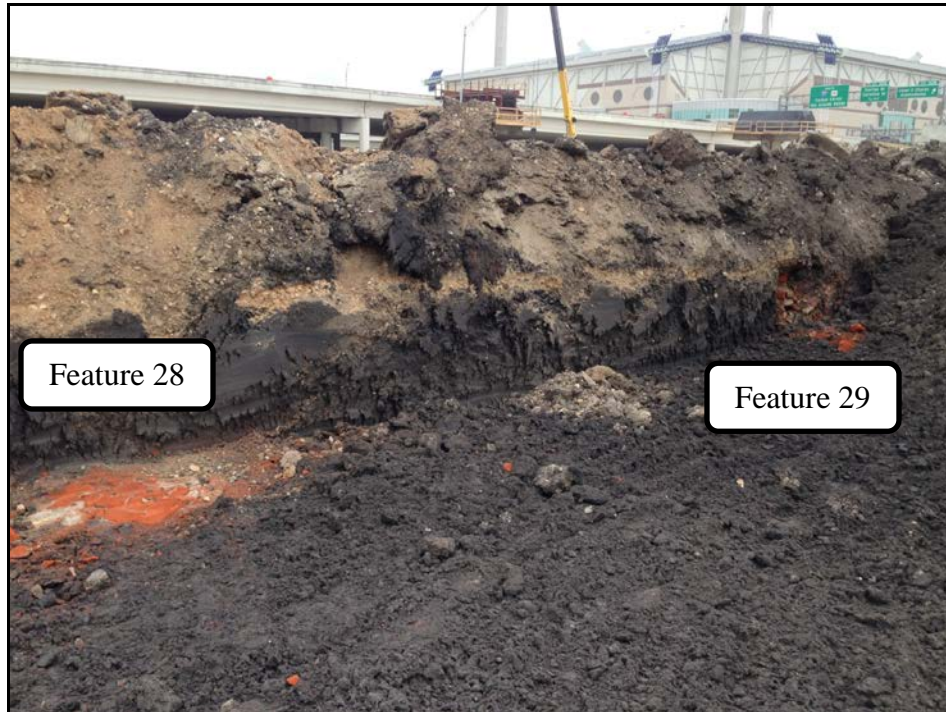
Figure 6-44. Features 28 in 29, facing southeast.

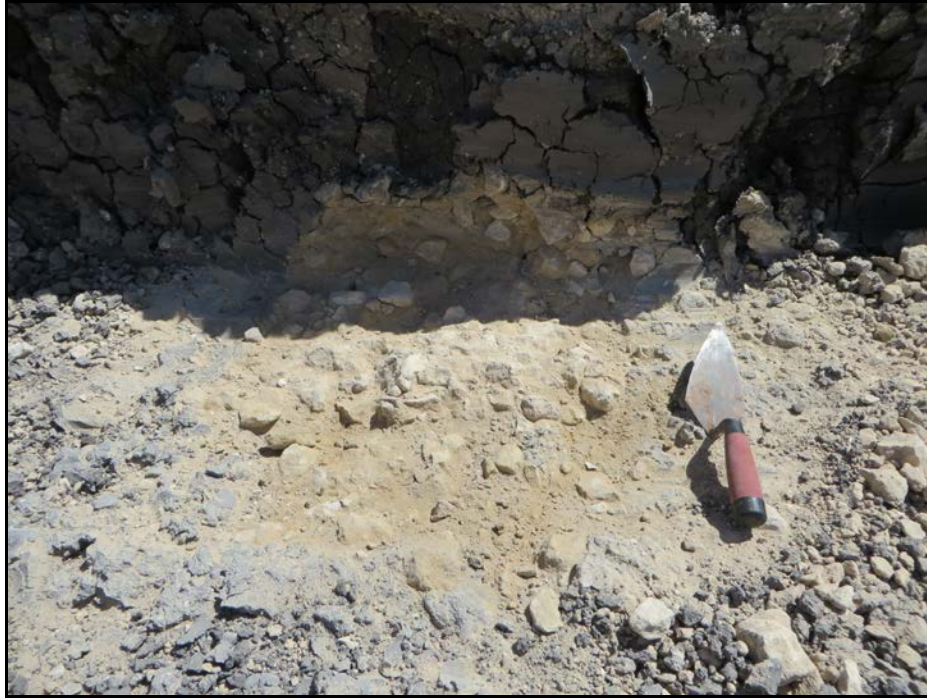
Figure 6-45. South profile of Feature 32, facing south.

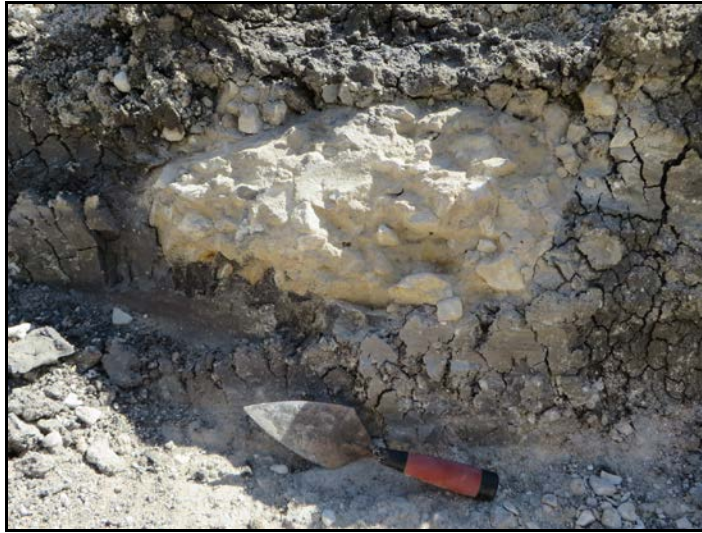
Figure 6-46. South profile of Feature 33, facing north.

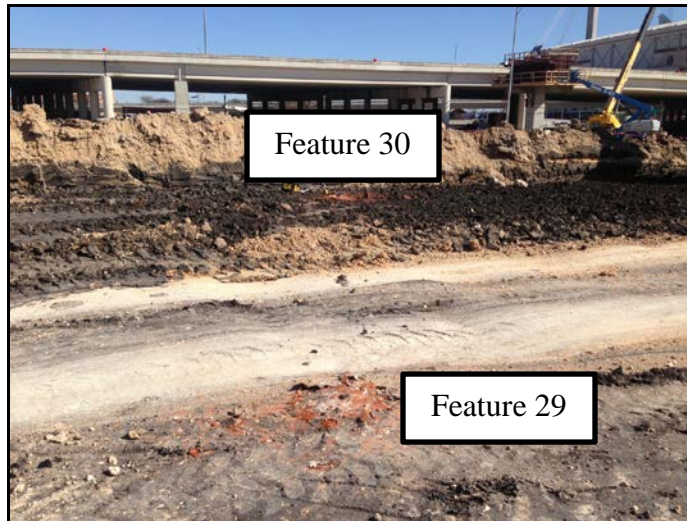
Figure 6-48. Features 29 and 30, facing east.

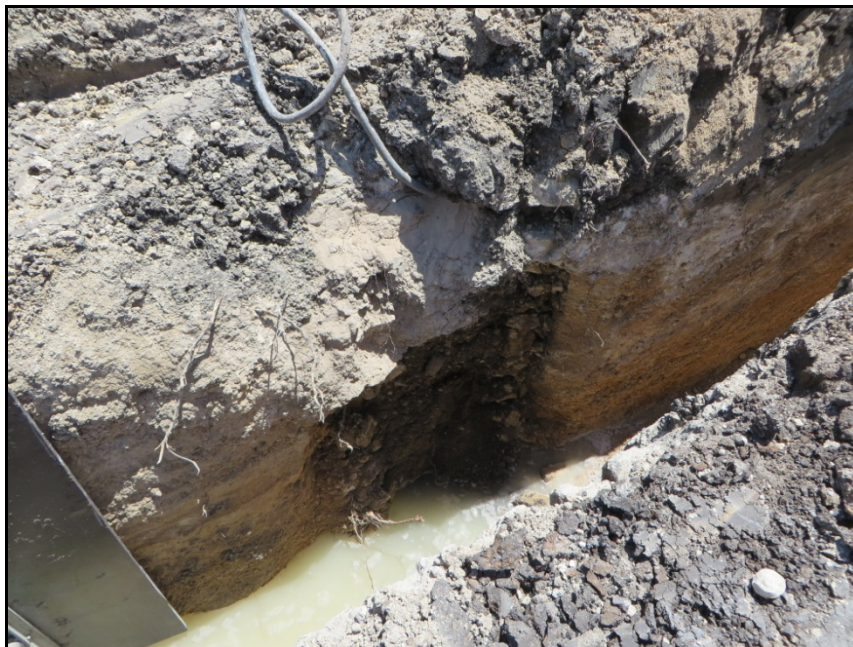
Figure 6-50. Feature 31, facing south.

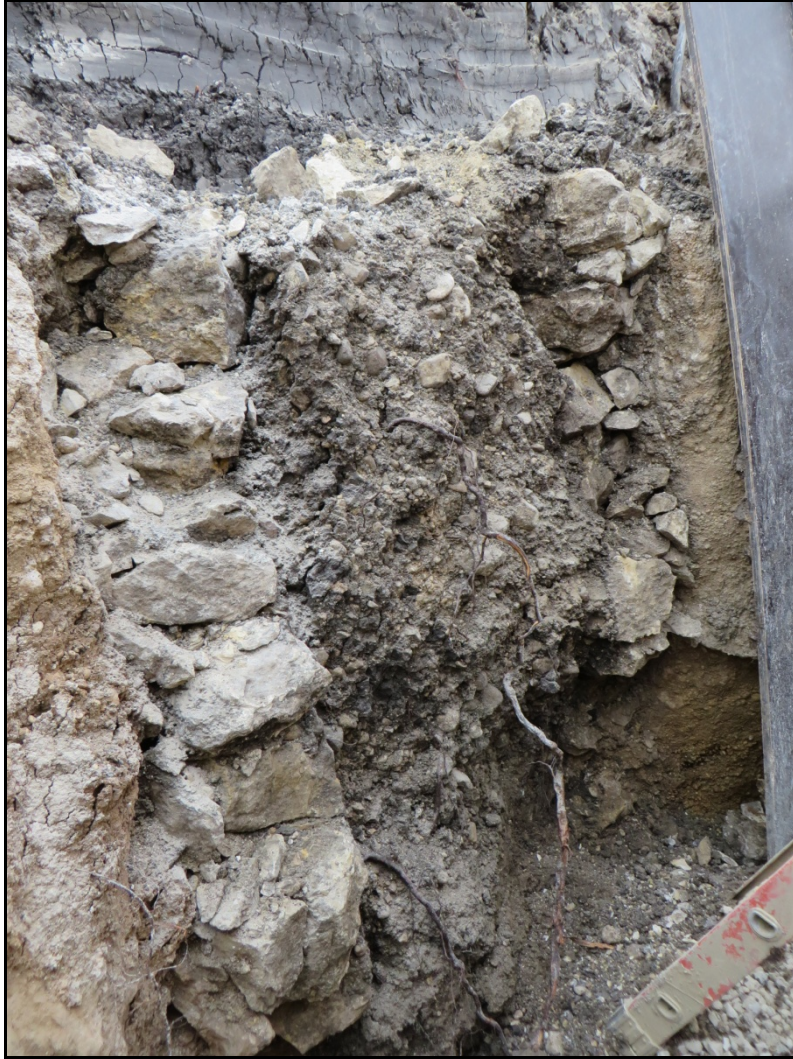
Figure 6-51. Feature 31, facing southwest after exposure.
