Report for Archeological Survey

Farm-to-Market (FM) 116
Improvements from US 84 to
Cactus Lane, Coryell County, Waco
District.

CSJ: 0724-01-044

Geoarcheological Observations, Survey of Proposed Bridge Replacement, FM 116 at Cowhouse Creek, Coryell County, Texas

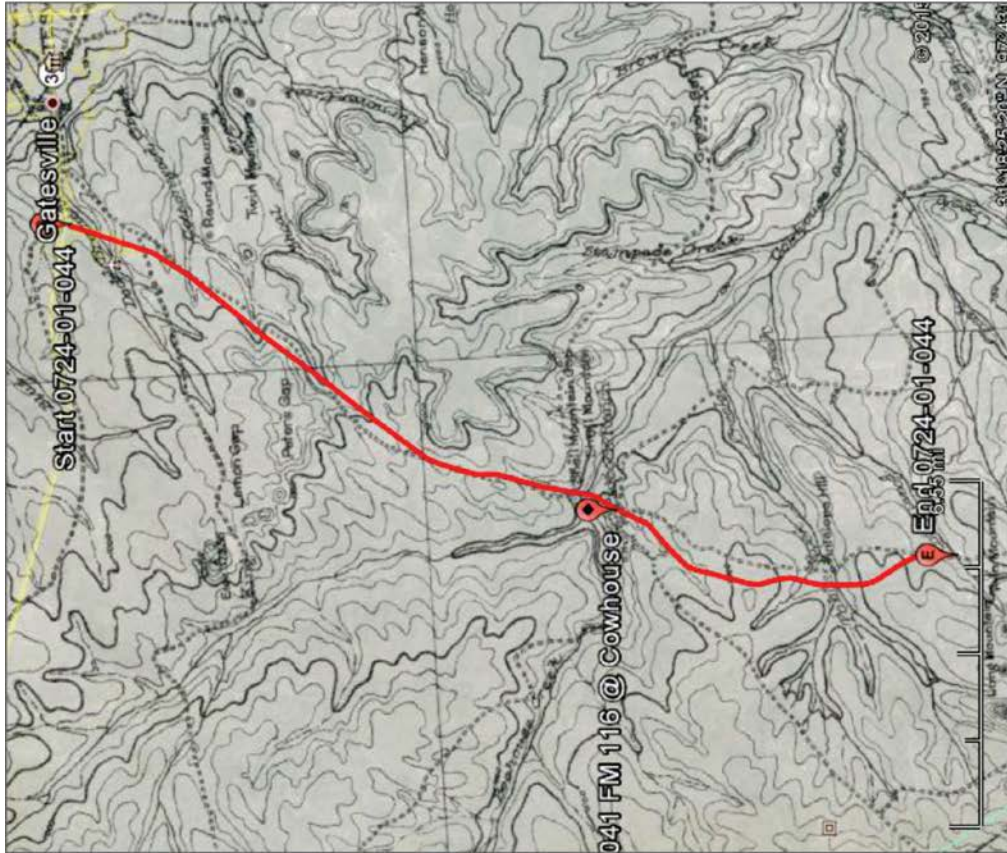
Figure 4a. 1917 [1894 Survey] USGS Reconnaissance Gatesville, Texas Sheet

Figure 4a. 1917 [1894 Survey] USGS Reconnaissance Gatesville, Texas Sheet.

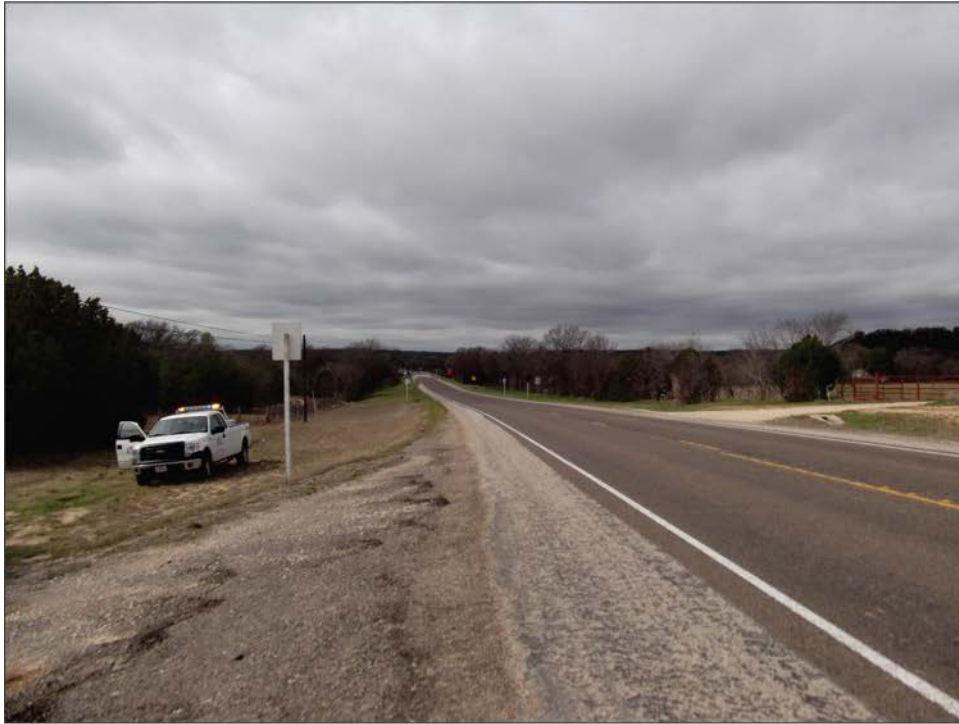
**Figure 7. Looking south towards Cowhouse Creek.
Note elevated section and drainage ditch.**

- **Project Area Description:** The APE is predominantly cleared and maintained highway right of way, typically 100 feet in width. The roadway occupies approximately 30 feet of the width, and considerably more in cut sand fill sections. Drainage ditches one to three feet deep were installed along segments of the APE (**Figure 7**). At Cowhouse Creek, disturbances from prior bridge construction were extensive close to the channel (**Figure**

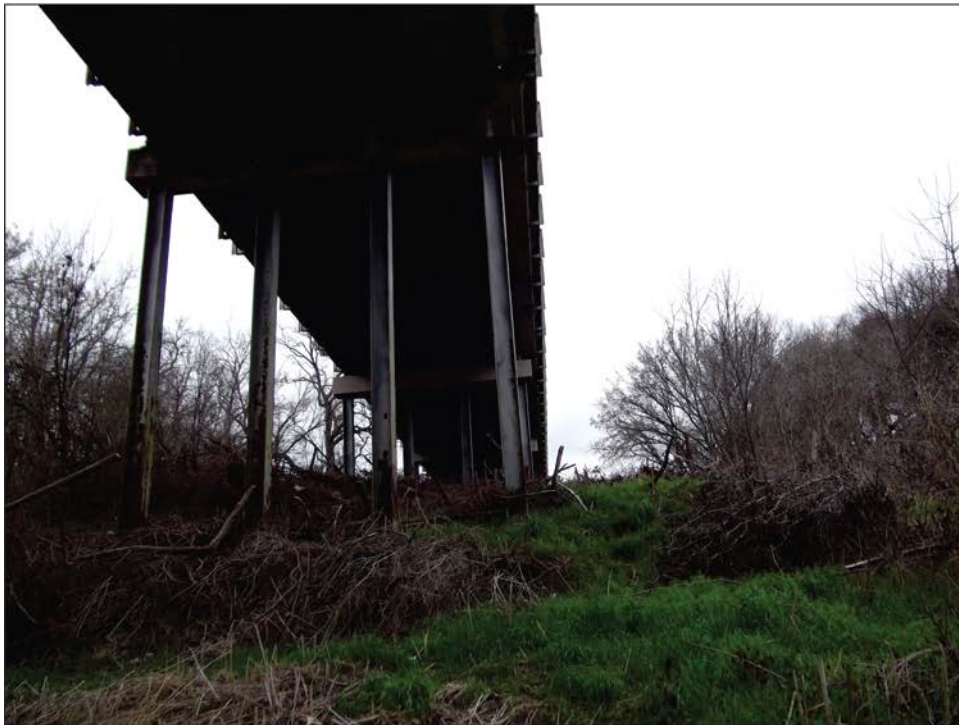
**Figure 8. South abutment of existing bridge at Cowhouse Creek.
Note mechanically shaped terrace.**

8). The previous alignment from the 1930s was visible east of the APE with the north abutment still standing (**Figure 9**). In the northeast quadrant, a box culvert extends to the edge of the right of way, reducing the available area for trenching so that a single location was selected (**Figure 10**).

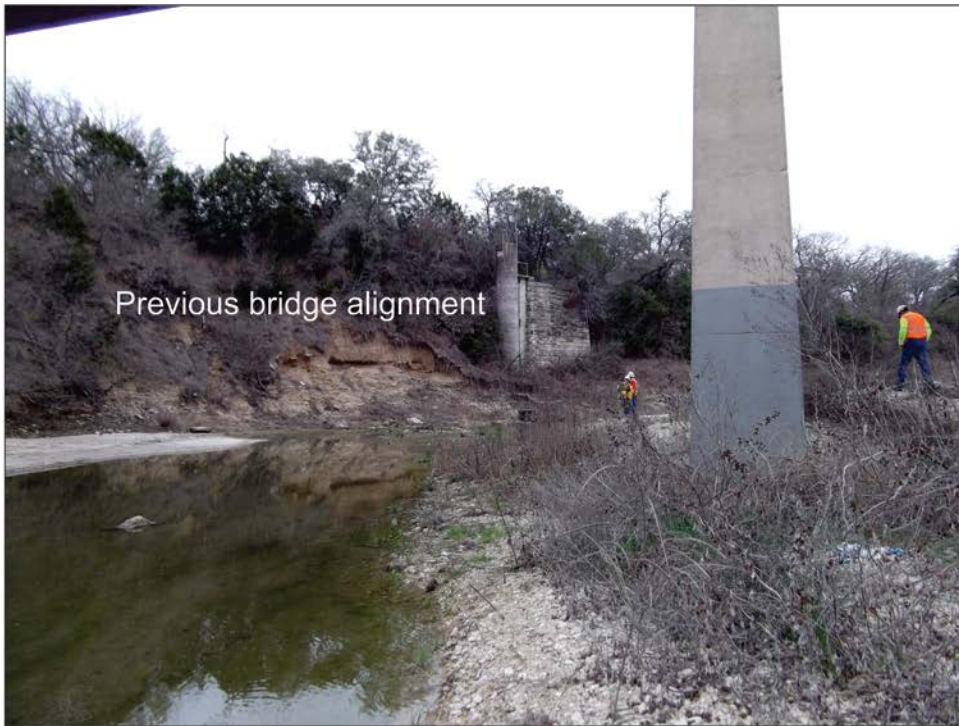
Figure 9. Existing bridge with previous alignment visible on north bank at Cowhouse Creek.

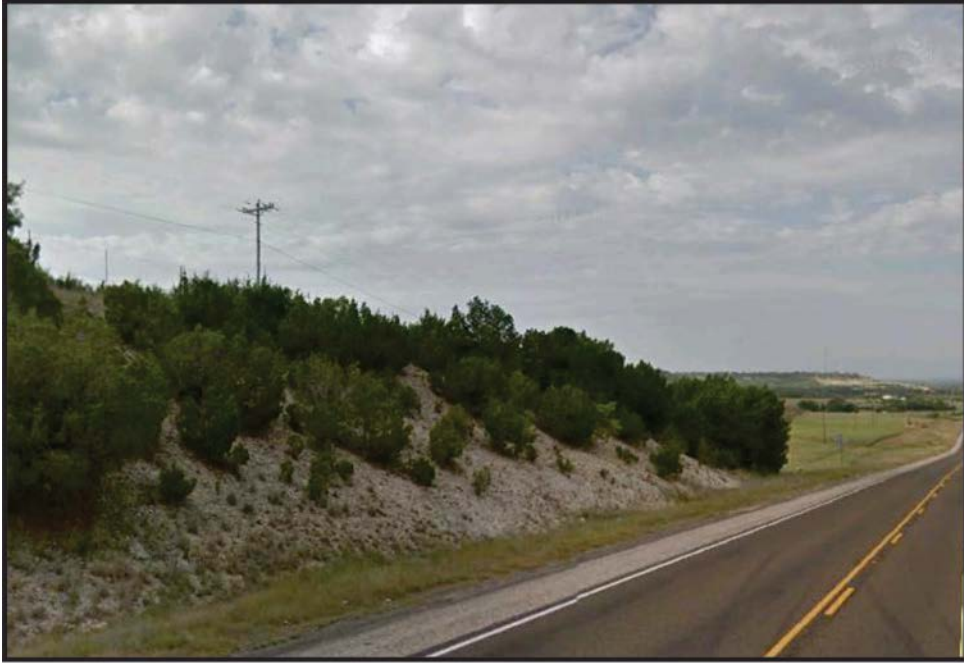
Figure 11. Typical uplands cut section on FM 116 exposed Cretaceous-age geology. Looking south.

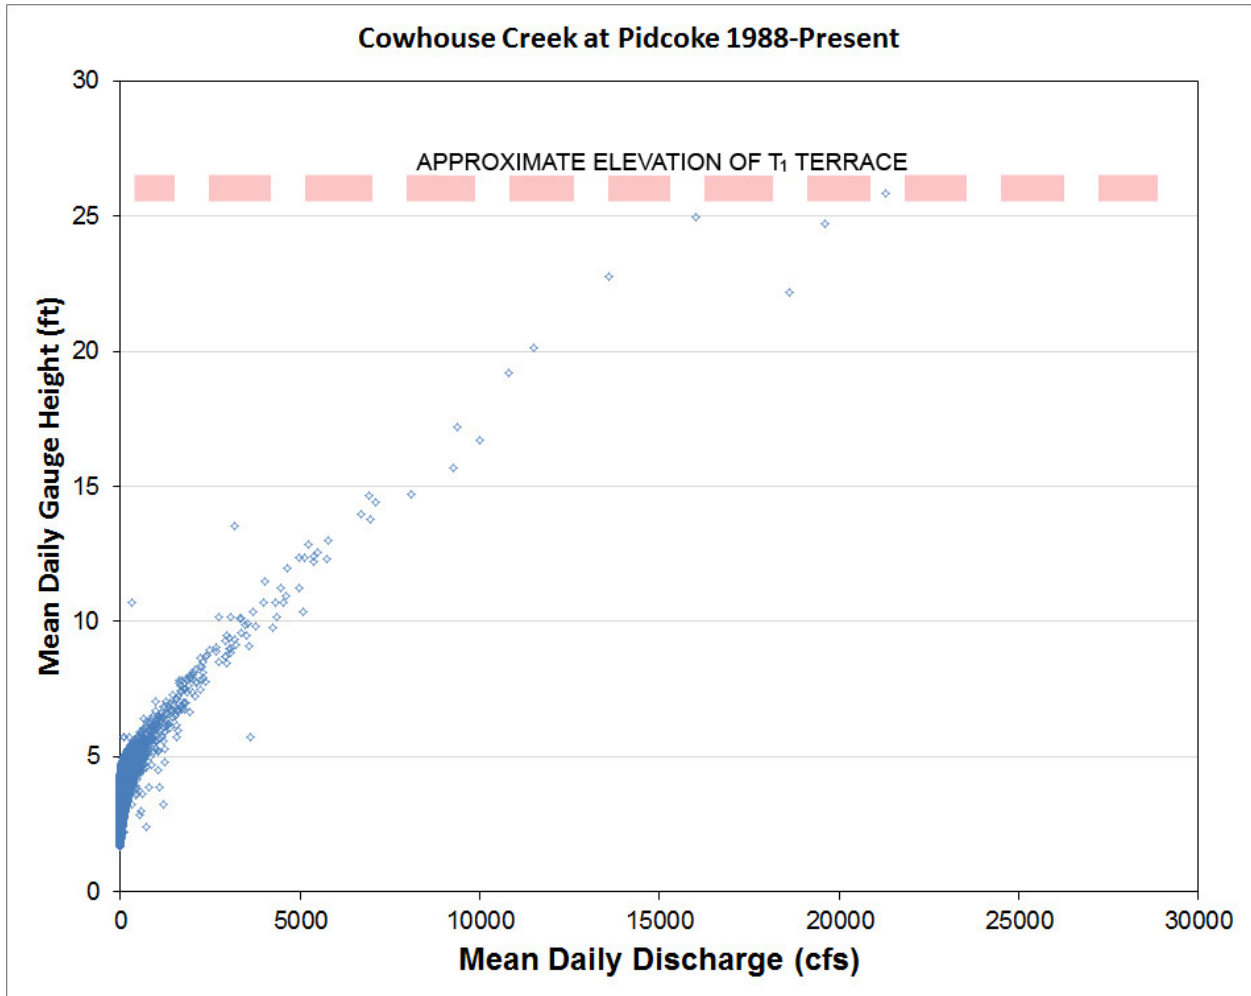
Figure 6: Relationship between mean daily discharge and mean daily stage height for Cowhouse Creek at FM116, 1988 to present.

Most deposits laid down since the Jackson fill was abandoned underlie this first (T_1) terrace, which is at an elevation of 8-10 m above the modern channel. These deposits include the Georgetown, Fort Hood, and Upper and Lower West Range units. Each represents a period of alluvial aggradation separated by an episode of stream entrenchment, and all but the Georgetown are exposed at the surface at various places on the terrace tread. The most recent unit is the Ford alluvium, which dates roughly to the last few centuries and underlies a narrow, discontinuous and irregular modern floodplain (T_0) up to 7.5 m above the channel. Floods in the Cowhouse valley are generally confined to the relatively narrow channel trench, and events overtopping the T_1 terrace are relatively rare and subside quickly (**Figure 6**).

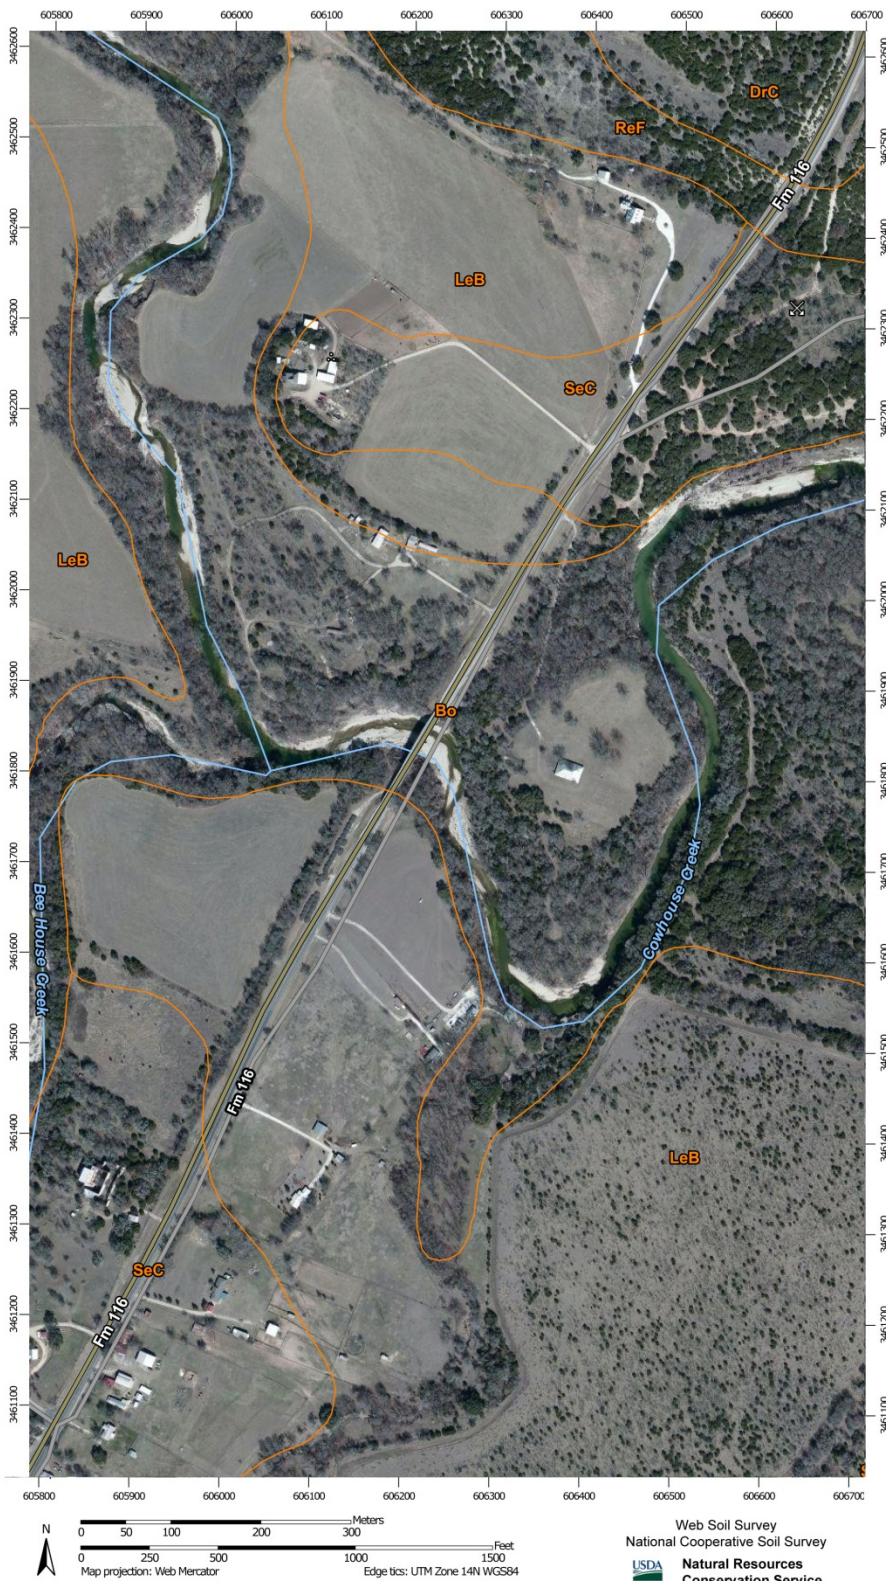
Figure 8: Soil map of study area. Key to mapping units : B0 = Bosque clay loam, 0-1% slopes; DrC = Doss-Real complex, 1-8% slopes; LeB = Lewisville clay loam, 1-3% slopes; ReF = Real-rock outcrop complex, 12-40% slopes; SeC = Seawillow clay loam, 3-5% slopes.

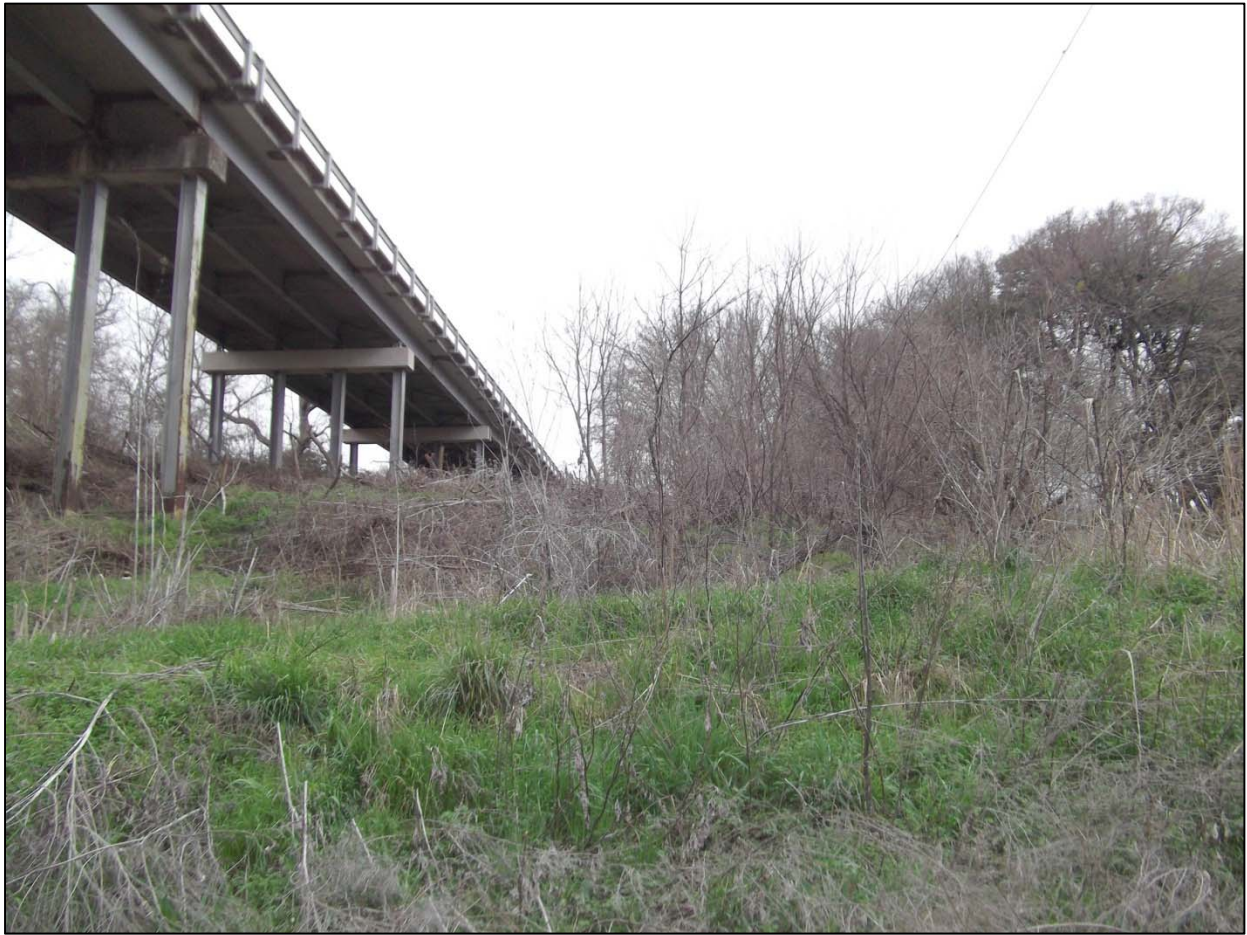
Figure 10: View looking up from at the channel at the irregular T_0 surface.

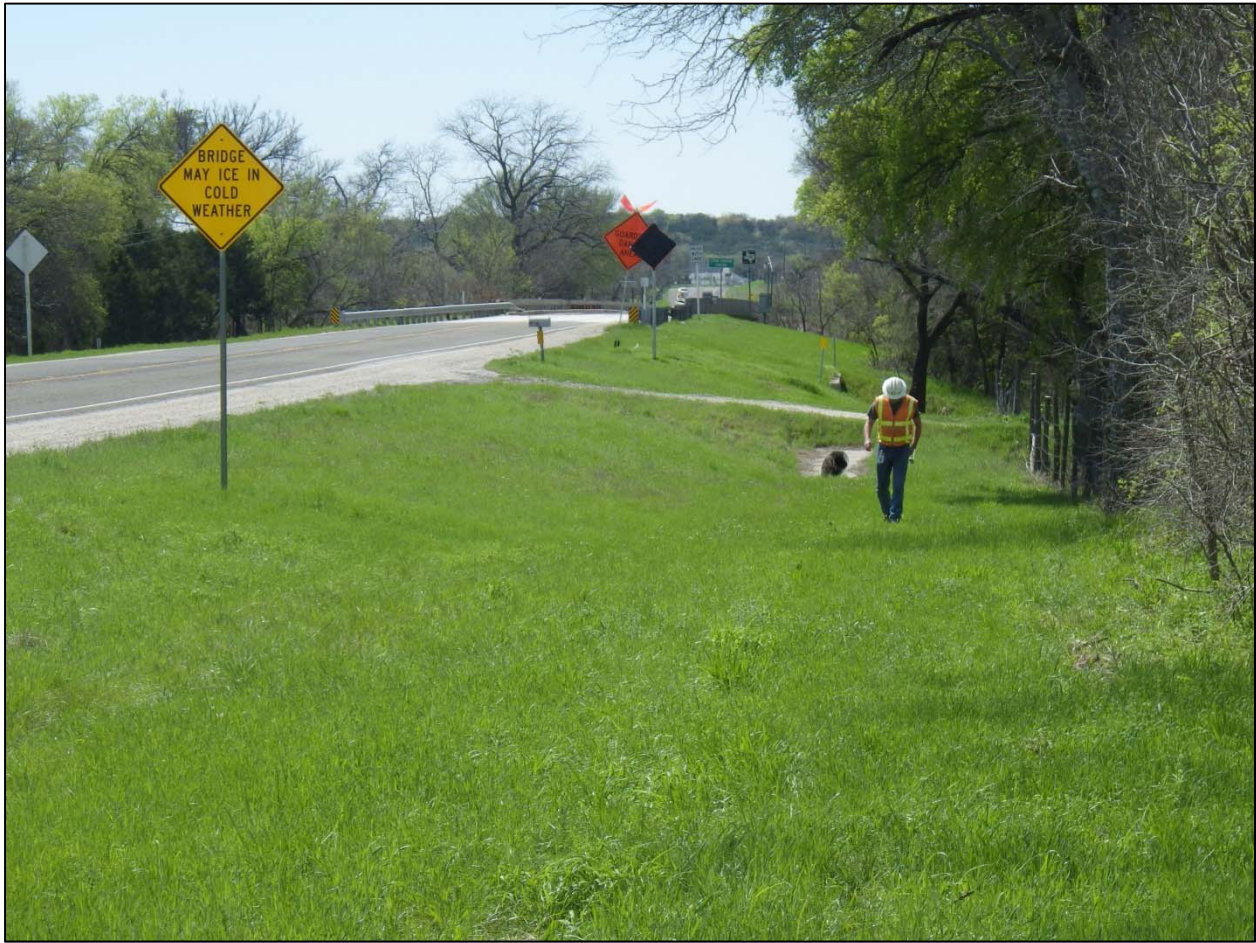
Figure 11: View looking south toward the bridge from the approximate location of BT4, showing ditching and wide fill section of the ROW in proximity to the bridge.

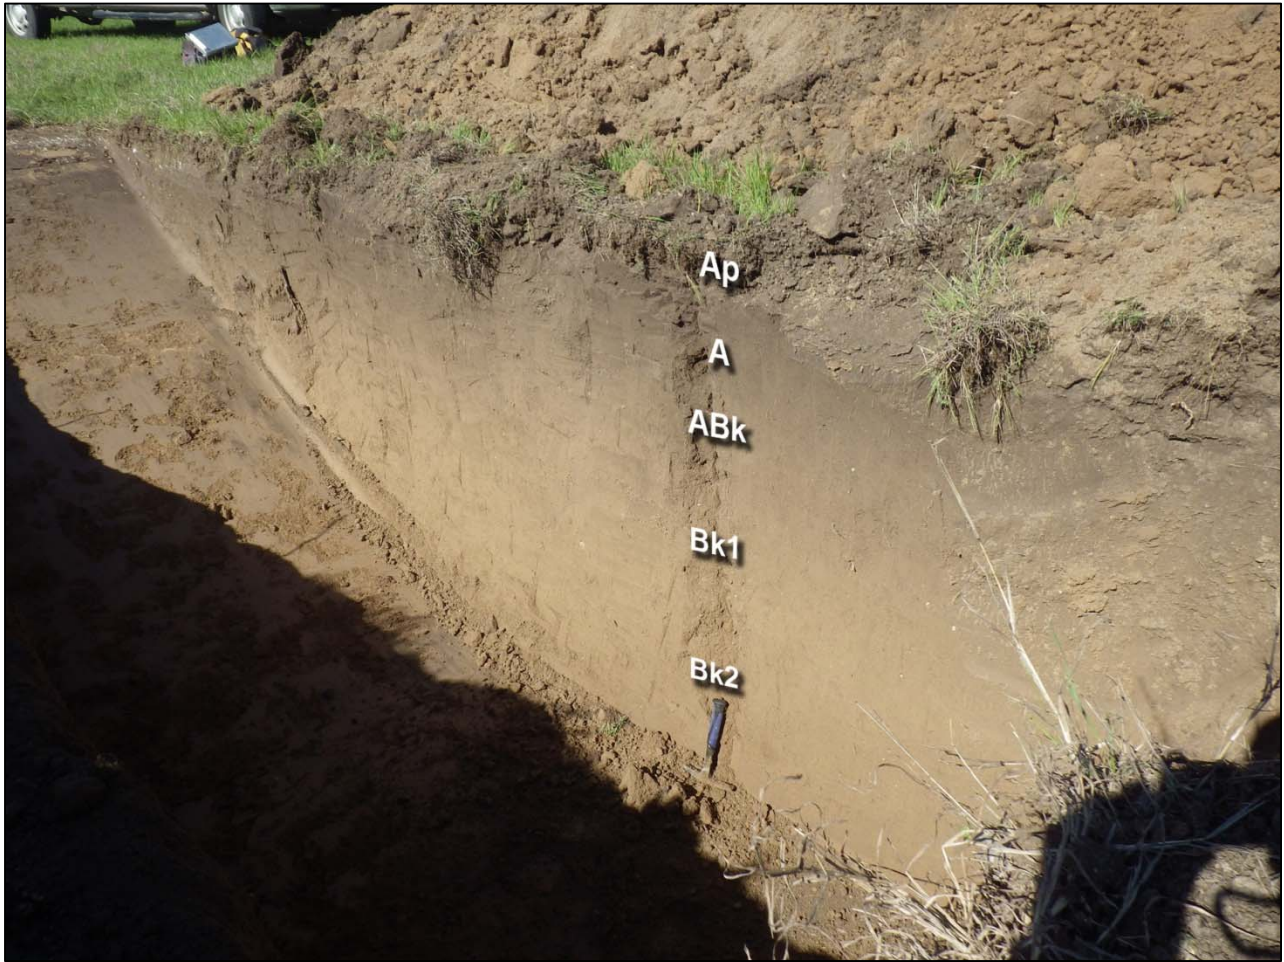
Figure 12: Profile of BT1

one in the NW quadrant. Those trenches in the southwest quadrant exhibited an A-ABk-Bk profile developed in a relatively light silt loam, while the trench in the northwest quadrant exhibited a more clay-rich A-Bk profile containing probable reworked carbonate nodules and very sparse crumbs of burned rock that are likely in secondary context.

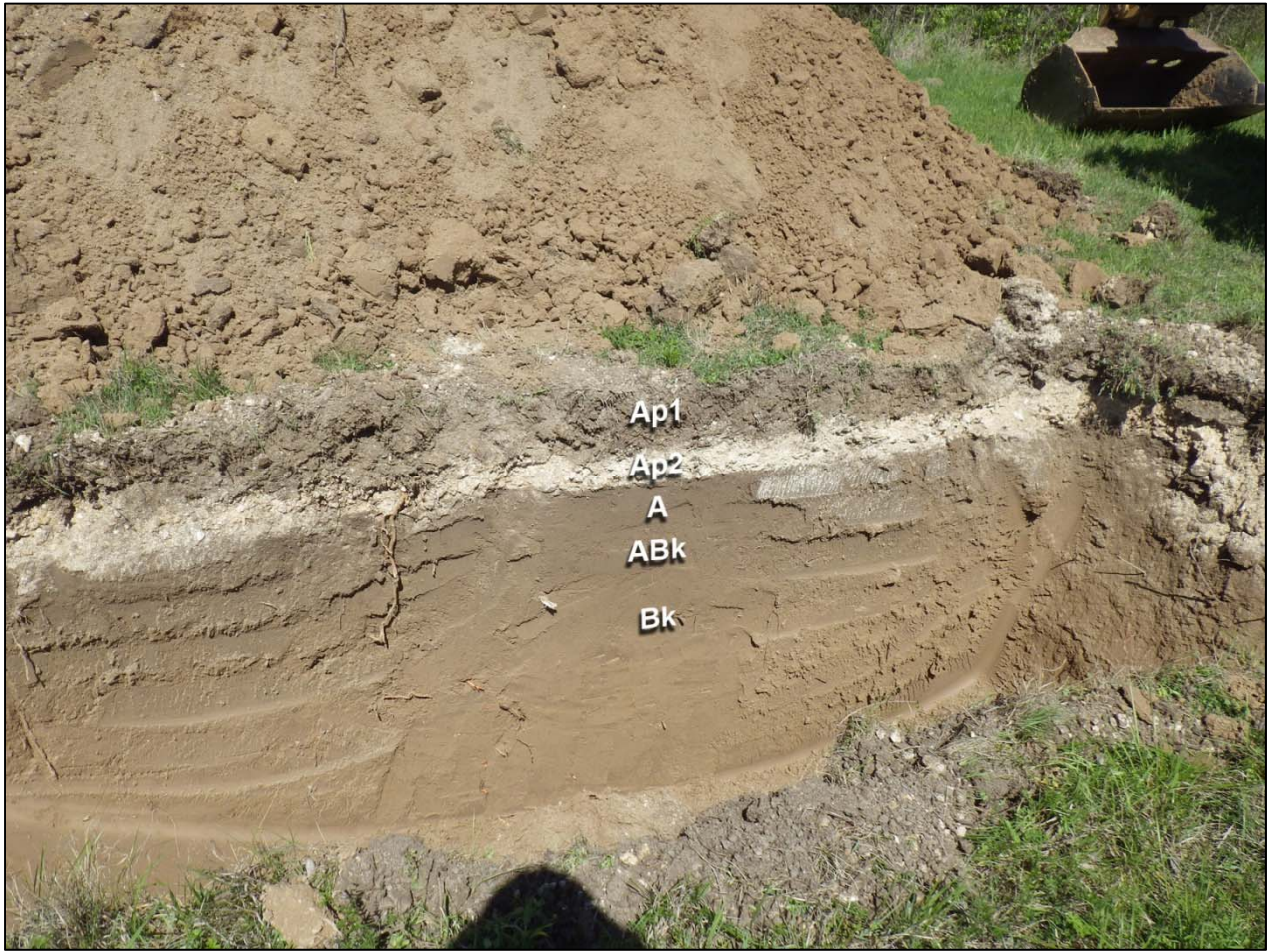
Figure 14: Profile of BT 3.

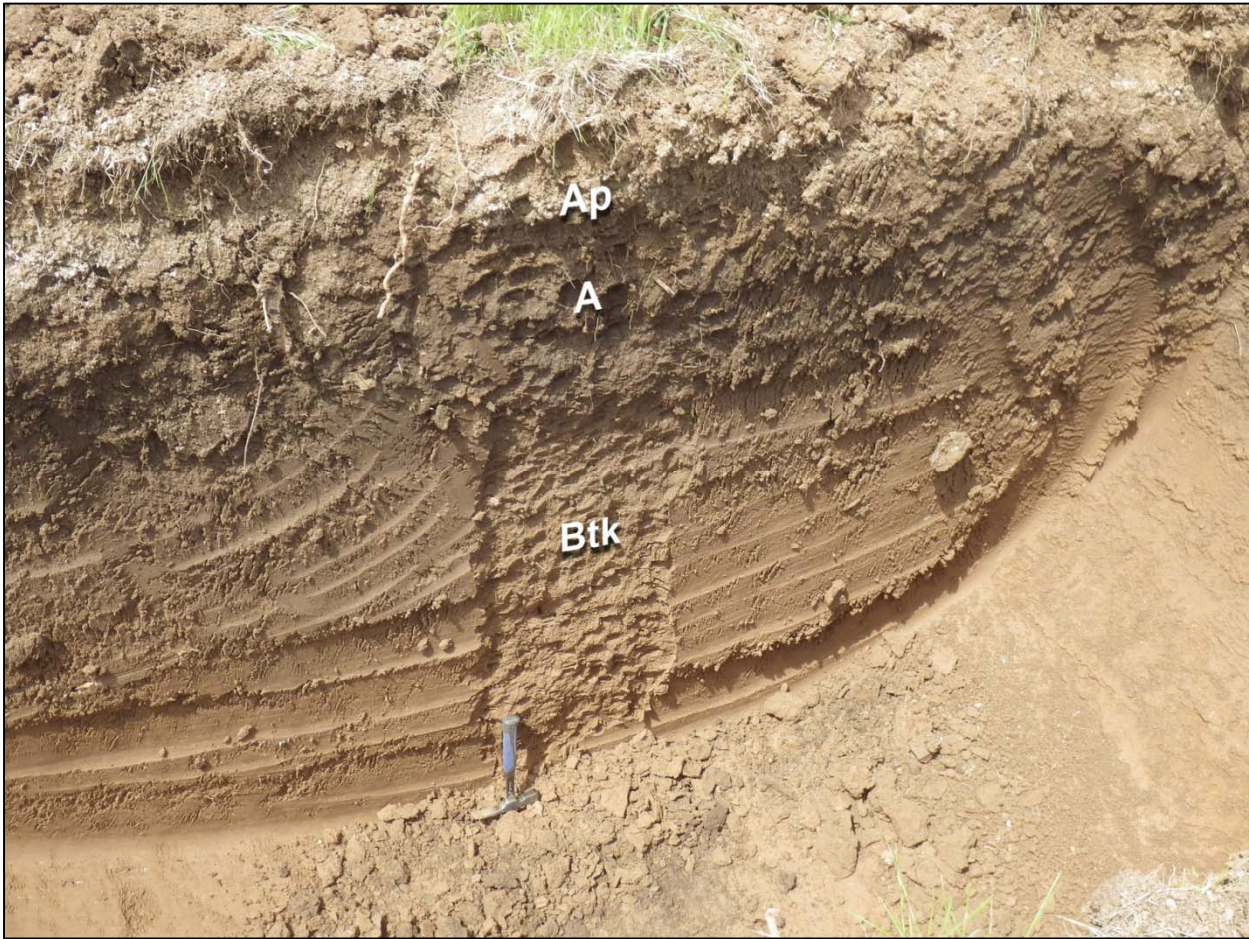
Figure 15: Profile of BT4.
