Intensive Archeological Survey on County Road 151 at the Nueces River, Live Oak County, Texas

Report for Archeological Survey

Corpus Christi District

CSJ: 0913-29-013

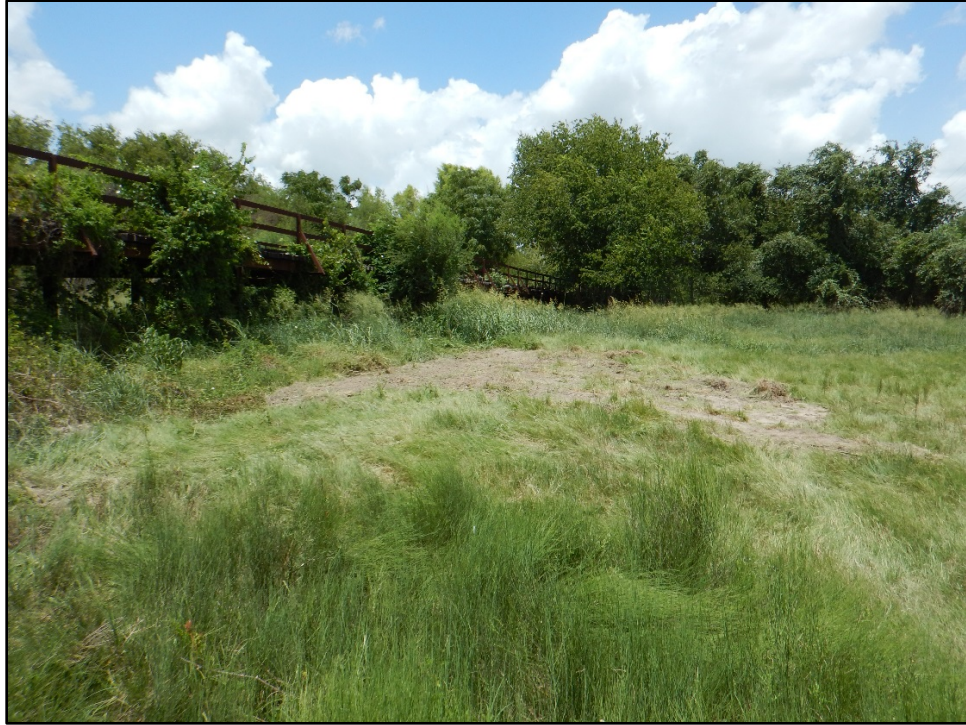
Vegetation: The existing APE consists of tall grasses in the floodplain, along with oak and mesquite stands with dense undergrowth (Figures 4 and 5).

Figure 4. Overview of tall grasses within the floodplain of the Nueces River, facing north.

The APE is located on a T₀ terrace and is subject to frequent flooding and the deposition of alluvium (see Figure 4). The natural stratigraphy within the existing ROW consisted of six alluvial strata with a maximum depth of 200 centimeters below surface (cmbs). The top two strata of BHT01 consisted of a yellowish brown (10YR 5/4-5/6) sandy loam with mottles of pale brown (10YR 6/3) overlying a light gray (10YR 7/1) sand lens measuring 10 cm (Figure 8). The third stratum consists of a light yellowish brown (10YR 6/4) silt loam. The fourth, fifth, and sixth strata are all very similar dark yellowish brown (10YR 4/4) loams and are differentiated by the amount of clay in the matrix. One modern brown bottle glass fragment was found at 90 cmbs and one wire nail was found at 200 cmbs (Figure 9). These two artifacts were attributed to disturbance from road construction and the installation of a nearby buried telephone line. BHT02 is composed of a single stratum similar matrix to BHT01 stratum 1, although it was more disturbed with evidence of mottling up to 100 cmbs where an abandoned buried telephone line was encountered (Figure 10). The strata were all alluvial in nature and no clear evidence of a buried soil was observed. No cultural materials were encountered during the trenching efforts.

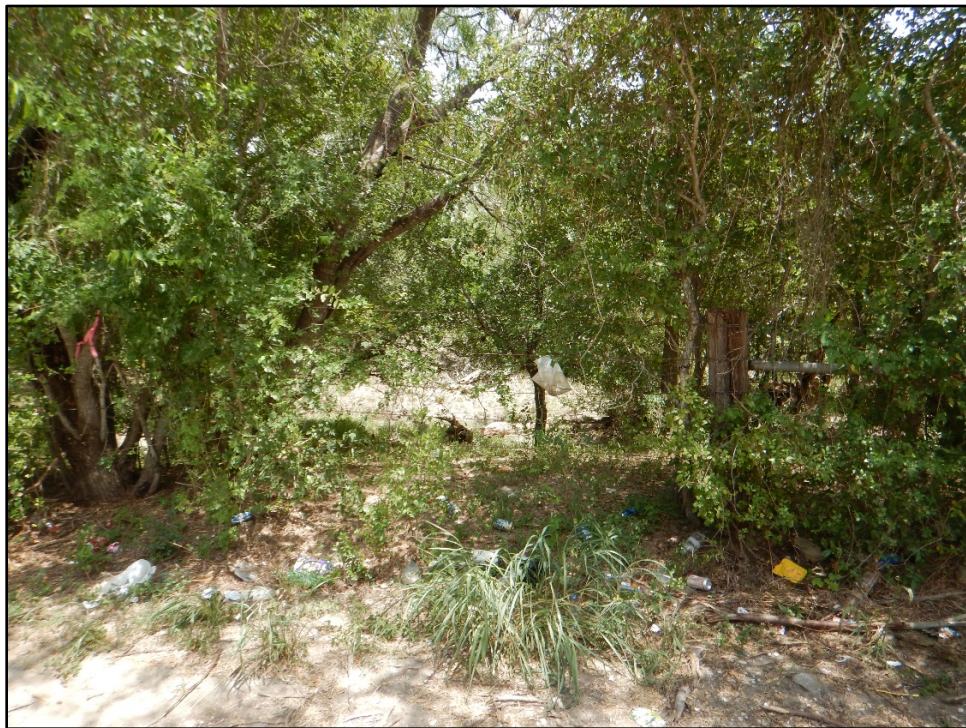
Figure 5. Overview of trash littering existing ROW within northeast quadrant, facing east.

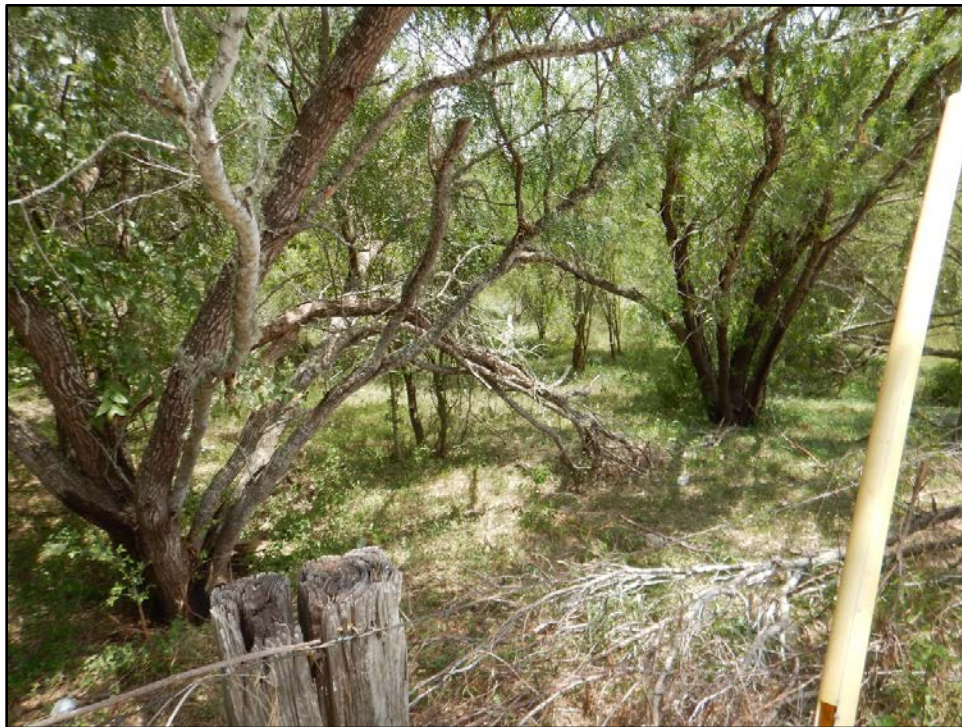
Figure 6. Overview of mesquite stand within APE, facing west.

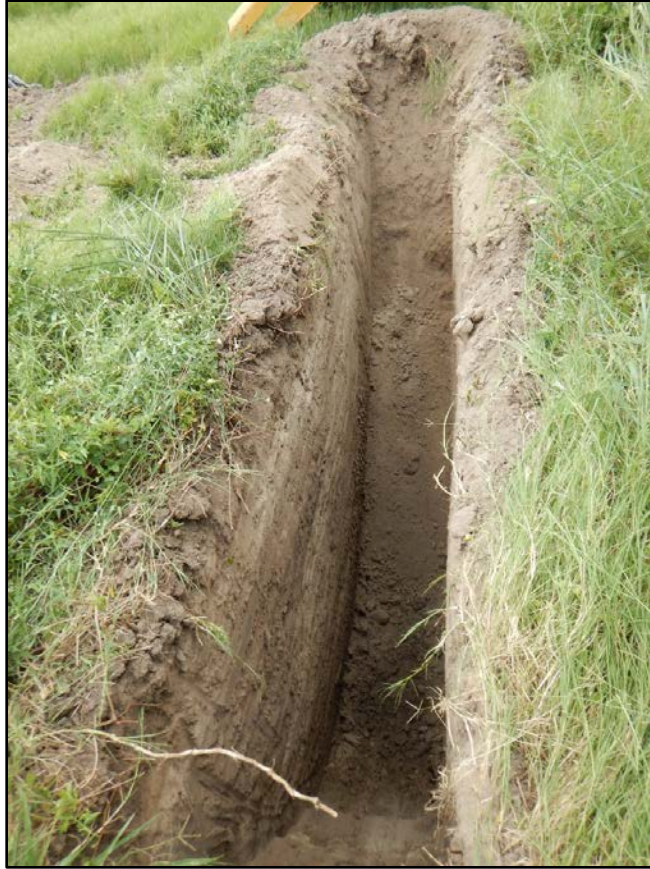
Figure 8. Overview of BHT01, plan view.

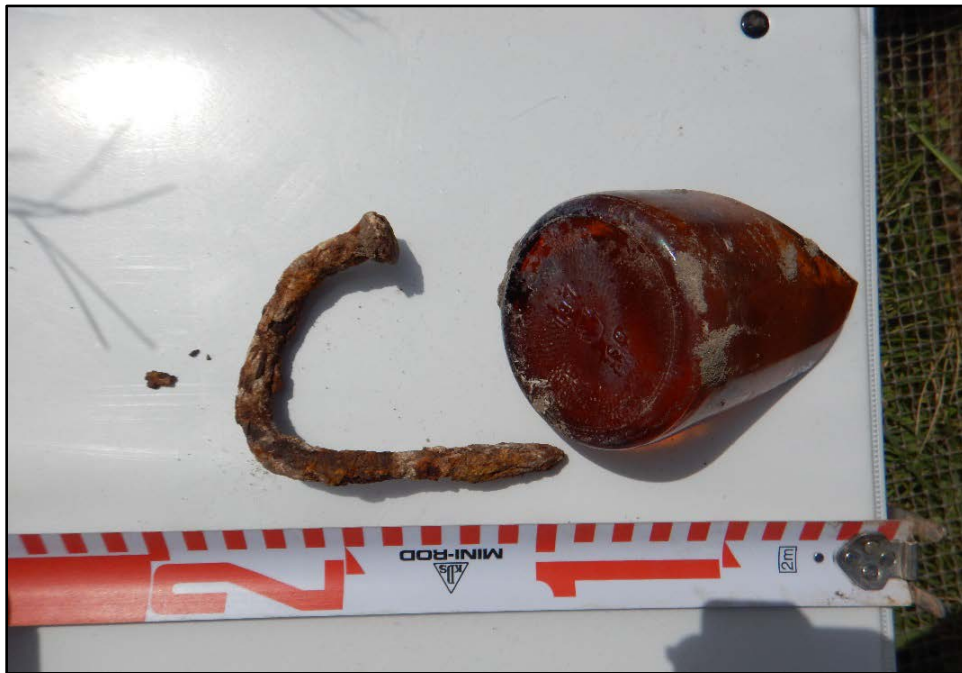
Archeological Materials Identified: SWCA did not encounter any cultural resources other than modern roadside debris including glass soda and beer bottles, a buried abandoned phone cable, and plastic fragments, within the project area.

Figure 9. Overview of brown bottle glass and wire nail found in BHT01.

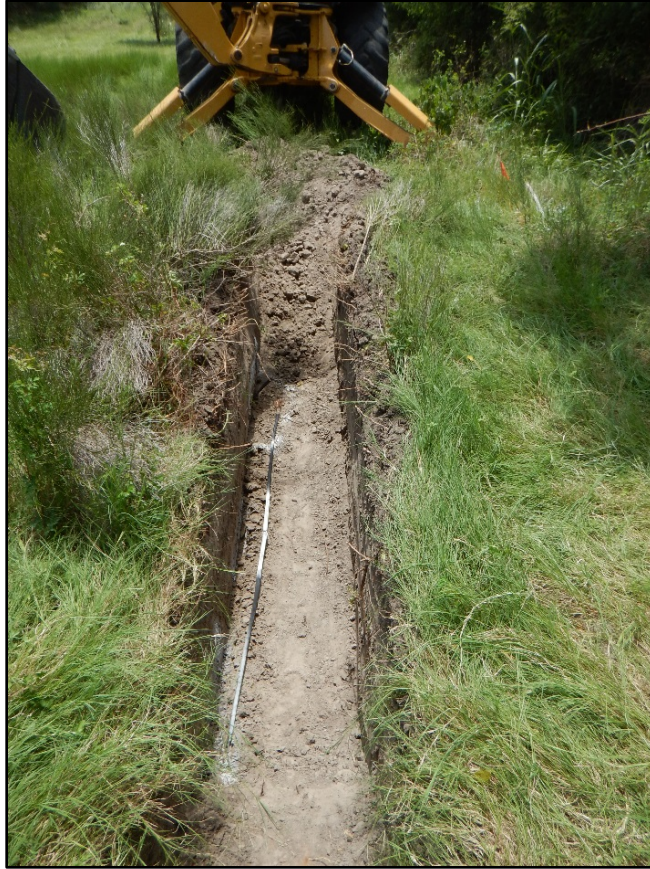
APE Integrity: The existing CR 151 APE exhibits extensive prior disturbance from road construction the installation of a telephone cable thereby compromising the integrity of the survey area and any cultural resources that might be present within them.

Figure 10. Overview of abandoned telephone line encountered in BHT02.
